NAVAL AIR ENGINEERING CENTER LAKEHURST N J ENGINEERIN--ETC F/G 1/5  
METALLURGICAL ANALYSIS OF ARRESTING GEAR DECK PENDANT FAILURES.(U)

NAEC-ENG 7910

METALLURGICAL ANALYSIS

ARRESTING GEAR DECK PENDANT FAILURES

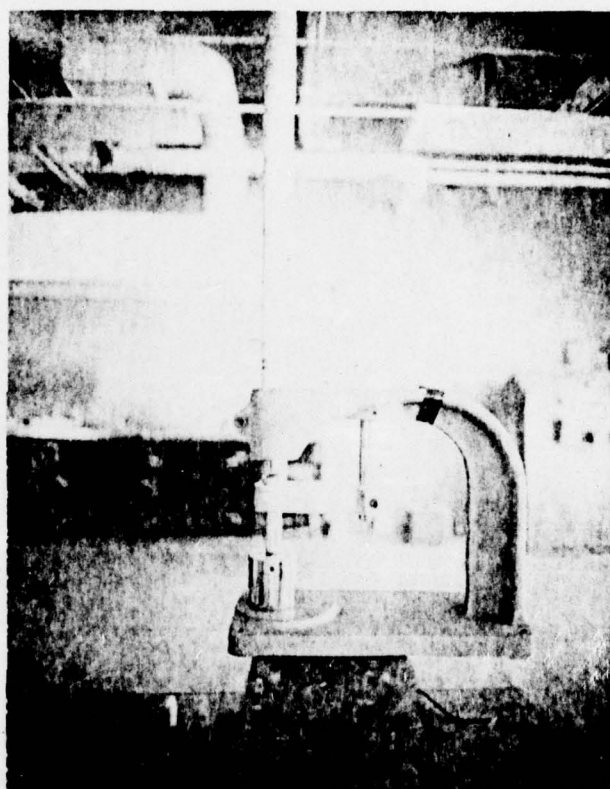
FIGURE 27

The Gardner heavy-duty impact tester (Model No. 1G-1120) was utilized. This unit consists of a graduated vertical tube which guides a 4 pound weight, dropped against a punch-hammer, from a maximum height of 40 inches. This enables the available impact force to range from 0 to 160 inch-pounds. (See Figure 27)

Side view of the Gardner heavy-duty impact tester

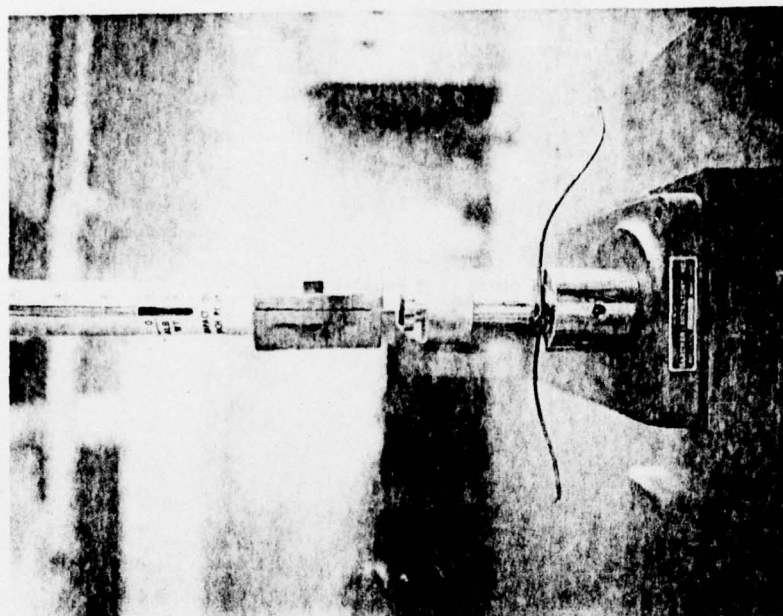
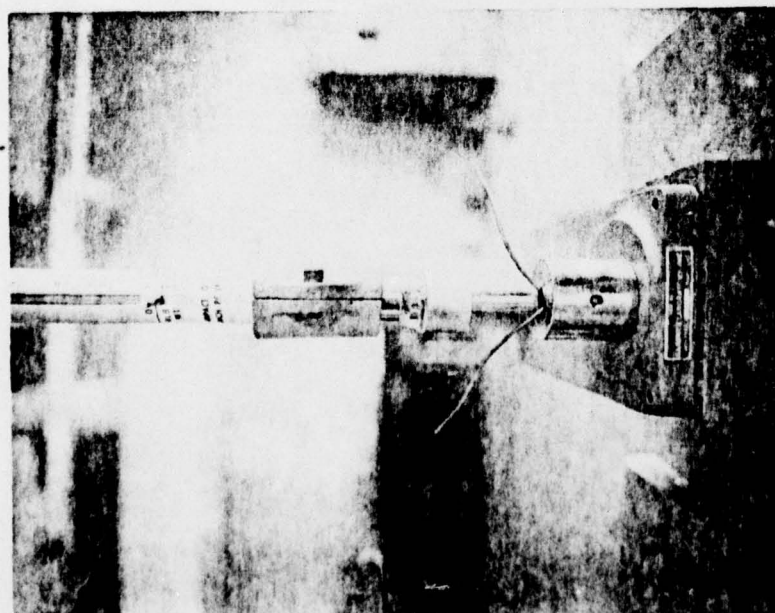
FIGURE 28.

The wire specimens were placed between the .500 inch punch-hammer and the .640 inch die with the "white martensite" fully face down (see figure 28). Each set of specimens were impacted from 160 inch-pounds down in increments of 20 inch-pounds. The lowest force required to consistently part a wire is referred to as the wire's minimum impact strength. These values are listed in Table V.

Before impact test

After impacting with  
4-pound weight
