LABORATORY TEST AND EVALUATION OF A GRAPHITE EPOXY AIRCRAFT WHEEL

MECHANICAL BRANCH VEHICLE EQUIPMENT DIVISION

JUNE 1976

TECHNICAL REPORT AFFDL-TR-76-54 FINAL REPORT FOR PERIOD JULY 1972 - JULY 1975

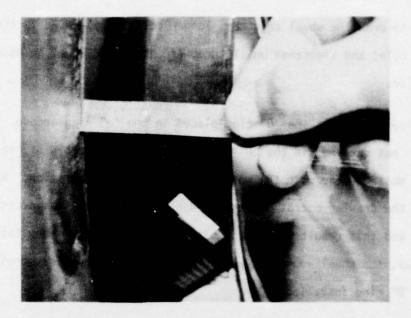
Figure 10 illustrates the gap between the graphite epoxy wheel and the tire after the wheel half had been pressed (by hand) into the tire. Based on a measurement of this gap, the interference between the tire bead and the wheel - with the tire seated against the rim - was estimated to be 1/8 in. on the diameter. For comparison purposes, Figure 11 shows the gap between the aluminum production wheel and the tire under similar conditions. As a result of this gap, the G/E wheel had to be drawn together before the correct tie bolts could be installed. Six tie bolts are used on the wheel,

Figure 10. Gap Remaining with Tire on G/E Wheel (Tie Bolts Not Installed)

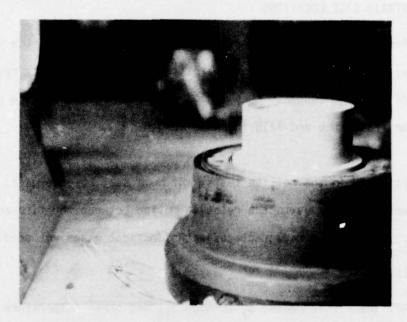
Figure 12 shows the "O" ring placed in the "O" ring groove. The "O" ring is not retained in the "O" ring groove, thus assembly of the wheel halves must be done with the wheel in the horizontal position. However during the drawing operation described above, the wheel was occasionally titled and this resulted in a pinching of the "O" ring. When this occurred, the wheel would not retain air and had to be disassembled and a new "O" ring installed.

Figure 12. "O" Ring Placed in Groove

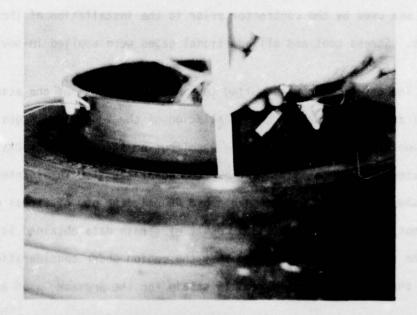
Once the wheel bolts were fully torqued (15 ft-1b), a gap remained between the wheel and the tire as shown in Figure 13. At approximately 20 psi, the tire seated against the outer flange. Prior to assembly, a liberal coating of silicon grease was spread on the barrel of the wheel and the aluminum hub. This was done to reduce the tendency for the tire to cling to the wheel during disassembly.

Figure 13. Gap Remaining After Wheel Halves Were Bolted Together

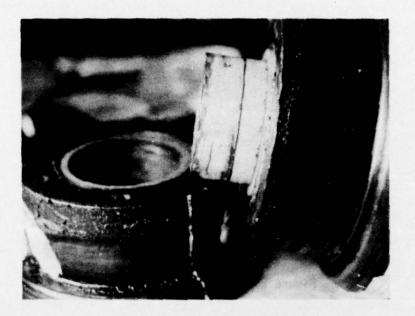
At 260 miles into the straight slow roll test, several events occurred which delayed the tests. During a visual inspection of the wheel, crazing lines were discovered in the outer flange area near the bead seat. At this point the test was stopped and the wheel was disassembled. Figure 22 illustrates the wheel immediately after disassembly. A crack was discovered in the composite structure near the Al hub and this is shown in Figure 23.

Figure 22. Disassembled Wheel After 260 Miles of Straight Roll

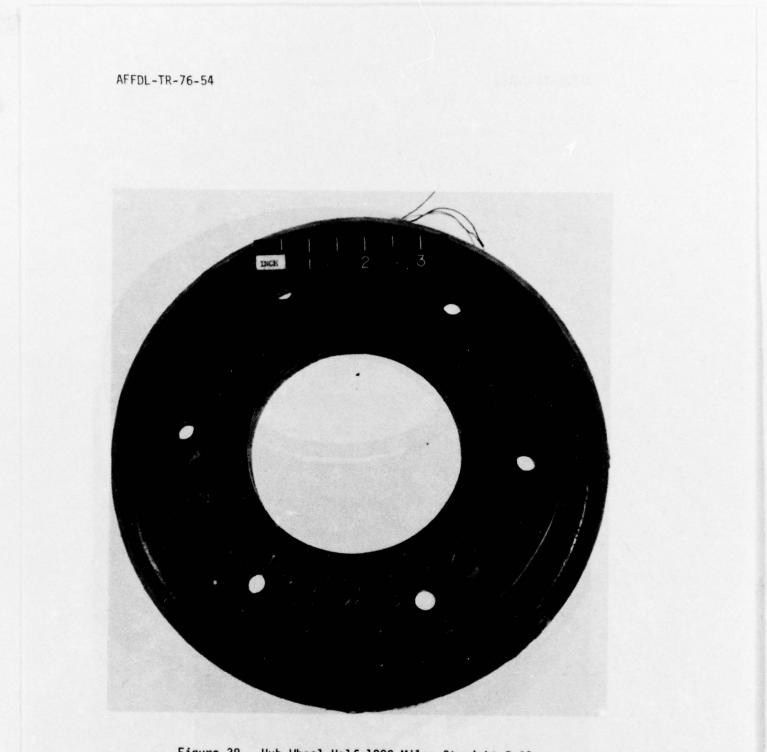
The roll test was uneventful from 650 to 1000 miles of straight roll. After 1000 miles, as the wheel was disassembled for inspection, the Al hub had moved axially and could finally be forced from the wheel. Figures 37 through 42 depict the wheel after 1000 miles of dynamometer straight roll. At this time the crack discovered at 650 miles had developed into definite corner delamination. As shown, this delamination extended over halfway around the circumference of the wheel. Since this delamination extended over halfway around the circumference of the wheel. Since this delamination did not extend into the hub of the wheel its effects on the structure of the wheel were negligible. Figures 37 through 42 also illustrate the condition of the bolt bosses, the wheel hub, bead seat, and the Al hub after 1000 mile of slow roll. All of the wear which resulted from the rubbing of the Al hub on the G/E wheel half was confined to the hub.

Figure 38. Hub Wheel Half 1000 Miles Straight Roll

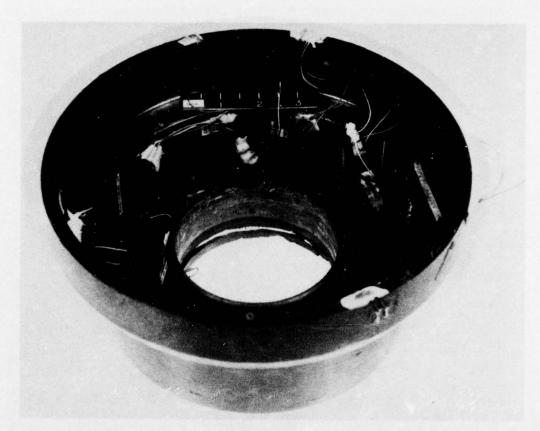
Figure 39. Hub Wheel Half 1000 Mile Straight Roll

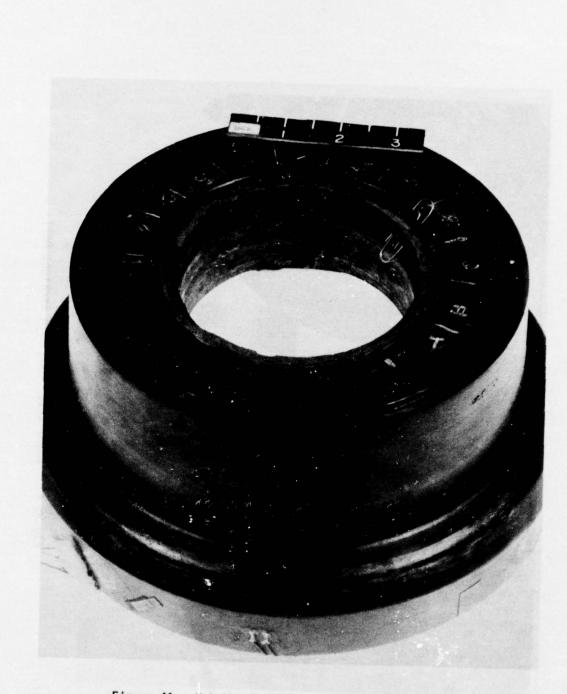
Figure 41. Hub Wheel Half 1000 Mile Straight Roll

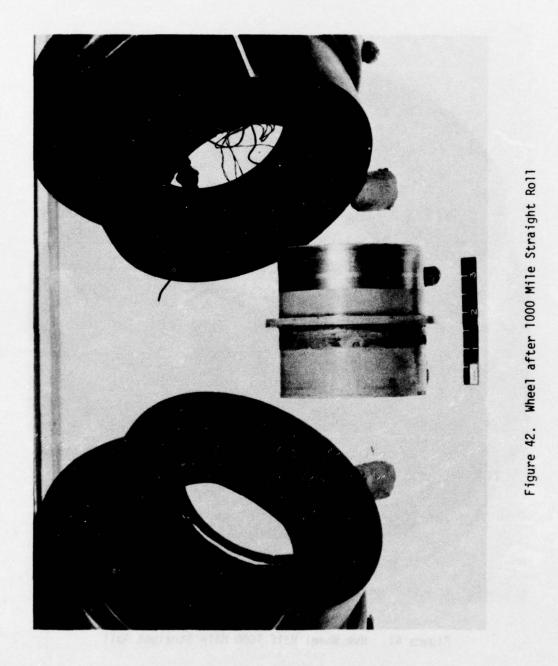
At 1093 miles into the straight roll tests a fatigue failure of three wheel bolts occurred and this is shown in Figure 43 and 44. This caused an immediate unbalanced load on the wheel and broke the epoxy bond between the hub and the wheel. As soon as the air pressure in the tire dropped, the dynamometer unlanded the tire and removed the load. The wheel bolts were only torqued to 15 ft-1bs (the torque requirements for the same bolts on the aluminum wheel are 25 ft-1b) and this must have caused the early fatigue failure. A close visual inspection of the wheel revealed no structural damage had been done by this mishap. The Al hub was pressed out of the wheel, cleaned and rebonded again.

Next the hub was machined to have 0.004 in. clearance on the diameter with respect to the wheel and bonded back to the wheel using Hughson Chemical Co. Epoxy Adhesive, No. RD-1927-62. The wheel was then assembled with the tire and the straight roll test started again.

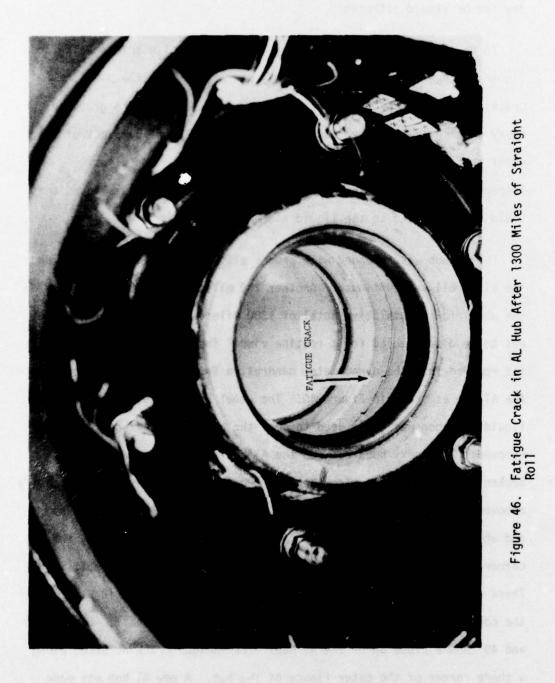
The Al hub was rebonded with proper alignment to the wheel half and the slow roll was continued. Another 200 miles of slow roll were put on the wheel for a cumulative total of 1300 miles. At this time the wheel was to be disassembled for a routine visual inspection. When the wheel was removed from the dynamometer mandrel, a fatigue crack was found in the Al hub as shown in Figure 46. The wheel was then disassembled and liquid nitrogen was again used to cool the hub so that it could be removed. The epoxy bond between the Al hub and the wheel had also broken again sometime during the last 200 roll miles and so it was easily removed with the aid of the liquid nitrogen. Figure 47 shows the hub and wheel with the hub removed. Attempts had been made to epoxy the corner delamination (shown in Figures 37 to 42) to the wheel half. These attempts were only partially successful and as shown in Figure 47, the corner delamination had broken clear off the wheel half. Figures 48 and 49 show a close up of the Al hub. The fatigue crack occurred along a sharp corner of the outer flange of the hub. A new Al hub was made for the wheel with a thickened center wall and a chamfer which matched

Figure 47. Wheel after 1300 Miles of Straight Roll

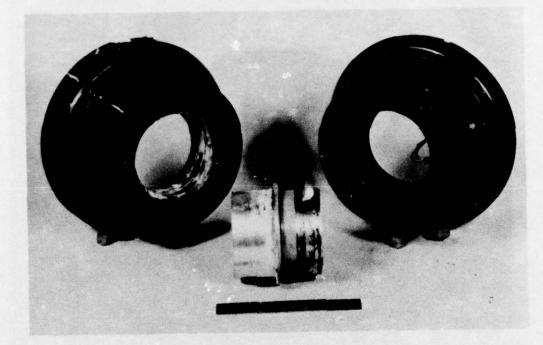
Figure 48. Crack in AL Hub after 1300 Miles Straight Roll

the delaminated wheel half. The half of this hub which was to be bonded was also knurled and the clearance between the hub and the wheel half increased to 0.006 in. The new hub was then bonded into the wheel and the straight roll test continued. Another 100 miles was attained without incident. This satisfied the straight, unbraked roll requirements of the AF qualification drawing (Reference 1 summarized in Chapter 2).

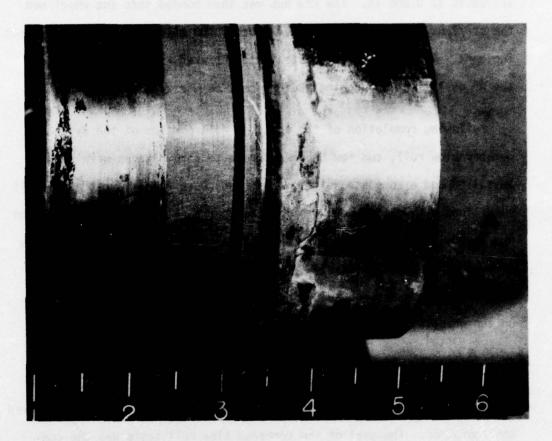
Figure 49. AL Hub after 1300 Miles Straight Roll

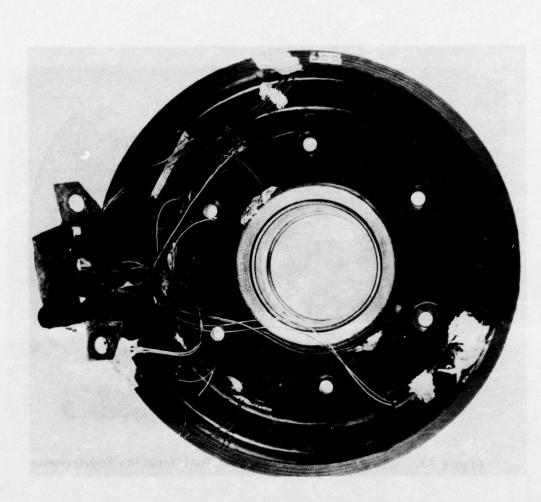
touchdown at 90 mph. The landing was then followed by another two minute, 30 mph taxi roll. After these qualification tests, the wheel was disassembled and photographs were taken (Figures 51 through 53). These photographs show a certain amount of wear on the bolt bosses of each wheel half but the wear was judged to be reasonable, especially when considering the large number of times that the wheel had been assembled and disassembled. It is pointed out that the white material is only a protective epoxy coating which was applied over the strain gages. It was also noticed that the new Al hub was also beginning to show some signs of wear (see Figure 53). This indicates that the proper epoxy adhesive bond still had not been achieved. Also there was a region in the barrel of the wheel, directly over the "0" ring groove, that was beginning to crack slightly. This region was broken off when the "O" ring groove was machined and had, at that time, been bonded back to the wheel. Since the region is in compression, the effects of this cracking were negligible.

Figure 52. Hub Wheel Half after 1400 Mile Straight Roll and 400 Mile Camber Roll

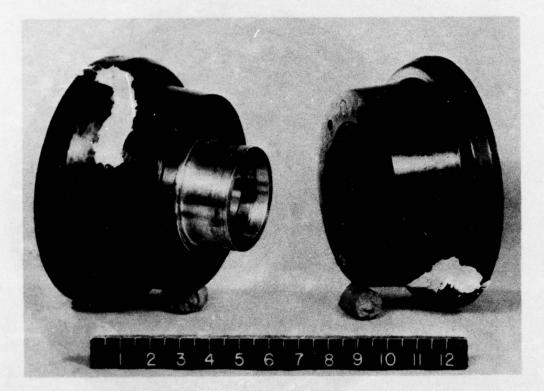
Figure 53. G/E Wheel after Completing Qualification Requirements

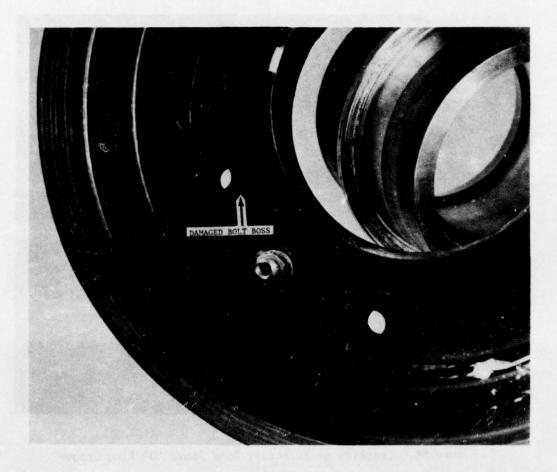
Figures 54 through 56 illustrate the condition of the wheel at this point in the testing. Figure 55 shows the worst bolt boss of both wheel halves. As stated before, when consideration is made of the large number of times that the bolts had been tightened or removed, it is felt that these bosses were holding up well. Figure 56 shows the crack of the original secondary bond region above the "0" ring groove. Also as stated before, this area is in compression when the wheel is assembled and thus the effects of this crack are negligible.

Figure 55. "Worst" Bolt Boss after 2200 Roll Miles

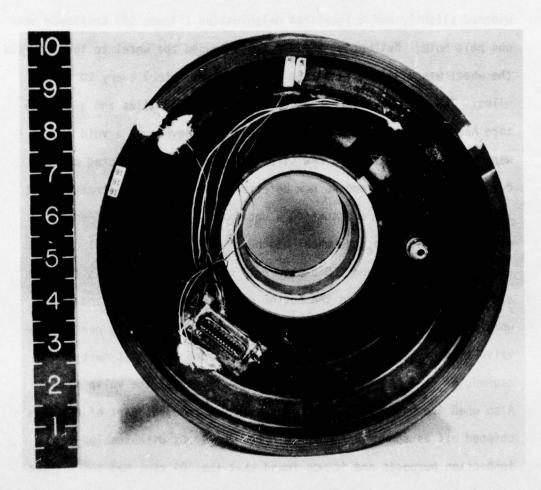
Figures 57 through 59 show the wheel after an additional 850 miles of straight roll. The crack in the barrel of the wheel (Figure 58) had widened slightly and a localized delamination (Figure 59) developed near one bolt hole. Neither of these defects caused the wheel to lose air and the wheel was visually inspected (on the dynamometer) every 20 to 30 miles. The tie bolts were changed about every 500 miles and after the tire had accumulated 1,270 miles the sidewall developed a void and it was necessary to install a new tire. The wheel was inspected closely during this teardown and no new defects were found. The straight roll tests were restarted and continued until the wheel had attained 1,712 miles. At this time, the wheel had been subjected to a total of 3,112 straight roll miles and 400 camber roll miles. Also, at this time, an air leak developed around the bottom of the air valve boss and the wheel began to lose air at a rapid rate. One of the bolts next to the valve stem broke off, apparently due to fatigue, and this must have caused, or at least contributed to, the air leak at the valve stem. Also when the nut end of the broken bolt was removed, part of the boss chipped off as shown in Figure 60. The wheel was disassembled for inspection purposes and it was found that the "O" ring had not slipped out of the groove. Thus, the air leakage was apparently caused by a defect that developed in the bond between the air valve and the graphite epoxy boss. This air leak was fixed by liberally applying an adhesive around the valve stem. Figure 61 shows an overall view of the same wheel half.

Figure 57. Wheel after 400 Mile Camber Roll and 1400 Mile Straight Roll

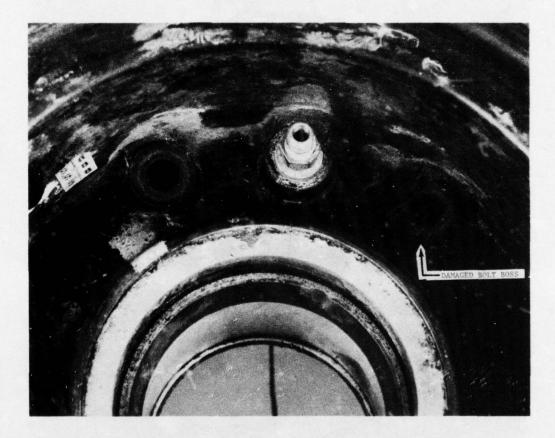
Figure 59. Delamination near Bolt Hole
