FINAL
REPORT OF
PRODUCT IMPROVEMENT TEST OF U-8F
(ECP-BEA-L23-138)
USATECOM PROJECT NO. 4-4-1004-01

22 DEC 1964

AVIATION TEST BOARD

⑥ PRODUCT IMPROVEMENT TEST OF U-8F
(ECP-BEA-L23-138)

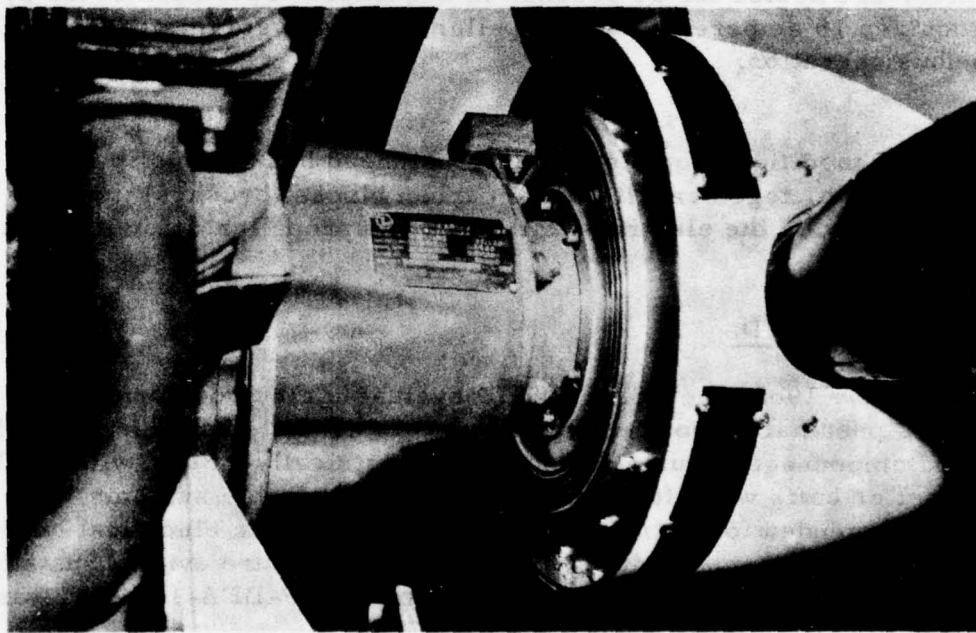
Figure 2. Modified propeller spinner bulkhead showing slip rings.

1.5.6. The modified propeller spinner bulkhead has three slip rings (figure 2) which, together with three carbon blocks (brushes) mounted on the engine, provide the electrical circuit to the propeller deicing boots.
