USAAMRDL-TR-76-32

**OTTAWA SPRAY RIG TESTS OF AN ICE PROTECTION SYSTEM
APPLIED TO THE UH-1H HELICOPTER**

November 1976

Final Report for Period January 1976 - May 1976

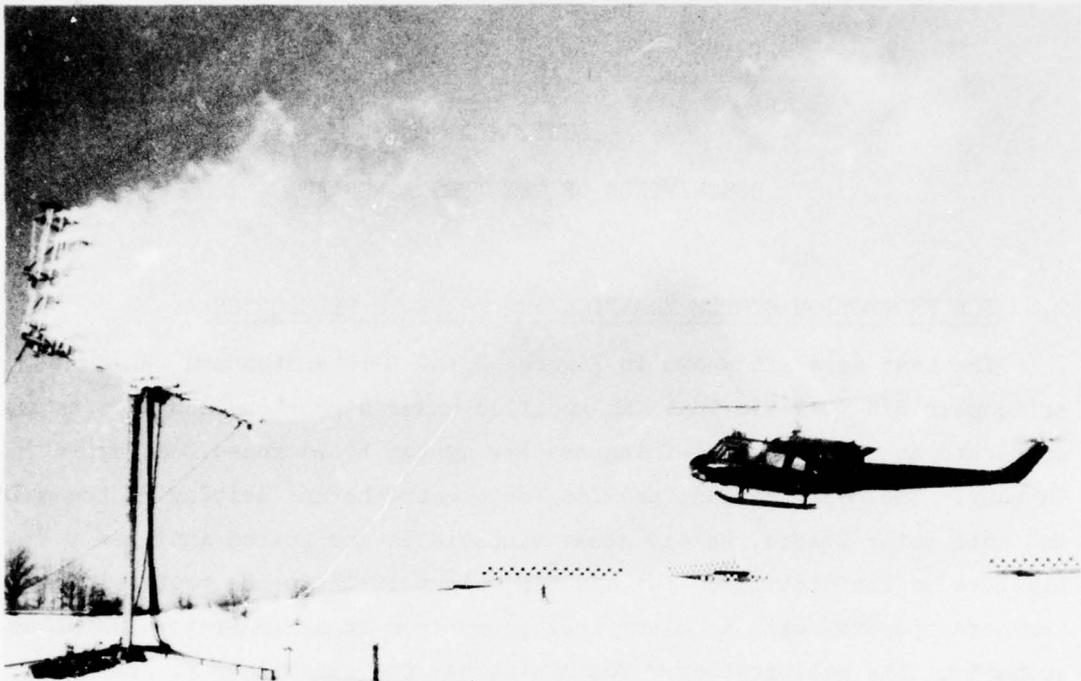
Figure 1. Test UH-1H in the NRC Spray Rig
(10 mph Wind, - 10 °C, 0.3 g/m³)

Operations in the NRC spray rig showed that the data gathered and the conclusions drawn are subject to careful analysis and evaluation of the test environment. It was found that for acceptable spray cloud operation with the UH-1H, the wind velocity should be a minimum of 10 mph. At lower wind velocities, satisfactory immersion of the rotor and the aircraft cannot be obtained within pilot visibility requirements. The difficulty in maintaining or obtaining satisfactory aircraft immersion in the spray cloud resulted in inconsistent spanwise blade icing distribution, permitted only a partial or momentary evaluation of the ice detector systems, and limited forward and aft fuselage (tail rotor) icing evaluations. Even at higher wind velocities, these factors were still present and repeat runs would be required to obtain sufficient data for an adequate quantitative evaluation. Figure 7 illustrates two typical variations in a spray cloud at low wind velocity. These pictures are during the same test run at -3.5°C and $\text{LWC} = 0.8$ gram per cubic meter in a 7-mph wind. Neither condition is considered to be good. Figure 1 illustrates a more desirable

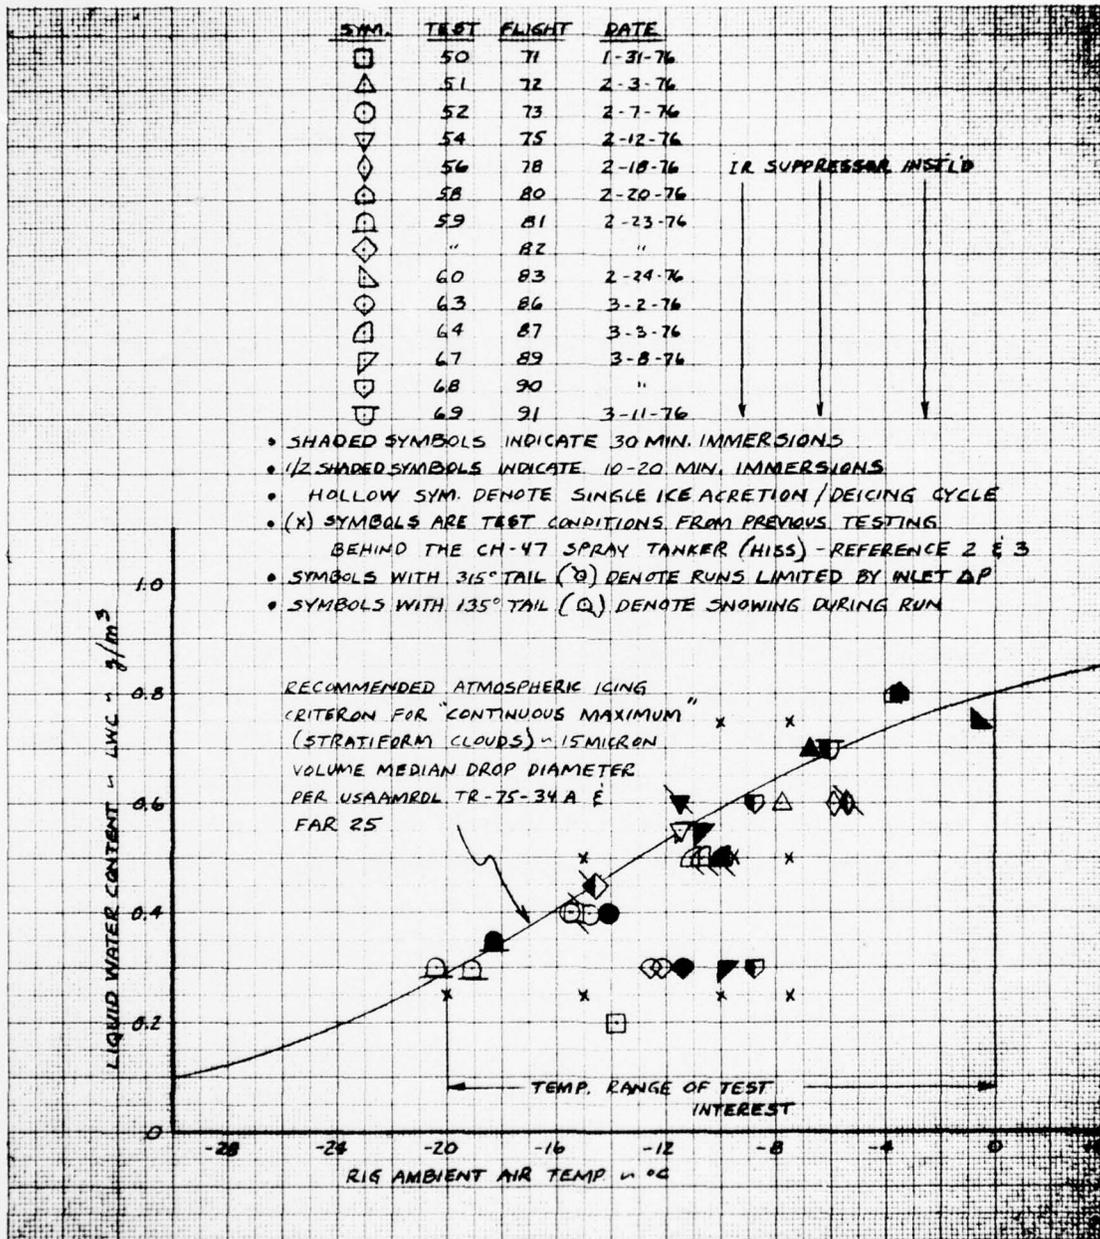
Figure 5. Summary of UH-1H Test Conditions in the Ottawa NRC Spray Rig

It can be seen in Figure 5 that the boundary conditions were adequately investigated. Additional testing within the boundary at lower liquid water contents (LWC) would have been desirable.

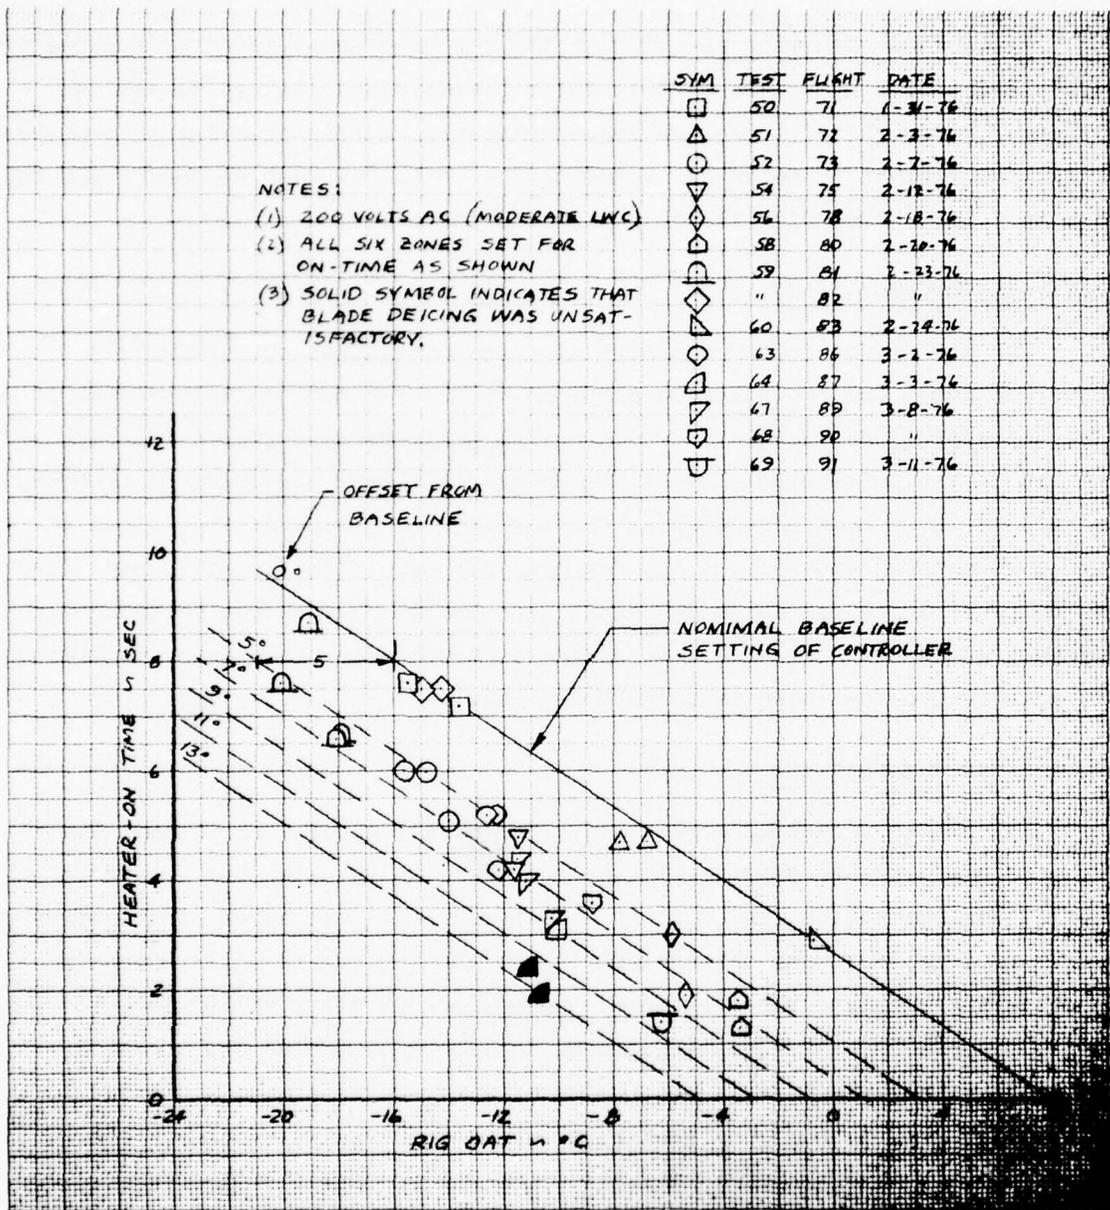
Figure 12. Summary of Main Rotor Blade Heater-On Times Used in Ottawa Test Program

Figure 12 shows the heater-on times that were evaluated during the program. As mentioned, the on-times were reduced by setting the OAT control to a warmer than actual temperature. This OAT offset method effectively shifted the on-time versus OAT schedule line downward and provided an expeditious way to make adjustments from run to run at the spray rig. Note on Figure 12 that only 2 points resulted in unsatisfactory deicing because of too short a heater-on time. An optimum on-time schedule versus OAT, equivalent to approximately a 10-degree offset, is indicated by these qualitative test results. A recommended on-time schedule was determined also from the measured blade surface temperature data. These data are presented in Section 4.13 and agree closely with the foregoing indications.

Comparison of these data with the qualitative deicing results of Figure 12 shows excellent agreement. It is concluded, therefore, that the optimum on-time, or at least the schedule that should be evaluated in future testing, is equivalent to an 8 to 10 degree offset from the present nominal setting of the controller. The difference between 8 and 10 degrees is only 0.7 second, therefore, in the interest of convenience, 10 degrees should be used. This would permit simply changing the OAT selector graduation labels from the present $+5^{\circ}$ to -30°C range to -5° to -40°C range. Zones 5 and 6 can be adjusted 1 to 2 seconds shorter at -20°C , but this should be done after initially evaluating the longer time.

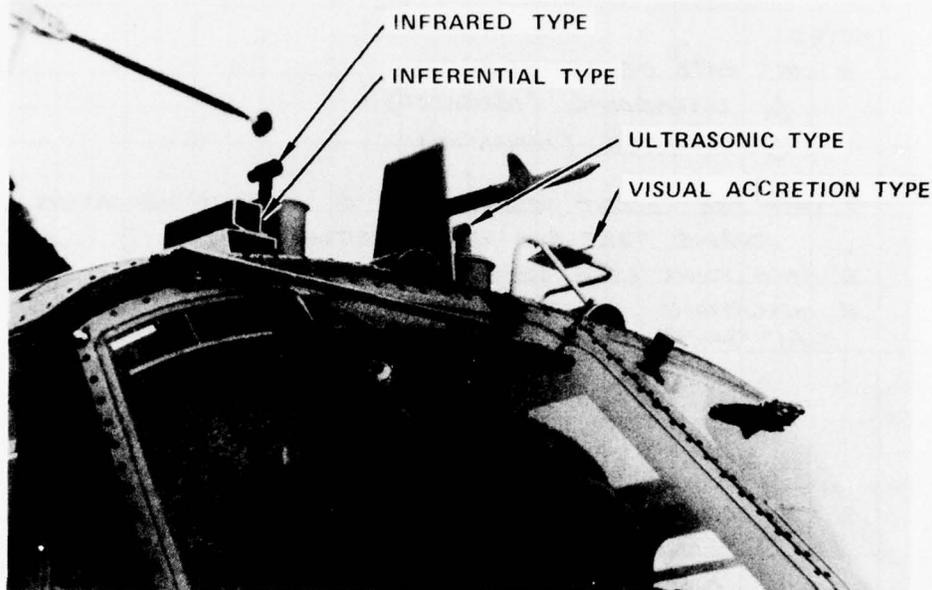
Figure 17. Ice Detector Installations on the Test Aircraft

Figure 17 shows the installations of all three types after a series of cloud immersions at -12°C in a 15-mph wind.

Cockpit indications and test tape recordings showed that both detector systems functioned properly, whereas during the Moses Lake testing last year the infrared type did not indicate in flight at all. Because the nose of the aircraft could not be fully immersed in the cloud in order to permit the pilot to maintain outside visual reference, both of the rate meters usually indicated lower than the LWC setting for the cloud. Thus, a quantitative accuracy evaluation could not be made. An overall evaluation based on flight crew reported observations is shown in Figure 18. This shows that the ultrasonic type generally read a lower LWC condition than the cloud. Based on these data, the infrared type appears, in general, to correlate with the cloud LWC. Both were supplied with the same bleed airflow at approximately 40 to 45 psi and 70°C . Further evaluation on a more quantitative nature is required.

One discrepancy was noted in operation of the ultrasonic type's rate meter. It appears that the hold period of 16 to 17 seconds on the rate indication while the detector probe deiced and cooled in preparation for the next accretion period was insufficient, as the rate indication would decrease to zero periodically. This was not noted during the previous winter's

testing and can be corrected. The amount of ice accretion between probe deice cycles was set for 0.040 inch thickness. The system can be adjusted to trip at as low as 0.020 inch thickness. This would permit deicing within the present hold time or the hold time can be increased. In order to use the ratemeter information to schedule blade heater off-time, a shorter updating time would provide greater accuracy and therefore be more desirable.

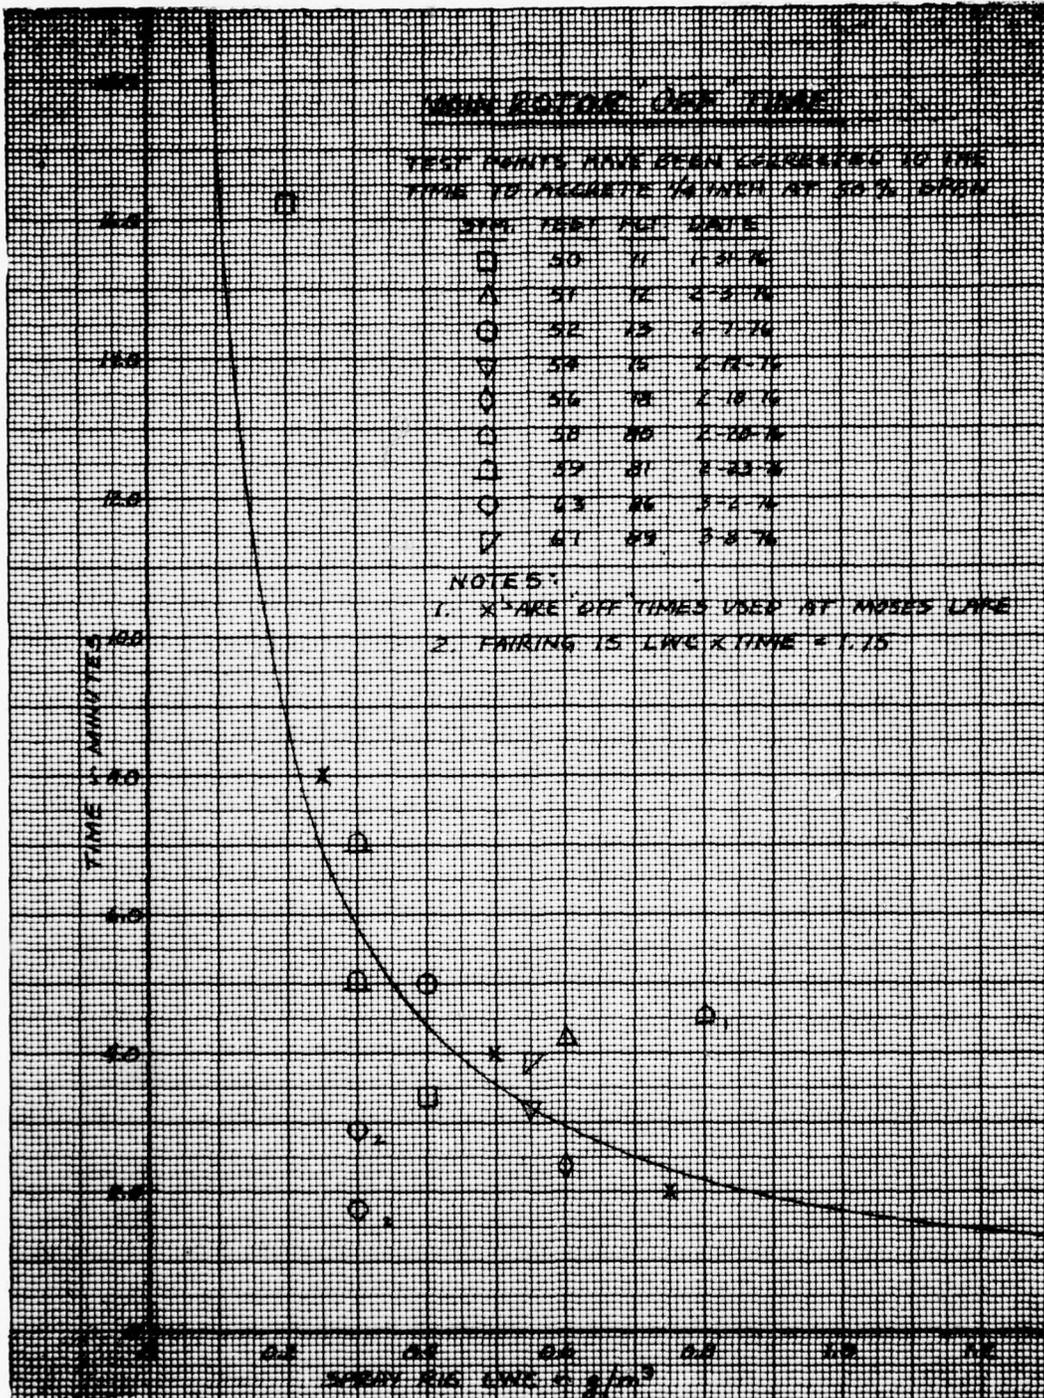
Figure 19. Main Rotor Off-Time

As described in Section 4.2, the initial testing at each cloud LWC consisted of runs to determine the time to accrete 0.25 inch of ice on the main rotor blades at the midspan point. The time thus determined was used as the off-time between deicing cycles when operating in the cloud for 30 minutes. Figure 19 shows the test data obtained from these ice accretion runs. All measured ice thicknesses were not the desired 0.25 inch and not always available at the midspan point because of self-shedding and nonuniform cloud immersion. Appropriate corrections were applied to the

measured data using the local velocity ratio to correct thickness for span location and the desired-to-measured ice thickness ratio to correct the time. The fairing shown is for a product of LWC and time (in minutes) equal to a constant of 1.75. This obviously assumes that the catch efficiency is constant and independent of temperature. Figure 19 also shows the accretion times used during the HISS test program last year. As might be expected from the many variables in the spray rig tests, considerable data scatter is apparent. An attempt was made to associate the scatter with temperature and/or wind velocity but no positive relationship could be established. The points indicated by a subscript 1 and 2 were from runs with marginally light and relatively high wind speeds, respectively. Discounting these points, the curve is a reasonable basis for use in future testing of the UH-1H aircraft. It appears to be valid for in-flight or spray rig operation.

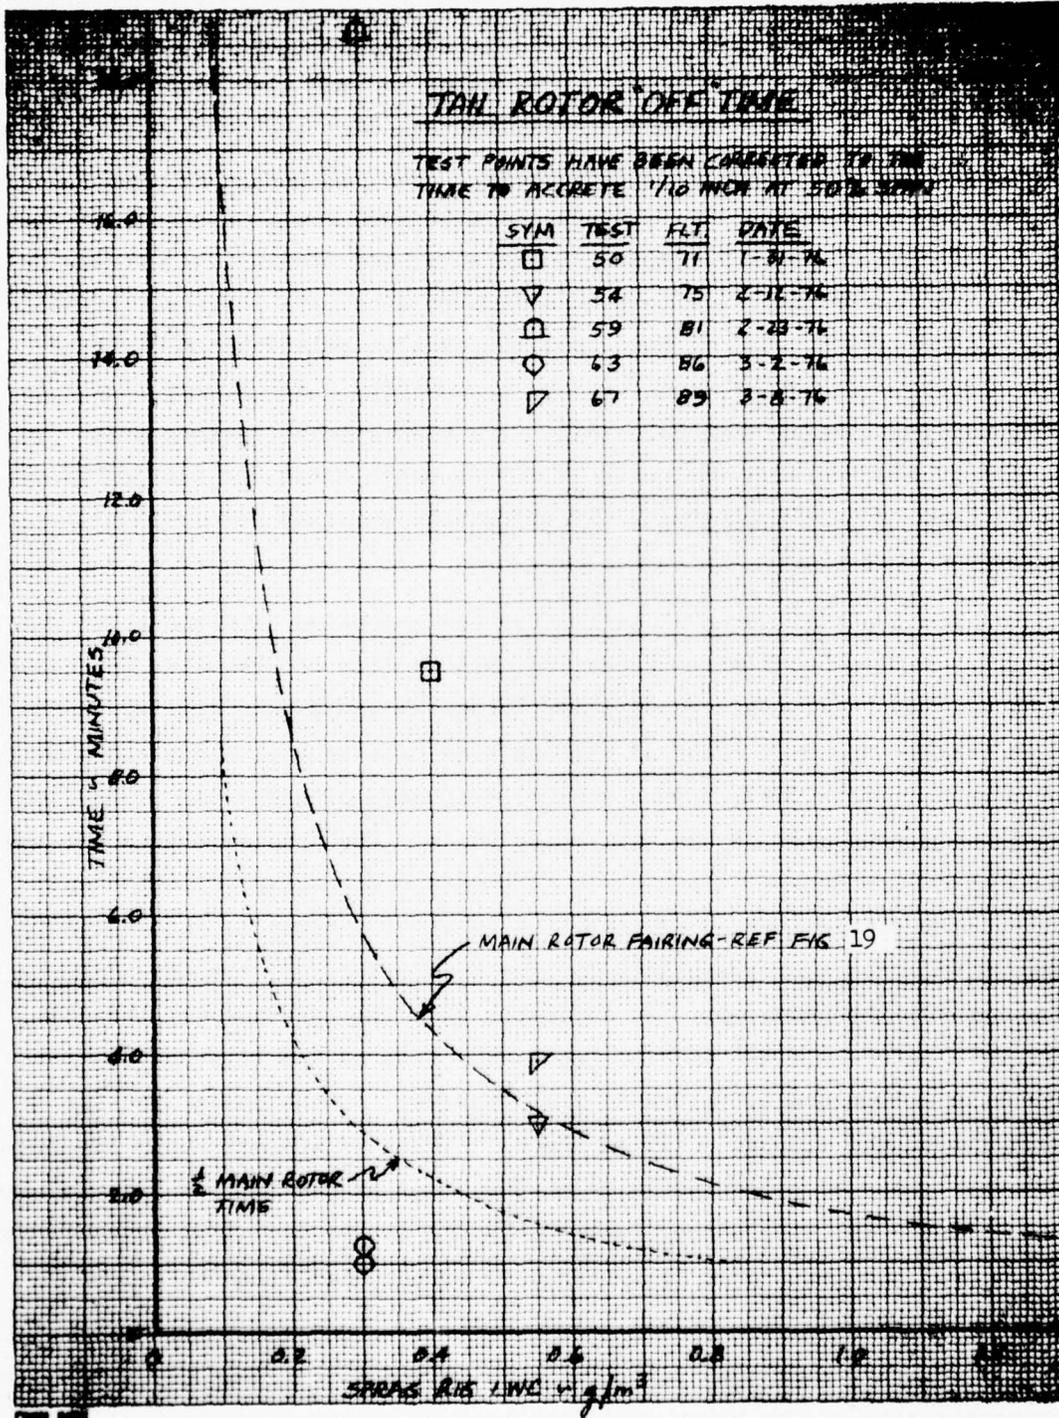
Figure 20. Tail Rotor Off-Time

A similar evaluation of tail rotor ice accretion data was tried but there is little confidence in the indications from the results. An assumption was made that the criterion for thickness would be a scaling of the 0.25 inch on the main rotor on the basis of main to tail blade chord dimension ratio. This results in a desired thickness of one-tenth of an inch at the midspan point of the tail rotor blade. The available data for the tail rotor are shown in Figure 20. The data are extremely limited and show considerable scatter although the relative scatter is interestingly very similar to the same points for the main rotor. If the same fairing is used for the tail rotor, it indicates that the off-time for the tail rotor to accumulate 0.1 inch of ice is the same as the time for the main rotor to accumulate 0.25 inch of ice. However, on the basis that the velocity of the midspan point on the two blades is approximately the same, the tail rotor off-time should be on the order of one-half of that for the main rotor. The discrepancy is probably due to the fact that in the spray rig cloud, the tail rotor is not exposed to the same icing environment as the main rotor.

It is felt that the tail rotor data obtained in the spray rig is not representative of the hover condition because of the incomplete cloud

coverage. Therefore, until more definitive data are obtained, the recommended tail rotor off-time to use is one-half of the main rotor off-time.

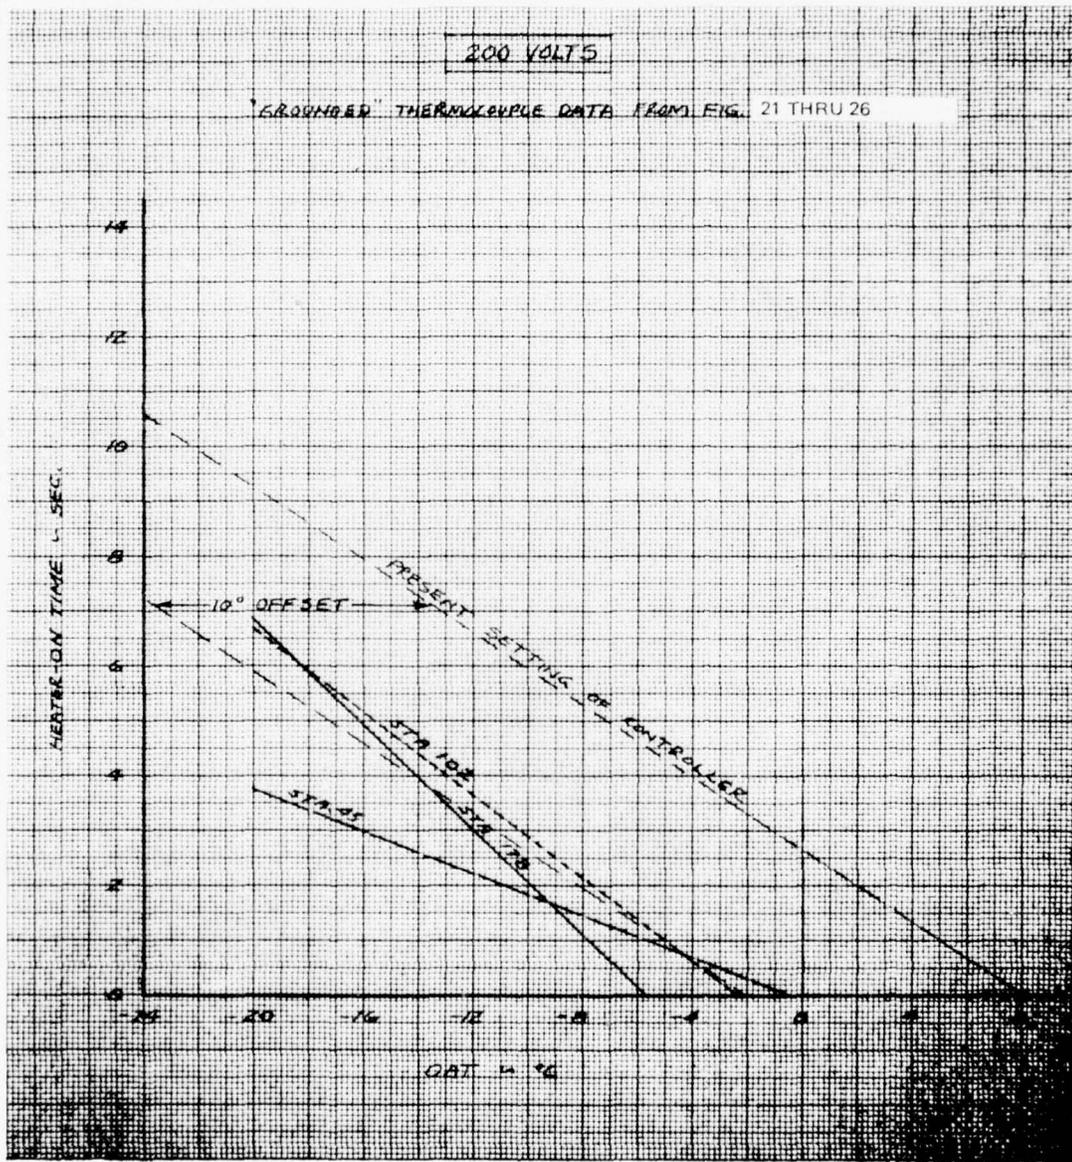
Figure 27. Main Rotor Heater-On Time to Raise Surface Temperature to 0°C

Using these data for surface temperature rise under heater operation and accounting for kinetic heating with ice, the heater-on time required to raise the surface temperature with ice on the blades to 0°C for each thermocouple station was determined and shown in Figure 27. This temperature should be approximately the temperature required to deice. It can be noted that the schedule for any zone is considerably shorter than the nominal controller setting that was used during the Moses Lake testing and initially at Ottawa. It can be seen also that at Station 45, which is in the most inboard zone, an even shorter on-time is indicated. More testing is required to verify this and determine if runback can be eliminated.

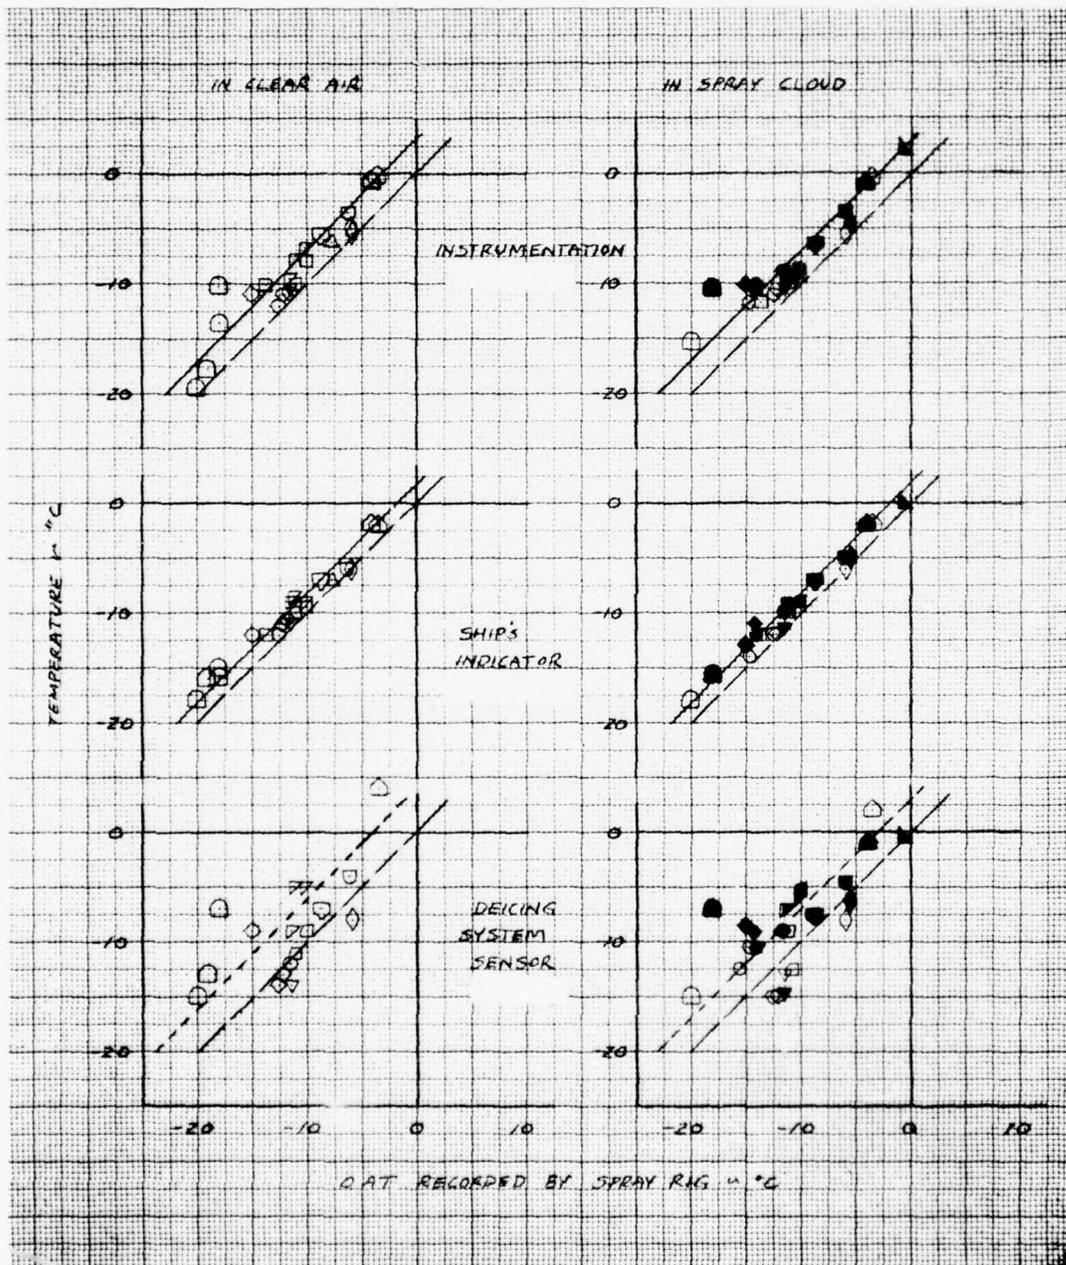
Figure 33. Comparison of OAT Measurements

Figure 33 shows the comparison of each system with the spray rig measurement. The flight data are shown for operation in clear air and while in the spray rig icing cloud. The data show that the TEST and the SHIP OAT read approximately 2 to 3 degrees warmer than the spray rig whether in clear air or in the icing cloud. This could be due to the exhaust recirculation effects in hover or it could be that the spray rig OAT is in error. Excessive test point scatter in the readings from the SYSTEM OAT indicates a problem of unknown nature at this time, but one which makes the present system and/or location unsatisfactory for a deicing system input. Conflicting trends and comparisons have been indicated by the data obtained so far. For example, lab tests indicated a humidity and/or moisture problem in the signal conditioning in the deicing control panel. A correction was made which eliminated the sensitivity in the lab; however, flight data still indicated approximately a 5-degree error. A biasing resistor was added to the circuit prior to the results shown in Figure 33 but a 5-degree average error is still indicated in hover. Limited comparison with a mercury thermometer showed good agreement under static conditions. Data in climb showed exact correlation with the TEST OAT but increasing error when compared to SHIP OAT. In level flight, the SYSTEM OAT showed decreasing temperature with increase in air speed whereas the TEST OAT showed the proper change. A more detailed investigation of the system calibration and possible signal conditioning errors should be accomplished prior to use as a SYSTEM OAT input. It is possible that the sensor location under the nose is unsatisfactory. Since there are two sensors presently installed, one could be relocated and evaluated in future testing.

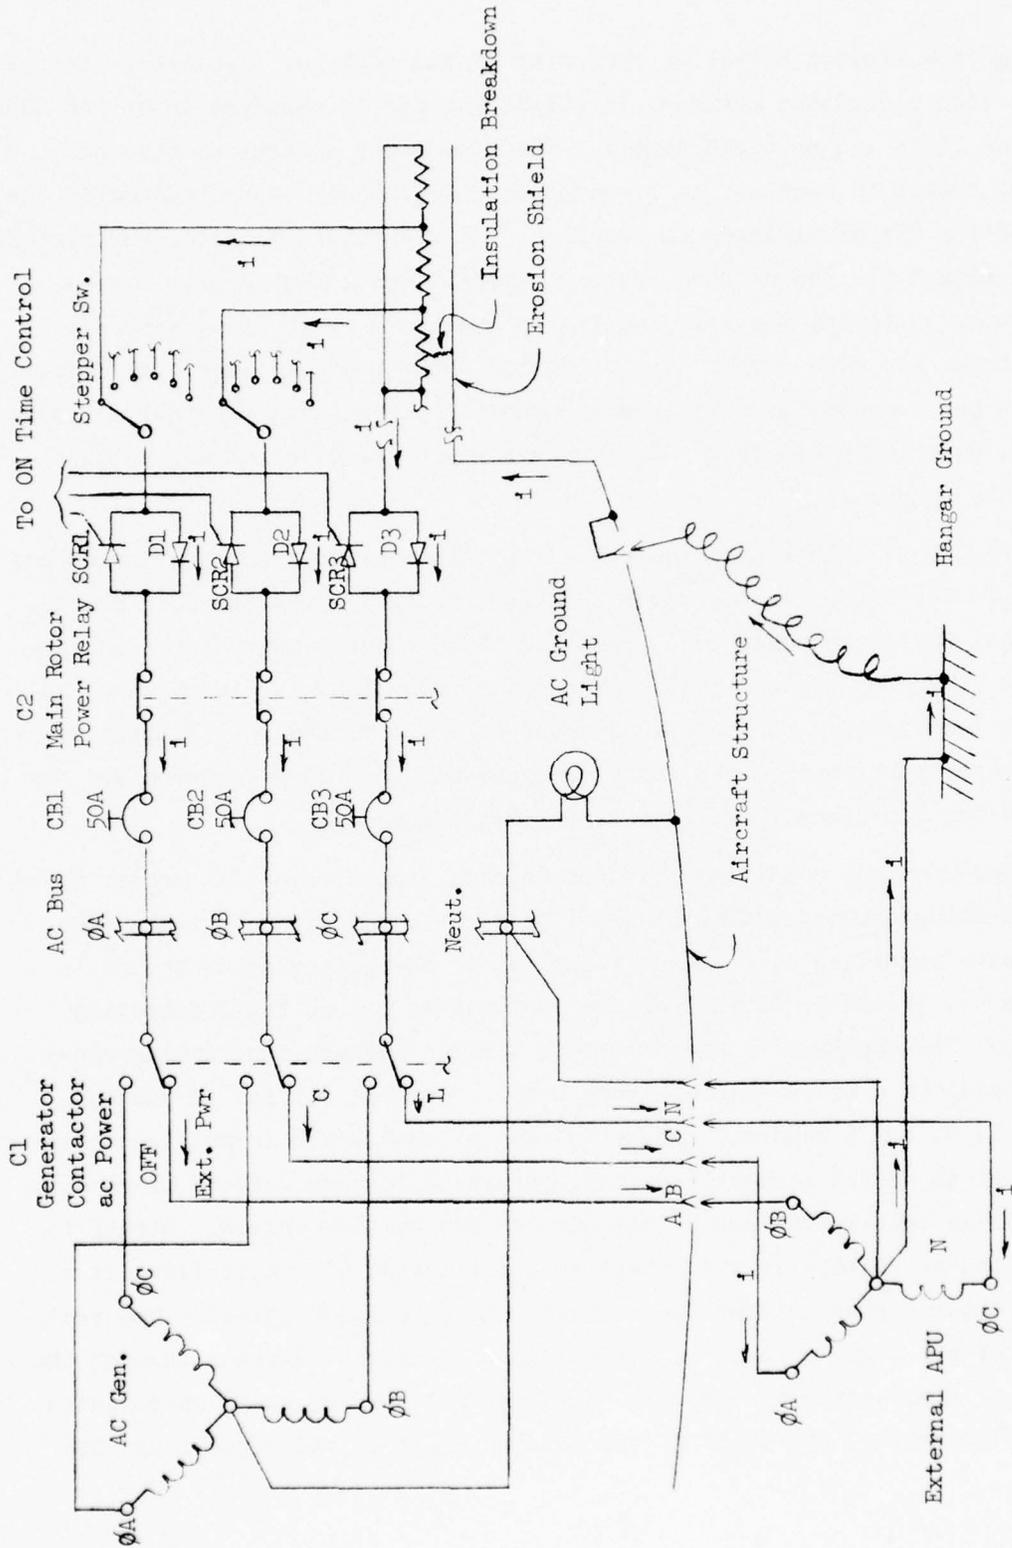
Figure 34. Schematic Showing External AC Power Connected to the Ship and Current Flow through an Insulation Breakdown

Figure 34 illustrates schematically the conditions which existed when the hole was burned in the blade. External ac power was supplied by the external auxiliary power unit (APU), and the generator contactor (C1) connected it to the ac bus. Main rotor power relay (C2) is closed when the master power switch on the deicing controller is turned on. Shortly after the master power switch was turned on, an audible arcing occurred and the switch was immediately turned off, stopping the arcing.

Under normal conditions between deicing cycles when with heater power is not being applied to the blades (SCR's not conducting), three-phase half-wave rectified dc voltage is applied to the heater grid through diodes D1, D2 and D3 as part of the system's ac ground fault detection system. This voltage is approximately 165 Vdc between the heating elements and the erosion shield. When heater power is applied to deice, SCR's 1, 2, and 3 conduct, and ac voltage of each phase is applied to the appropriate heater element terminal, resulting in peak voltage of as much as 165 Vac between the heater element and the erosion shield. Either the dc or the ac voltage is sufficient to light the AC GND fault light if a short should occur between the element and the erosion shield. The resistance of the light circuit is sufficient to limit the current through the short to a nondestructive level. With the floating or ungrounded neutral at the generator, operation of the deicing cycle is still possible with

no deterioration in ability to deice the blades. Should a second insulation breakdown occur, an overcurrent condition would be sensed and the main short light would be illuminated and the deicing cycle halted.

There are ways to maintain the protection afforded by the ungrounded ac electrical system when operating on an external auxiliary power unit (APU). The neutral-to-hangar-ground connection of the power unit can be disconnected. This would require special placarding on the unit to warn other users of the nonstandard APU. In lieu of that, an isolation transformer could be inserted between the APU output and the external power receptacle of the aircraft, or a smaller isolation transformer could be interposed between the circuit breakers and the main rotor power relay in the aircraft as shown in Figure 35. The latter approach would add weight but this is considered acceptable for a test aircraft and provides the simplest compromise for the testing problem. There are other additional changes that could be implemented on a production design that would minimize the weight penalty.
