ROOF MOISTURE SURVEYS AT PEASE AFB, NEW HAMPSHIRE, AND OFFUTT AFB, NEBRASKA

MISCELLANEOUS PAPER M-77-2

Lewis E. Link, Jr.

January 1977
Final Report

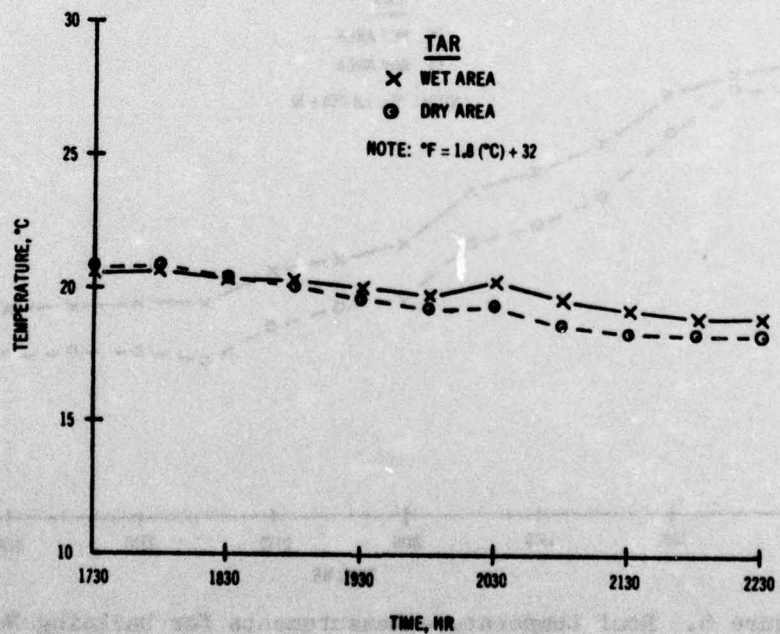
Figure 4. Roof temperature measurements for building No. 112, Pease AFB, New Hampshire

7. Examination of the temperature data in Figures 4 and 6 reveals that a considerable temperature contrast occurred between wet and dry roof areas from approximately 2030 to 2130 hr for building No. 112 and from approximately 1930 to 2330 hr for building No. 130. The time of maximum temperature contrast (considering both buildings) occurred between 1930 and 2130 hr. Examination of Figure 5 reveals that there was very little temperature contrast between the wet and dry roof areas on building No. 119. The lack of contrast was hypothesized to be caused by the persistently cloudy, hazy weather conditions that occurred on the day of measurement, and is a good example of the influence of the weather on the magnitude of the wet-dry temperature contrast and, thus, the potential influence of the weather on the successful delineation of wet and dry roof areas on thermal IR imagery.

8. Based on the temperature data in Figures 4 and 6, the time-of-day for the thermal IR imagery mission at Pease AFB was selected to be approximately 2200 hr.

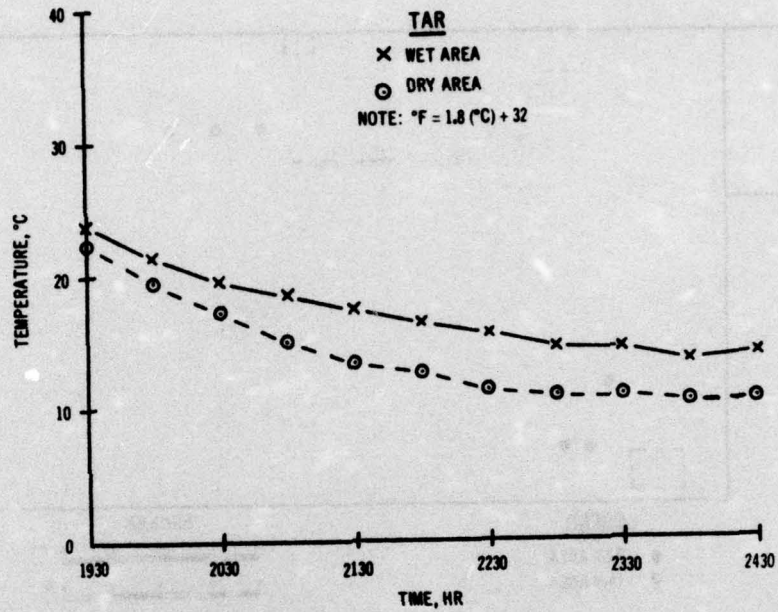
Figure 9. Roof temperature measurements for building No. 407, Offutt AFB, Nebraska

12. Examination of the temperature data for building No. 407 (Figure 9) reveals that a significant temperature contrast between wet and dry roof areas occurred after 2030 hr with a maximum occurring

between 2130 and 2330 hr. The temperature data for building No. 324 (Figure 10) did not have as much contrast as the data in Figure 9, but good control separation occurred from 2130 to 2330 hr as in Figure 9. Based on these data, the time-of-day for the thermal IR imagery mission at Offutt AFB was selected to be approximately 2130 hr.

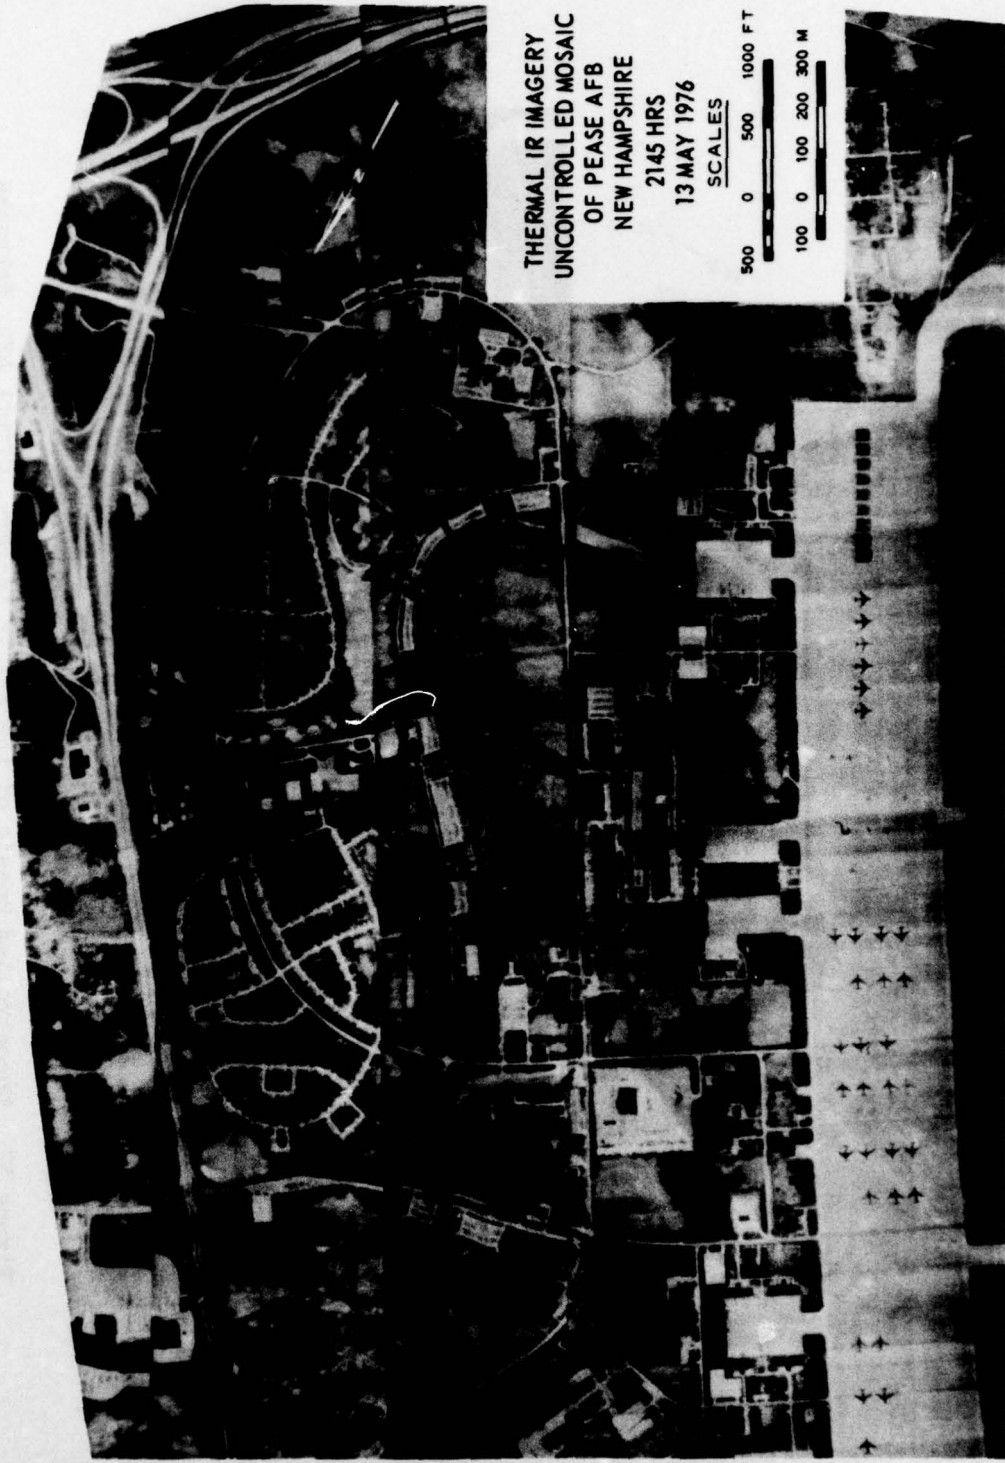
Figure 11. Uncontrolled mosaic of thermal IR imagery, Pease AFB, New Hampshire

22. Examination of the uncontrolled mosaic in Figure 11 shows that the IR imagery for Pease AFB was not of the best quality. The "hazy" appearance of the imagery was caused by fogging of the film (the creation of a significant neutral density on the film by a source other than the planned exposure of the film). The cause of the fogging was not determined, but it may have been due to excess heat near the film or some aspect of the film development process. The fog level on the film was an obstacle for the image interpreter, because it effectively reduced the contrast between the wet and dry roof areas and at times made it difficult to determine the precise outer boundaries of the roofs. The effect of the fogging is especially evident in the imagery enlargements presented for the individual buildings in Figures 13-26.
