USAACOM-TR-77-14

**FLIGHT TEST EVALUATION OF OH-58A
TAILBOOM FAILURE DURING AUTOROTATION
LANDINGS**

Thomas L. Sanders
BELL HELICOPTER COMPANY
Post Office Box 482
Fort Worth Texas 76101

14 March 1973
Final Report

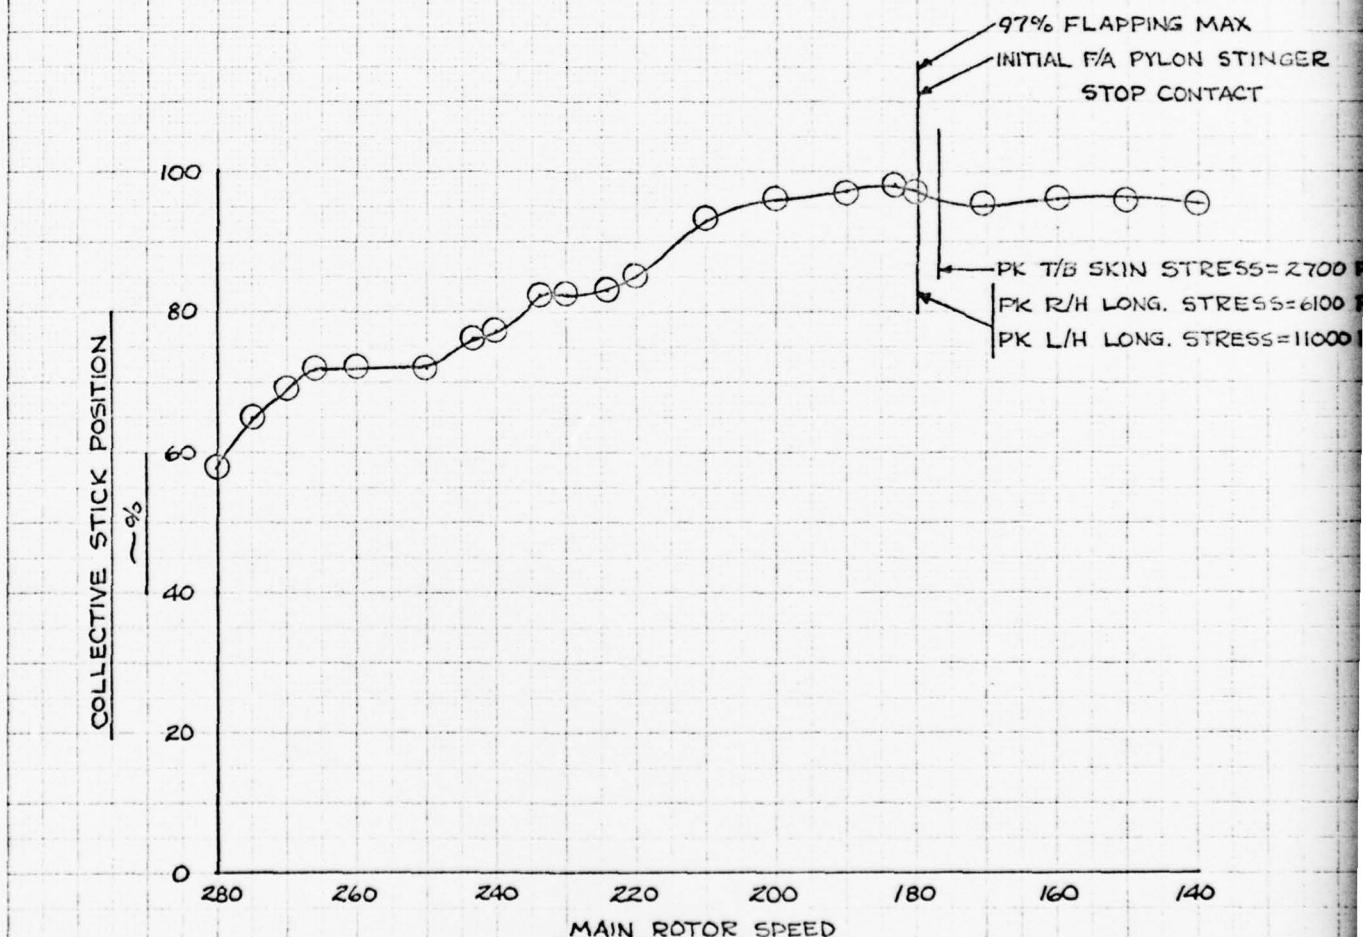
FIG. 1 COLL STK POSITION VS. M/R SPEED DURING RUN-ON
AUTO LANDING.

A total of 36 touchdown autorotation landings and 10 throttle chops were flown to obtain data. Analysis of autorotation data began to suggest certain trends of maximum main rotor flapping with high touchdown airspeeds at low main rotor speeds of 200 rpm or less, see Figures 1 through 10. During the third flight, a tailboom failure was duplicated to study the influential circumstances associated with the failure.

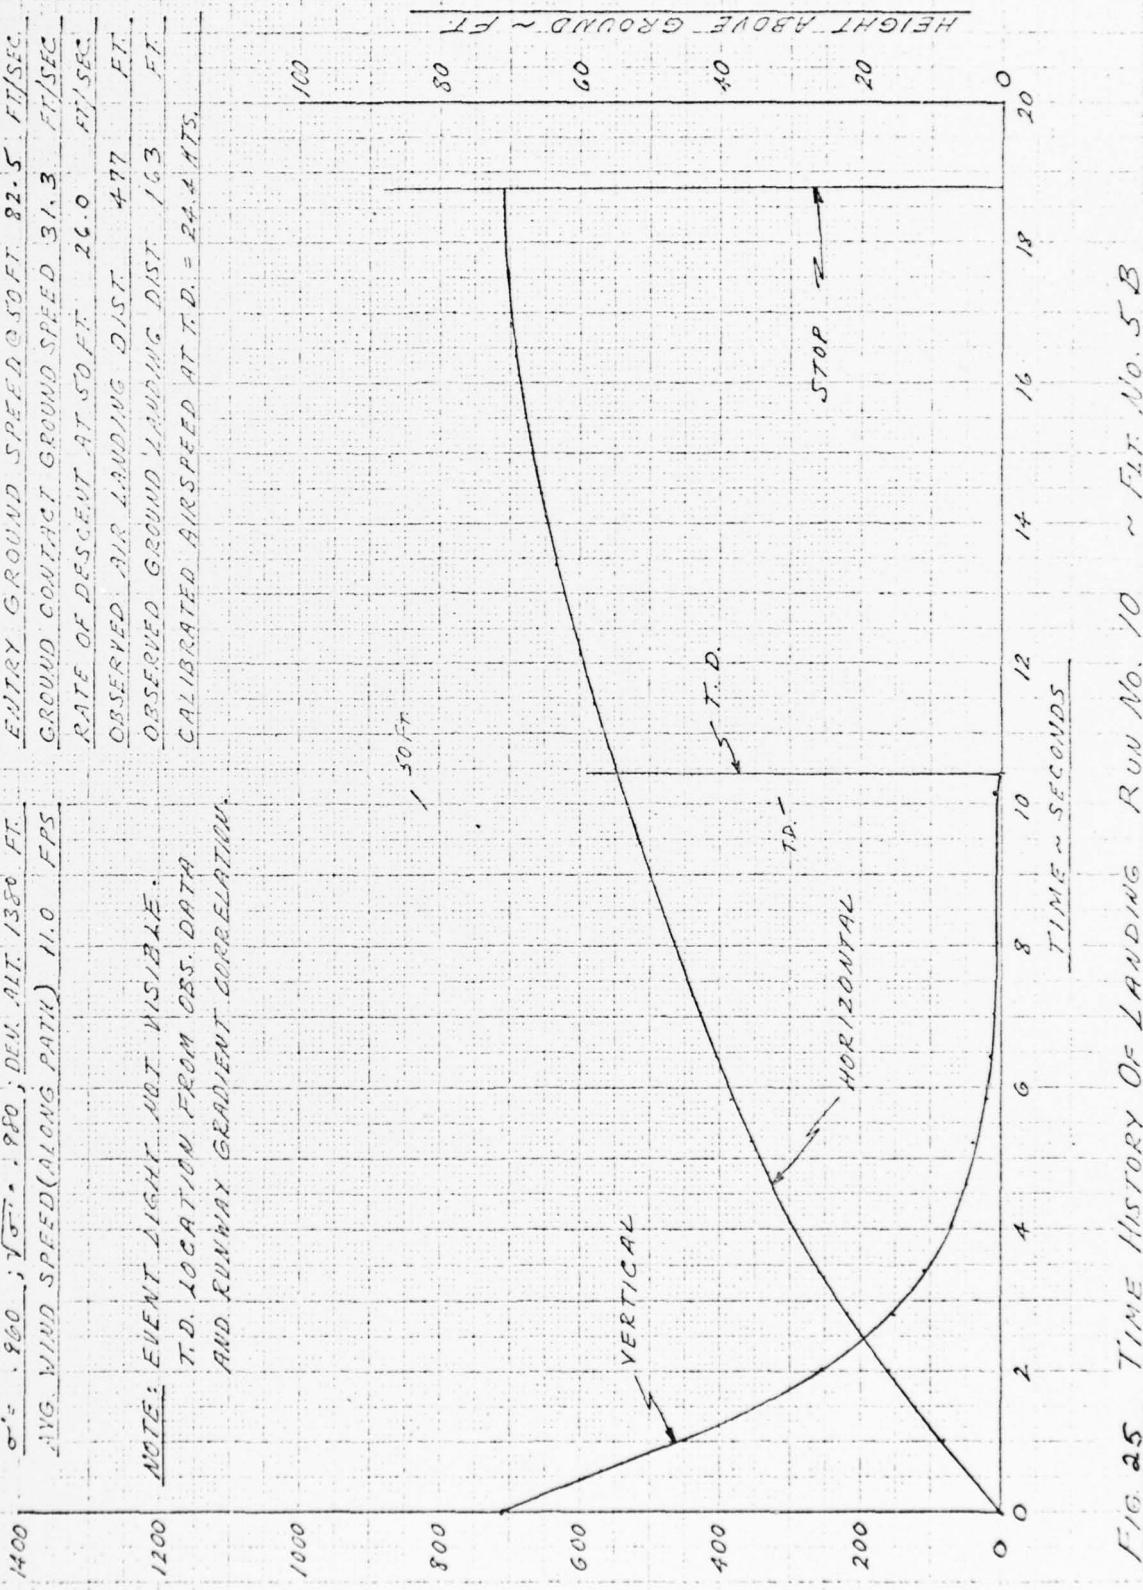
FIG. 25 TIME HISTORY OF LANDING RUN NO. 10 ~ F/T NO. 5-3

Six autorotation landings were accomplished with the available collective pitch reduced by approximately 20 percent, and Figures 25 through 30 present the data obtained by using the Federal Aviation Administration (FAA) Runk Grid Camera. Touchdown calibrated airspeed varied from 24 knots to 41 knots. Table III presents important oscillograph parameters recorded during the autorotation landings.

Reduced Collective Evaluation: After reviewing the options available, indications were the best solution to the problem was that improper autorotative techniques needed revising. However, in the event the ship were landed improperly it was judged that a reduction of the collective range would be beneficial. As a result, a Model OH-58A Helicopter, S/N 41155, was instrumented and a series of tests were begun to determine the feasibility of limiting the available collective pitch during auto-rotation landings (Option 3). This reduction was accomplished by attaching an adjustable cable on the copilot collective stick that physically limited the maximum up position of the collective, see Figure 23. Figure 24 shows the results of a hangar calibration of collective stick position versus main rotor blade angle. A series of hovering throttle chops, slide on landings, and autorotation touchdowns at various percent of collective reduction were evaluated to determine if a reduction in the available collective would prohibit maintaining adequate height-velocity margins. During the hovering throttle chops at a gross weight (GW) of 3000 pounds, there was a definite change in the character of main rotor blade stall when the available collective blade angle was reduced to 75 percent; however, time airborne, which is an indicator of rotor capability, was also reduced. At 80 percent available collective the time airborne after throttle chop was adequate, 3.6 seconds, and pylon motion and main rotor flapping were greatly reduced.

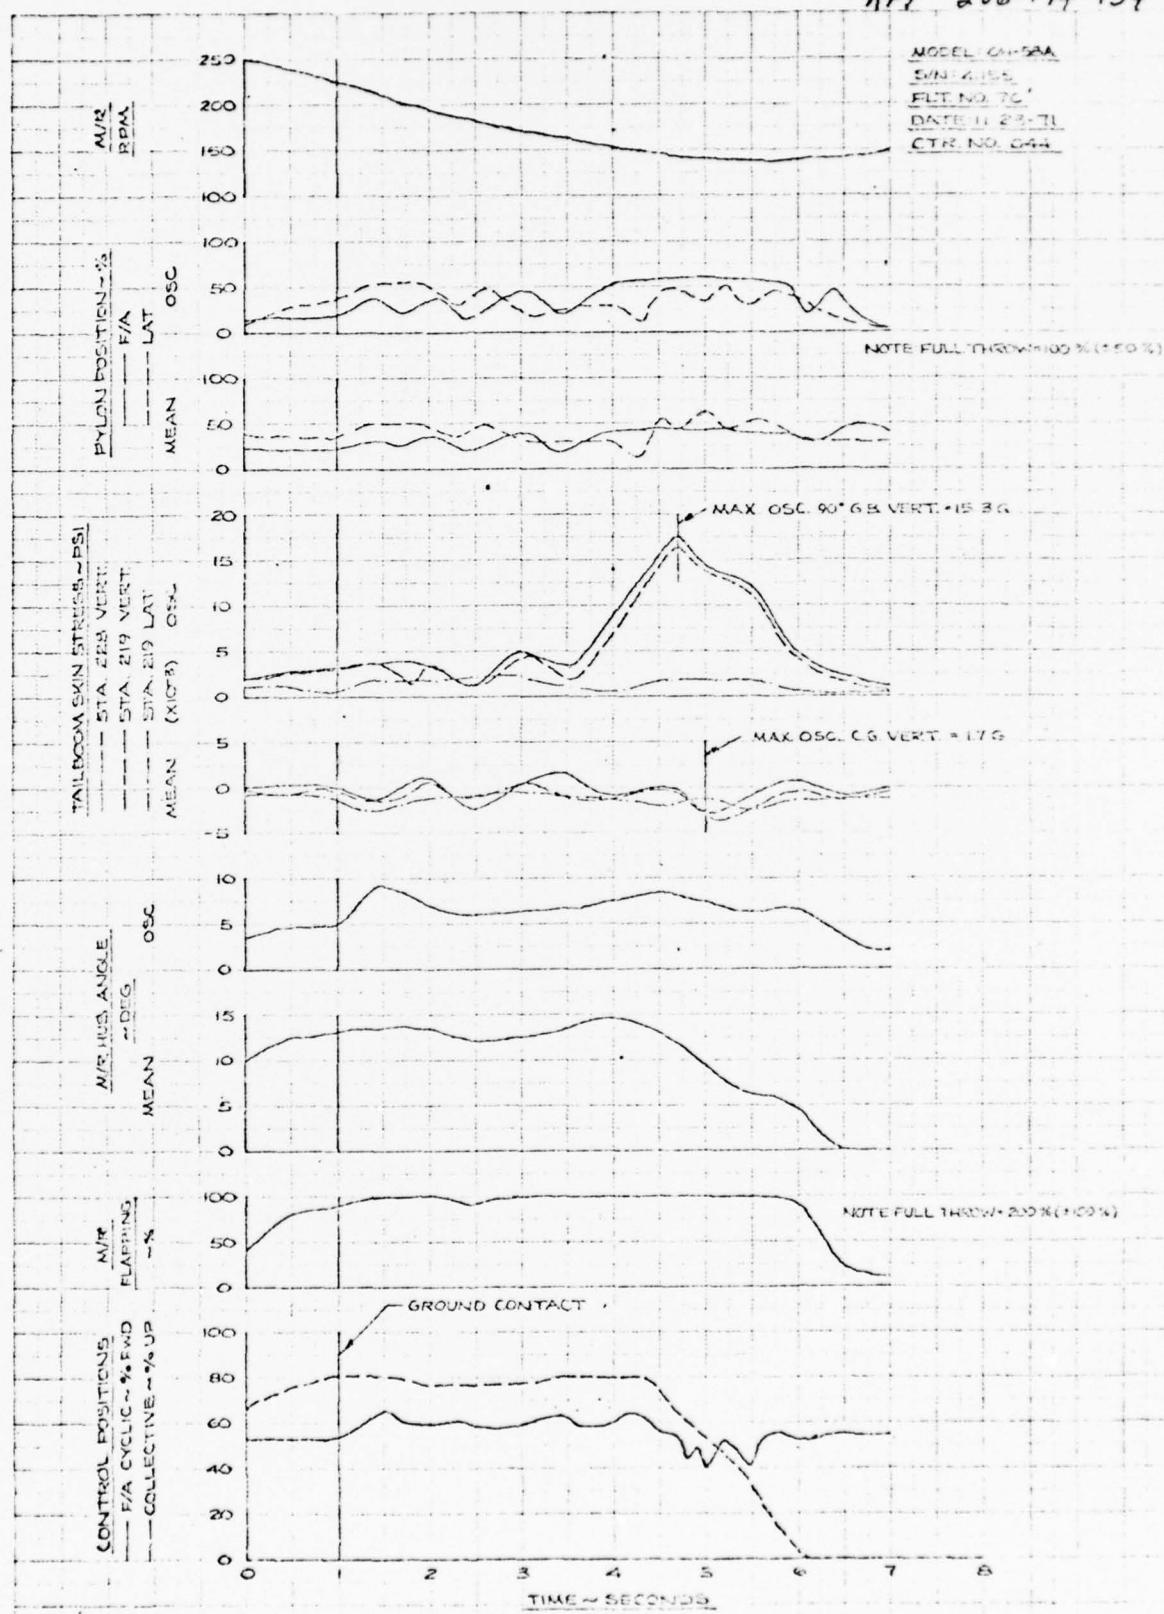
FIG. 31 TIME HISTORY OF AUTOROTATION LANDING.

A series of touchdown landings were made utilizing techniques that had produced tailboom failures in the past. Figure 31 presents a time history of an autorotation touchdown landing that produced a considerably high level of vertical tailboom excitation with a near damaging stress of 17,586 psi. The pilot reported the touchdown airspeed was probably in excess of 40 knots indicated airspeed (KIAS). Visible airframe damage was limited to minor pylon upper cowling contact and

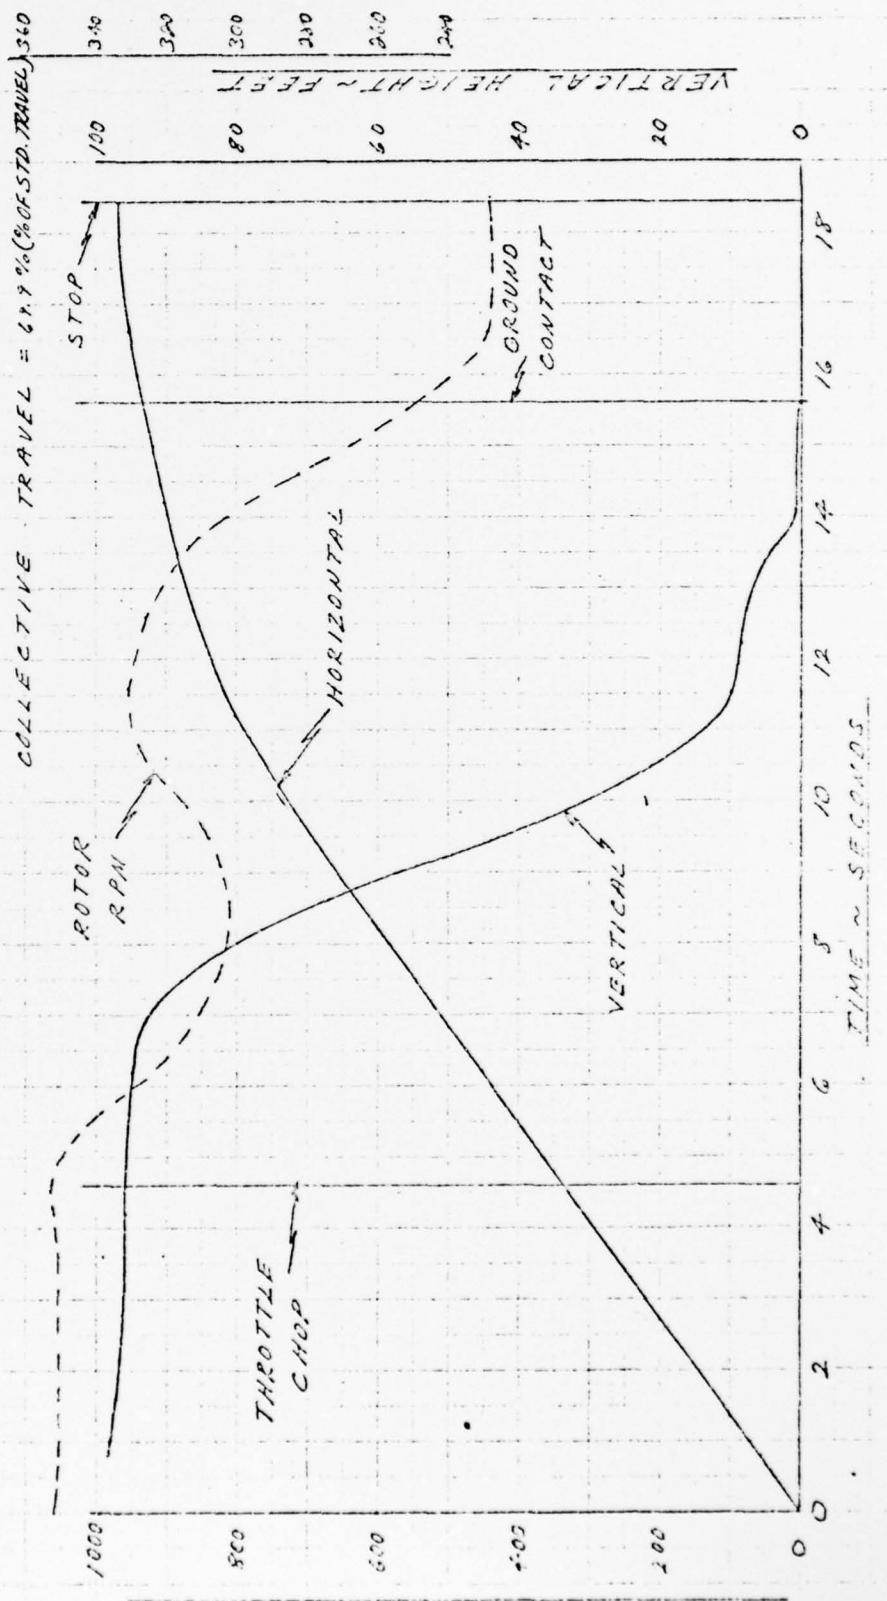
FIG. 32 Time History Of Horizontal Distance, Height Above Ground
 And Main Rotor RPM ~ Throttle Velocity Run No. 6

The Army test team also conducted tests to determine if the present height-velocity margins could be maintained when the available collective range was reduced to avoid excessive dynamic loading. Data were obtained by using the FAA Runk Grid Camera and results are presented in Figures 32 through 34. Table IV presents the height-velocity time history data. Figure 35 shows the runway gradient at the test site. Maximum available collective was limited to 85 percent. Results of the evaluation indicated that the maximum collective utilized during the autorotation was 70 percent and as a result, shows that adequate collective is available to maintain present height-velocity margins at the altitude the test was conducted.
