RECREATIONAL BOAT SAFETY  
COLLISION RESEARCH-PHASE II

VOLUME II - COLLISION ACCIDENT  
INVESTIGATIONS - 1975

1. Report No. CG-D-129-76		2. Government Accession No.		3. Recipient's Catalog No.	
4. Title and Subtitle RECREATIONAL BOAT SAFETY COLLISION RESEARCH — PHASE II Volume II — Collision Accident Investigations - 1975				5. Report Date July 1976

6. Performing Organization Code	
7. Author(s) R. MacNeill, S. Cohen				8. Performing Organization Report No. MSR 76-39	
9. Performing Organization Name and Address Wyle Laboratories P.O. Box 1008 Huntsville, Alabama 35807				10. Work Unit No. (TRAI5)

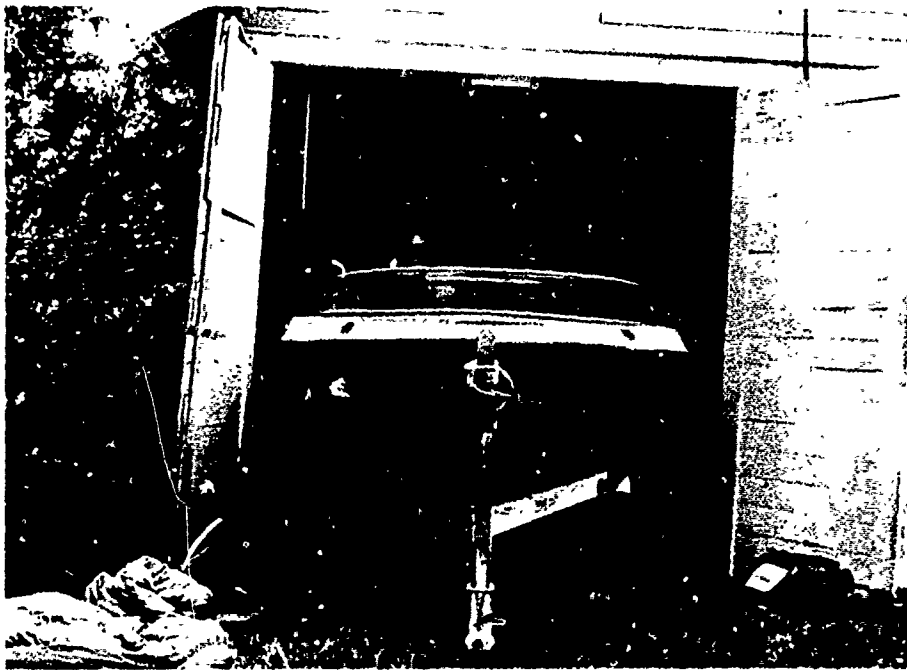
Photograph 5 Sixteen Ft Sidewinder Runabout

Examination of the boat showed minor damage on the port bow about 6' aft (see Figure 3). Of considerable interest was the fact that this small runabout was equipped with twin 135 hp Mercury outboards with power trim. The transom had been raised to accommodate the motors. They were each equipped with two bladed bronze cupped props. Twin single lever Mercury controls were used. Otherwise, the boat appeared well kept and in good working order. The only exception was that the starboard running light was inoperable (blown lamp). All steering and engine controls operated properly. However, the controls for the power trims were mounted on a wooden panel, but were not connected to any boat structure. They were simply lying on the deck by the operator's right foot. Apparently, the installation was never completed. The 18 gallon tank was about 1/4 full. The boat was kept stored in a garage at the owner's father's home (see photographs 5-8).

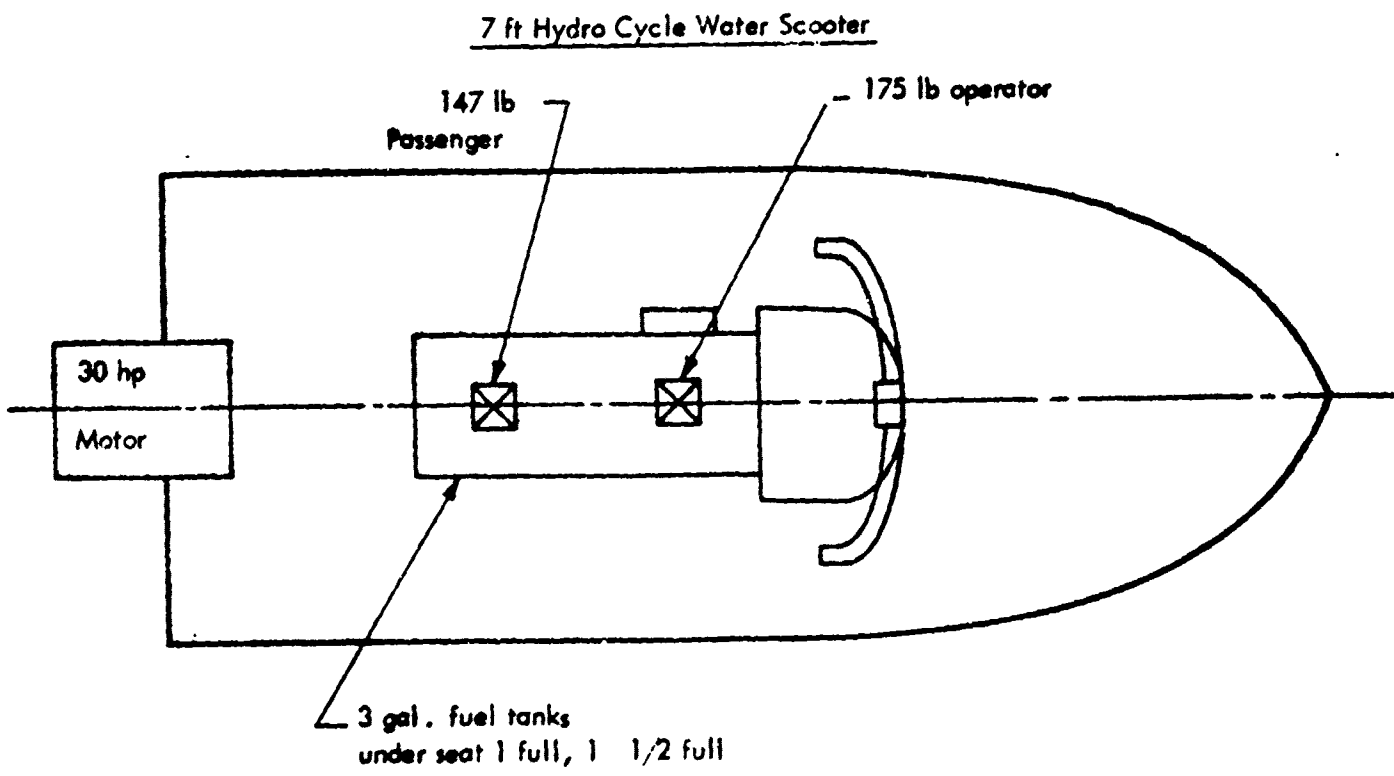
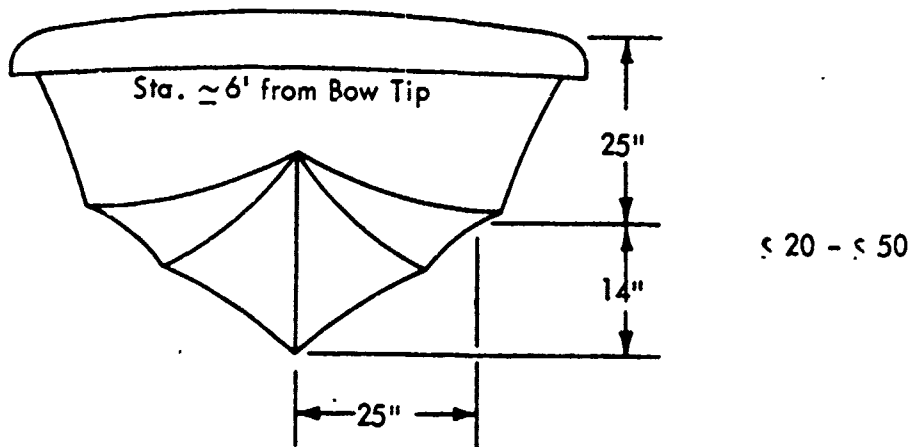
Figure 2. Boat Load Distribution At Time Of Accident

Gear aboard was as shown in Figure 2 and the weather as noted in Section 2.0

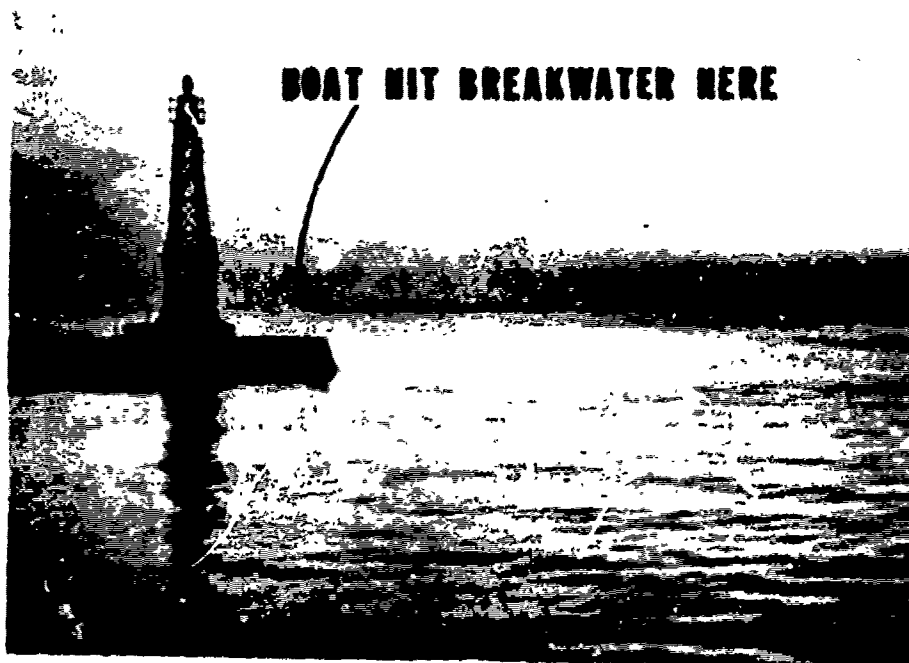
**Figure 6. (Top) - Breakwater at Dusk  
(Bottom) - Breakwater - Inner Red Light In Foreground**

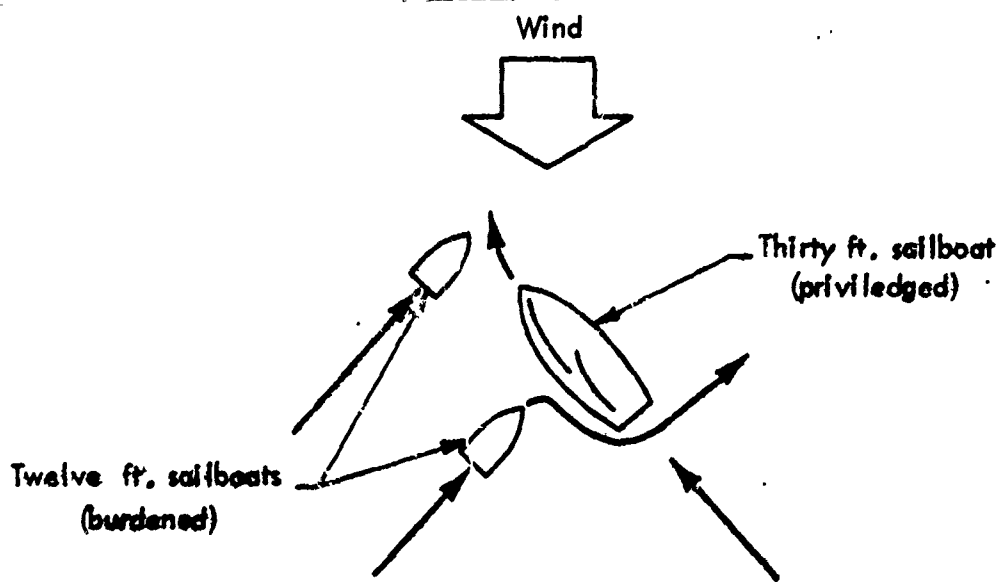
First twelve ft sailboat passed "under" the thirty ft boat.

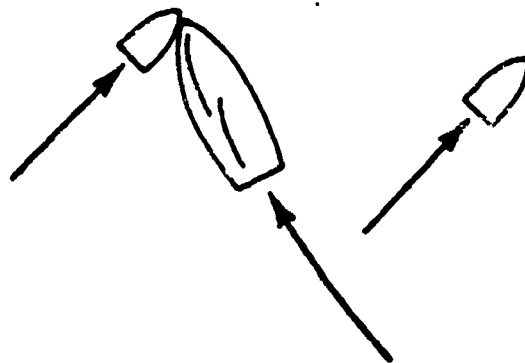
Thirty ft boat "headed up" and hit second twelve ft boat.

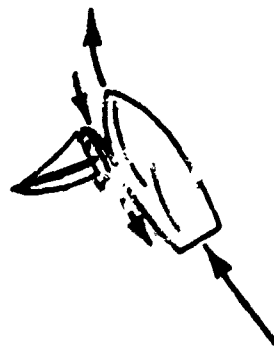
Figure 2. Accident Scenario

Twelve ft boat capsized and slid along port side of thirty ft boat.

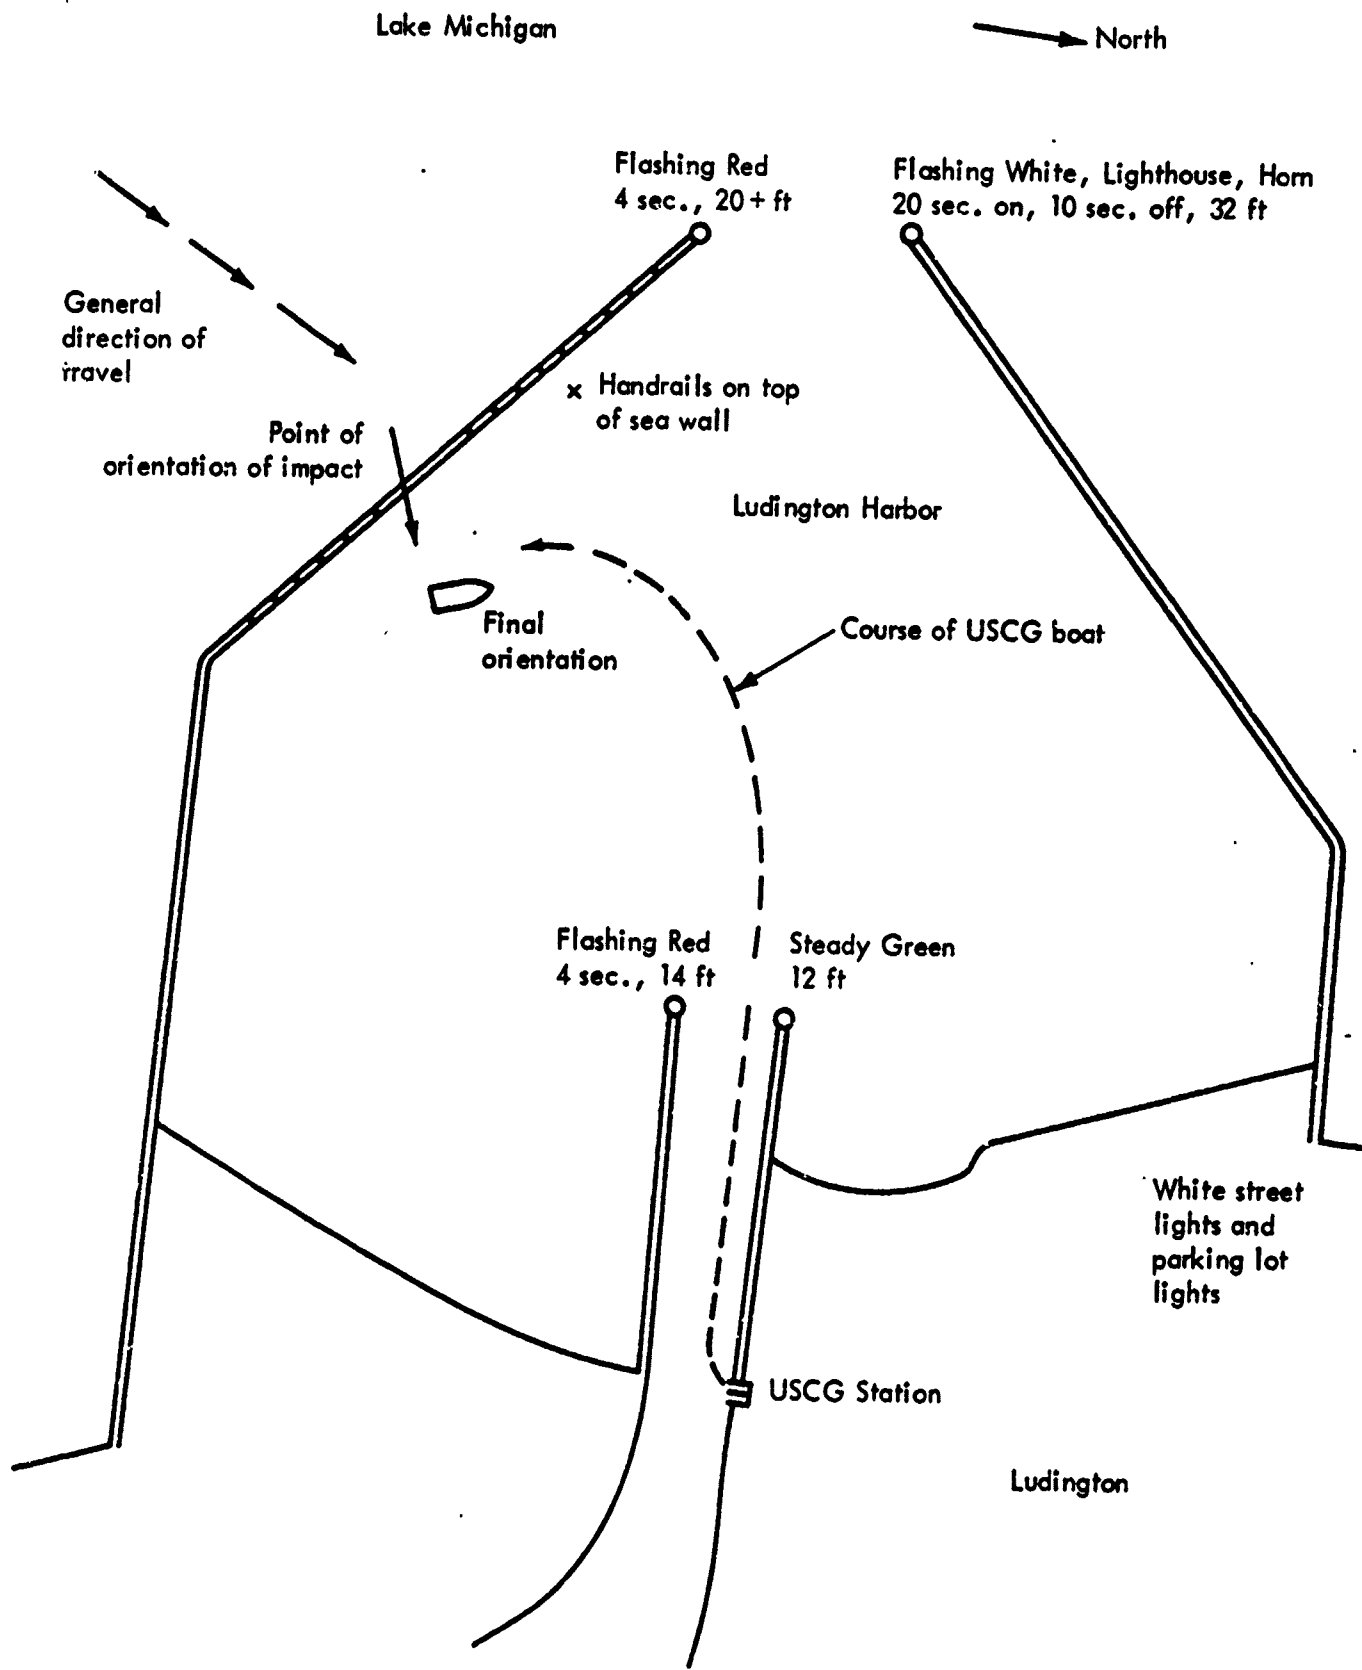
Figure 1. Diagram of Accident Site

In the interview, the operator referred to the "beautiful weather." It was clear and calm. Sunset was 2129. Visibility was good. The air temperature was 68° F. There were no other boats in the vicinity at the time and the water depth was six feet at the point of impact with the sea wall. There were several harbor light, shore street lights, and parking lot lights on (see Figure 1) that were visible from the vicinity of the breakwater.

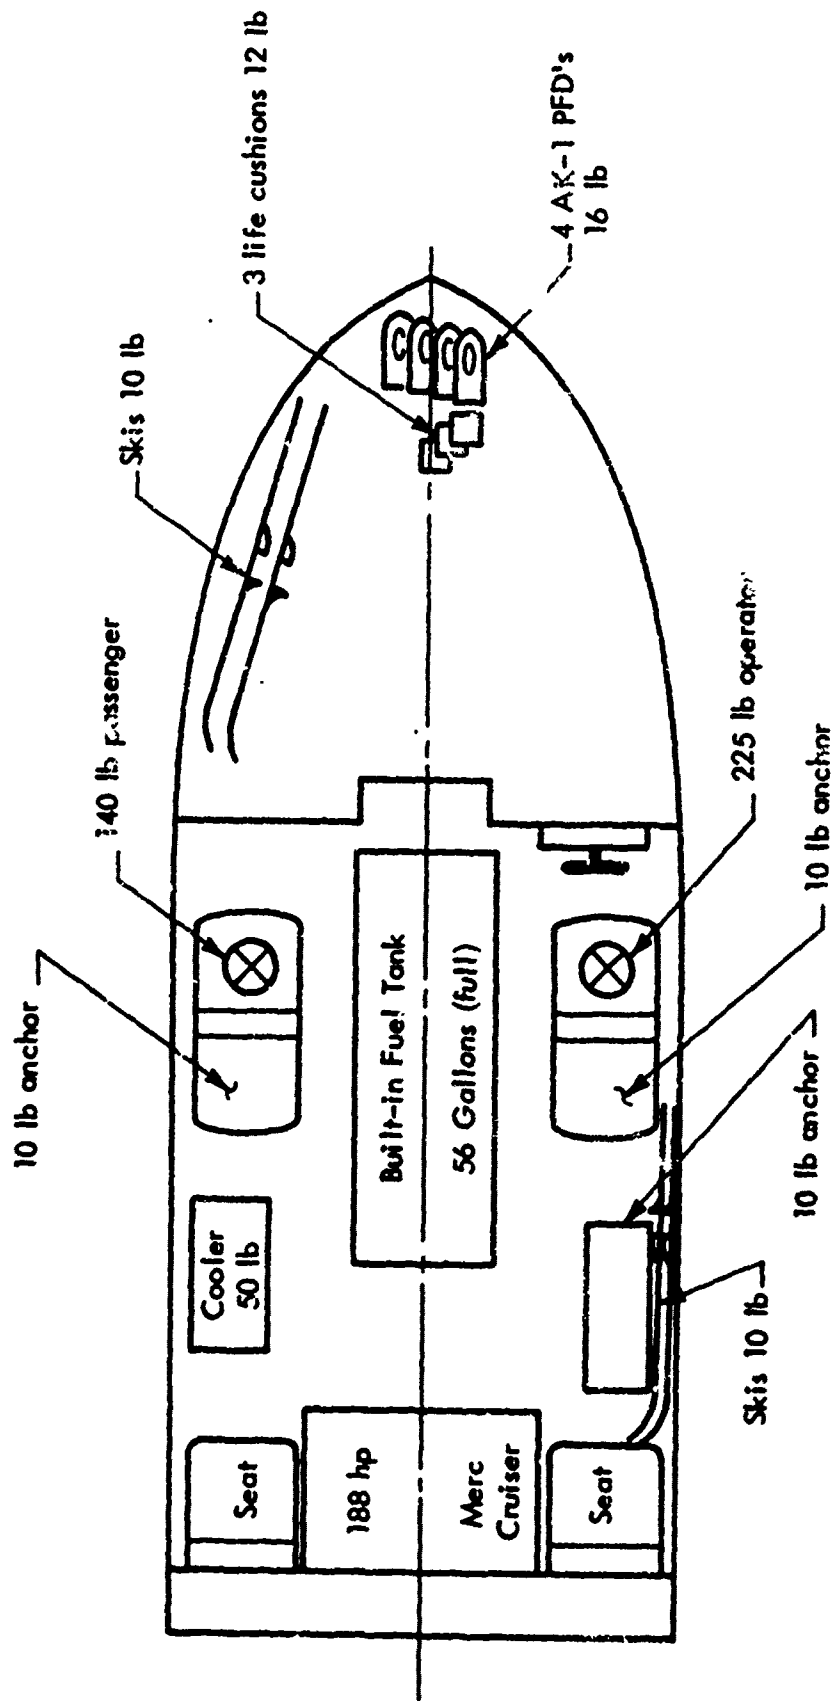
The locations of occupants and gear are shown in Figure 6. There were plenty of PFD's, although none were being worn. Soon after impact, the operator got a couple of these out of the bow in case they were needed. The lights were operable and on: separated red and green mounted on the cockpit sides and combined fore and aft white lights (360° total coverage) on a pole above the windshield. A control switch enabled the operator to have all lights on, or just the windshield white lights, or none. The boat was equipped with a compass which the operator thought was fairly accurate.

Figure 6. Locations of Occupants and Gear

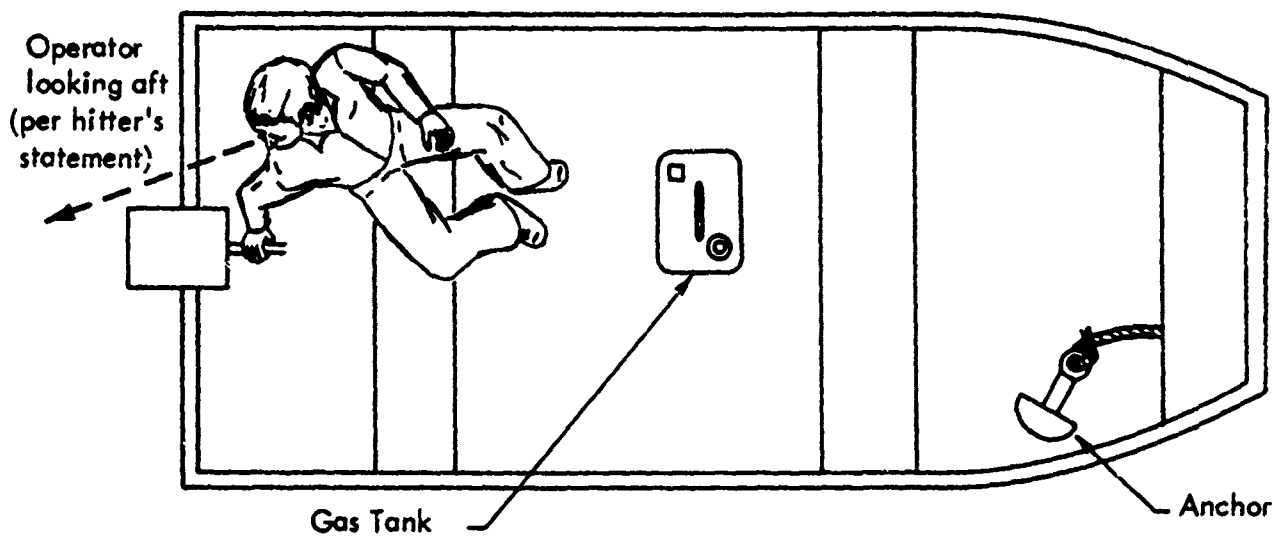
Figure 2. Plan Of Johnboat

The johnboat's bow was high, making the center of lateral resistance of the hull quite close to the transom. Therefore, when Boat # 1 hit the side of the johnboat, near the bow, the johnboat pivoted about its center of lateral resistance, and in effect, moved out of Boat # 1's path, thus avoiding for more serious damage.

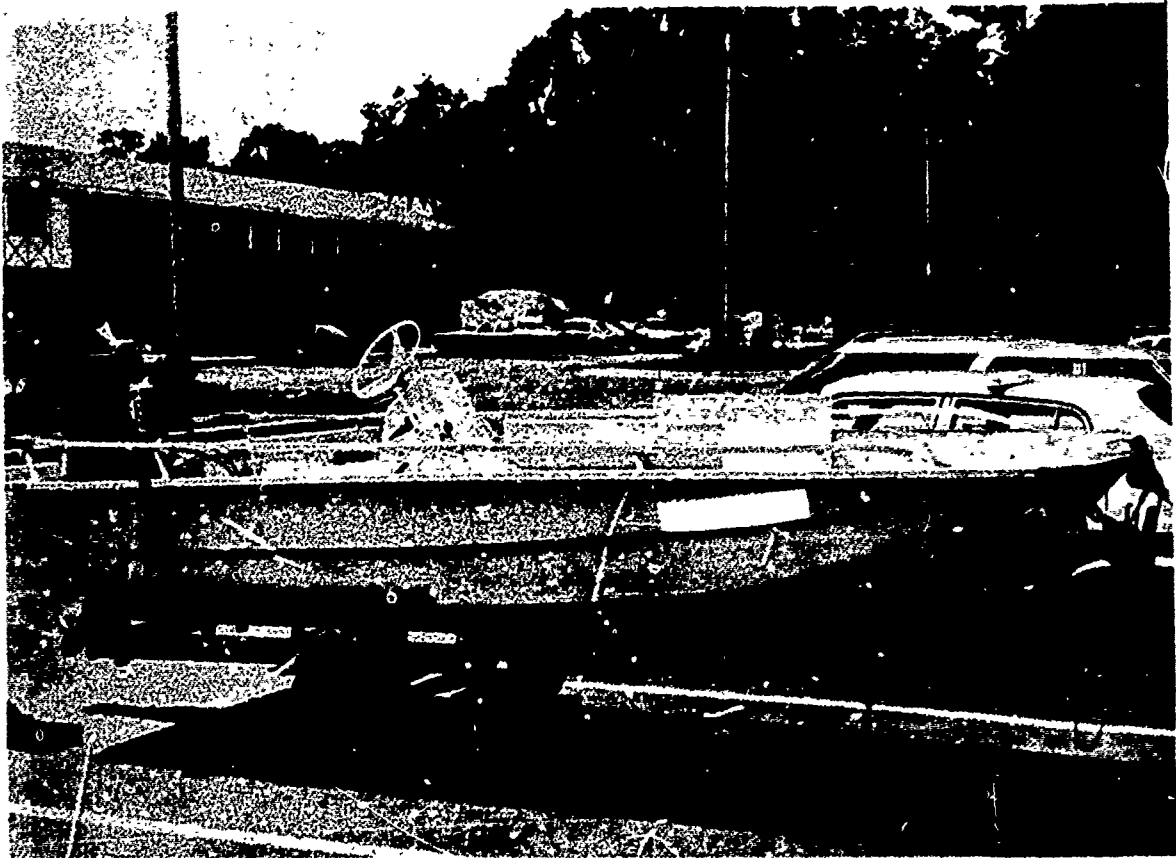
Figure 5 Profile Of Hitter
