USAARL REPORT NO. 77-7

AEROMEDICAL EVALUATION OF UH-1 INTERNAL ADVANCED PERSONNEL RESCUE HOISTS
WESTERN GEAR CORPORATION HOIST MODELS 42277R1 AND 42305R1
BREEZE CORPORATION HOIST ECP-720 MODIFICATION

February 1977

US Army Aeromedical Research Laboratory
Fort Rucker, Alabama 36362

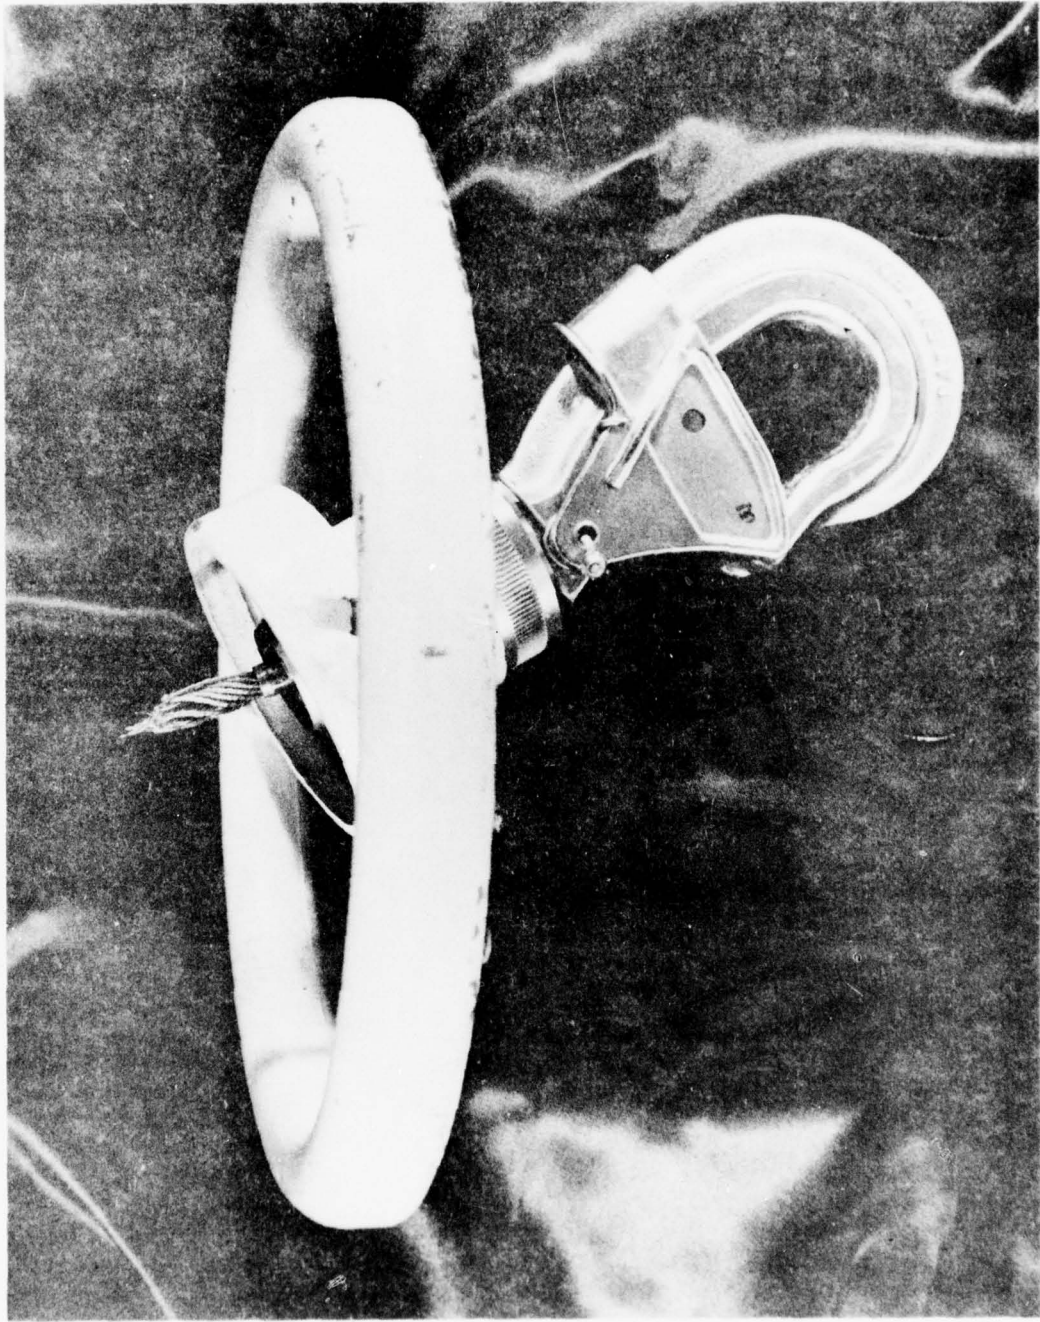
PHOTO 3

The cable was a Type A, MIL-W-83140 standard cable. The ultimate strength demonstrated a relatively consistent break strength with a decrement of 0.6% to 4% from design strength of 3,300 pounds. This data is comparable to the cable test data reported by the USAF Critical Design Review (CDR) of the UH-1N Helicopter Rescue Hoist.¹³

Cable ultimate tensile strength was obtained using a Tinius Olsen load device. Three cable samples were cut from the five foot section of cable immediately above the break site. The break strength results are provided in Table VII.
