CRITICAL DESIGN REVIEW UH-1N HELICOPTER RESCUE HOIST

TECHNICAL REPORT ASD-TR-73-25

JULY 1973

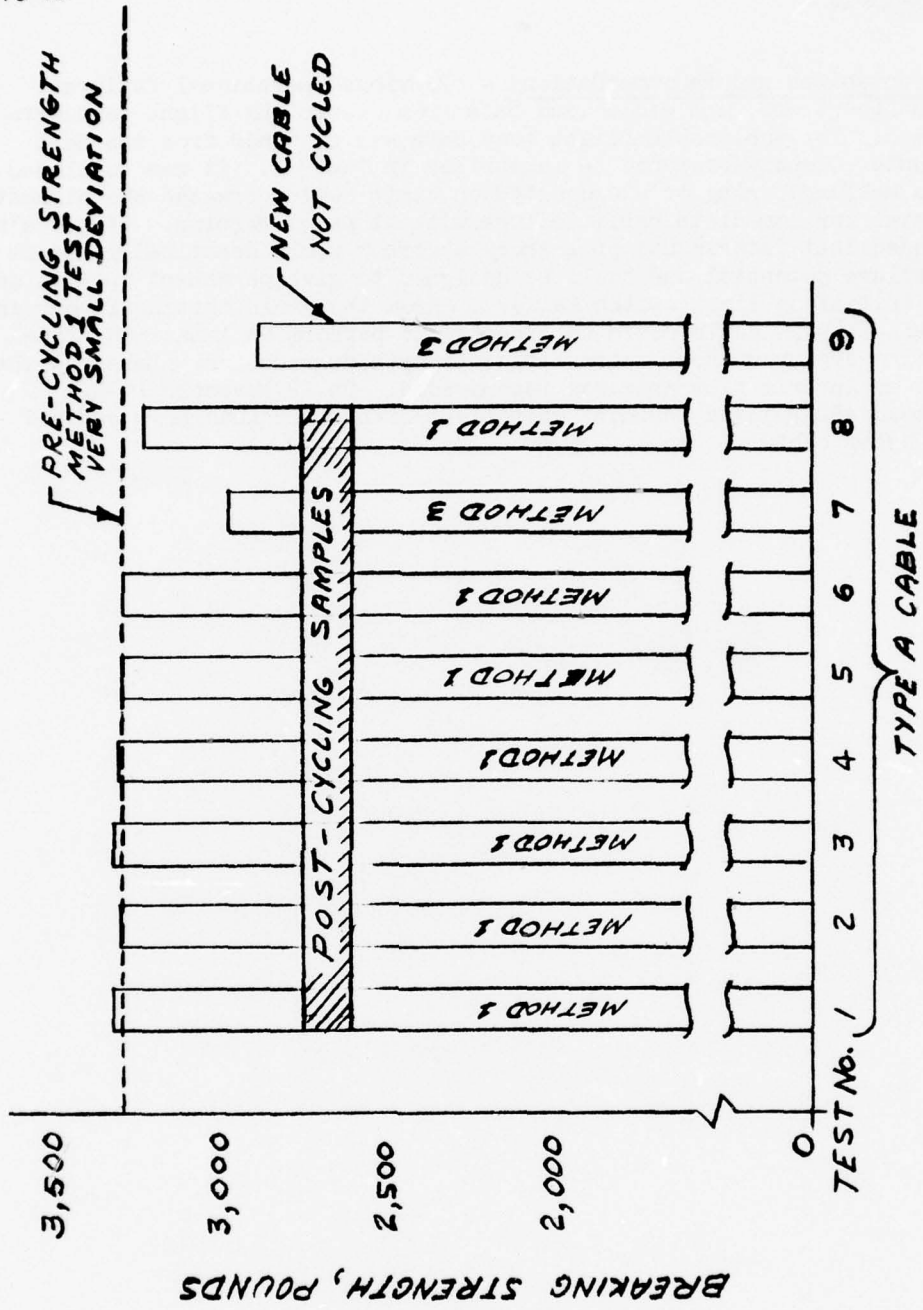
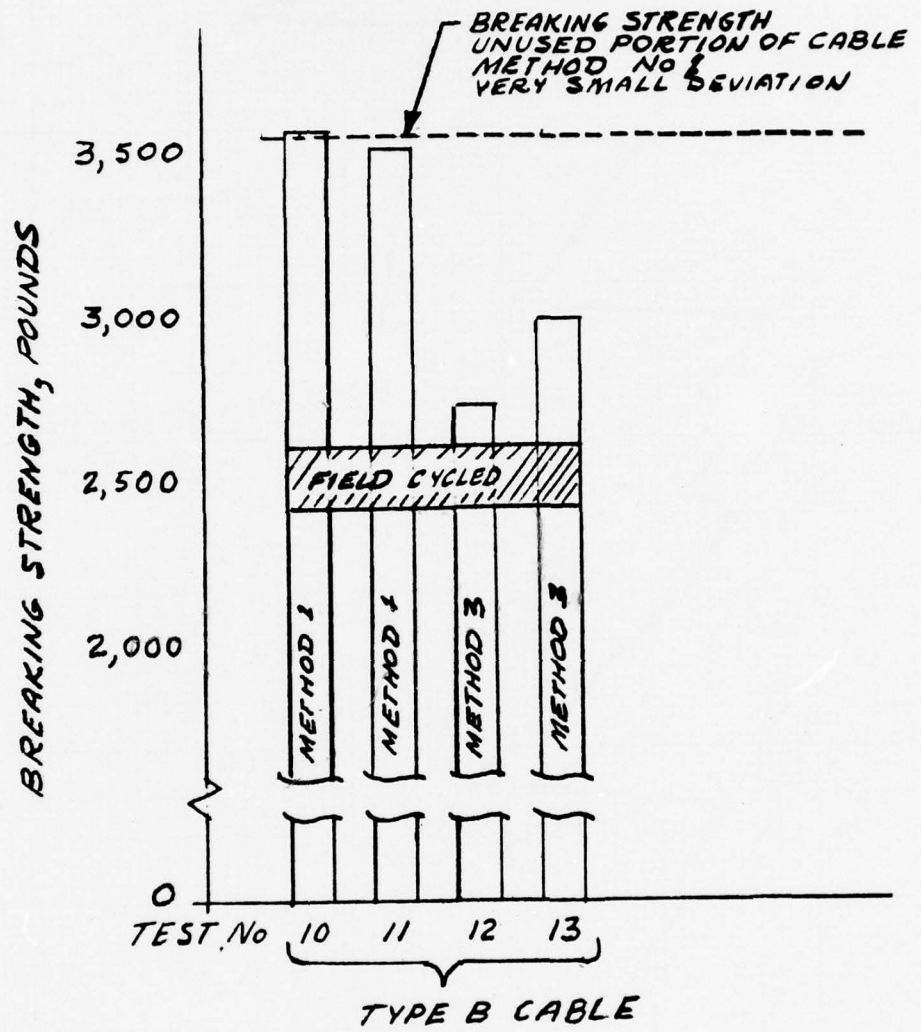
FIGURE 1 INTERIM CABLE TEST

3. Cable Test Results - Results of cable testing are graphically depicted in Figures 1 and 2. Of note is the lack of degradation in cycled cables and the difference in cable strength when the ends are fixed (Method 1) and when an end is free to rotate (Method 3).

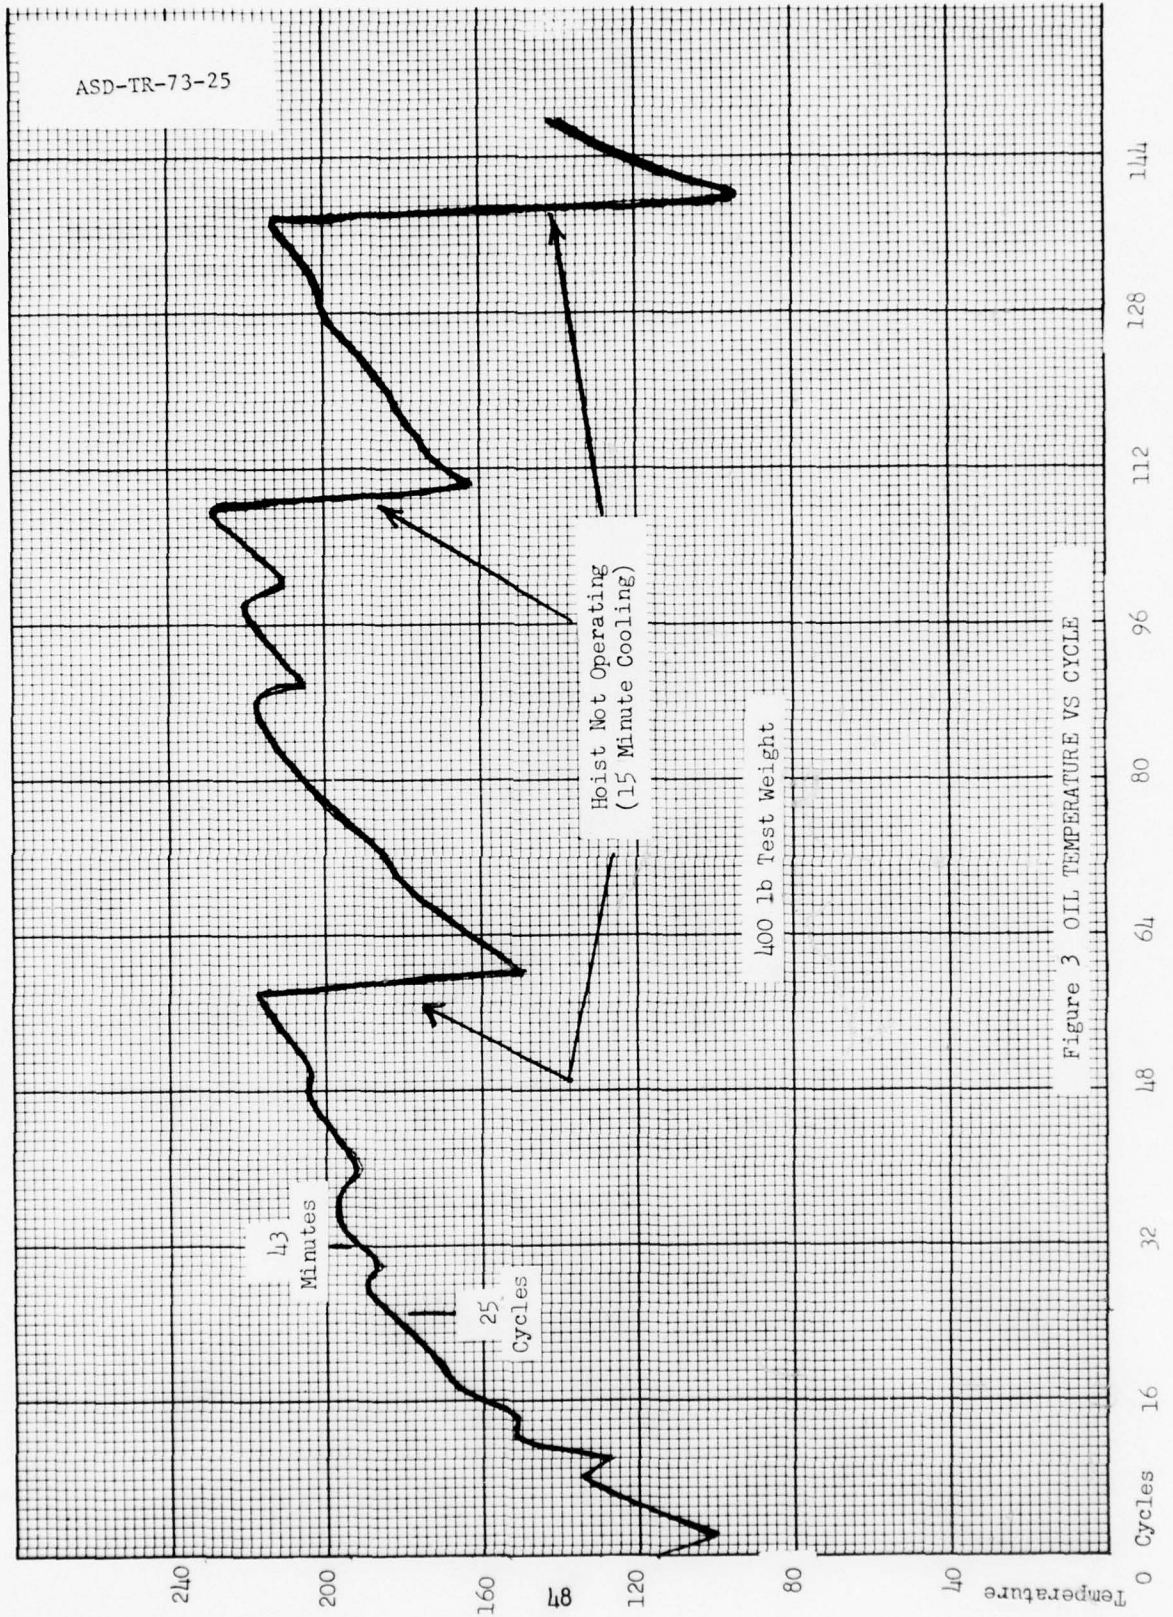
Figure 3 OIL TEMPERATURE VS CYCLE

c. Oil Leakage and Clutch Contamination - Originally, the intent had been to limit gear box oil temperature below 200°F. This temperature limit so grossly slowed the interim cable test that the limit was raised to 230°F. At this temperature gear case oil was bubbling out of the vent and seeping through seals. After 416 cycles of Test no 1, about one ounce of oil had been lost. It is emphasized that oil leakage was primarily caused by excessive temperature. The storage drum clutch started slipping at 474 cycles. Twelve cycles later the winch was replaced with an overhauled unit. Cause of the malfunction was oil contamination in the clutch. Origin of the oil was undetermined. Subsequent testing with associated oil leakage failed to cause a clutch malfunction. Figure 3 depicts the gear box oil temperature rise plotted against continuous cycles. It should be noted that excessive temperature was reached only after 32 continuous cycles.

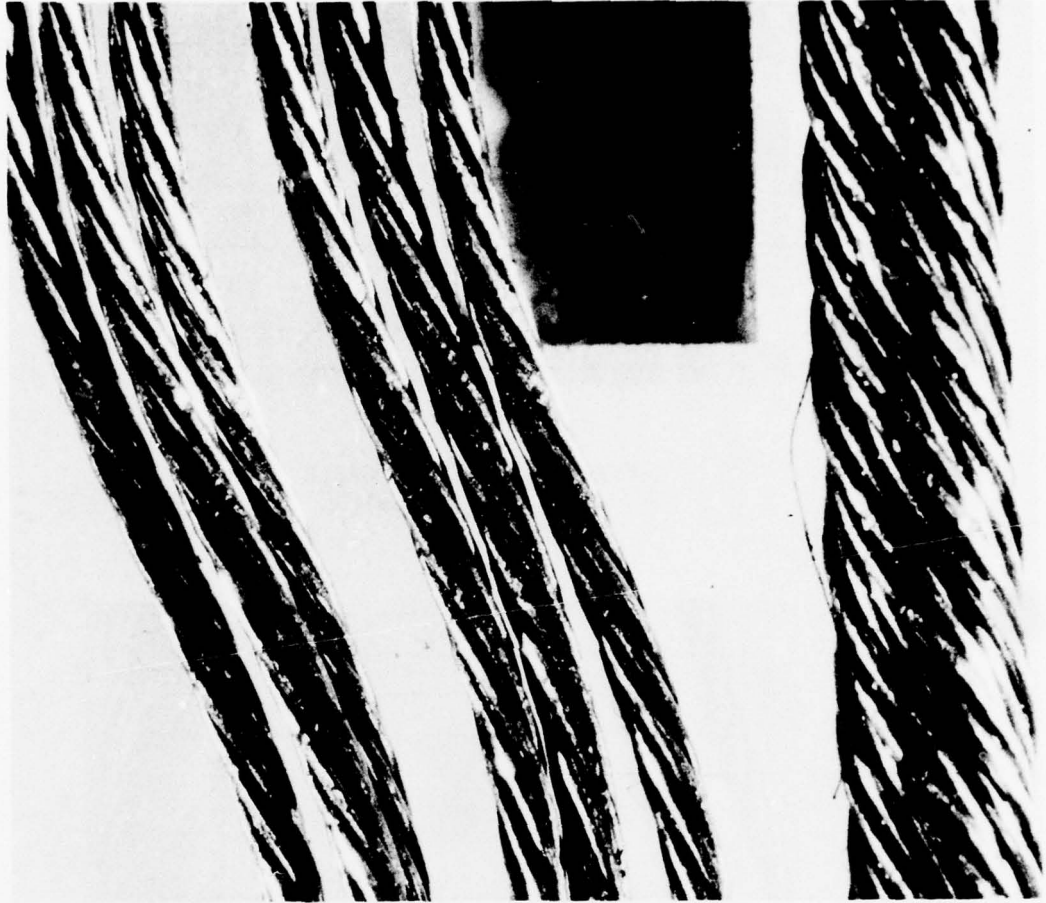
Figure 6 TYPE A CABLE
(50,000 Cycles)

d. The fatigue characteristics (strength degradation) of the cables tested appeared to be influenced to a large degree by cable ductility, cable manufacturing methods, and individual strand properties in lieu of initial breaking strength. Cables A and C showed a minimum strength reduction after endurance testing, while cables B and D failed to complete the testing at higher tension loads. It is interesting to note that cables B and D were also the cables which had the higher initial breaking strength when tested with fixed end attachment. The conclusion may be drawn that a higher initial cable breaking strength which sacrifices ductility tends to show poor fatigue life capabilities.

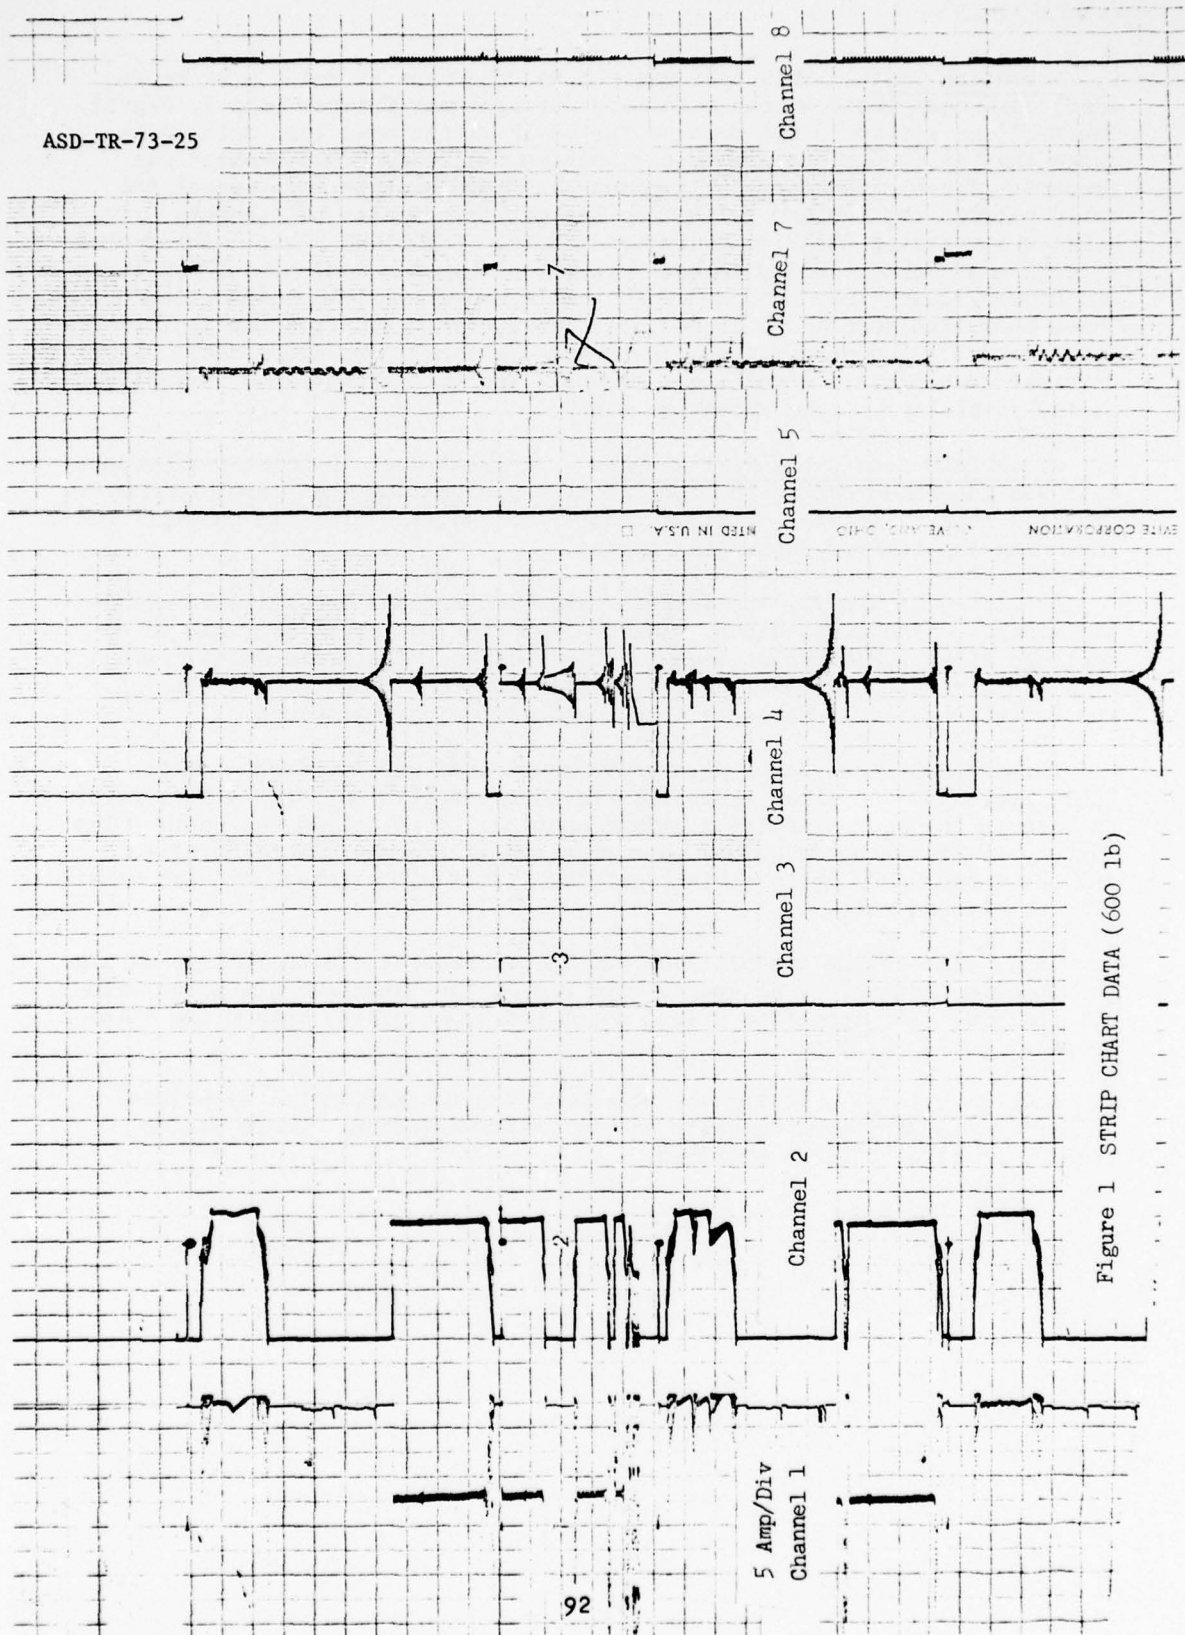
Figure 1 STRIP CHART DATA (600 lb)

Figure 1 depicts strip chart recorder data for cycles 2800, 2850, and 2900. The motor amperage and voltage (channels 1 and 2) appear erratic compared with Figures 2 and 3, which depict cycles 350, 400, 450, 800, 850, 900, and 950.

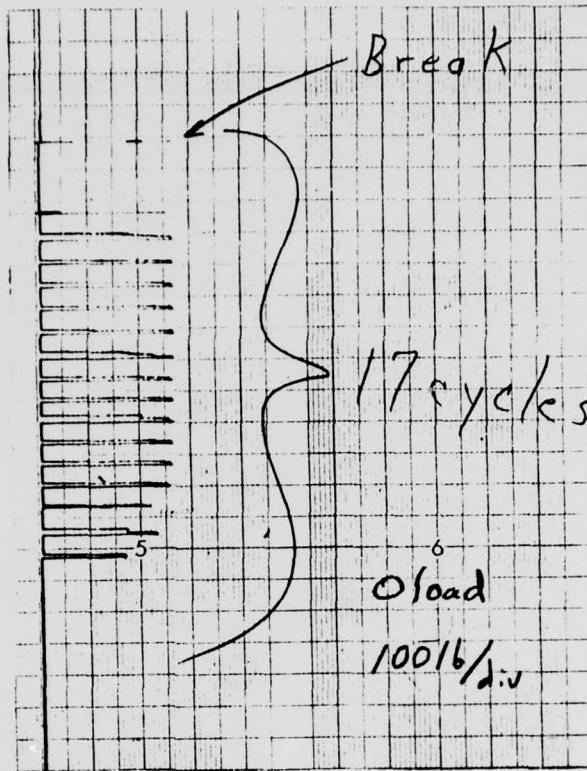
Figure 4 TWO BLOCK CABLE TO FAILURE

e. Two Block - At the completion of the 2,950 electro-mechanical test cycles, a short test was run to determine the effect of impacting the hook into an inoperative up-limit switch. Approximately 2,600 pounds of cable tension was generated at each impact. Four tests were run. New MIL-W-83140 (Type A) cables were used. The four cables broke after 35, 35, 17, and 25 impacts. There was no weight on the cable. Figure 4 depicts one of these tests showing the impact loads.
