TECHNICAL REPORT  
NATICK/76-062 - CEMEL

**FLAME TEST FOR MEDICAL UNIT,  
SELF-CONTAINED TRANSPORTABLE  
(INFLATABLE SHELTER ASSEMBLY)**

24 June 1977

UNITED STATES ARMY  
NATICK RESEARCH and DEVELOPMENT COMMAND  
NATICK, MASSACHUSETTS 01760

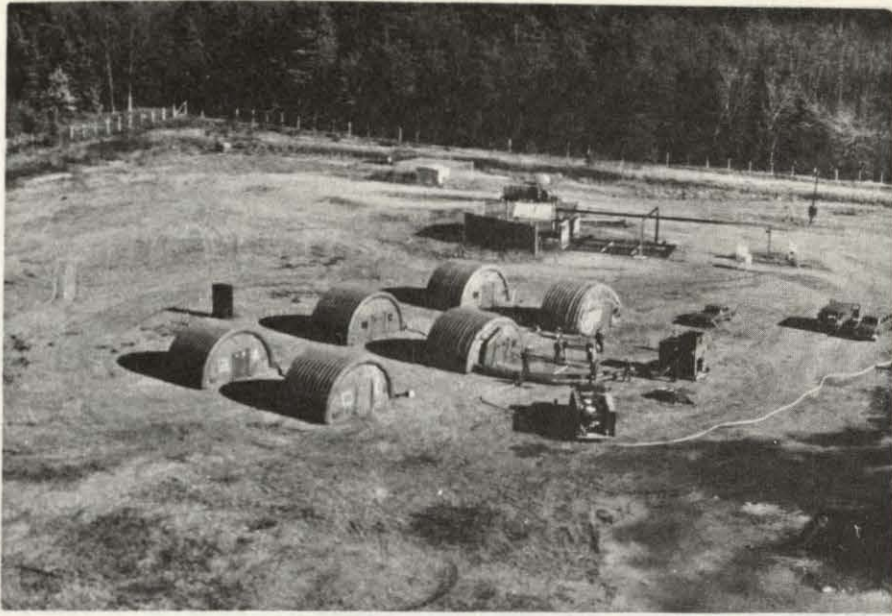
Figure 2. MUST Shelters at Sudbury Annex

The inflatable shelter, with two end panels installed, was connected through an air duct to a Utility Element which supplied recirculated air through the test unit and bleed air for inflating the cells. The airflow was throttled in such a manner that a flow of approximately 400 cfm of air ( $.19 \text{ m}^3/\text{s}$ ) was moving into the shelter. The shelter section was erected to a gage pressure of approximately 1.5 psi ( $10.3 \times 10^3 \text{ Pa}$ ) and was pressurized internally to 0.2 to 0.4 inches of water (49.8 to 99.6 Pa). The Utility Element was positioned a safe distance from the test unit with added lengths of ducting and cabling as required (see Figure 2). The fuel supply was located approximately 200 feet (61 m) from the test unit.

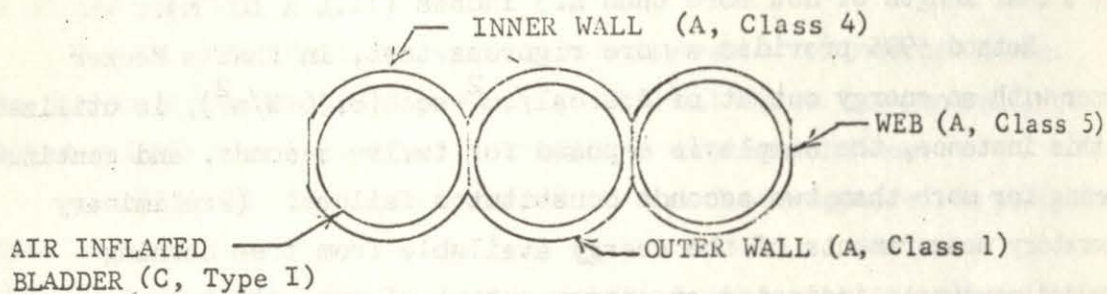
Fig. 24 Inflated Side Walls

Diagram of Inflated Side Walls with  
 Identification of Basic Materials. (Ref. Table 3)

A comparison of Figures 24, 25, and 26, and Table 3 shows that the exterior surfaces of the shelter and the interior surface of the end panels are polyester fabric, coated on both sides, and are required to meet a flame-resistance test, while the remaining inner surfaces are polyester fabrics coated on the exposed side only and are not required to be flame resistant.

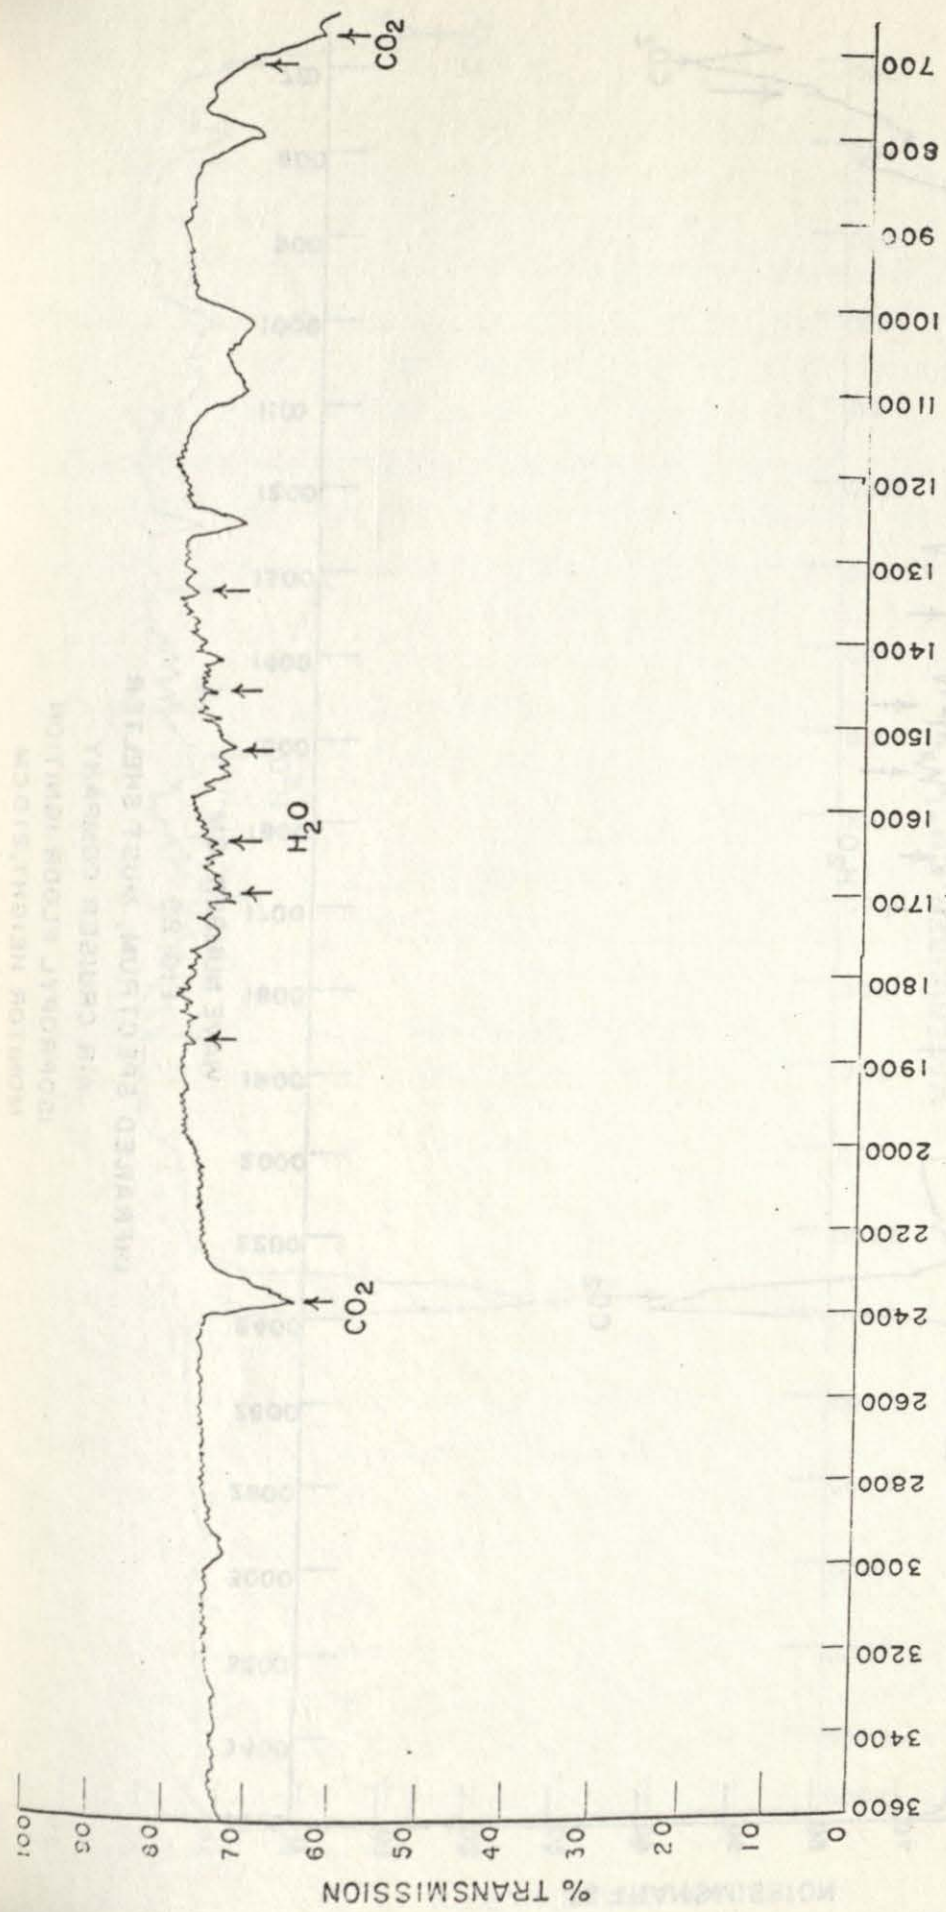
FIG. 28  
 INFRARED SPECTRUM, AIR BACKGROUND  
 CELL PATH, 1 METER

In addition to the Raman spectra cited, additional gas samples were analyzed by infrared techniques and again compared to laboratory air. The spectra obtained in these analyses are shown in Figures 28 to 30. These spectra also show an increased presence of  $H_2O$  and  $CO_2$  in the gases collected within the shelter, but no presence of materials normally considered toxic.

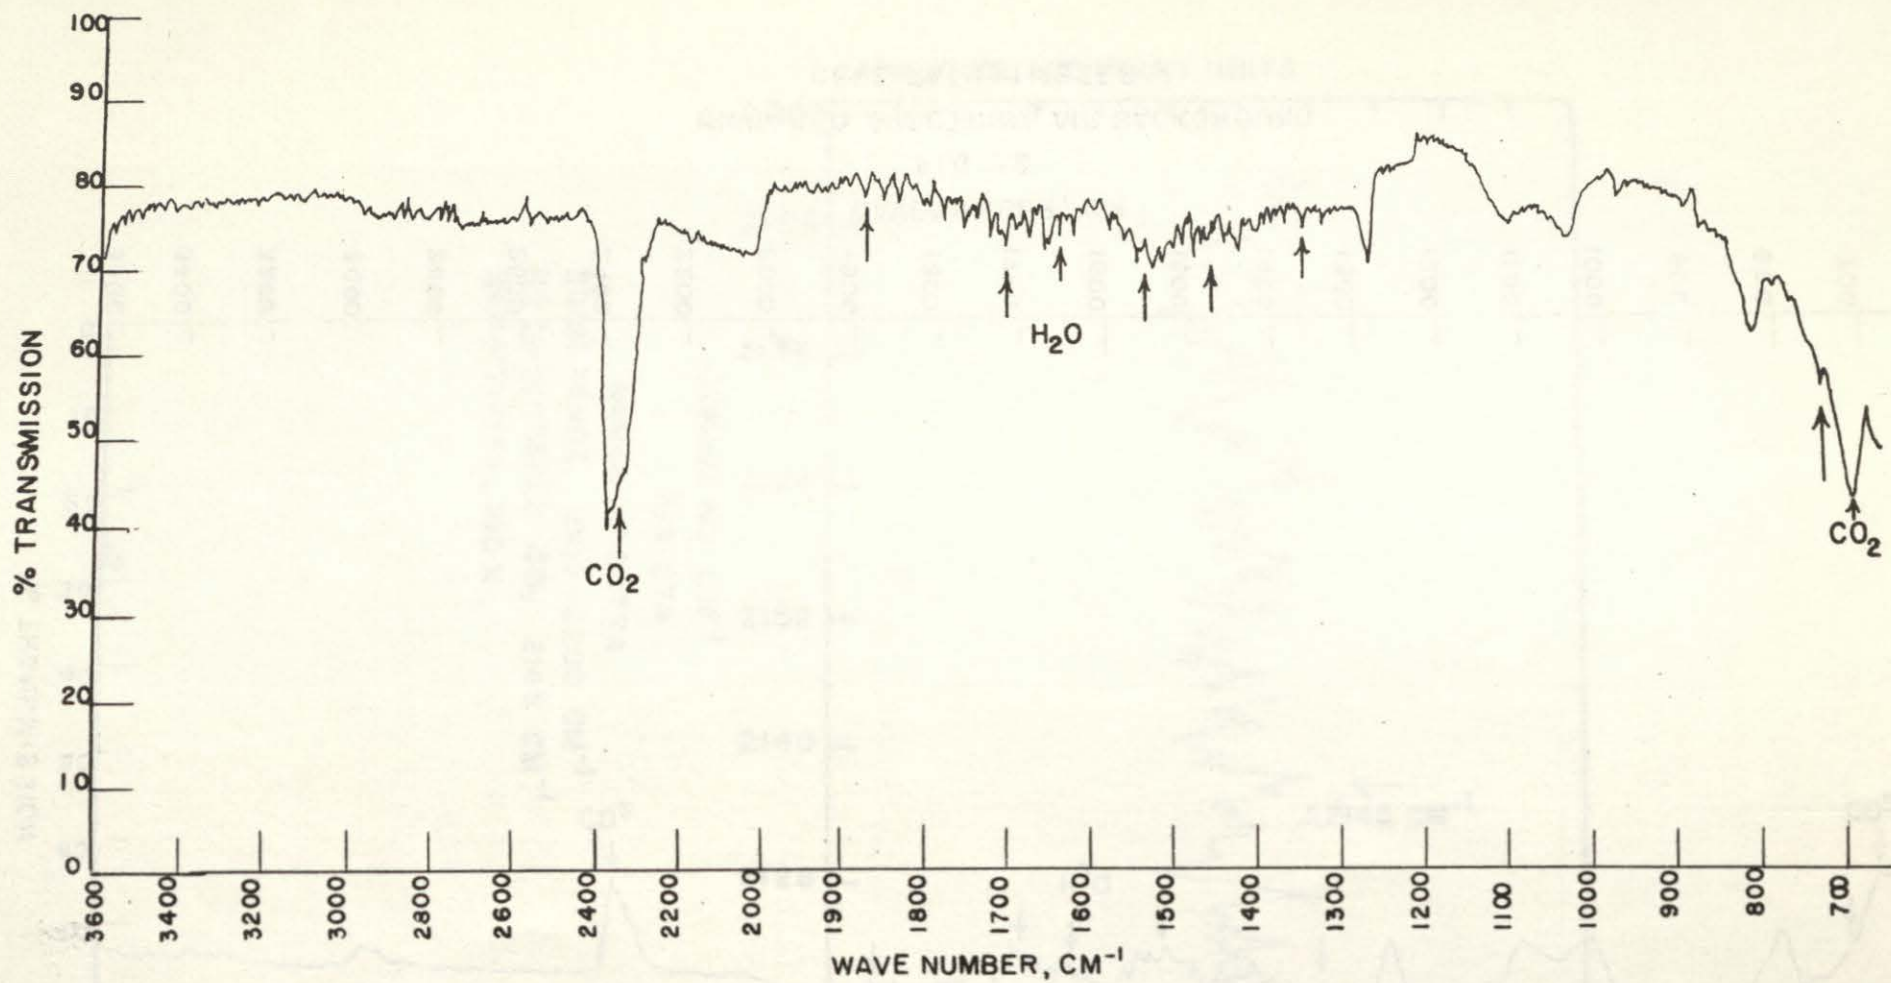
FIG. 29

INFRARED SPECTRUM, MUST SHELTER  
AIR CRUISER COMPANY  
ISOPROPYL FLOOR IGNITION  
MONITOR HEIGHT, 210 CM

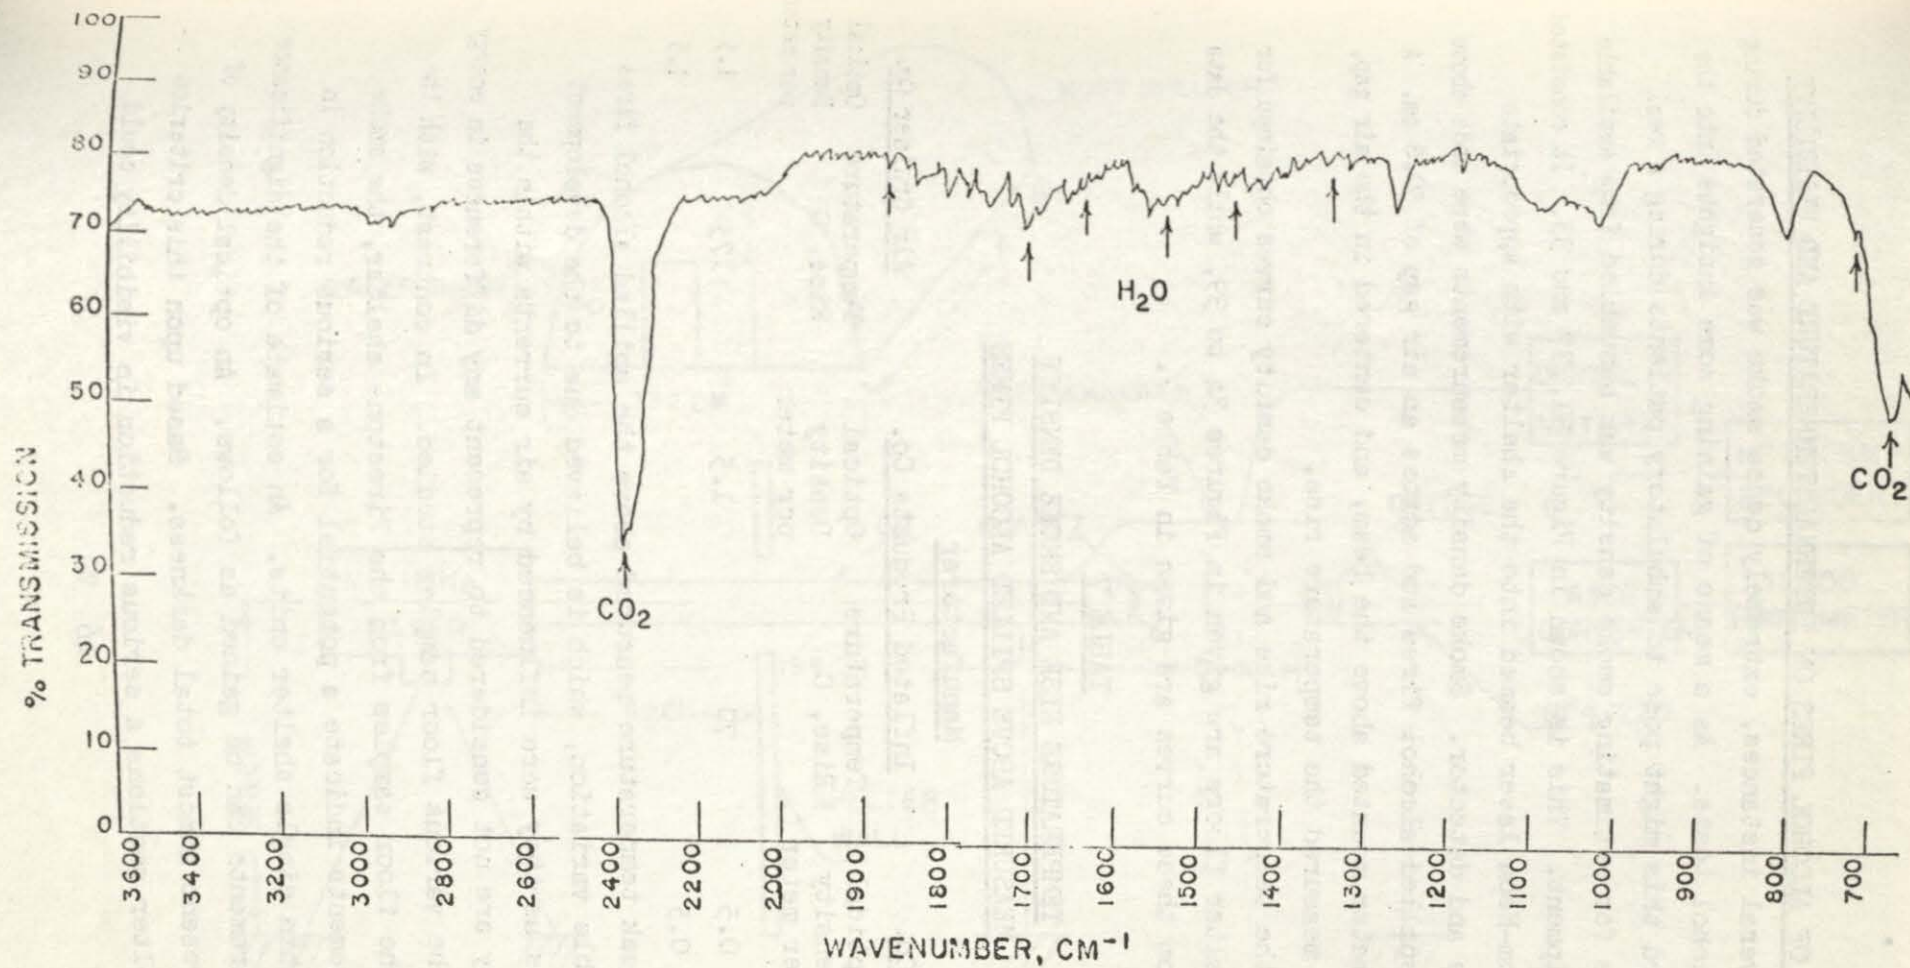
INFRA RED SPECTRUM, MUST SHELTER  
AIR CRUISER COMPANY  
ISOPROPYL FLOOR IGNITION,  
MONITOR HEIGHT, 100 CM

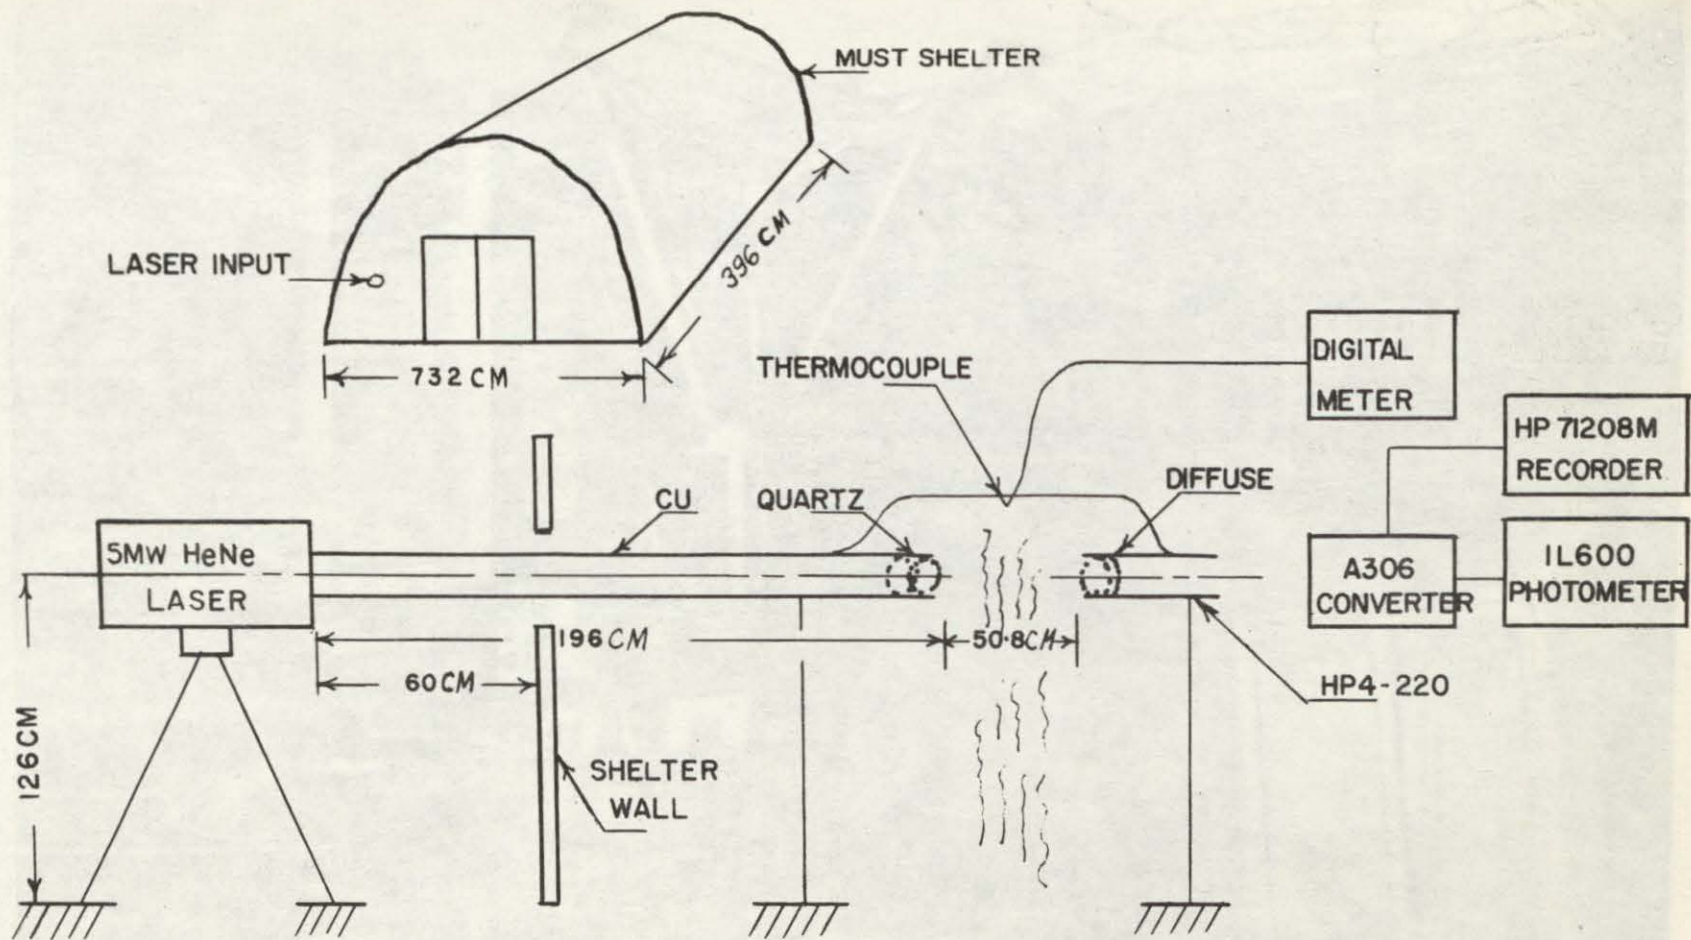
FIG-31  
SCHEMATIC DIAGRAM FOR SMOKE DENSITY  
AND TEMPERATURE MEASUREMENTS

In several instances, extremely dense smoke was generated during the spilled alcohol tests. As a means of gaining some insights into the potential hazard this might pose to ambulatory patients during a real event, a device for estimating smoke density was assembled from available laboratory equipment. This is shown in Figure 31, 32 and 33. It consisted of a 5-mW Helium-Neon laser beamed into the shelter with appropriate optical windows and detector. Smoke density measurements were made above the simulated spilled alcohol fires and across an air gap of 50.8 cm. A digital thermometer mounted above the beam, and centered in the air gap, simultaneously measured the temperature rise.

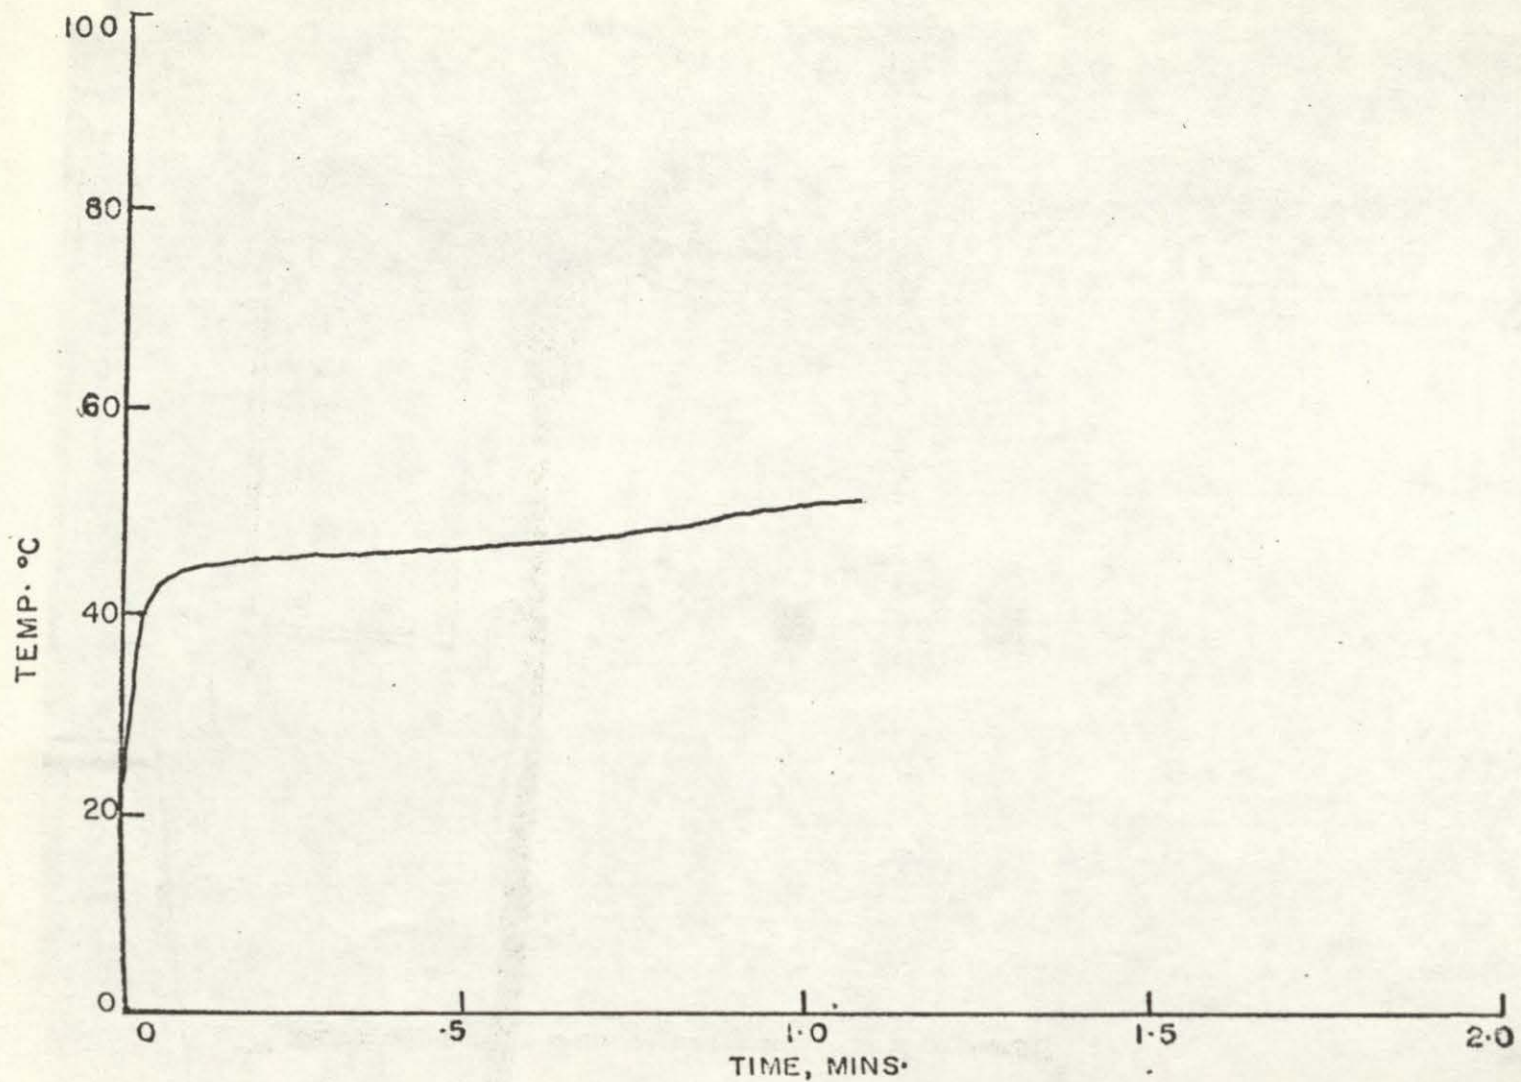
FIG-34

The peak temperature measured above the spilled alcohol fires show considerable variation, which is believed due to the development of flame plumes as they were influenced by air currents within the shelters. They are not considered to represent any differences in energy generated by the various floor samples studied. In contrast, with the exception of the floor samples from the Firestone shelter, the smoke density measurements indicate a potential for a serious reduction in visibility within single shelter units. An estimate of the significance of these measurements can be gained as follows. An optical density of 3.0 would represent almost total darkness. Based upon this criterion for single shelter sections a serious reduction in visibility could

TIME TEMPERATURE PROFILE OF AIR DURING  
BURNING OF SHELTER NO 2 FLOOR

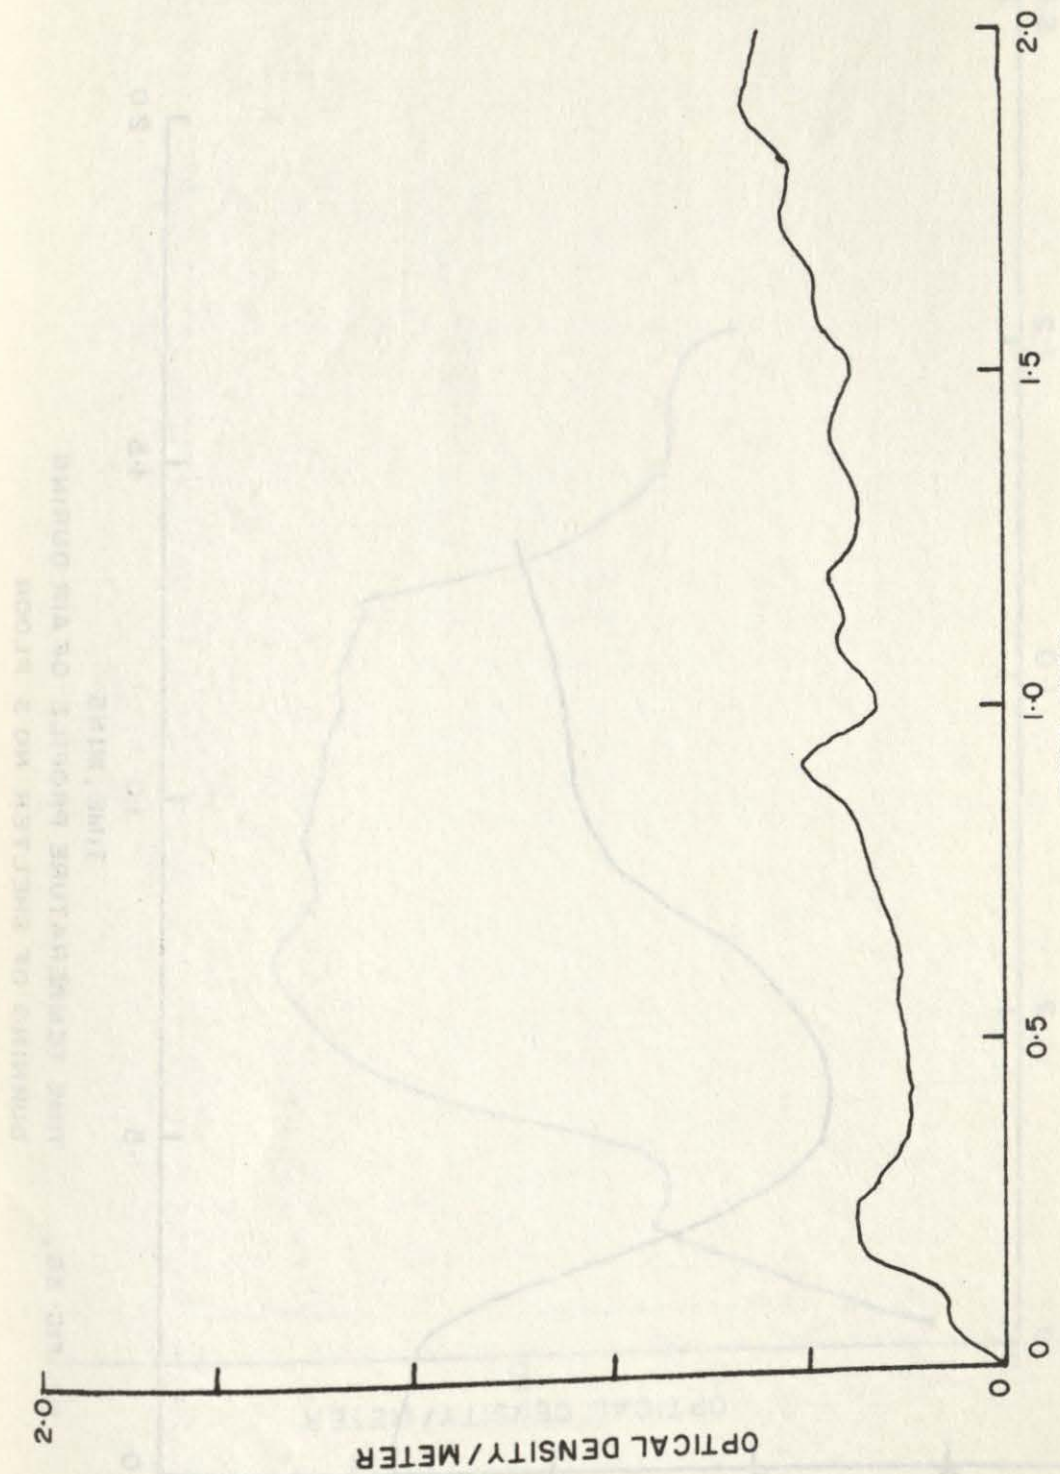
FIG. 35, SMOKE DENSITY PROFILE DURING BURNING OF SHELTER NO 2 FLOOR

occur at distances of 6, 2, and 2 meters for the Firestone, Inflated Products, and Air Cruiser Shelters, respectively, while total darkness could be anticipated at distances of 8, 2.7, and 2.7 meters. The optical density curves indicated these conditions would persist for the first one to two minutes, after which the shelter's exhaust system would clear the air.

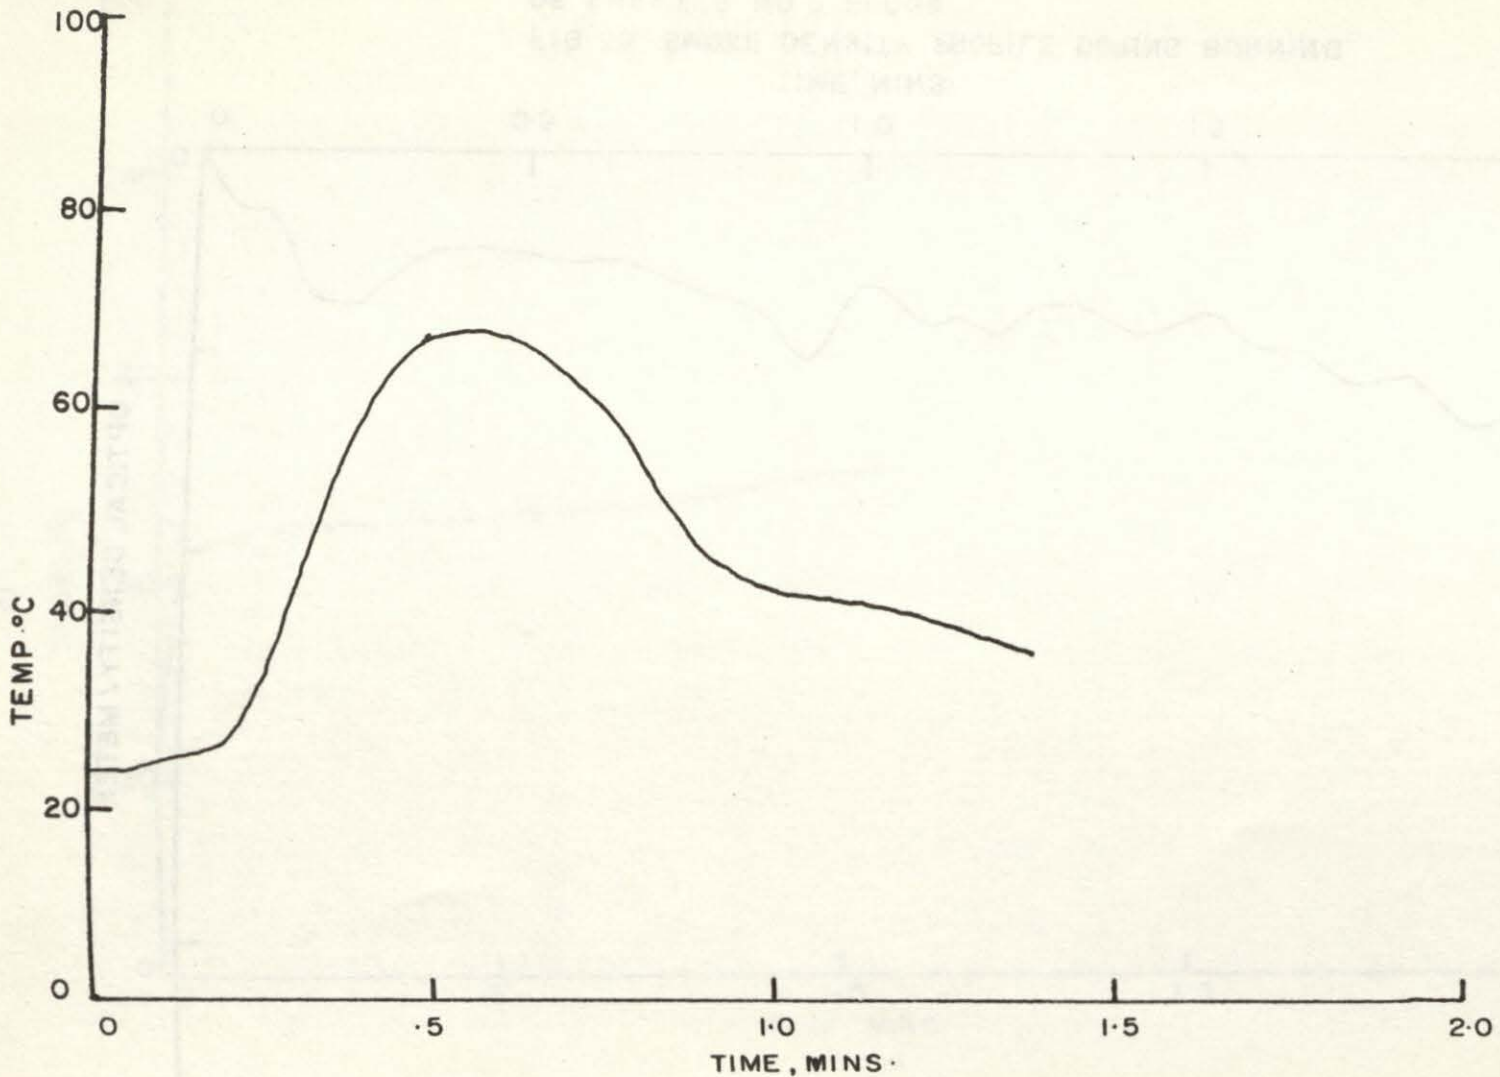
FIG. 36, TIME TEMPERATURE PROFILE OF AIR DURING BURNING OF SHELTER NO 3 FLOOR

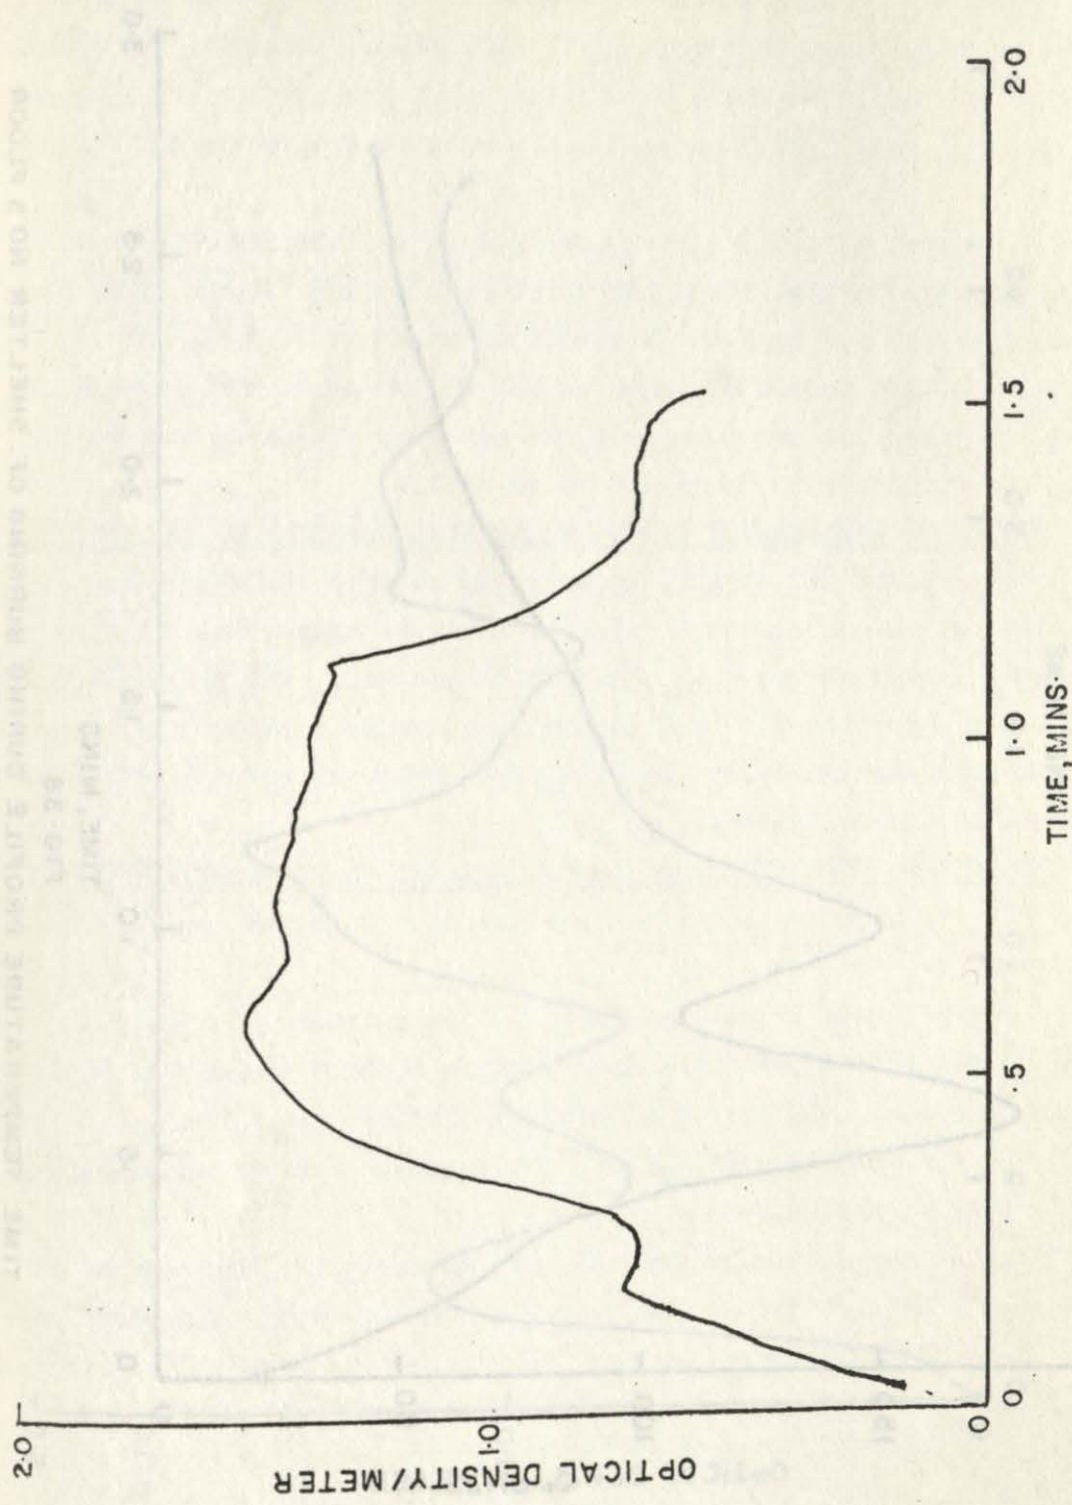
FIG. 37, SMOKE DENSITY PROFILE DURING BURNING OF SHELTER NO 3 FLOOR

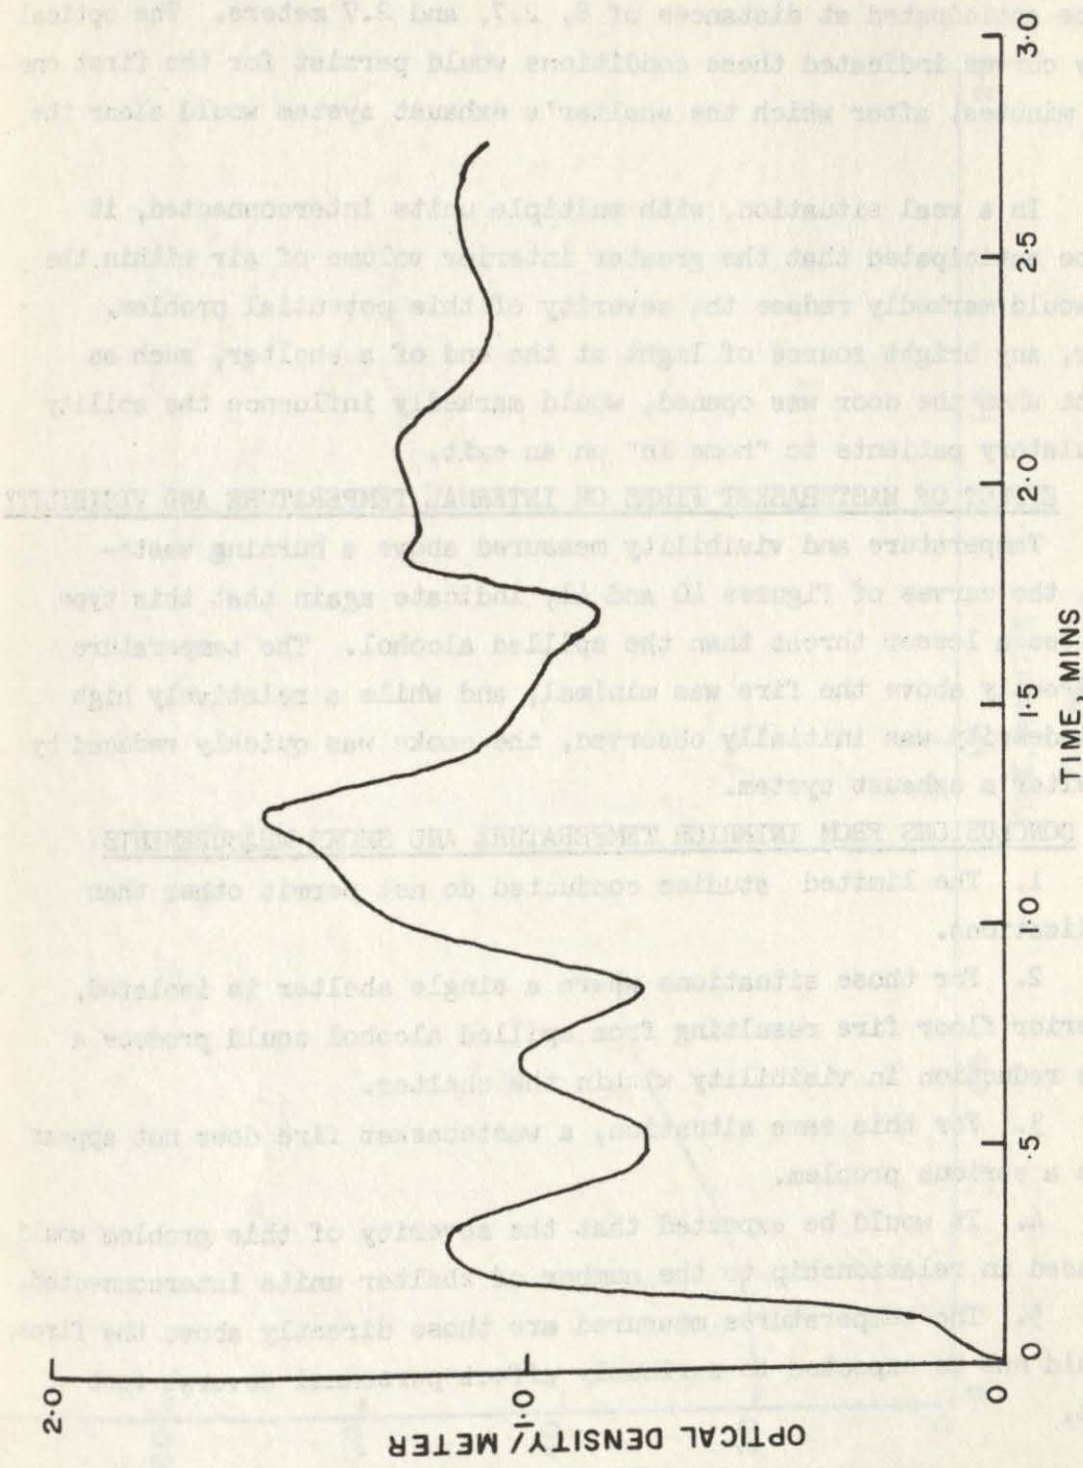
FIG. 39, SMOKE DENSITY PROFILE DURING BURNING OF SHELTER NO. 5 FLOOR
