Report No. FAA-RD-77-13

FULL-SCALE AIRCRAFT CRASH TESTS OF MODIFIED JET FUEL

Robert H. Ahlers

JULY 1977

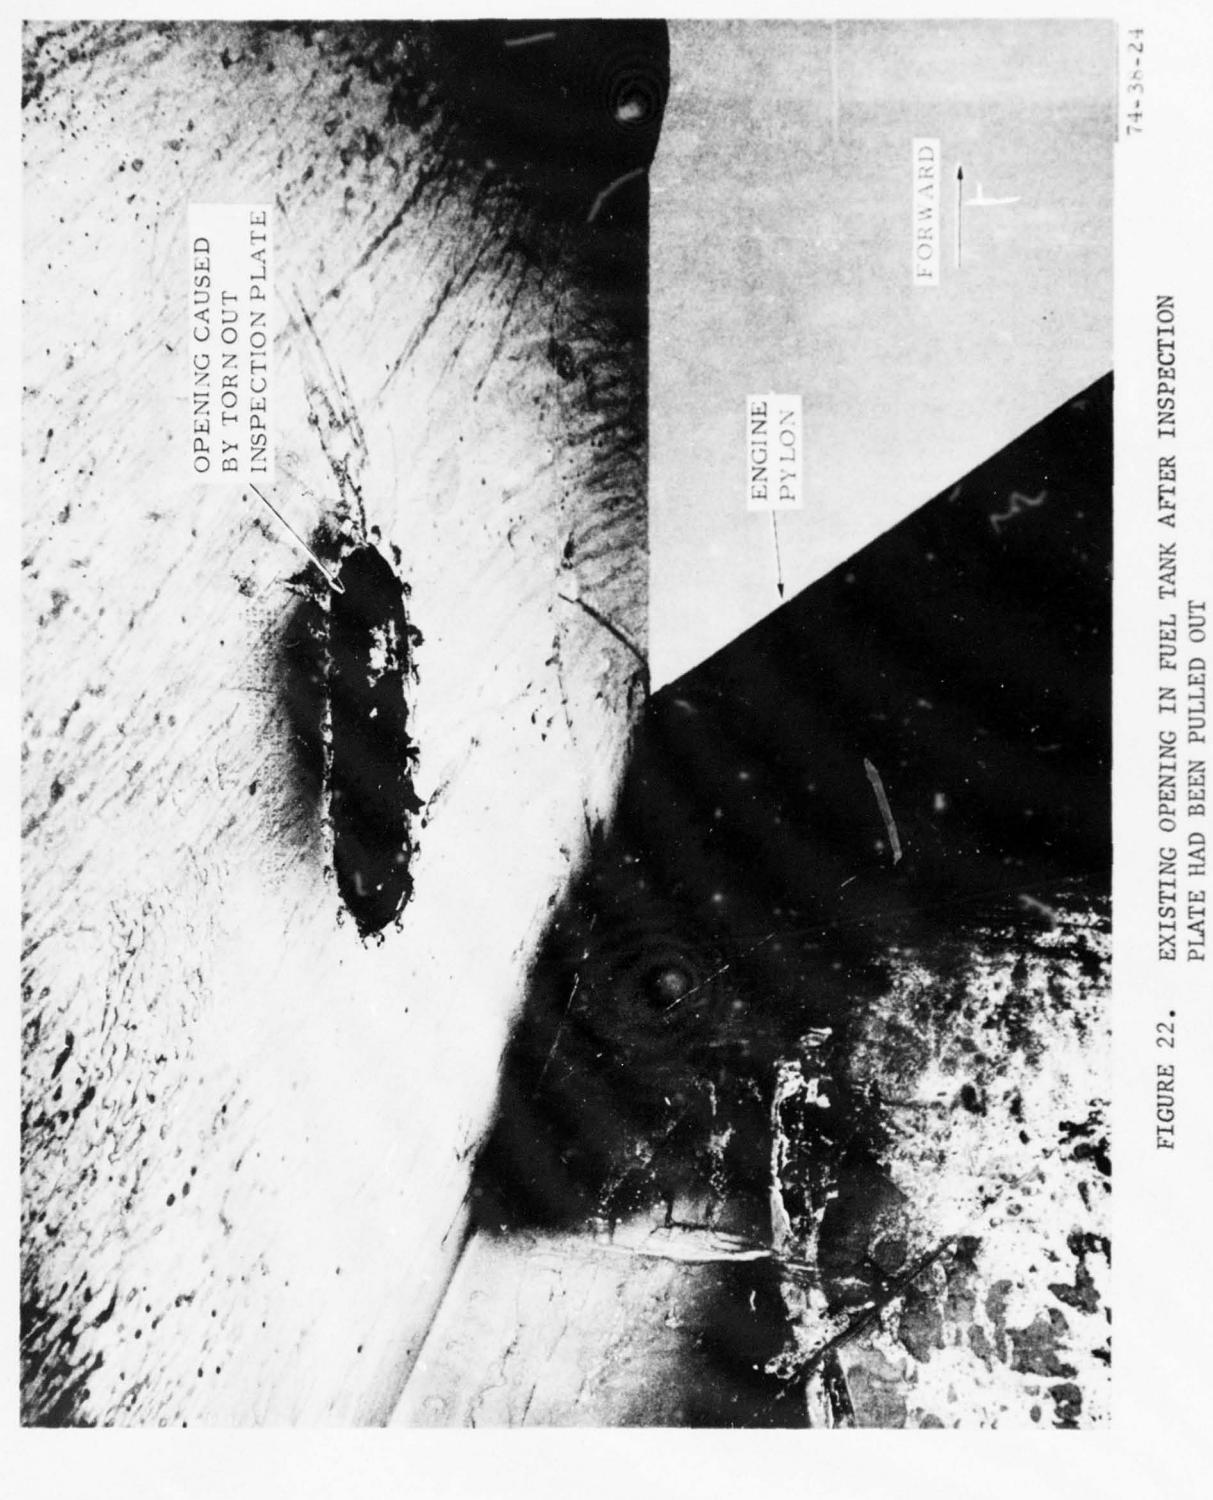
FIGURE 21. FUEL TANK INSPECTION PLATE PULLOUT INSTALLATION

A special effort was made on this test to increase the quantity of fuel gushing from the wing tanks as the test airplane passed through the test site area. One scheme was to forcibly pull out two fuel tank inspection plates under each wing. Figure 21 shows the installation on the port wing. Heavy steel levers were welded to a modified inspection plate that had a weak membrane of thin aluminum, fabricated within its structure. The steel lever arm was connected to the main landing gear strut by 3/8-inch-diameter stainless steel cable, and during the actual test, when the landing gear was knocked off, the inspection plates were torn out of the wing tank skin allowing the fuel to escape. Figure 22 shows the underside of the wing after an inspection plate had been pulled out during the test.
