### ER-7867-F

# ULTRASONIC INSPECTION OF CERAMICS CONTAINING SMALL FLAWS

TRW Inc. Cleveland, Oh. 44117

**Final Technical Report**

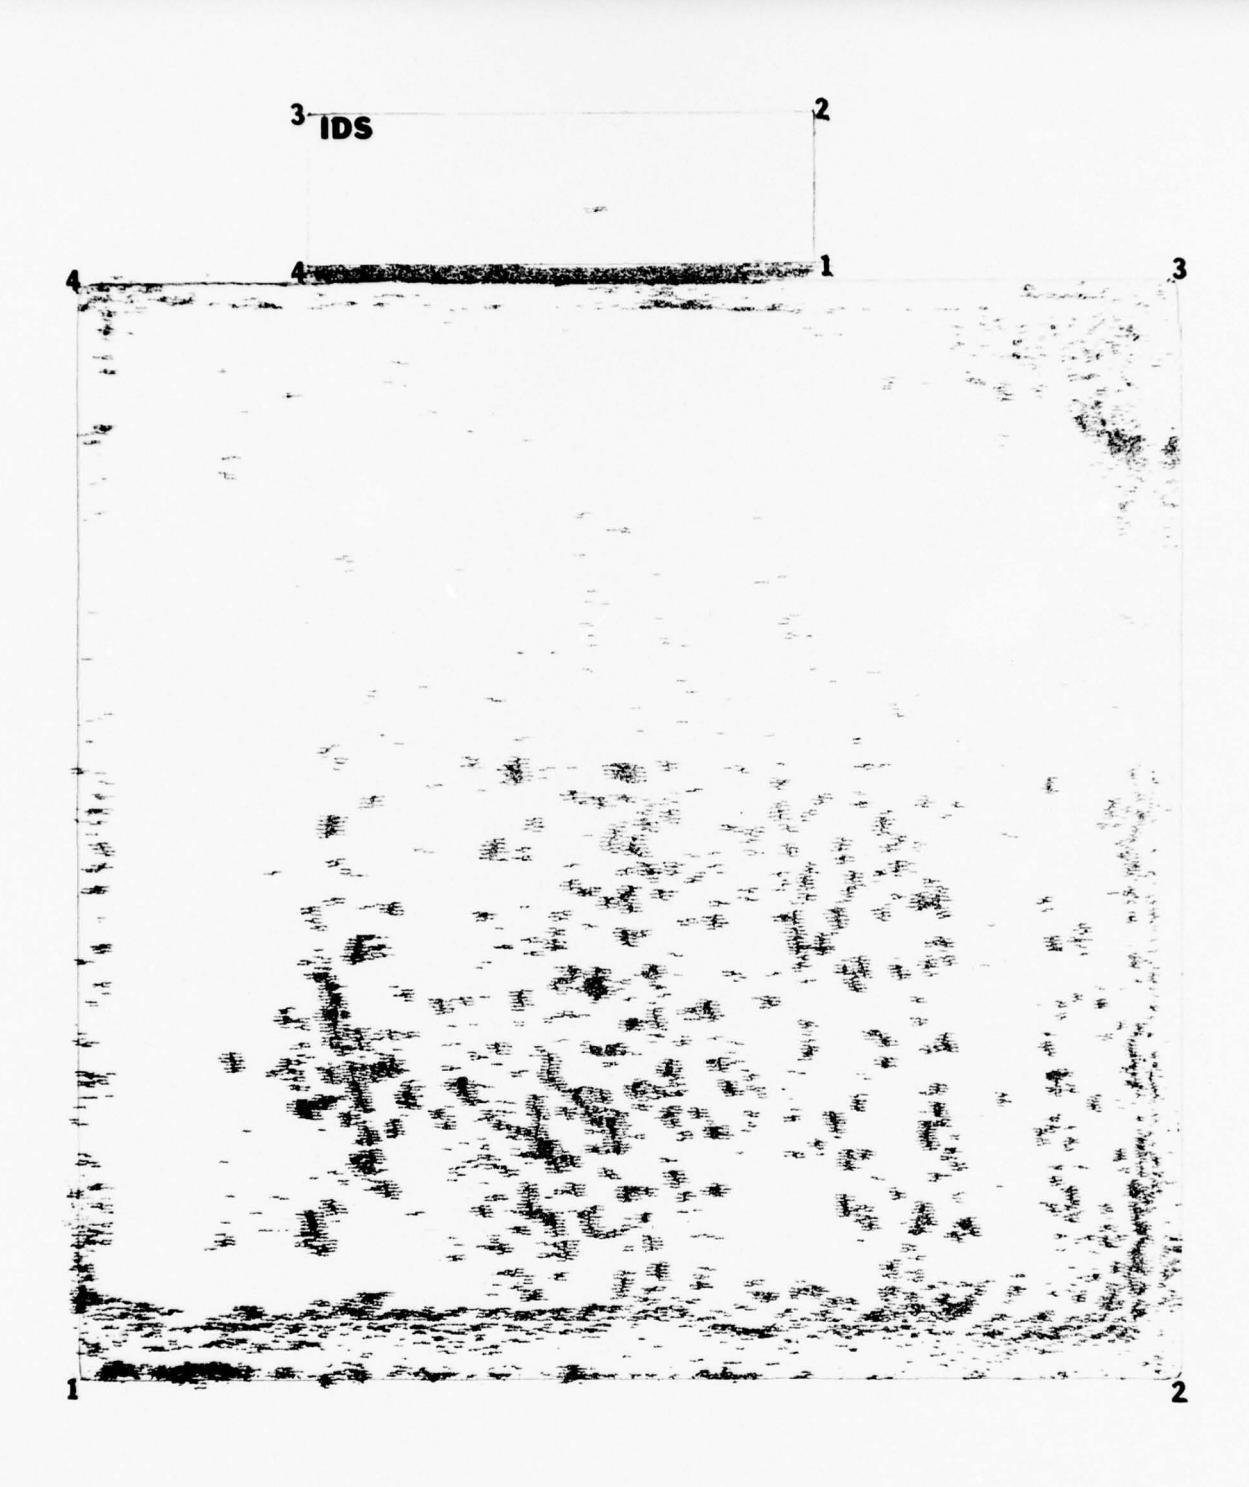
Figure 8. C-scan Recording of 45 MHz Longitudinal Wave Inspection of NC-132 Before Machining.

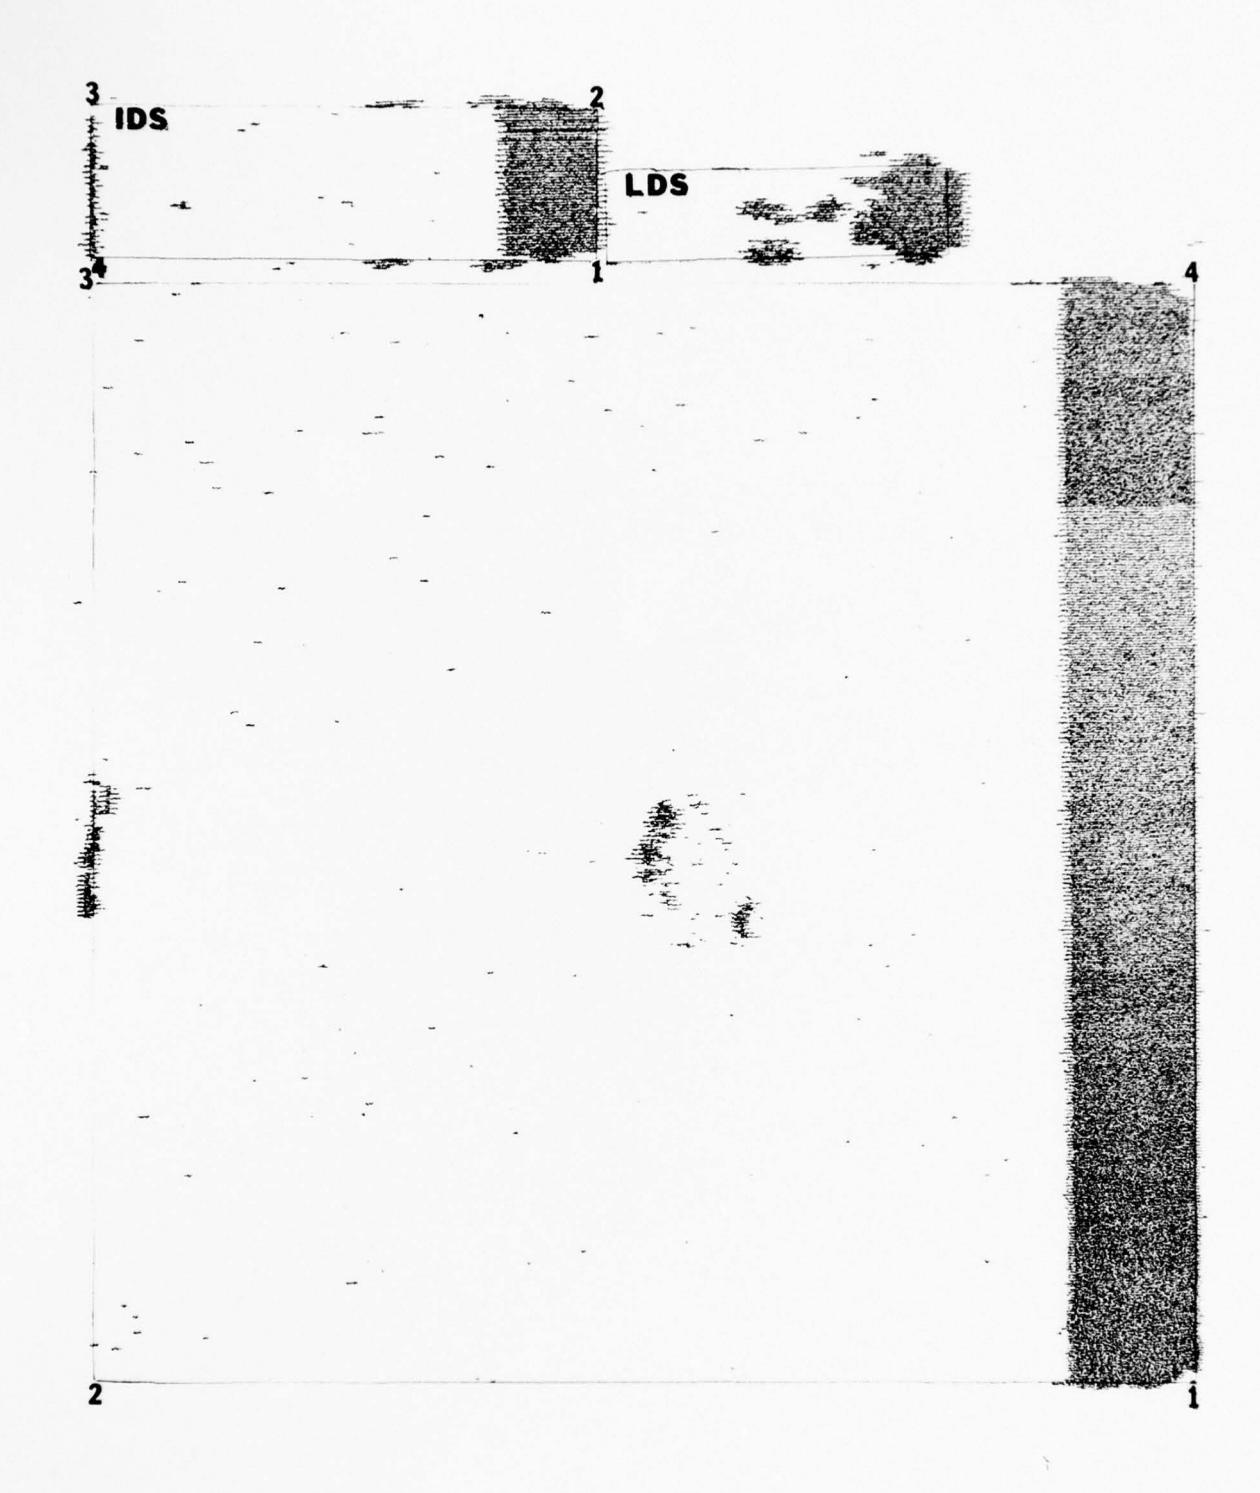
The Ceralloy 146A, which was inspected in the previous program using longitudinal waves and found to have only a few small defects, was not found to have any additional defects by shear wave inspection. The billets of NC-203A were also found to be relatively free of defects, except for the area of visible surface porosity near the center. This area was detected both by shear wave inspection from either side (Figures 13 and 15) and by longitudinal wave inspection from the same side (Figure 16). The A-scan display observed during the inspection shown in Figure 16 revealed that this defective area is not confined to the surface but extends somewhat into the material.

Figure 15. C-scan Recording of 45 MHz, 11° Shear Wave Inspection of NC-203A After Machining with Surface Porosity Up.

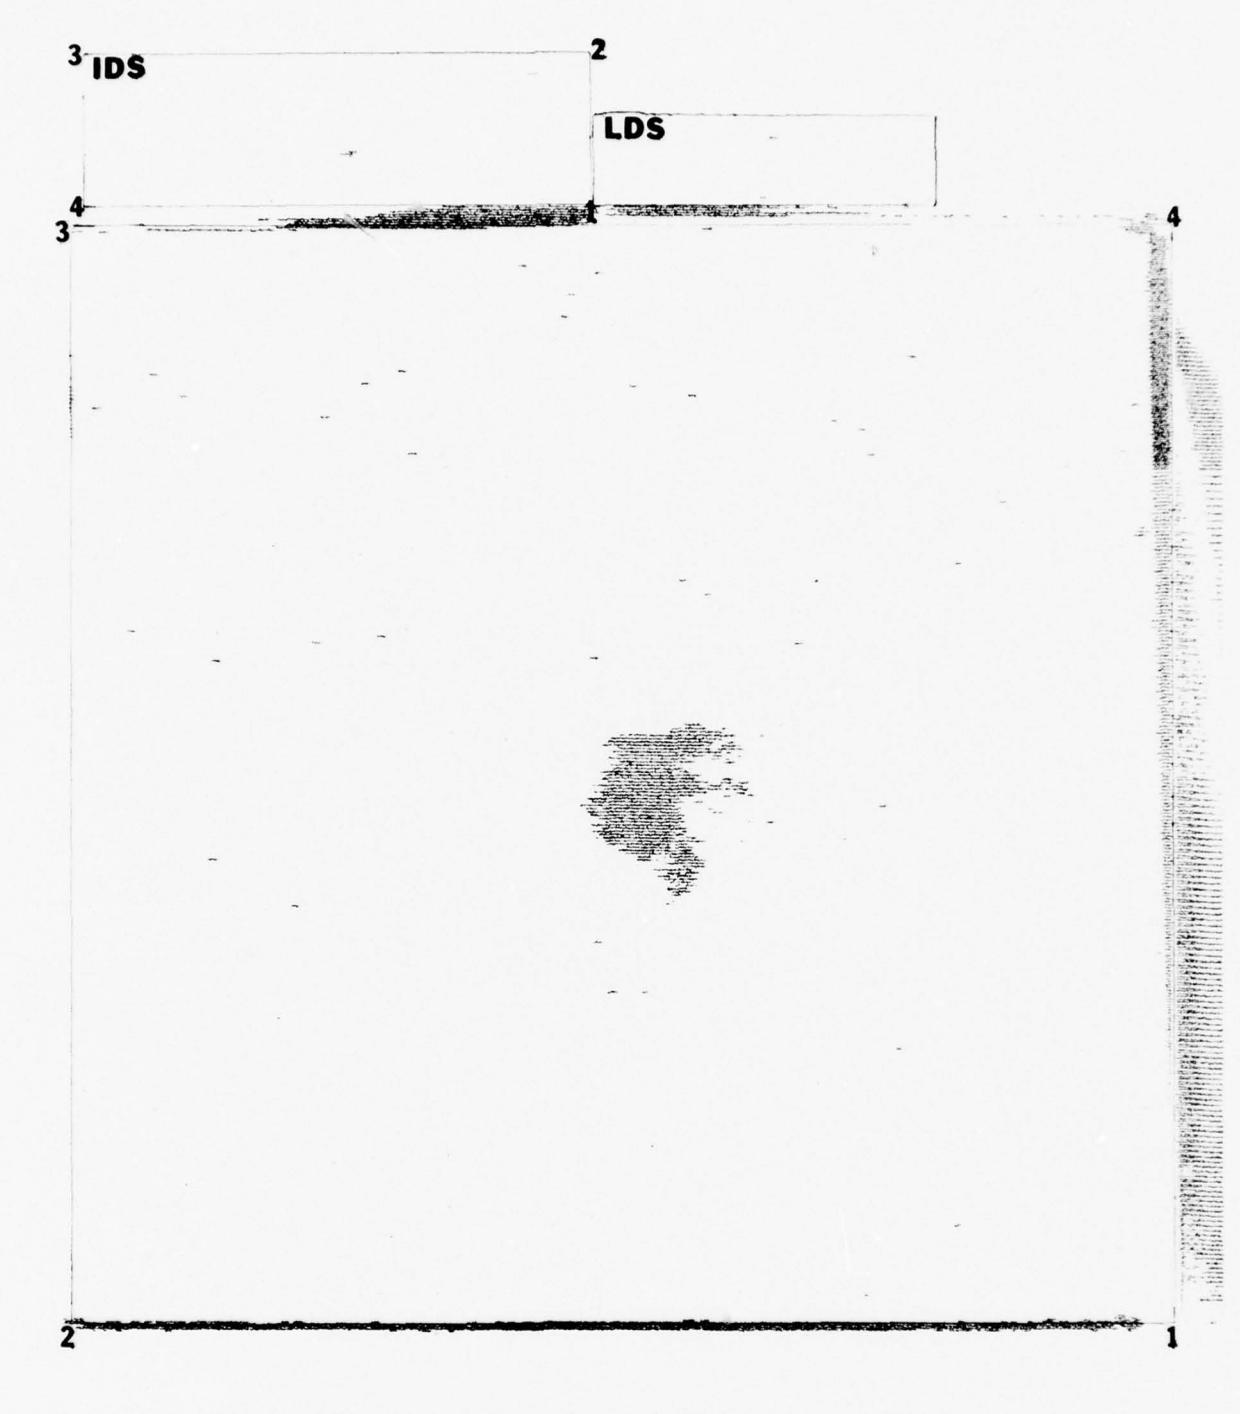
Figure 16. C-scan Recording of 45 MHz Longitudinal Wave Inspection of NC-203A After Machining with Surface Porosity Up.

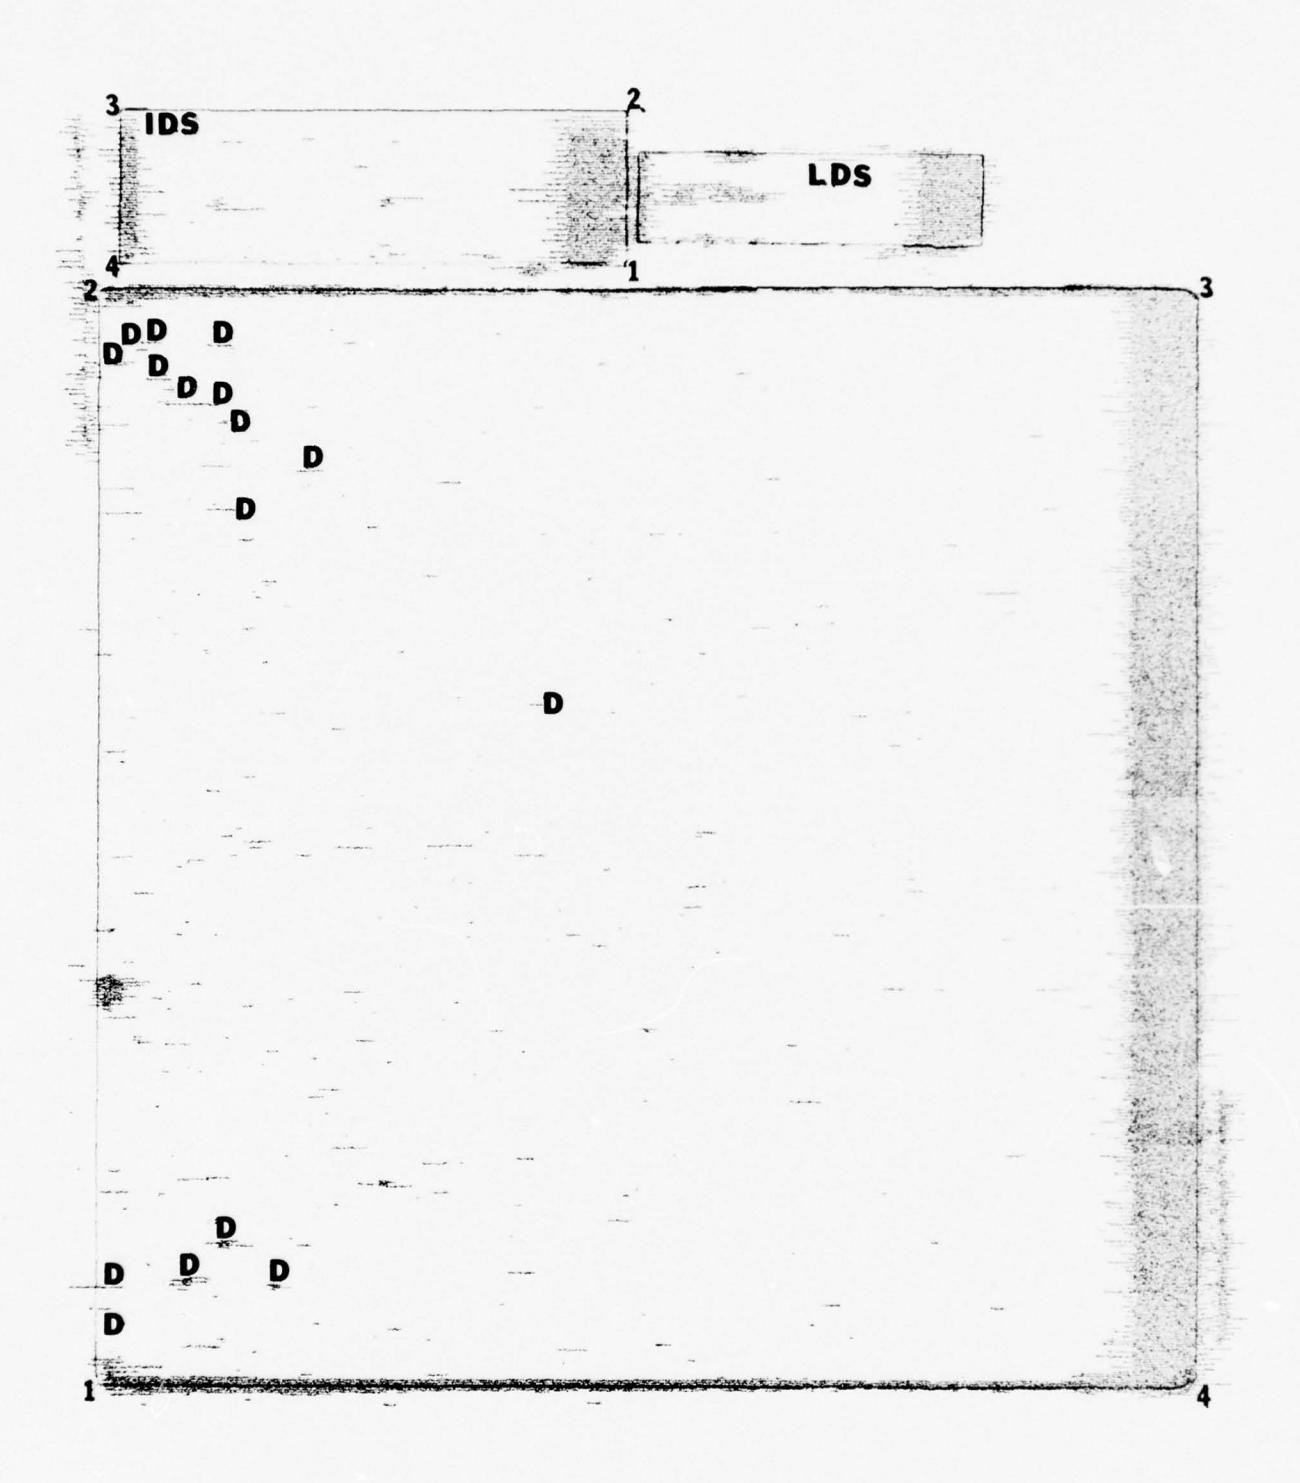
The billet of NC-132 was also relatively free of defects. In addition to one small defect detected by longitudinal wave inspection (labelled D in Figure 9), a number of mostly small defects were detected by the shear wave technique (Figures 17 and 18). These two figures show C-scan recordings for shear wave inspections made at two orientations 90° apart. The indications labelled D appear in both figures. Subsequent measurements of defect depths revealed most of these indications to be the result of residual surface pits that were too deep to remove by surface machining. In contrast, the billet of Ceralloy 147A was found to have a large number of defects scattered throughout the part (Figure 14). Because of the large number of scans and the large number of defects in each scan, it is difficult to present an overall recording of the inspection results on this billet which would clearly distinguish the circumstances under which each defect is detected. However, Figures 19 and 20 summarize the

Figure 18. C-scan Recording of 45 MHz, 11° Shear Wave Inspection of NC-132 (Billet Rotated 90° from Figure 17).

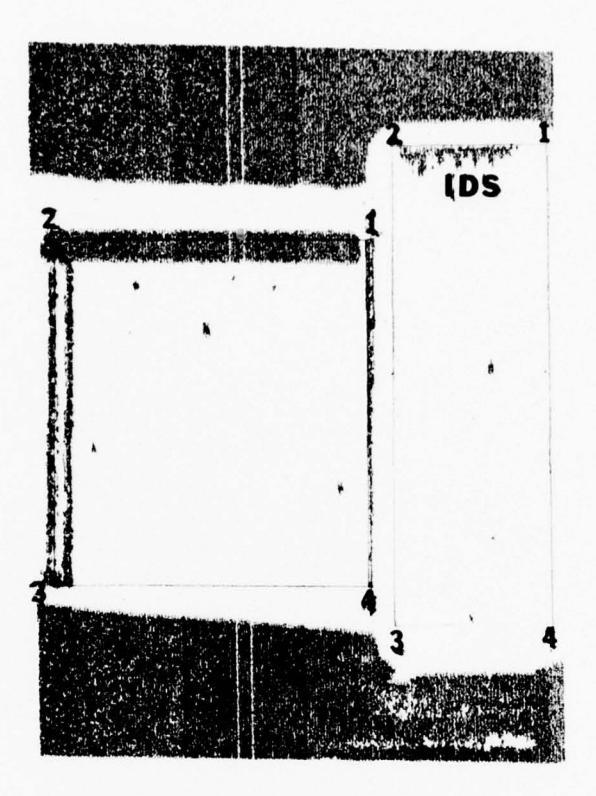
Figure 21. C-scan Recording of Ultrasonic Longitudinal Wave Inspection of Sintered Silicon Carbide Billet and Internal Defect Standard (IDS) at a Frequency of 45 MHz with a Water Path of 17 mm.

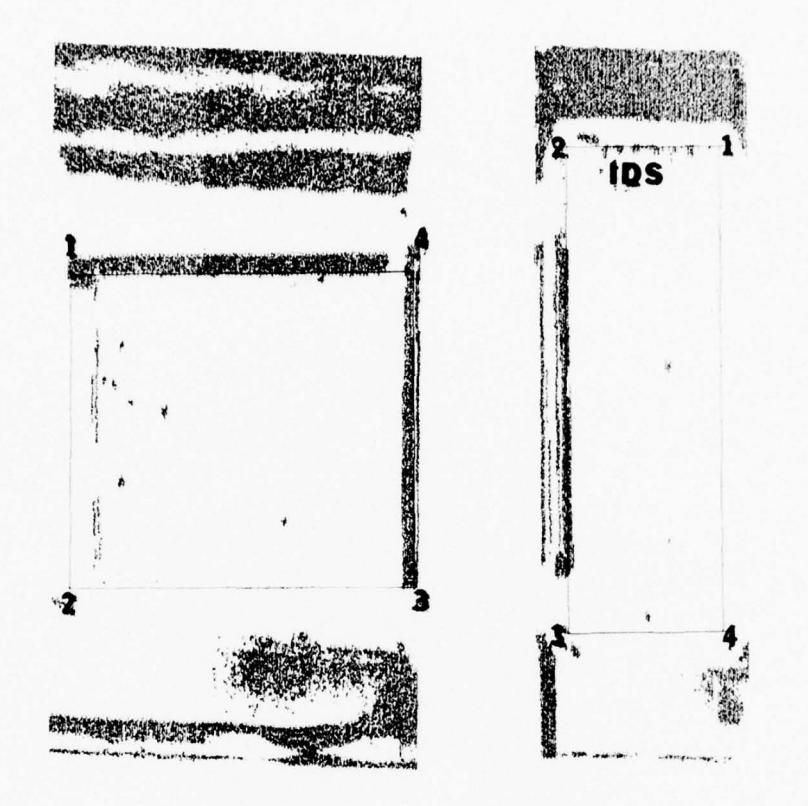
Figure 22. C-scan Recording of Ultrasonic Longitudinal Wave Inspection of Sintered Silicon Carbide Billet and Internal Defect Standard at a Frequency of 45 MHz with a Water Path of 17 mm.

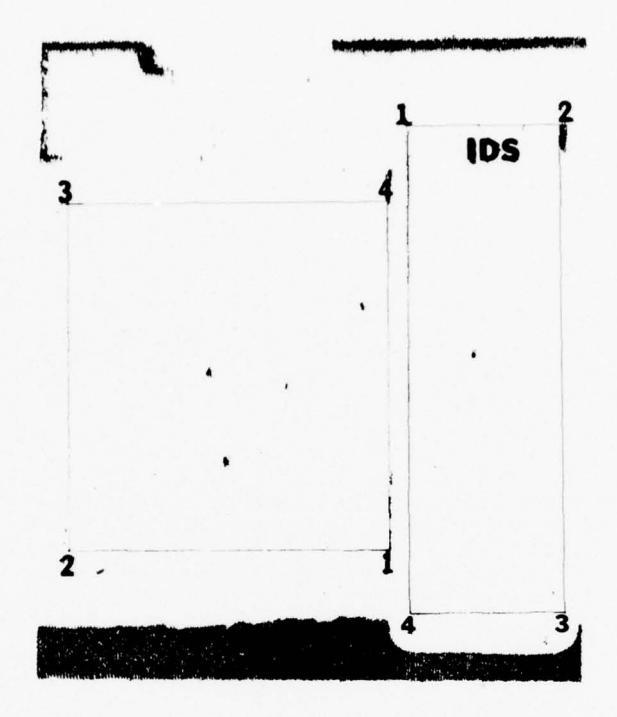
Figure 23. C-scan recording of Ultrasonic Longitudinal Wave Inspection of Sintered Silicon Carbide Billet and Internal Defect Standard at a Frequency of 5 mm (Top Side Down).

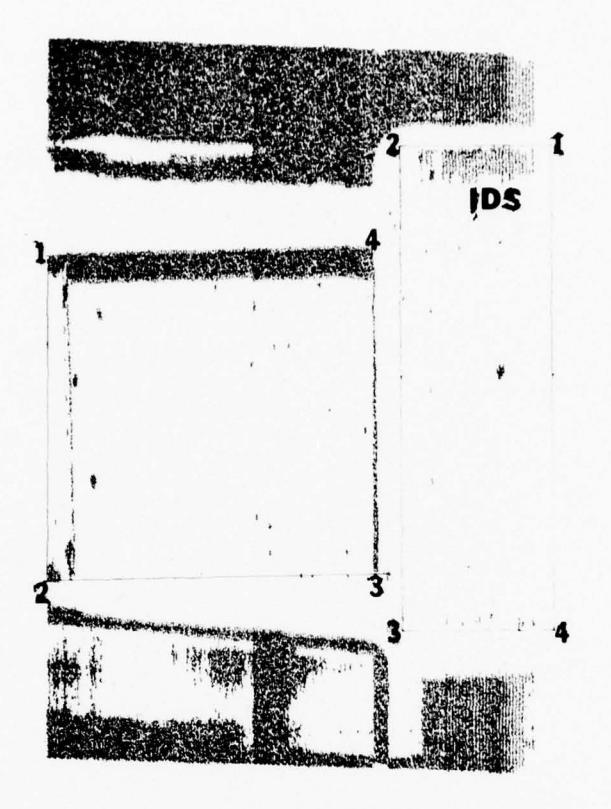
Figure 24. C-scan recording of Ultrasonic Longitudinal Wave Inspection of Sintered Silicon Carbide Billet and Internal Defect Standard at a Frequency of 45 MHz with a Water Path of 5 mm.

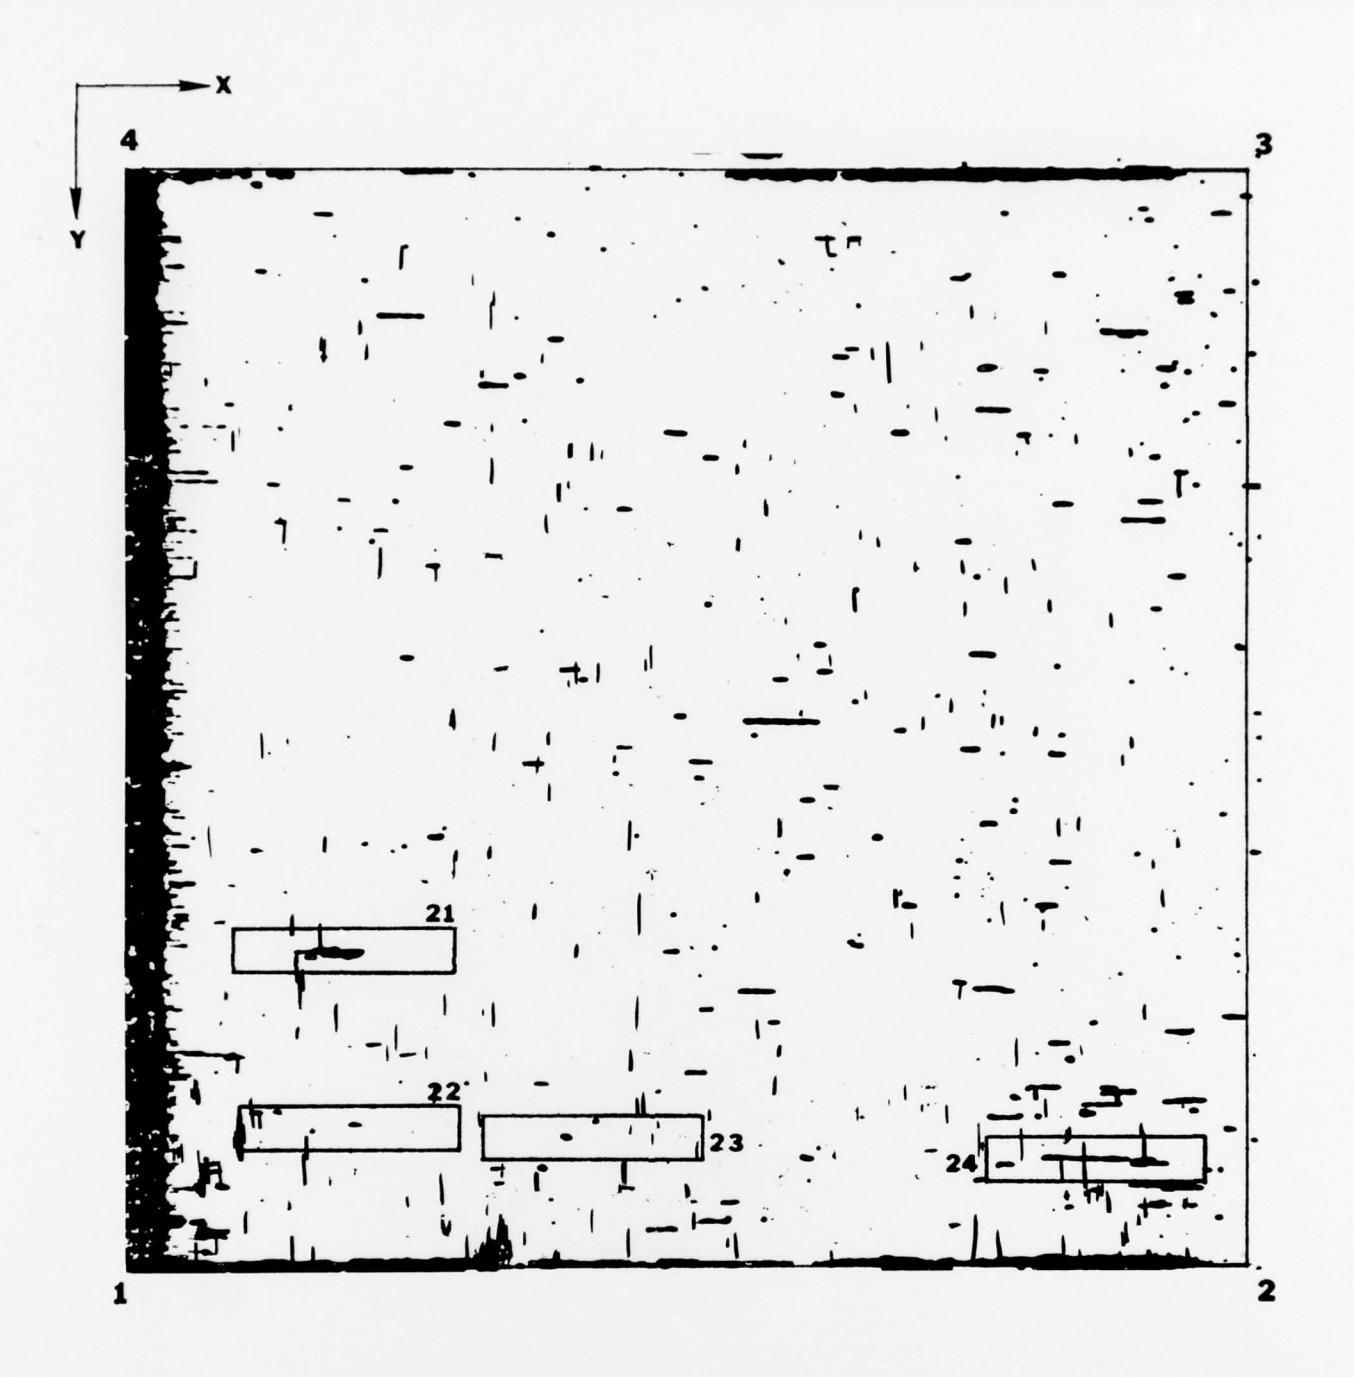
Figure 35. Specimen Locations in Billet of NC-132.

Four of the six defects whose locations were measured were selected for flexural strength specimens. Three of these four defects were found to be surface pits and the fourth was identified by depth measurement as being close to the surface. The specimens were prepared in the same manner as the specimens of Ceralloy 147A, except that no material was machined from the tensile surface in order to avoid removing the defects. Figure 35 shows a layout of the specimens on the C-scan.
