TN no. N-1496

title: INVESTIGATION OF SPRAY-APPLIED
POLYURETHANE FOAM ROOFING SYSTEMS - I

author: Robert L. Alumbaugh, Ph D
John R. Keeton, P.E.

date: July 1977

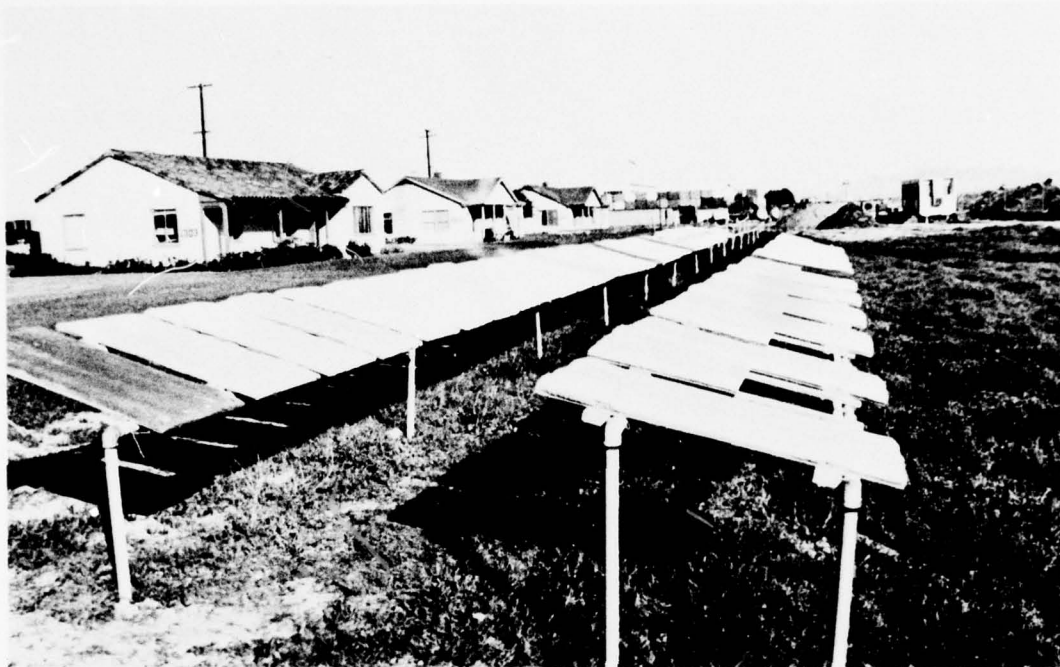
Marine Seashore Site - Port Hueneme, California. This site is a temperate marine atmosphere located along the coast about 60 miles northwest of Los Angeles. The experimental weathering racks shown in Figure 1 are located approximately 200 yards from the surf at an elevation of about 10 feet above sea level.

Figure 1. Experimental panels at seashore site, Port Hueneme, California.

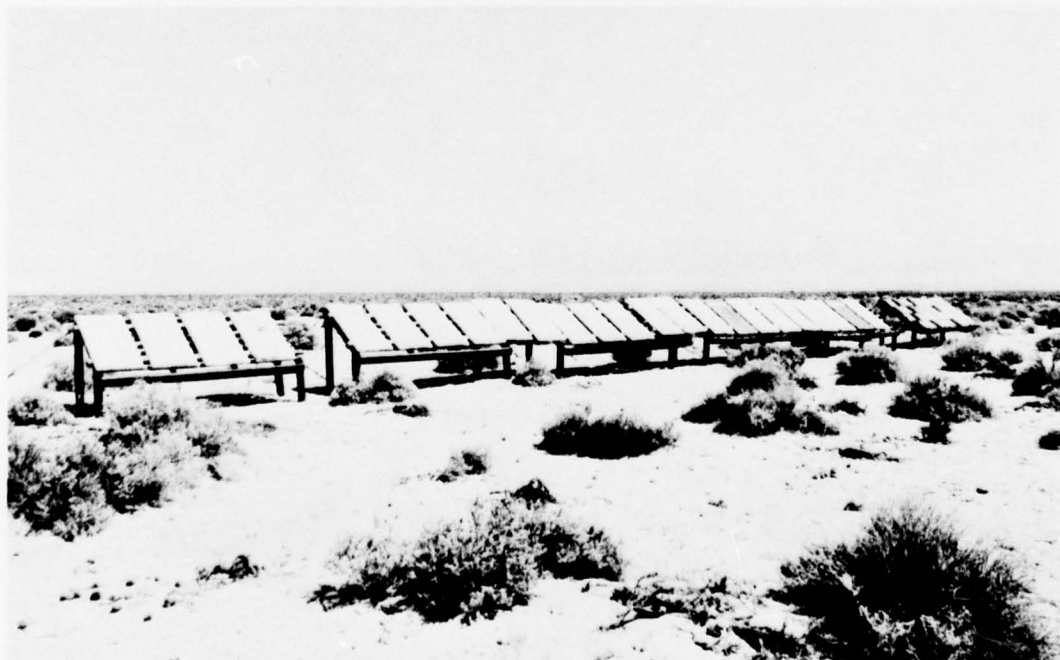
Desert Site - China Lake, California. This site is a dry, high desert area located about 125 miles northeast of Los Angeles. The exposure racks, shown in Figure 2, are situated on one of the test ranges at the Naval Weapons Center (NWC), China Lake, California, at an elevation of 2,440 feet.

Figure 2. Experimental panels at desert site, NWC, China Lake, California.

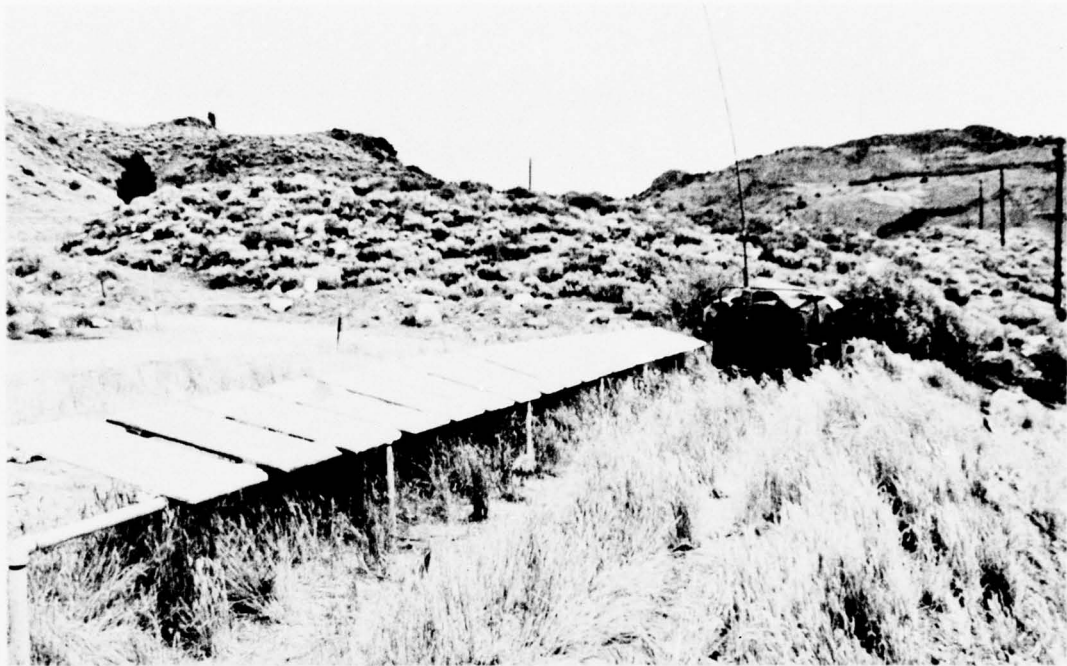
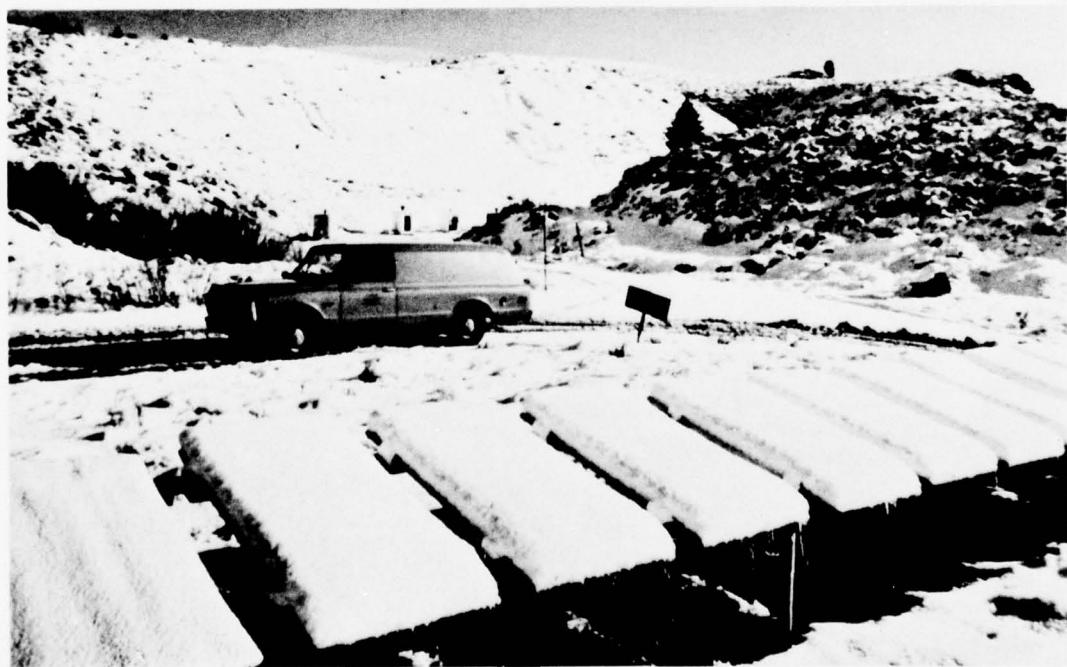
Cold Weather Site - Pickel Meadows, California. This site is located at the Marine Corps Mountain Warfare Training Center, Pickel Meadows, California (MCMWTC). This activity is located in the Sierra Nevada mountains about 18 miles west of Bridgeport, California at an elevation of 7,000 feet. Racks are shown in Figure 3.

Figure 3. Experimental panels at cold weather site, MCMWTC, Pickel Meadows, California.

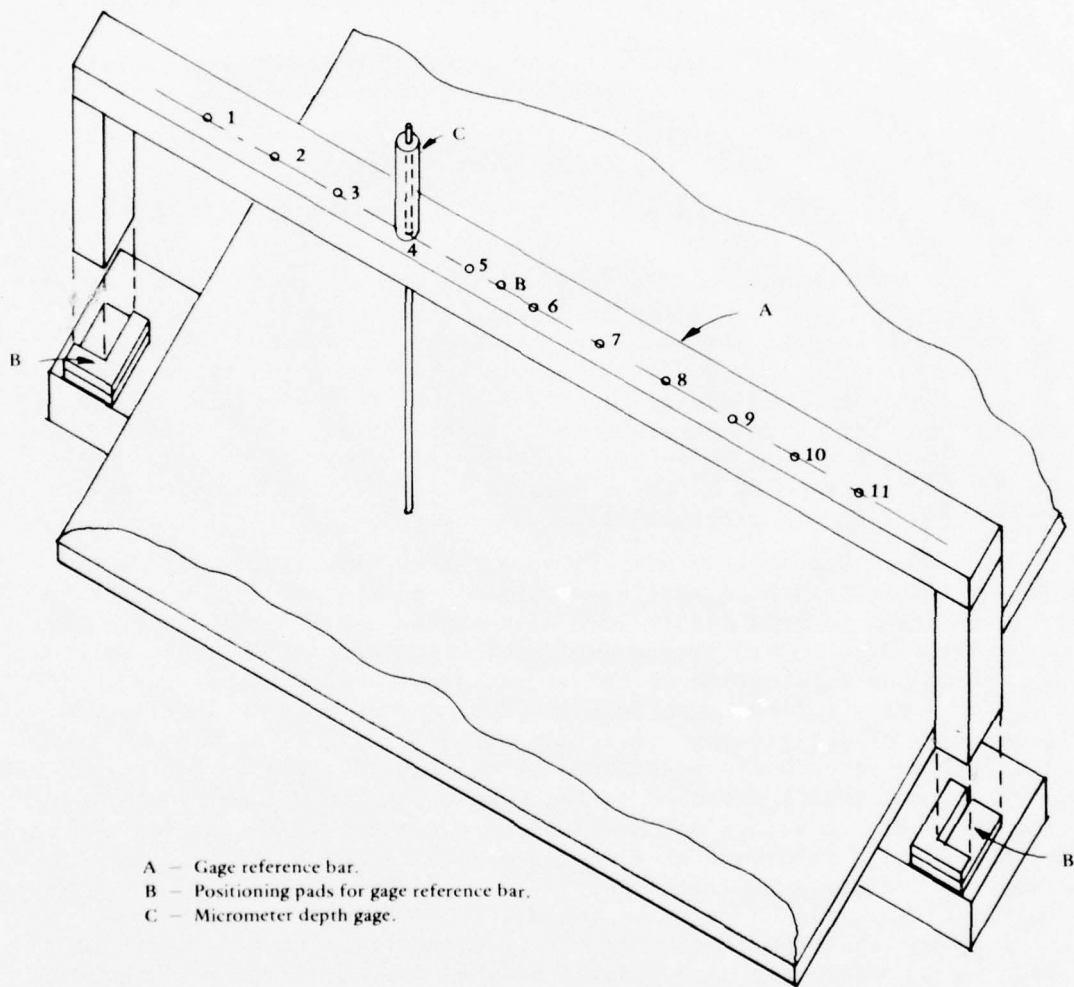
The device for determining foam degradation is shown in Figure 4. It consists of a rigid gage reference bar (A), made of aluminum 1 inch thick, which is properly positioned by seating its legs in two positioning pads (B) permanently attached to the supporting 2 x 4 inch cross-piece of each panel. Readings on the specimen are made by inserting a micrometer depth gage into each of 11 holes drilled in the reference bar; in Figure 4, the depth gage is shown in hole 4. Degradation of the foam is determined by noting changes in the distance from the reference bar to the foam surface from reading time to reading time. Before depth gage readings are made, degraded foam is brushed away so that the depth gage is seated on a sound foam surface. The foam degradation rate was determined by dividing the total degradation in inches by the total exposure period in months. Results for an exposure time of 8.3 months are shown in Table 3 for foams having densities of 2 and 2.5 pcf.

Figure 4. Device for measuring rate of degradation of uncoated urethane foam.

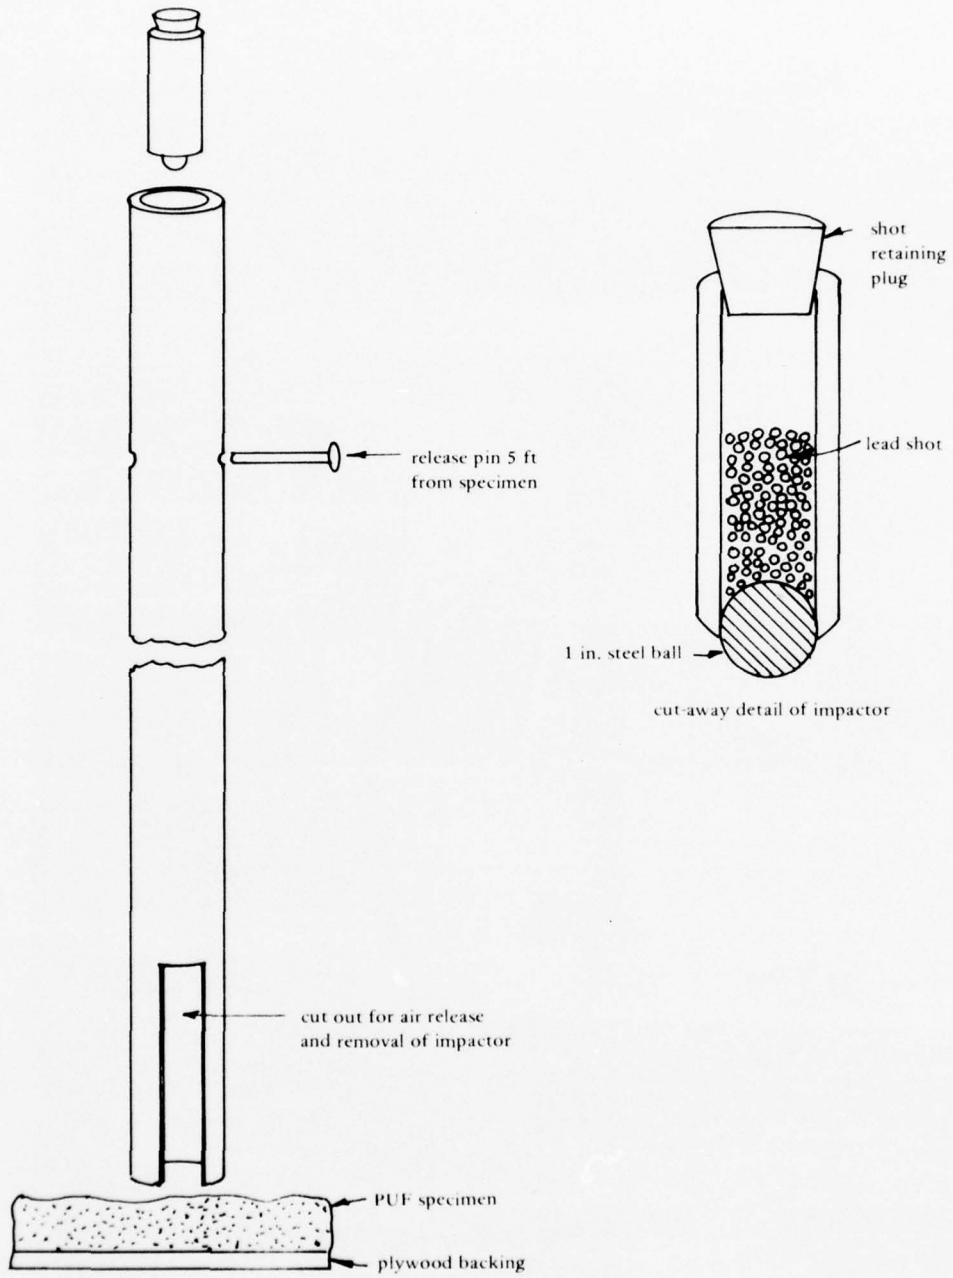
Impact Resistance. The impact test device, shown in Figure 6, was similar to that described in Reference 1. The impactor (called TUP in Reference 1) consists of a plastic cylinder with a 1 inch-diameter steel ball at the bottom. Metal shot can be added to the impactor to vary the weight. The impactor was dropped through a plastic pipe with a 1-1/2 inch inside diameter for a distance of 5 feet, at which point the steel ball portion impacted the coated surface of the PUF specimen. Starting with the minimum weight of 160 grams, the impactor weights used were 160, 200, 300, 400, and 500 grams (maximum). Each test was continued

Figure 6. Impact tester and weighted impactor.

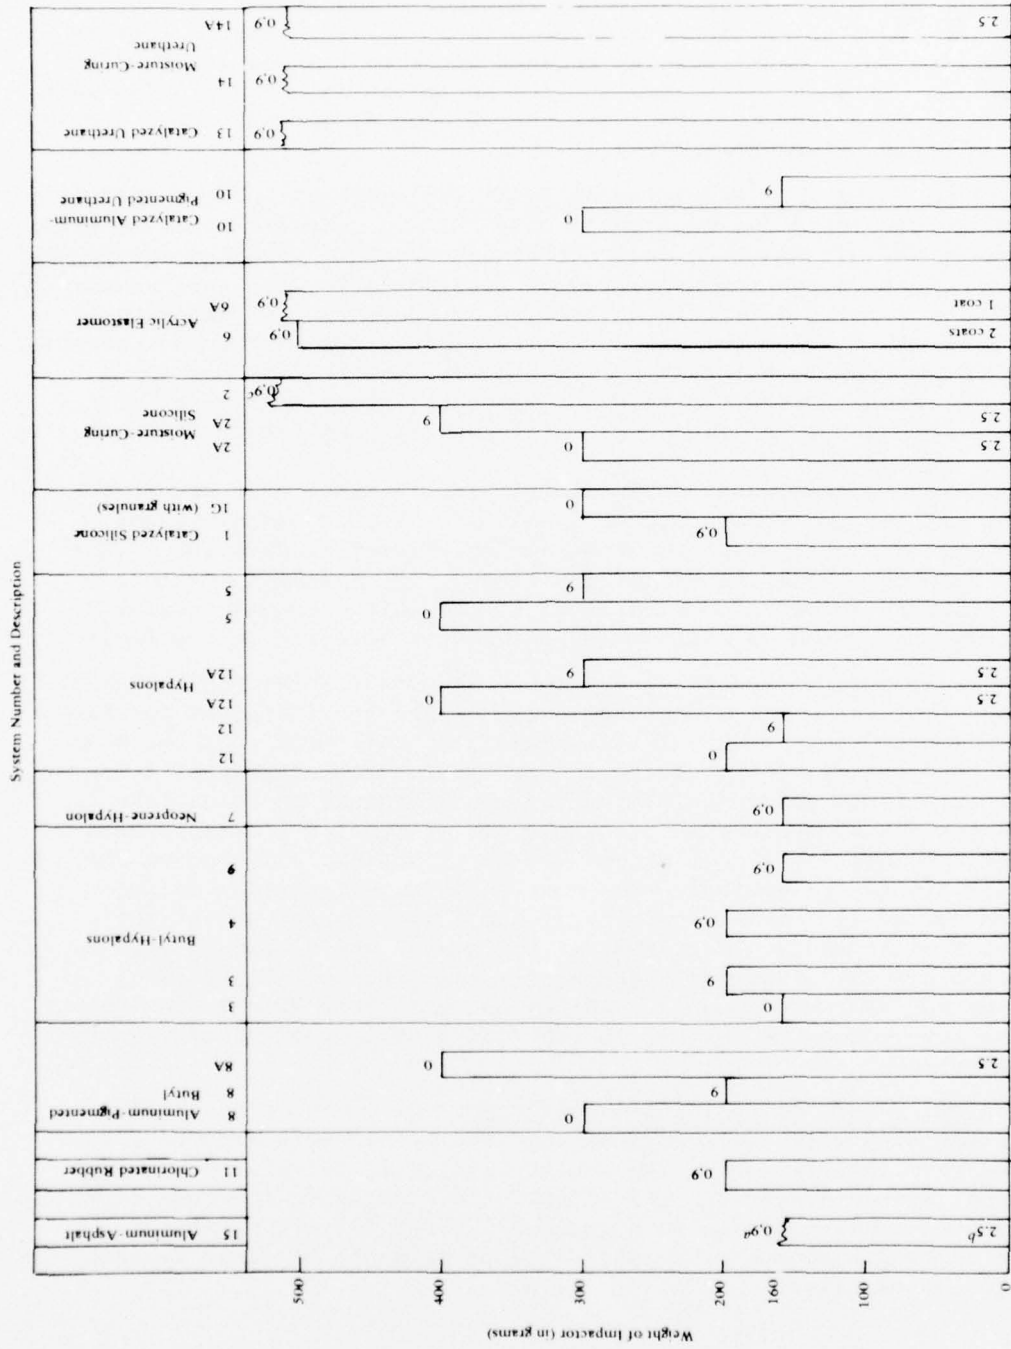
until the impactor caused a break in the coating or until the maximum of 500 grams was reached. At least five impacts were made at each impactor weight. Results of these tests are shown by means of bar graphs in Figure 7.

^a Time in months that samples were weathered in atmosphere before testing.
^b Density of foam was 2.0 pcf unless noted as 2.5 pcf.
^c Irregular line on top of bar indicates failure due to impact either above 500 grams or below 160 grams.

Figure 7. Results of impact tests.

The coating is considered to have failed the impact test when it is ruptured, at which point the weight of the impactor is recorded. This test was run both before samples had been exposed and after they had been exposed for 9 months. Results are presented graphically in Figure 7. The impact test result may be an indicator of the resistance of the coated PUF roofing systems to damage by hailstones and to some extent by foot traffic. Both can cause damage to a system having low impact resistance.

A study of Figure 7 points up several interesting factors. First and perhaps most important is that after 9 months of weathering, the aluminum-asphalt (System 15), the chlorinated rubber (System 11), all of the butyl-hypalons (Systems 3, 4, and 9), the aluminum-pigmented butyl
