FOURTH QUARTERLY REPORT ON  
MANUFACTURING METHODS AND ENGINEERING  
FOR TFT ADDRESSED DISPLAY

February 7, 1977 to May 7, 1977

Prepared by D. H. Davies, W. L. Rogers,  
F. C. Luo, S. D. Burkholder, M. Green

CONTRACT DAAB07-76-C-0027

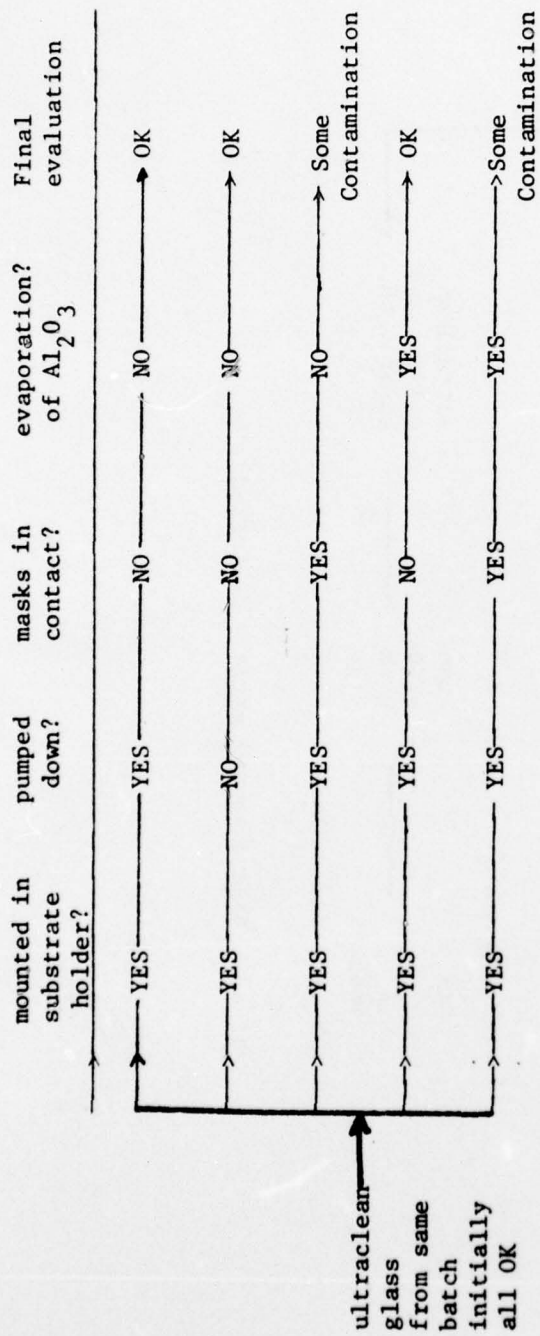
Fig (2) Contamination test sequence

2.2.3. Despite these very clean circuits the displays still show some residual shorts. It only takes a few crossover shorts to ruin legibility however and it was obviously essential that we track down the causes. Tracing the shorts to individual crossovers clearly showed a particulate source. A series of experiments was conducted following the path described in Fig ( 2). A novel edge lighting scheme was used to evaluate the surface contamination level.

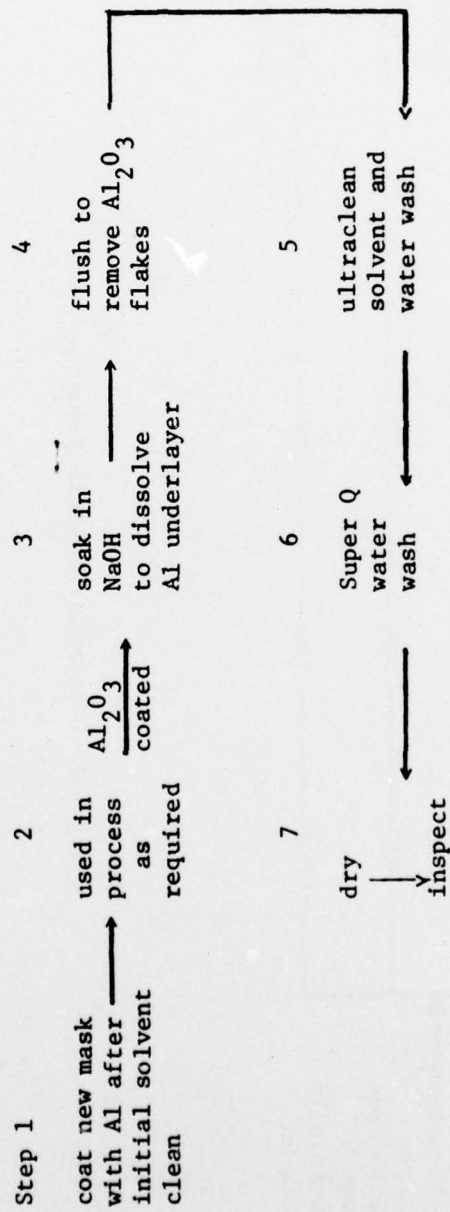
Fig (3) Mask cleaning cycle - dedicated

Now the masks themselves are subjected to a rigorous cleaning procedure, shown schematically in Fig ( 3). Despite this, obviously something is lacking especially relative to the X-Y mask. One clear difference in mask cleaning between the X-Y and dedicated mask approach is the physical scrubbing action possible with the former. The fine pattern tolerances in the dedicated masks require that the masks be thin

and therefore quite delicate. Hence they are not given a physical scrub action. This could be a cause; to establish it we examined a so-called clean  $\text{Al}_2\text{O}_3$  mask in detail at ultra high magnification. It became obvious that the grooves in the multiple film laminates are contaminated, see Fig ( 4).

A physical scrub action, with lint free brushes, was found to be possible providing great care was exercised; likewise heavily attenuated ultrasonics was utilized again with detailed procedures to avoid mask damage. These have been useful but are laborious and relatively dangerous procedures as regards mask damage.

The mask supplier fabricated a mask set for us made completely from kovar. This avoids any lamination and should make the mask easier to clean. In addition the kovar mask would be more magnetic, and have better thermal properties. Although the masks were of sufficient tolerance precision, it was found that they were too stiff to operate in the magnetic pull up jig. They did not "conform" sufficiently. An order has been now placed for less stiff masks.

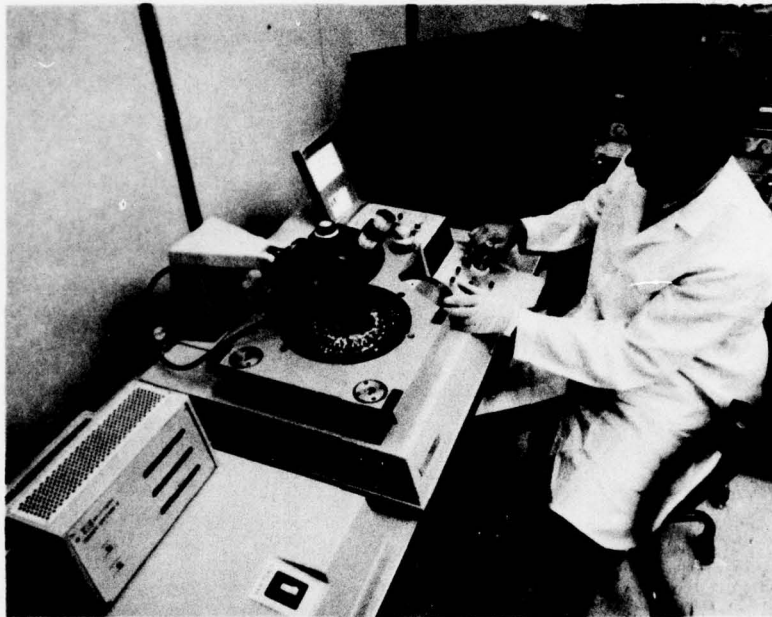
The automatic test facility is now actually complete and the hardware is all in and functional. Software development is in hand and is posing no major difficulties. The unit is now used in a semi-automatic mode and it is a significant advancement over the old individual manual probes. There has been some difficulty with scratches on the thin films due excessive probe pressure, softer probes are being evaluated.

Fig (13) The automatic circuit test facility- probe station

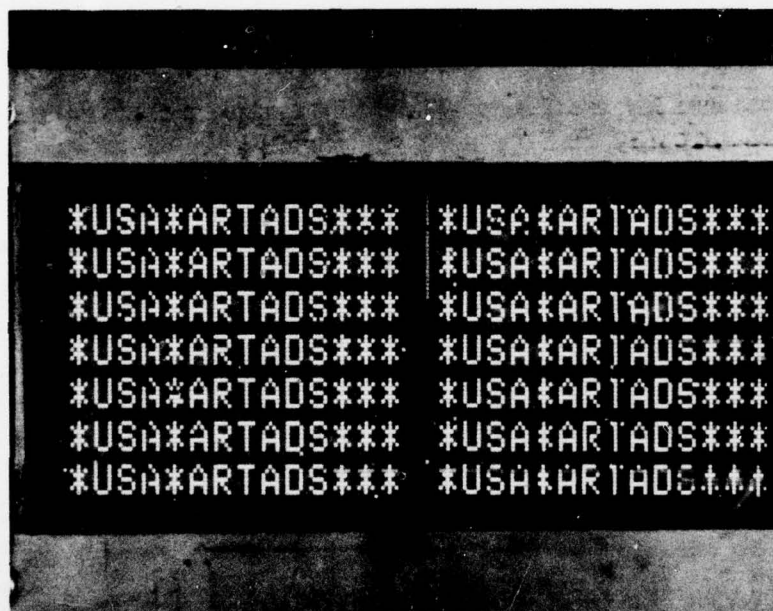
Fig (15) Best display produced recently on the X-Y facility

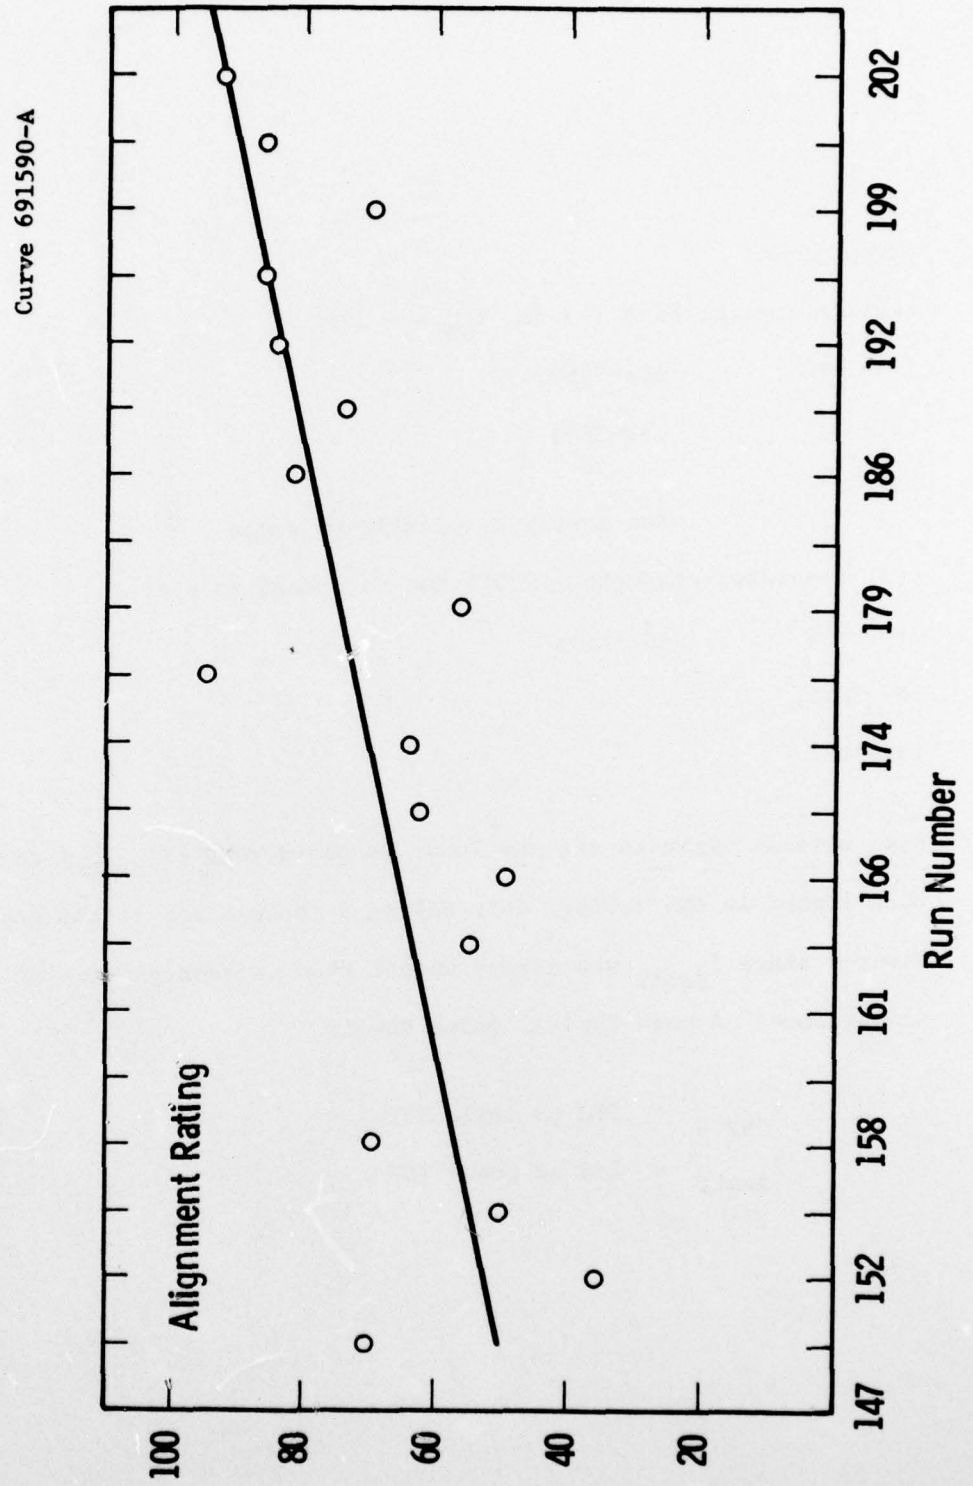
A creeping problem in recent weeks was pattern alignment; this had been generally satisfactory but started to drift off on a patchy, irregular, basis. In particular gate alignment over the corner to corner areas deteriorated. See Fig ( 7). Several causes were tracked down. Firstly it was thought that mask to mask pattern integrity was perhaps being lost due to the mixing up of mask sets as a consequence of the change in mask thickness as described in Section 2.3 above. The masks are however "pulled" from the same master and, although the mask metal thickness does have a slight effect, tests on the alignment registration system proved this to be wrong. Another

Fig. 16 — Recent results alignment rating

It is difficult to reproduce the same tension on the mask holder clamps and in addition a degree of uncertainty was found to exist as to whether it was useful to tighten down both sides of the mask. When this was cleared up the problem still remained. Recently (Run 192, see Table ( 1 ) Section 7) the cause was pinned down pretty well definitively -- the teflon bushings on the master alignment jig were slightly worn! The bushings were replaced and to date four out of five circuits have been good in this respect, the one poor sample being an error.

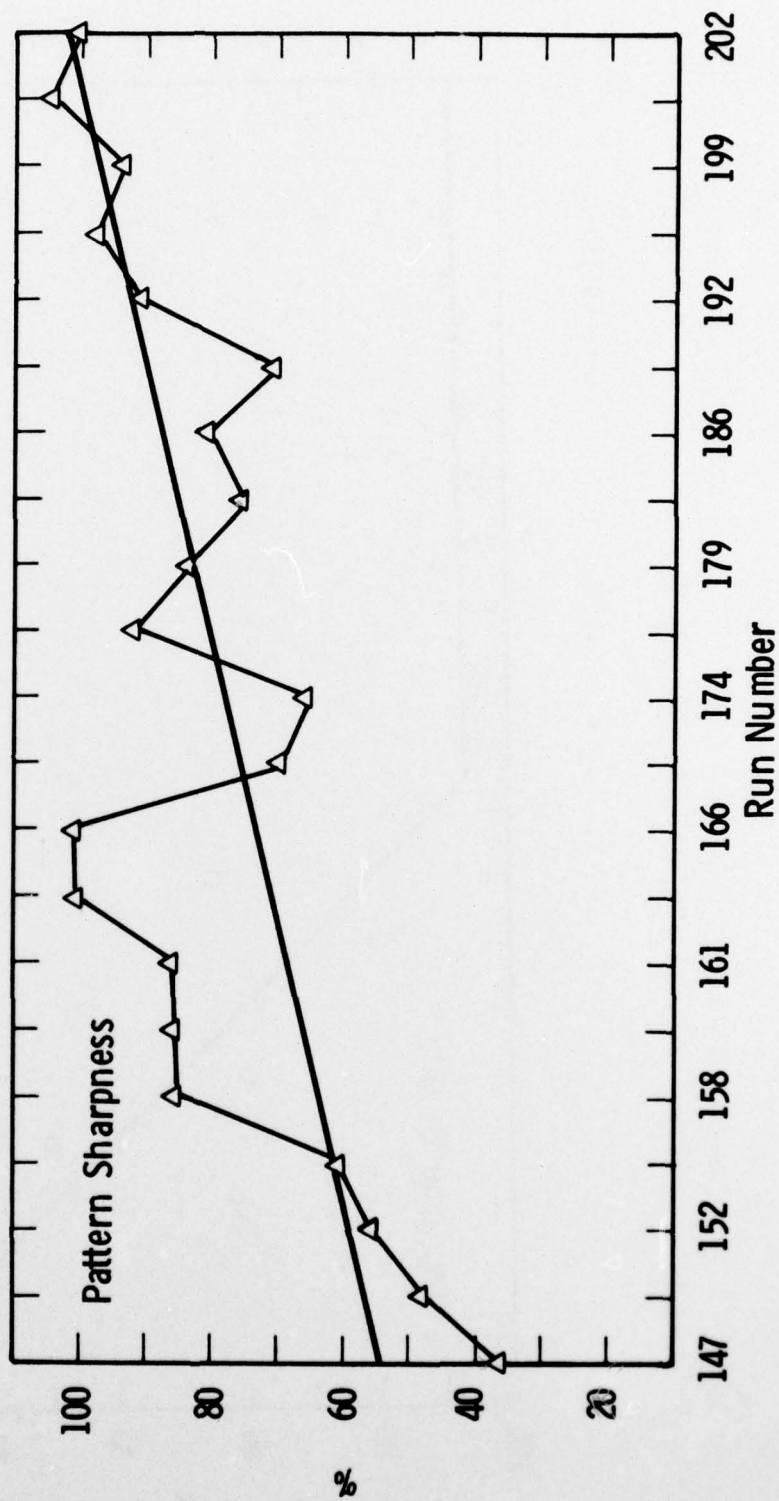
Pattern sharpness (an early problem) looks to be solved although once in a while a small patch of fuzziness appears. This is known to be caused by mask ripples sometimes induced by magnetic "pulls". Fortunately, the thinner masks described above help this problem also.

Fig. 17 - Recent results sharpness rating

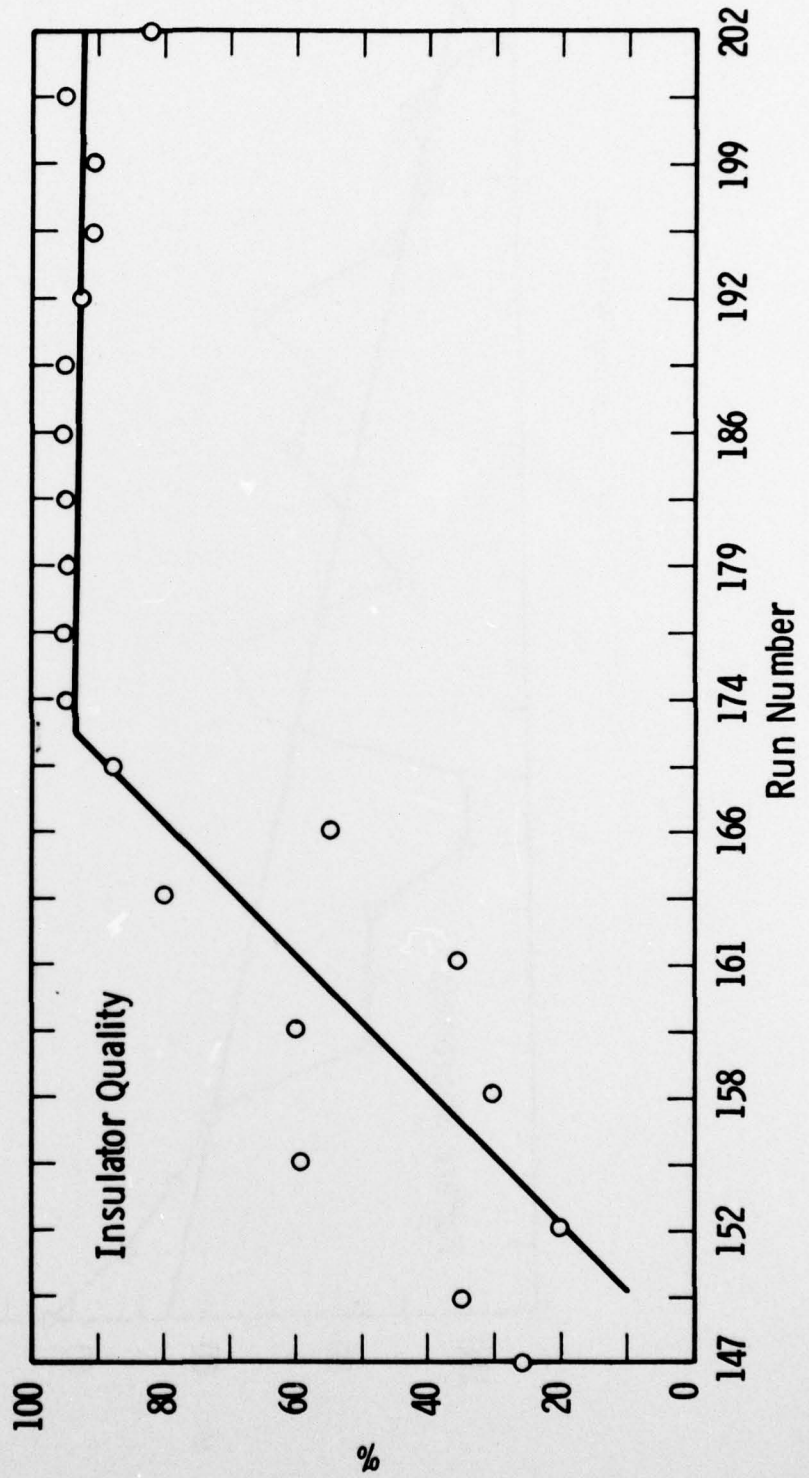
The main thrust of the effort to date has been to improve the insulator film quality; the intrinsic dielectric strength is not the prime concern we are confident that this is not the issue -- the problem is defects in the film. Defects observed in the insulator layers during the above analysis fell into three categories.

Fig. 18 - Recent results insulator quality
