ANALYSIS OF PROPELLANT STORAGE TANKS AFTER FOUR YEARS HYDRAZINE STORAGE

FINAL REPORT - MAY 1976 - APRIL 1977

BELL AEROSPACE TEXTRON DIVISION OF TEXTRON, INC. P. O. BOX ONE BUFFALO, NEW YORK 14240

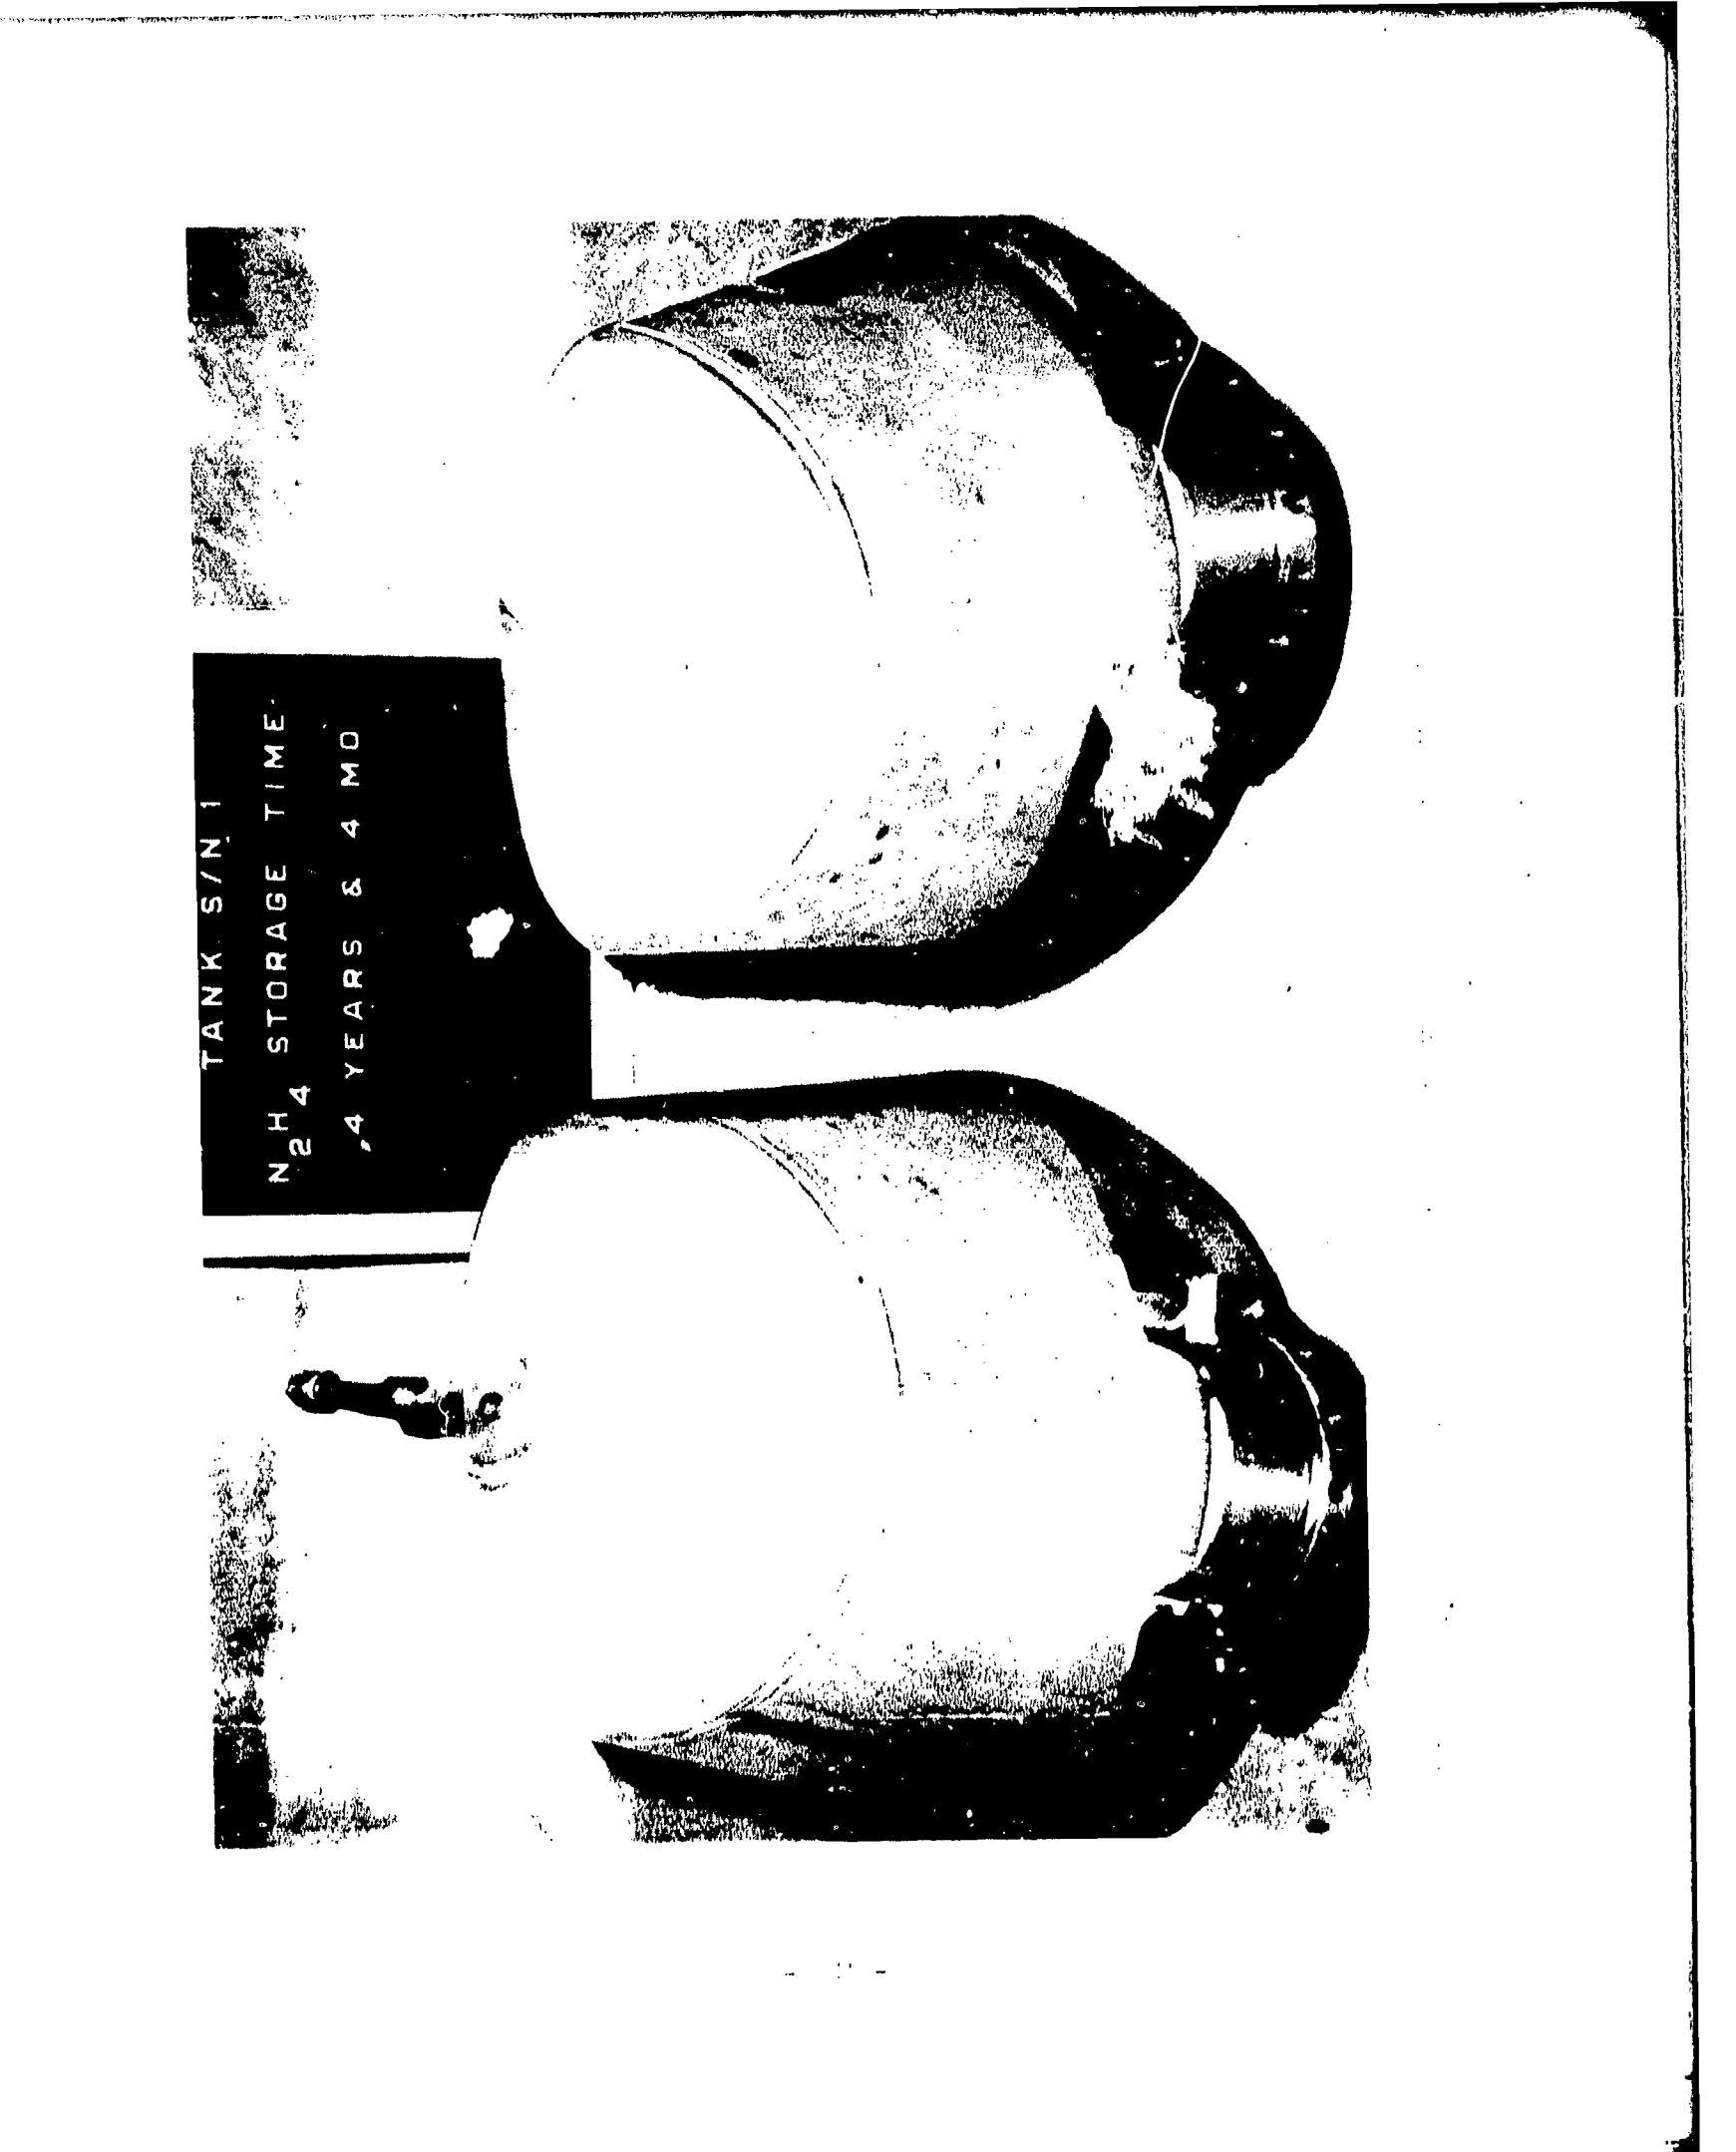
OFPOSITE HALF OF TANK S/N 1 IN THE AS-RECEIVED CONDITION SHOWING THE SAME TYPE OF MARKINGS AS SHOWN IN FIGURE 12. THESE PHOTO-MACROGRAPHS SUBSTANTIATE THE OVERALL INTERIOR CONDITION OF THIS TANK. NO EVIDENCE OF CORROSIVE ATTACK WAS OBSERVED IN EITHER HALF OF THIS TANK ON A MACROSCOPIC EASIS.

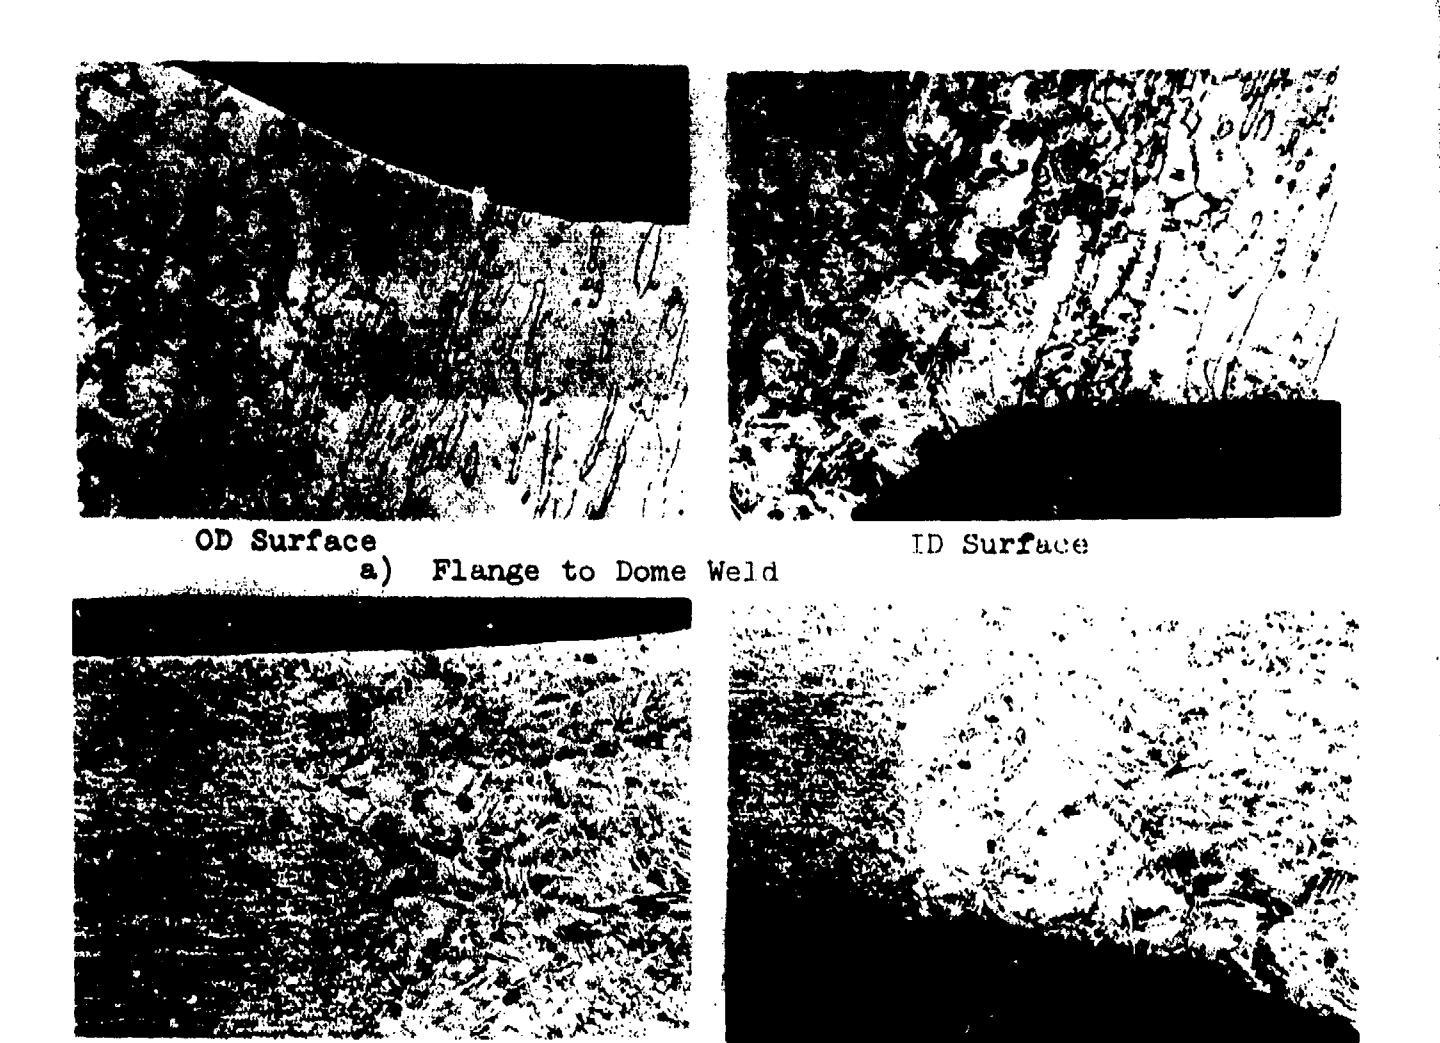
FIGURE 29. HIGH MAGNIFICATION VIEWS OF TWO TANK S/N 4 WELDS SHOWING ABSENCE OF ANY SURFACE ATTACK.

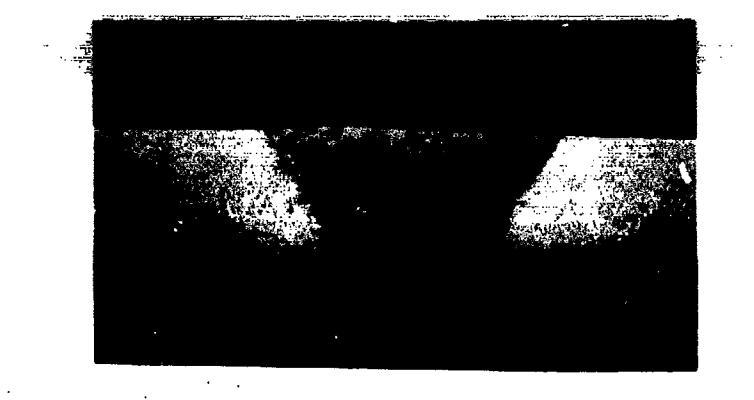
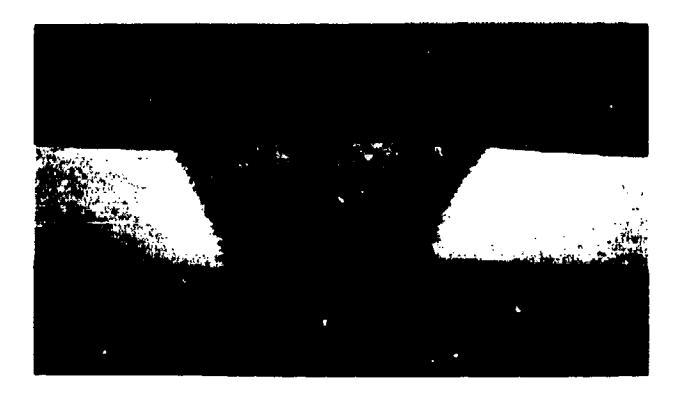
The welds produced by the Astro Arc process in stainless steel tuting are usually quite sound and of high integrity. Examples from Tanks 1 and 5 are shown in Figures 32 and 35, which demonstrate the sound, fully fused and penetrated nature of the typical tube welds. There is no corrocion or other unusual effects in these welds.

(a) Flange tube to connector fitting weld

b) Connector fitting to extension tube weld

c) Outlet tube to connector fitting weld
All views: Mag.: LOX Mat'l: AISI 347 SS Etch: Mixed Acids
FIGURE 32. CONFIGURATION OF TUBE WELDS FROM TANK S/N 1 PRODUCED BY "ASTRO ARC" PROCESS.
METALLURGICAL LABORATORY MET NO. 76-79016

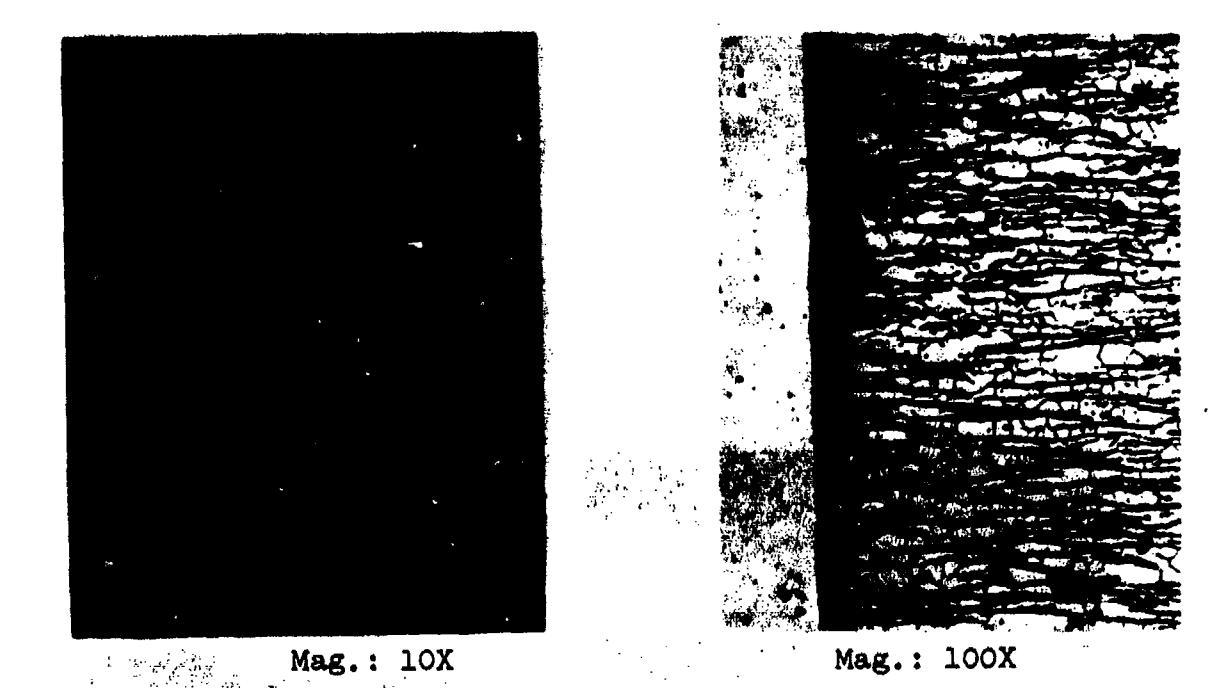
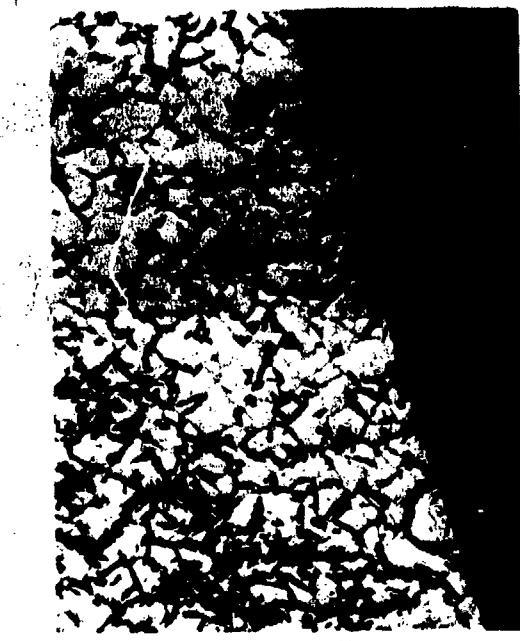
The coarse, somewhat banded structure of the flange cover and outlet fitting is evident in Figure 33. This was observed in all tanks and represents the consequence of using heavy forgings for these components. This coarse structure caused no difficulty in welding even though in some situations it would be expected to be deleterious. Except for the corrosion on the exterior of the outlet fitting of Tank S/N 5 (discussed earlier), no corrosion was found on the interior or exterior of any of these components.

a) Flange to tube weld showing no corrosion in extended crevice

b) Outlet to tube weld with no apparent corrosion. This is region in Tank S/N 5 where corrosion was observed
All Views: Etch - Ammonium Persulfate Mat'1: AM350 Flange Welded to AISI 347 SS Tube
FIGURE 33. CONFIGURATION AND LACK OF CORROSION EFFECTS IN WELDS WHERE TUBING JOINS FLANGE OR OUTLET IN TANK S/N 1.
METALLURGICAL LABORATORY MET NO. 76-79016

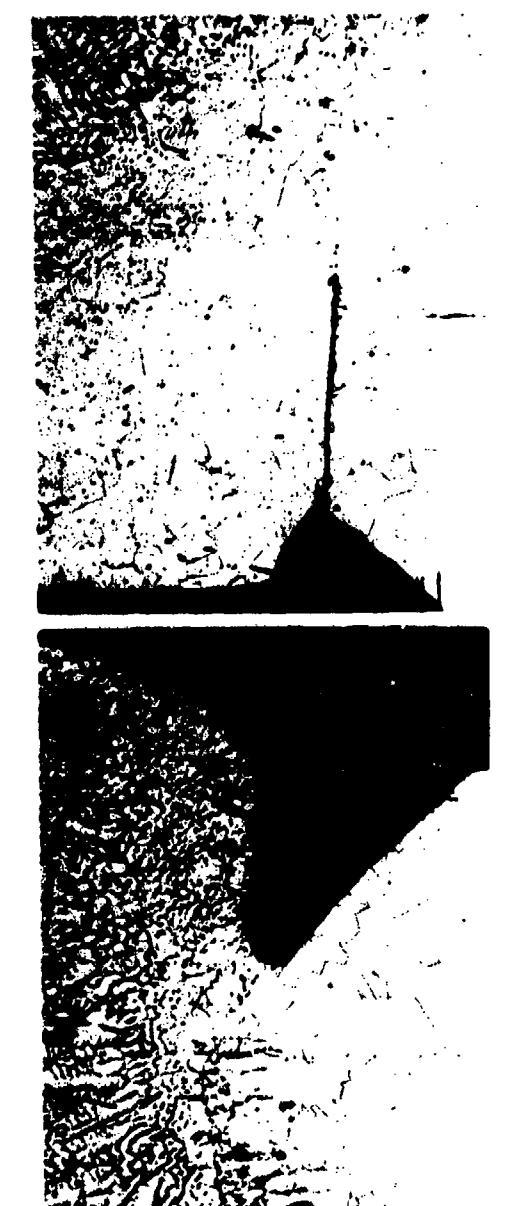
b) Detail views of unfused joint edges showing no corrosion or other effects

FIGURE 34. TUBE WELD FROM TANK S/N 4 (OUTLET CONNECTOR FITTING TO EXTENSION TUBE), SHOWING POOR LOCATING OF WELD TO ORIGINAL JOINT PREPARATION, GIVING CONSIDERABLE LACK OF FUSION BUT NO JOINT LEAKAGE.

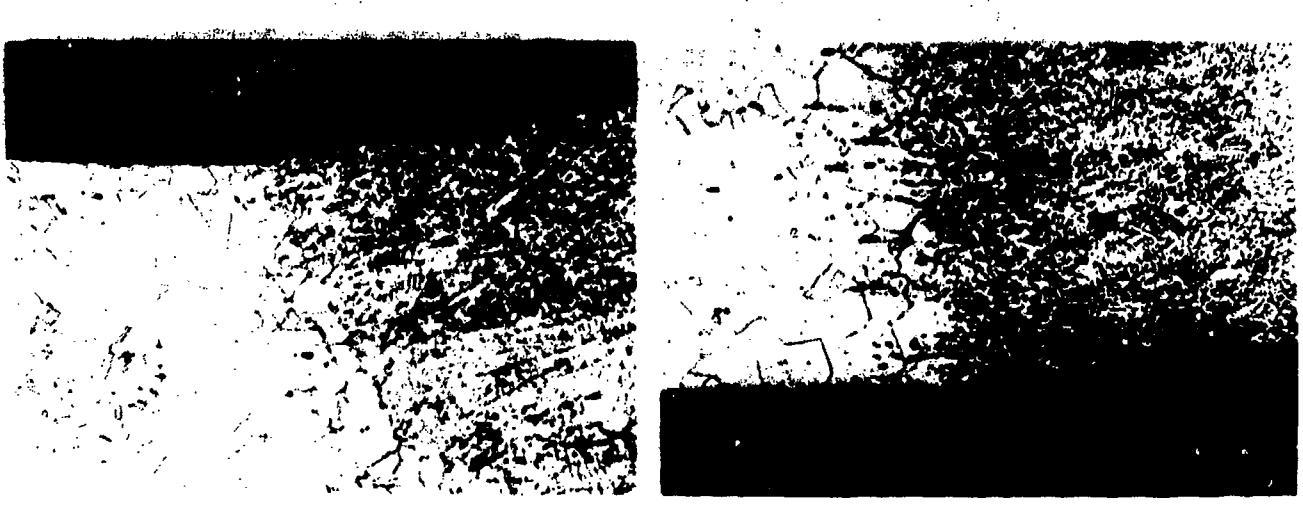
a) Normal and desirable configuration of tube weld produced by Astro-Arc process

b) Higher magnification view of connector to extension tube weld showing lack of corrosion effects

FIGURE 35. CROSS SECTION CONFIGURATION AND MICROSTRUCTURE OF TUBING WELDS AT FLANGE END OF TANK S/N 5.

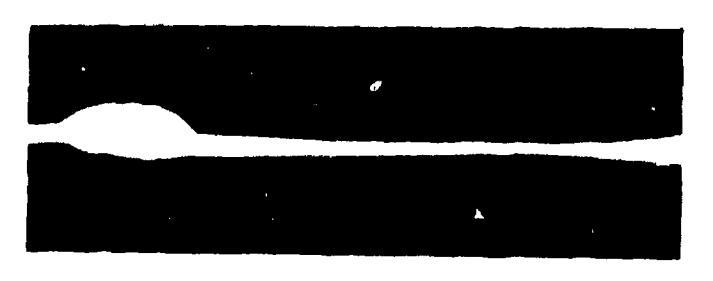
Cross section in outlet fitting of Tank S/N 4 showing thinning but not to extent of Tank S/N 5

e) Close up view of corrosion attack and penetration to interior

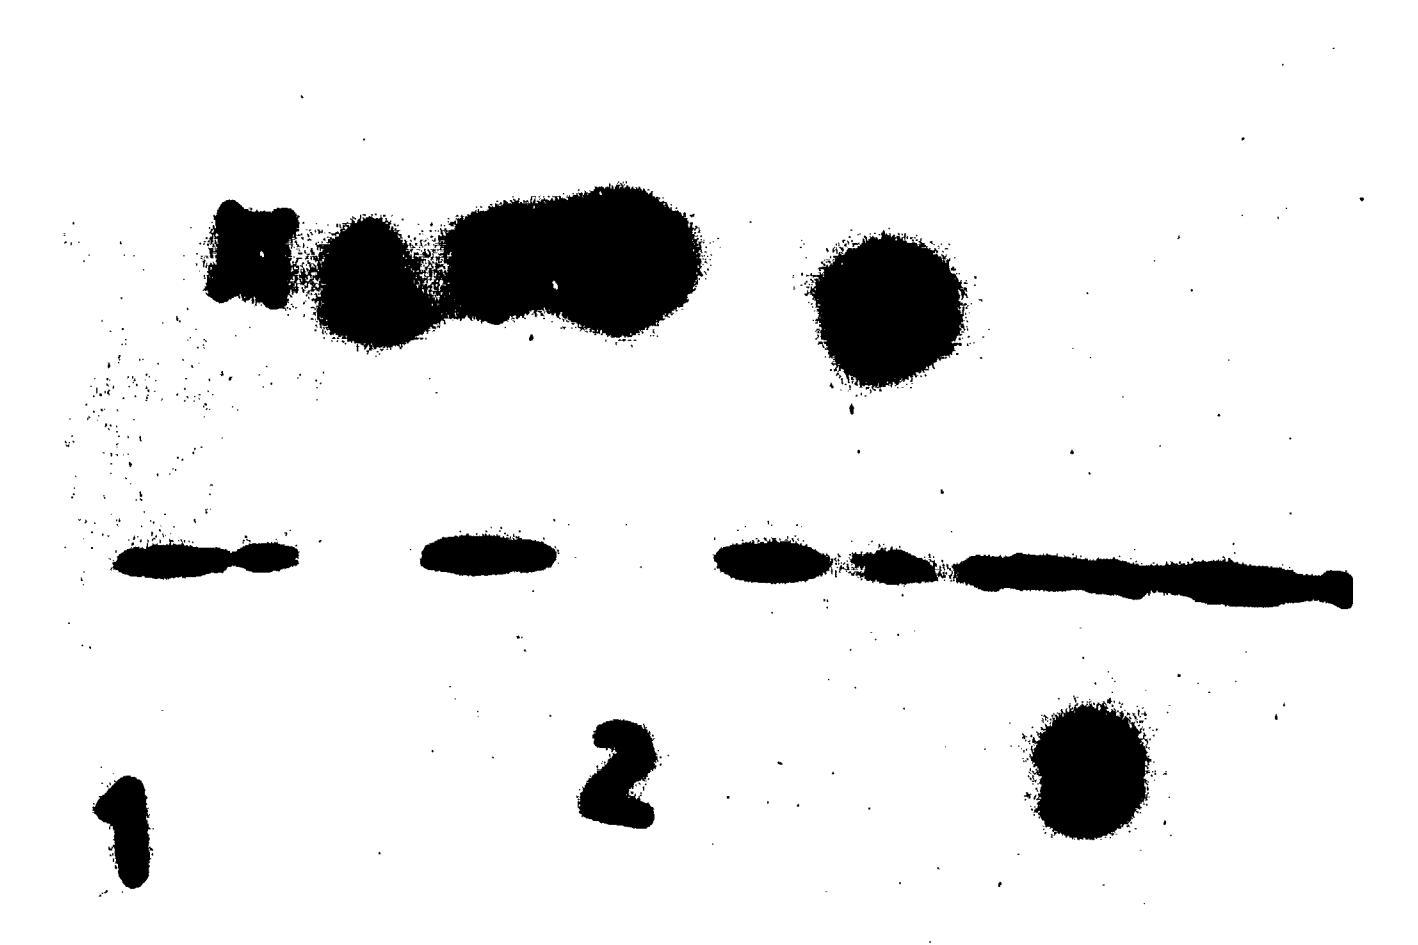
Note: Reproduction of X-ray reverses the normal shading. Light areas on X-ray (meaning thicker section thickness) become dark areas in above print. Overall view of area studied is shown in Figure 8.

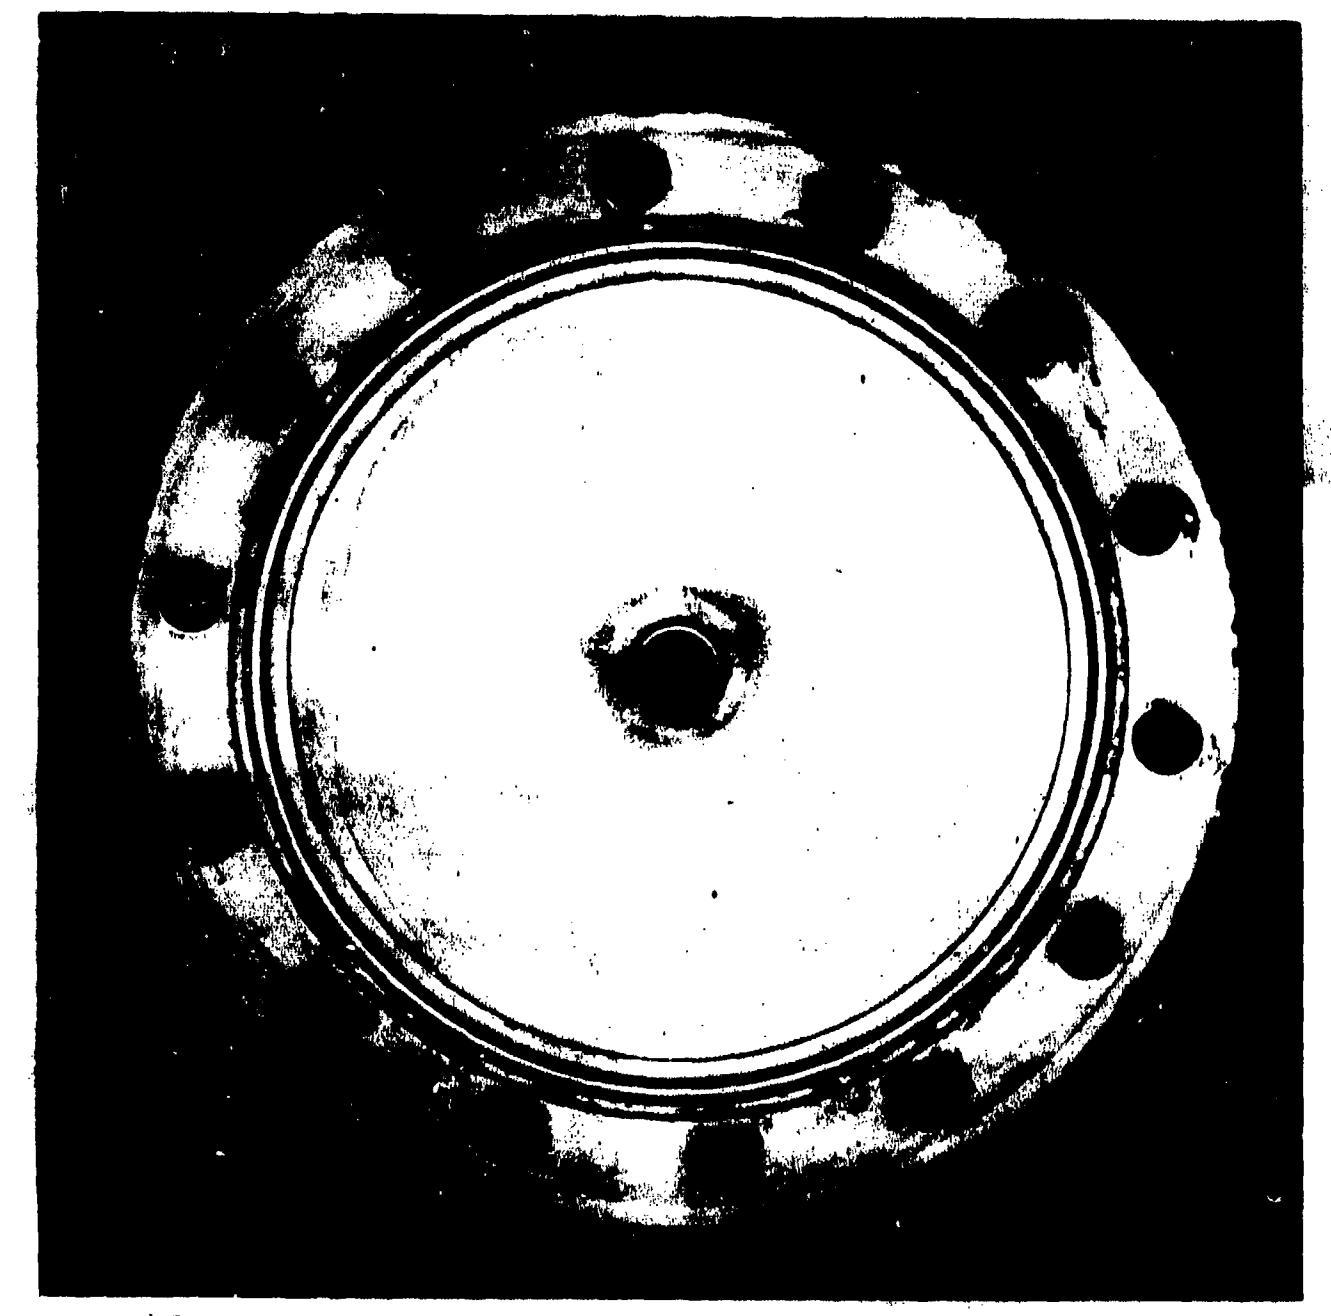
FIGURE 47. OVERALL VIEW OF FLANGE COVER FROM TANK S/N 3.

An overall view of the flange of tank S/N 3 with the aluminum sealing ring in place is shown in Figure 46. The corresponding view of the flange cover sealing side is shown in Figure 47. These views were taken after the 30 day water immersed leak test. Slight staining of the stainless steel and of the aluminum surfaces exposed to the water had occurred, but these are not readily apparent. Close inspection of the groove and sealing ridges in the flange cover showed the groove to be reasonably smooth with only a very slight ripple to the surface at some locations. The ridges were quite smooth and appeared to have an excellent machined surface that should have provided very good sealing with the soft aluminum ring, assuming sufficient clamping force was used. This is shown in Figure 48.
