PROCEEDINGS OF THE DICE THROW SYMPOSIUM 21-23 JUNE 1977

Volume 3

General Electric Company—TEMPO
DASIAC
816 State Street
Santa Barbara, California 93102

July 1977

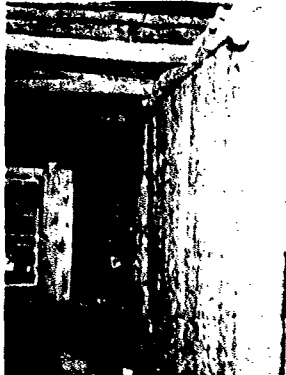
PHOTO
0704-77

The pole frame and plywood blast doors of the Small-Pole Shelter were essentially undamaged by the blast effects at the 53-psi overpressure range (see Fig. 4.6). However, occupants would have been injured if they had been standing with their heads close to the ceiling,

Fig. 4.6. Small-Pole Shelter after Being Tested with Blast Doors Closed at the 53-psi Overpressure Range. Note the slightly damaged expedient shelter-ventilating pump in the stoop-in entryway. Two men worked about 5 min. to replace the 4 blown-loose flaps, the only damage.

There was no damage to any of the life-support equipment in this shelter, except for quickly repairable damage to the expedient shelter-ventilating pump (KAP)¹² pictured in Fig. 4.6.

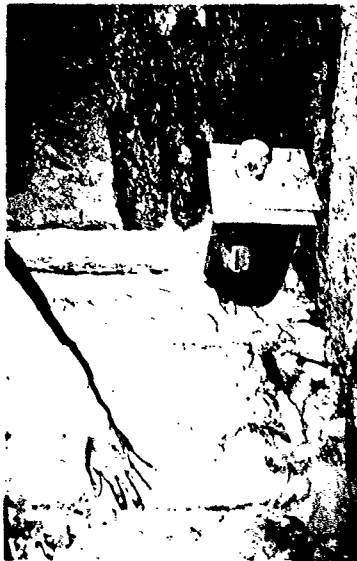
PHOTO
6459-76

Figure 4.8 shows how the floor "puffed up" about 6 in. in the northeast corner of the shelter in the east entryway; some pressurized earth caused some earth to "flow" up into the closed room, in which the measured peak overpressure was only 1.5 psi. About 85% of the floor area was undisturbed, as was the floor in front of the man's hand resting on the cross brace. Neither the blast gauge resting on the brace pole in the corner nor the small expedient fallout meter on top of it was moved.

Fig. 4.8. "Puffed-Up" Part of the Floor of Small-Pole Shelter due to the Start of Earth Flow under Moderately Long-Duration Blast Overpressure at the 53-psi Overpressure Range.

If a person had been standing on the floor when it was "puffed up" suddenly, possibly his legs could have been injured. To prevent possible injuries due to an intact ceiling moving very rapidly downward and/or the floor moving upward, occupants could recline in expedient bedsheet hammocks¹¹ slung from the upper horizontal brace poles of the main shelter room, as shown in Fig. 4.9.

4.4.2 - A modification of this shelter with a continuous pole floor under the wall poles should not fail as a possible result of a large amount of pressurized and destabilized earth flowing up into it through its floor when subjected to the long-duration overpressures and large movements caused by a megaton explosion.

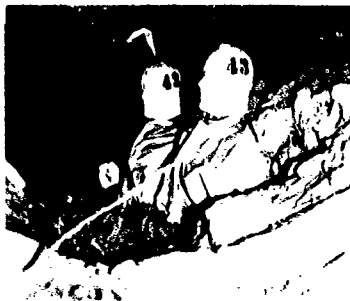
PHOTO
0705-77

Figure 5.4 shows the dummies trapped by the collapsing walls. Because their strong steel joints did not permit these dummies to bend forward, the collapsing walls did not bend them forward, knock them down, and bury them, as would have been the fate of two men. Note the unbroken roof poles.

Fig. 5.4. Dummies at 20-psi Range after Ground Shock Collapsed the Earth Walls of Shelter. Their steel "bones" and joints prevented them from being knocked down and buried.

The measured overpressure inside this shelter was 7 psi--high enough to break some persons' eardrums. (If this shelter had been subjected to the blast effects of a megaton weapon at the 20-psi range, the maximum overpressure inside the shelter would have been almost 20 psi.)

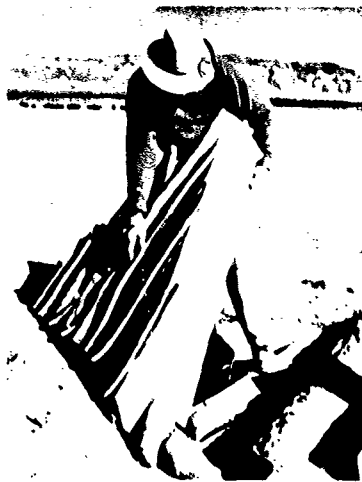
PHOTO
0700-77

Fig. 6.2. Expedient Triangular Blast Door Made of Pine Poles. The auto-tire flap valves over the 1-1/2-in.-wide spaces between the poles were undamaged by the blast effects at the 53-pai over-pressure range. Ground zero was to the left. Blast effects had moved the three connected blast-protector logs, preventing the door from being opened fully.

Figures 6.2 and 6.3 show the triangular blast door on the south end of the shelter, undamaged after the blast. Note that one of the 3 blast-protector logs (the log in the lower left corner of the photograph) has been pushed by the blast up against the hinge-pole of the blast door. The door was undamaged. However, the movement of the earth mound had broken the door-seat pole on which the man's foot is shown resting in Fig. 6.3. Figure 6.4 shows the break more clearly.

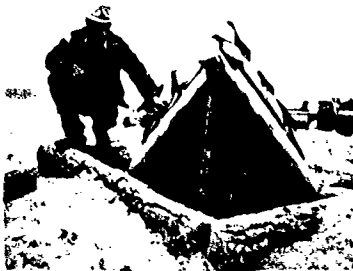
PHOTO
6442-76

Fig. 6.3. View of the Same Triangular Blast Door, Looking Toward Ground Zero. The hinge pole, originally 7-in. in diameter after peeling, had been flattened on its top and back side. The two other poles, 8-in.-diameter, had been flattened on their bottom, top, and inner sides. All three poles were notched and nailed together. Note the slots between the door-covering poles.

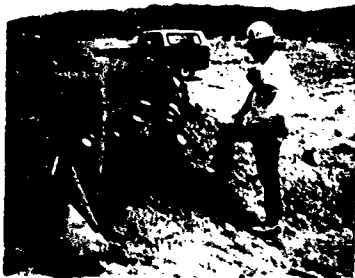
PHOTO
6478-76

The most surprising damage is shown by Figs. 9.6 and 9.7. Obviously, the dry earth "blow" away from the middle of the shelter and toward the two ends of the shelter. Apparently the pressures on the ends of the shelter were decreased as compared to the pressures on the center, both by the lack of reflected overpressures at the ends and the lowering of pressures at the ends caused by Bernoulli effects where the velocities of the blast winds were increased as the winds passed around the ends of the obstructing shelter.

Fig. 9.6. Collapsed Entrance Facing Away from GZ. The blast winds had scoured away most of the covering earth, and the earth had "flowed" away from the center of the shelter, pushing the upper part of the entry in a direction perpendicular to the radius from GZ.

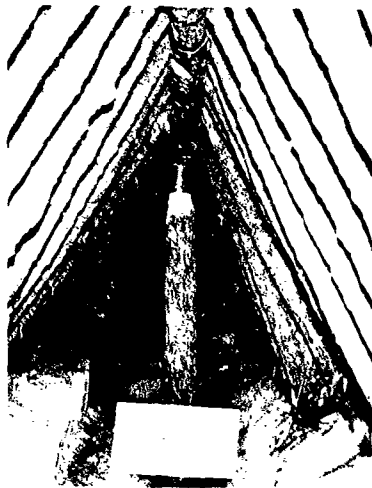
PHOTO
0698-77

Fig. 11.3. Undamaged Interior, Showing Earth Bench on One Side and Roof-Deflection Gauge on Post.

Contrary to our predictions, this lightly constructed shelter, tested closed, was undamaged by blast effects. The undamaged interior is pictured in Figs. 11.3, 11.8 and 11.9.

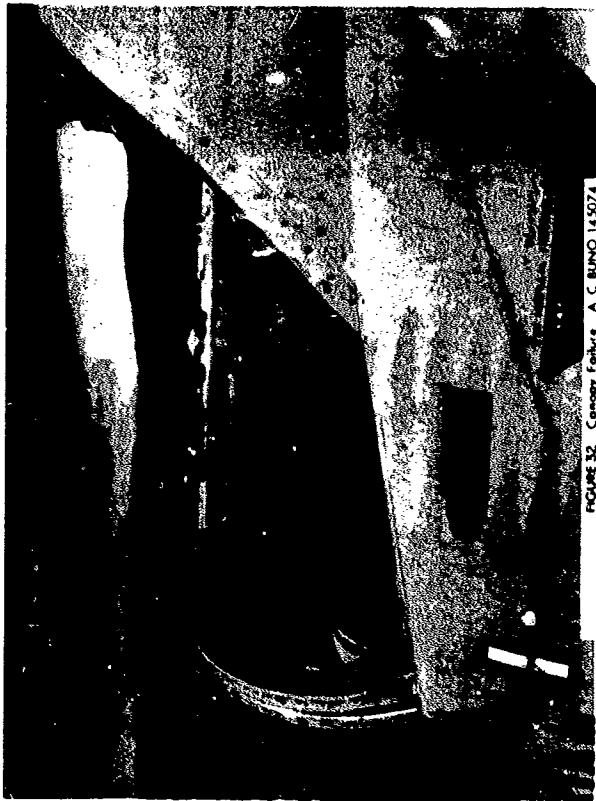
FIGURE 32 Canopy Feature A C BUNO 143074

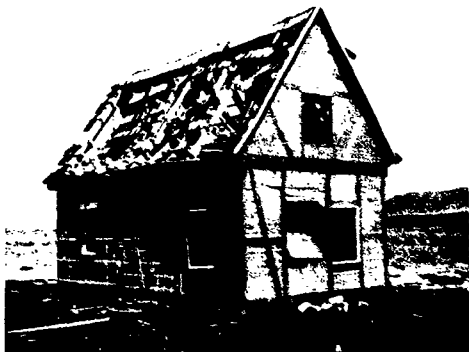
FIGURE 18b POST-SHOT VIEW OF STRUCTURE NO. 1 FROM
NORTHWEST MASONRY CAVITY WALL SIDE

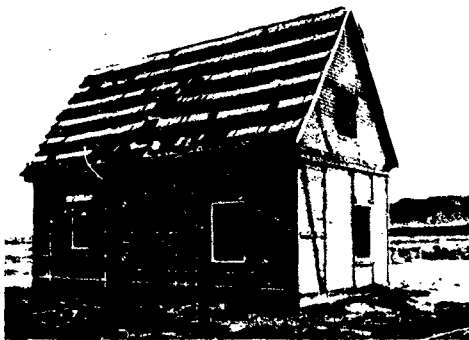
FIGURE 19 POST-SHOT VIEW OF STRUCTURE NO. 2
FROM SOUTHWEST FACHWERK SIDE

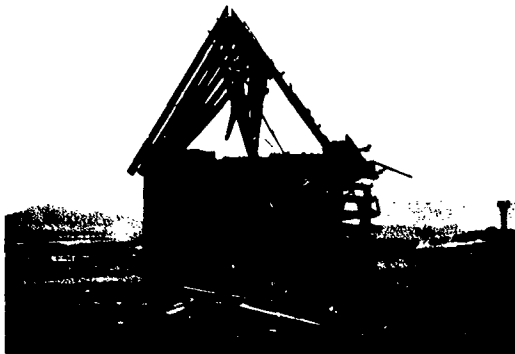
FIGURE 22 END VIEW OF COLLAPSED MASONRY CAVITY WALL STRUCTURE NO. 1

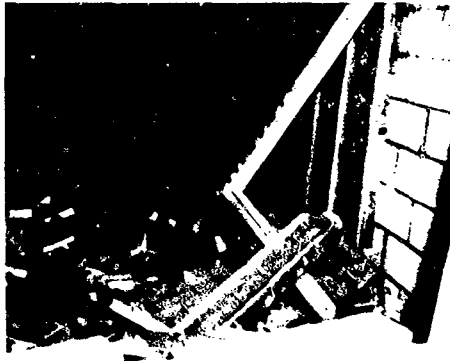
FIGURE 32 INTERIOR DEBRIS FACHWERK TEST CELL STRUCTURE NO. 1

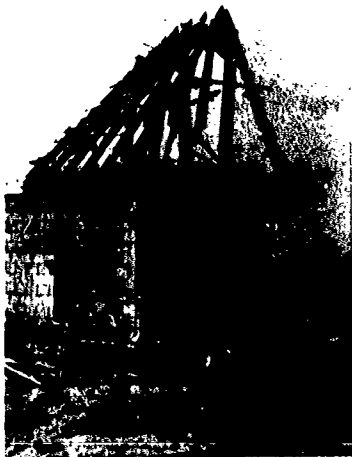
The roof framing over the cavity wall test cell was approximately in position although skewed, as noted in Figure 34. All front rafters, except the one adjacent to the north side cavity wall gable, had experienced typical flexural fractures near the center of the rafter span. The top portions of the rafters were still nailed to the ridge beam, but were hanging downward, and the bottom portions had rotated around the front plate and were resting on top of the reinforced concrete ceiling slab. Figure 34 also shows that the six rear rafters, four ridge beam posts, and the ridge beam above the masonry cavity wall are all structurally intact but somewhat displaced.

FIGURE 34 DAMAGED ROOF FRAMING ABOVE MASONRY
CAVITY WALL TEST CELL STRUCTURE NO. 1

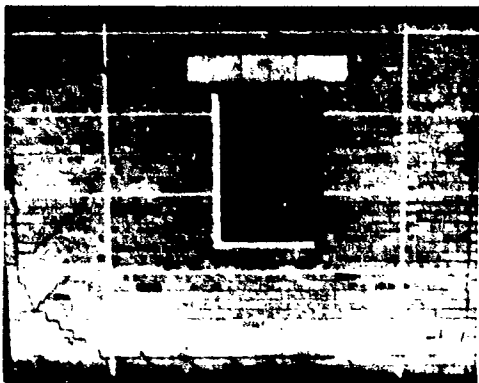
Masonry Cavity Wall. Although the front cavity wall was still in place, there was extensive cracking of the exterior wythe of brick as shown in Figure 35. As noted for Structure No. 1, there was also a vertical crack one-half brick in from the concrete pilaster support in Structure No. 2. Another vertical crack was apparent at the juncture of the front and side cavity walls; this crack extended the full height of the wall and was continuous in either the front or side walls. The crack width varied from a small crack at the bottom to about 1/4 in. near the top (Figure 36). The diagonal cracks from the left corners of the wall shown in Figure 35, showed some compressive spalling. It appears that the window jambs wedged

FIGURE 35 CRACKED FRONT MASONRY CAVITY WALL STRUCTURE NO. 2

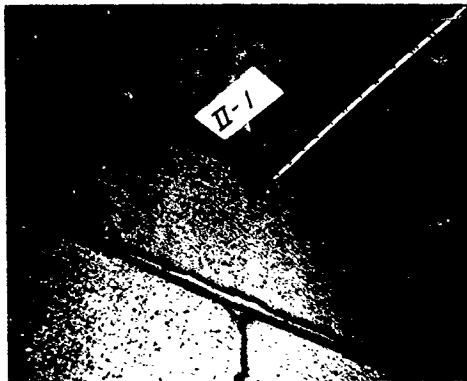
An examination of the interior surface of the CMU indicated that there was more extensive damage to the front cavity wall than was apparent from the cracks in the exterior surface of the brick. The inner face of the top course of CMU above the window had fractured just below the concrete ceiling slab for a horizontal distance of about 5 ft. The CMU below the fracture had a maximum inward permanent displacement of about 1/2 in. near the center of the fracture as can be seen in Figure 38; the displacement decreased to zero near the ends of the fracture. Also, the portion of the block above the fracture plane was still well bonded to the bottom surface of the concrete ceiling slab. The fracture plane on the inner face of the CMU in the front wall of Structure No. 2, which is shown in Figure 38, was identical to that observed in a like location in Structure No. 1 (see Figure 26).

FIGURE 38 FRACTURE IN INNER SURFACE OF CMU IN FRONT CAVITY WALL JUST BELOW THE CONCRETE CEILING SLAB STRUCTURE NO. 2

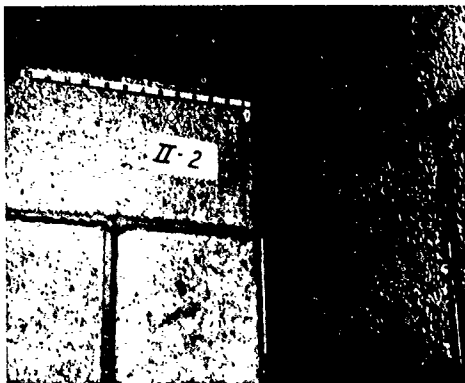
In addition to the fracture above the window, there was also a gap at the intersection of the CMU in the front and side walls. Figure 39 shows that the side wall, on the right in the photograph, has separated and displaced about 1/2 in. away from the front wall; the figure shows the gap in the second course of CMU below the concrete ceiling slab.

FIGURE 39 GAP AT INTERSECTION OF CMU IN FRONT AND SIDE MASONRY CAVITY WALLS STRUCTURE NO. 2

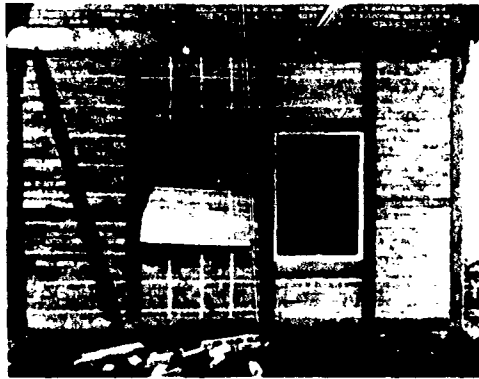
The damage to the south side Fachwerk wall is shown in Figure 46. As can be seen in the figure, the damage to the 48-in. wide brick panel on the side wall is different from that on the front wall in that a large section of the side wall panel, below the collapsed mid-section, is intact although rotated inward at the top. This type of failure mode was probably a result of failing to install one of the masonry-to-timber nails in the right hand post at about the mid-height of the rotated section. The masonry above and below the collapsed portion sustained considerable cracking and spalling of the brick similar to that noted in the front wall panel.

FIGURE 46 DAMAGE TO SOUTH SIDE FACEMERK WALL STRUCTURE NO. 2

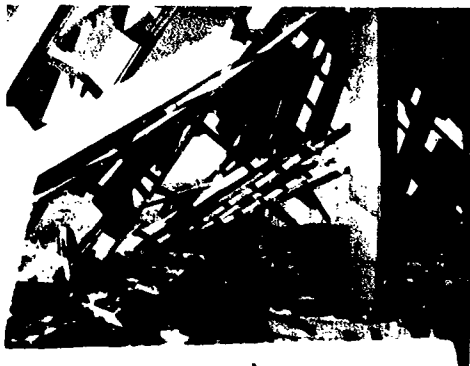
FIGURE 47 INTERIOR VIEW OF FRACTURED FRONT
ROOF RAFTERS STRUCTURE NO. 2

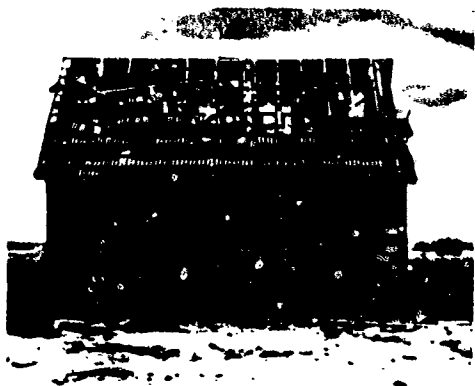
FIGURE 48 REAR VIEW OF DAMAGE TO ROOF TILE STRUCTURE NO. 2

concentrated in the lower courses. A total of 73 percent of the tiles were broken or missing from the front surface. As shown in Figure 48, on the rear half of the roof, in contrast to the front, there was much more damage to the tile on the upper portion of the roof than towards the bottom; in fact, the top three courses down from the ridge were completely destroyed. Although the overall tile damage appears less on the rear than on the front roof, 68 percent of the rear roof tiles were broken or missing.
