REPORT 77-31

Roof moisture survey

Ten State of New Hampshire buildings

ROOF MOISTURE SURVEY: TEN STATE OF NEW HAMPSHIRE BUILDINGS

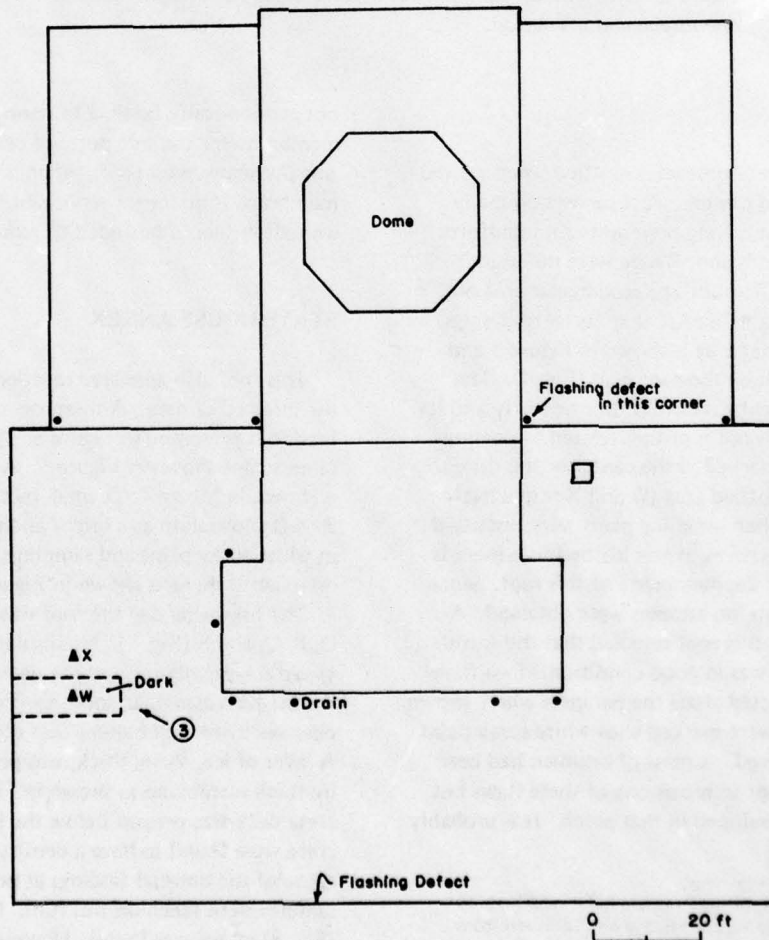
This roof appeared somewhat mottled when viewed through the infrared camera. Past surveys on many roofs indicate that mottling represents a nonuniform dampness of the insulation. There were no bright* well-defined anomalies, but one rectangular area on the roof was noticeably darker than its surroundings. A thermogram of that area is shown in Figure 3 and its location is shown on the roof plan (Fig. 4). The well-defined rectangular nature of this anomaly and its darkness suggest it is not moisture related. Locations for sampling were marked in the center of the dark area and the adjacent mottled area (W and X respectively in Fig. 3 and 4). When sampling plans were discussed with State representatives, it was learned that there is no insulation under the membrane of this roof. Since there is no insulation, no samples were obtained. A visual inspection of this roof revealed that the gravel-covered membrane was in good condition. Two flashing flaws were detected along the parapets where shown in Figure 4. They were marked with white spray paint and should be repaired. A mass of bitumen had been applied in an attempt to repair one of these flaws but new cracks have developed in that patch. It is probably

Figure 4. Plan view of State House roof. Circle and arrow indicate location and viewing direction of Figure 3.

not economically feasible to remove and replace this membrane for the sole purpose of adding insulation to this thermally poor roof. When, in due course, this membrane is no longer serviceable and must be replaced, insulation should be added to reduce heat losses.

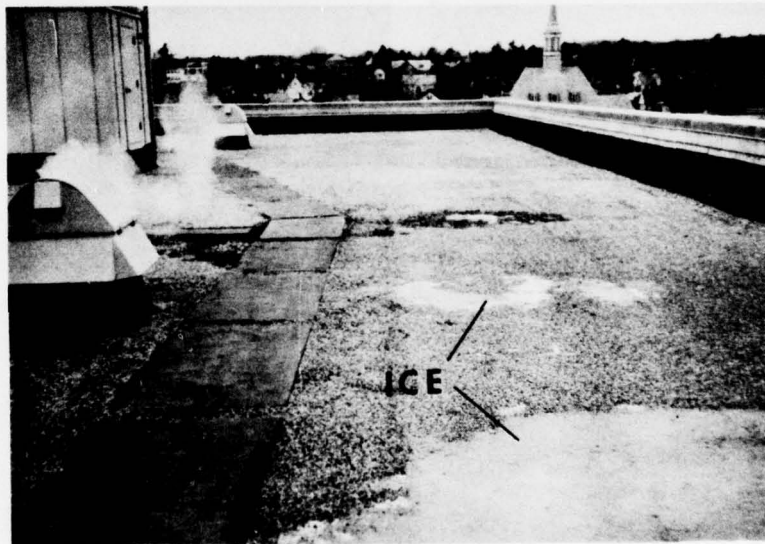
Figure 6. Photograph of the area shown in Figure 5.

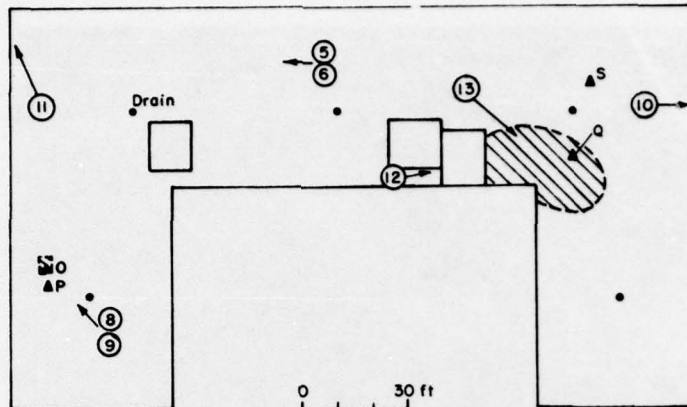
Figure 7. Plan view of the State House Annex roof. Circles and arrows indicate location and viewing direction of Figures 5, 6, and 8-13.

A larger, egg-shaped anomaly was also detected with the infrared camera (Fig. 13). It did not have a well-defined boundary as did the rectangular anomaly previously discussed nor was it as uniformly bright. A dashed line of white spray paint was used to approximate its extent (Fig. 7). At S the membrane was in good condition but at Q the membrane was brittle, dry and easily delaminated. No insulation was present under the membrane at either Q or S. S was in a mottled area similar to the area in Figure 5. The water content of chips of the concrete deck at points Q and S was determined to be 9% and 15%, respectively. It is likely that such differences in deck moisture explain the surface temperature differences seen by the infrared camera over most of this roof. Moisture in the concrete deck decreases its insulating value.

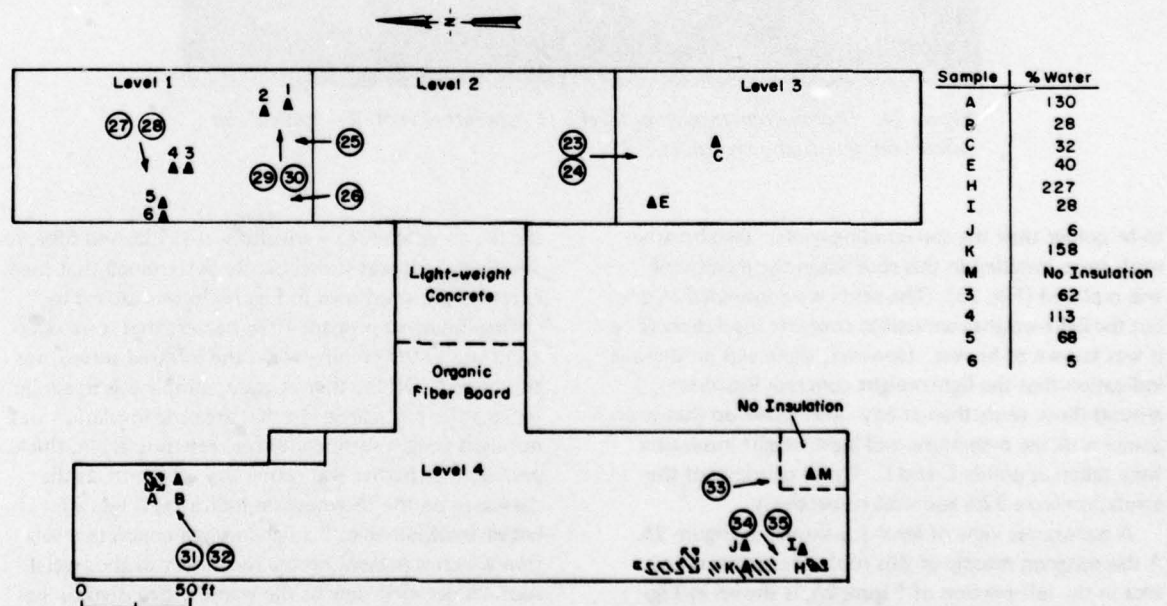
The roof of the Highway Garage was thermally complex. Four levels are present as indicated on the roof plan (Fig. 22). All levels are relatively flat with ridges along their centerline that provide slope sufficient to drain water to the eaves or to scuppers along the eaves. It is understood that the gravel-covered membrane is only a few years old.

Figure 22. Plan view of the Highway Garage roofs. Samples were not taken at locations 1 and 2.

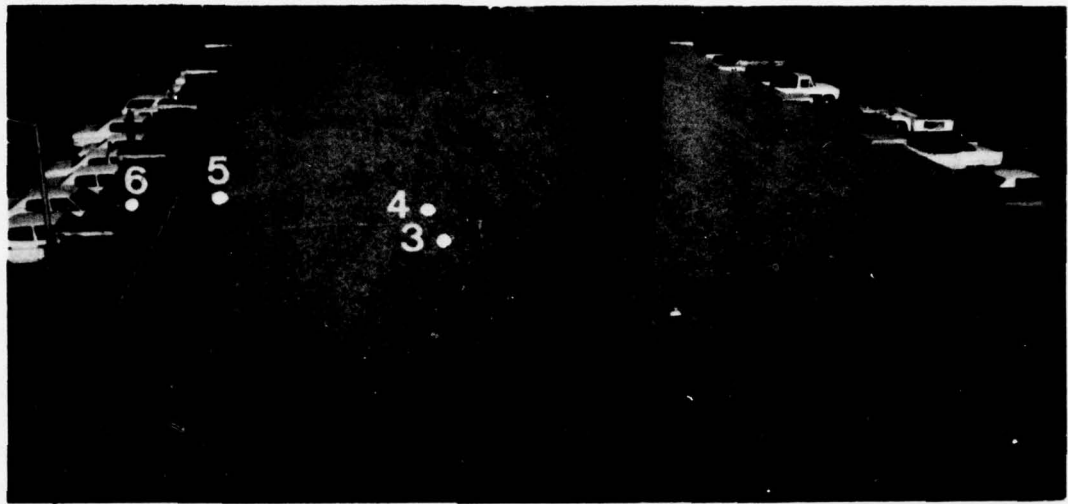
A panoramic view of level 1 is shown in Figure 25. A thermogram mosaic of this roof, which covers the area in the left portion of Figure 25, is shown in Figure 26. The thermogram strongly suggested that white portions of the roof are wet. Sample 3 was wet (62%) as expected, but samples 4 and 5 in the dark area of

the thermogram (26) were also wet (113% and 68%, respectively). It was subsequently determined that the extra brightness shown in Figure 26 was caused by ceiling-mounted propane-fired heaters that were operating late in the evening when the infrared survey was conducted. On the thermogram, sample 6 is in a long rectangular black area. In that area the insulation was not light-weight vermiculite concrete but 2¼-in.-thick perlite. The perlite was rather dry (5%) and, as the dark area on the thermogram indicates, it was a far better insulator than the light-weight concrete insulation which is present on the remainder of the level 1 roof. A detailed view of the well-defined division between the thermal image of the dry perlite and the wet light-weight concrete is shown in Figures 27 and 28.

Figure 25. View of level 1, Highway Garage. Points 3-6 are sample locations.

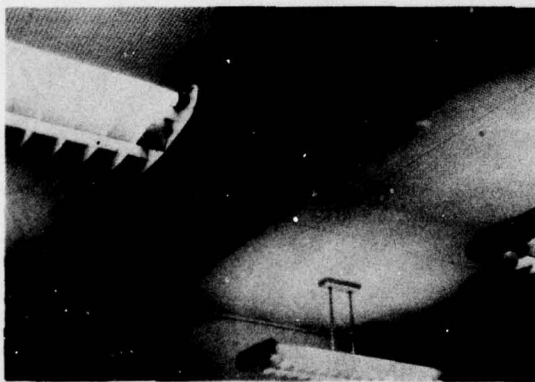
Figure 39. Ceiling under the area shown in Figures 36 and 37. The lights and beams can be "seen" in the thermogram (Fig. 36).

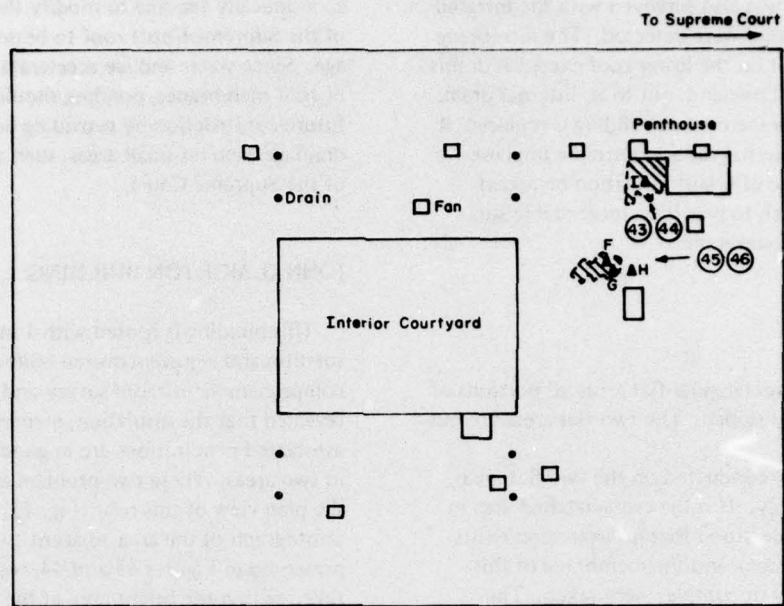
Sample	%Water
F	200
G	197
H	1
I	377

Figure 42. Plan view of the John O. Morton Building showing the two wet areas detected by the infrared camera and verified by core samples.

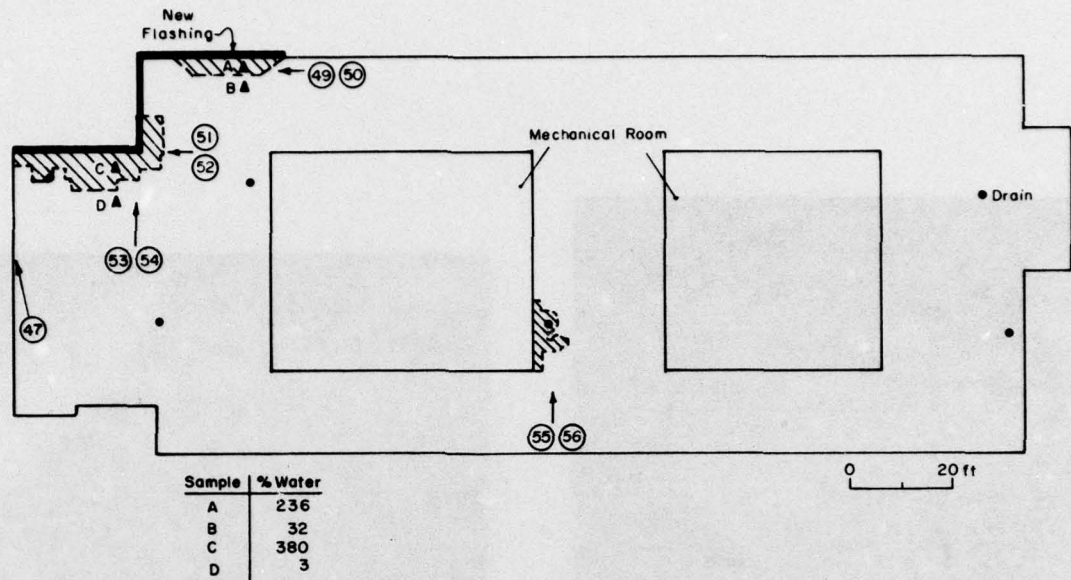
Figure 48. Plan view of the Department of Health and Welfare Laboratory.

This building is only a few years old but is suffering from chronic roof leaks. Visually the gravel-covered membrane is in excellent condition. The only visible flaw on the roof is the displaced parapet wall cap flashing in one area (Fig. 47). The location of this problem is shown in the plan view of this roof (Fig. 48). This material should be repositioned as soon as possible.

A comprehensive infrared survey of the roof uncovered three potential problem areas as shown in Figure 48. A thermogram and photograph of the first of these areas are shown in Figures 49 and 50. Insulation samples taken at A and B had water contents of 236% and 32% respectively. The perlite board insulation was

Sometime in the past the copper counter flashing along a portion of this wall was stolen. It is understood that this area remained without counter flashing for over half a year. The bold perimeter in the plan view (Fig. 48) has new copper counter flashing. It is quite likely that moisture entered this area during the period when the counter flashing was missing. Consequently, it is expected that the cause of this problem has been eliminated. Water in the insulation could cause membrane deterioration when it vaporizes in warm weather. Therefore, it is suggested that two breather vents be installed in this area in an attempt to dry out this insulation. There is some question whether this will work, but it is considered worth a try.

The second anomaly detected with the infrared camera was located nearby (Fig. 48). Two views of it are shown in Figures 51-54. Sample C, within the anomaly, had a water content of 380%, while sample D nearby (Fig. 52) had a water content of 3%.

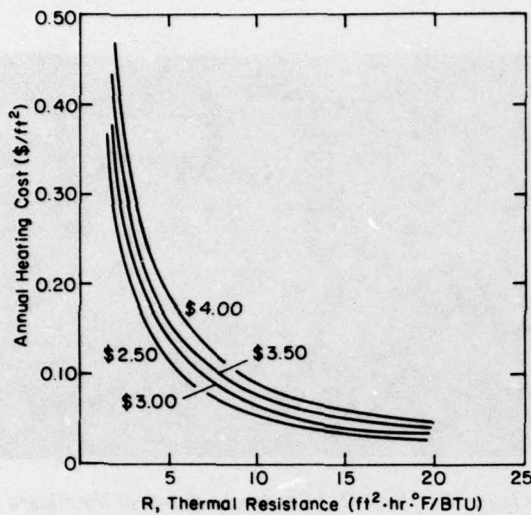
The thermal resistance of the wet insulation on the library roof was measured by Tobiasson and Dudley (1977). To their average value of R = 6.9 ft² hr °F/Btu should be added R = 0.8 to account for inside and outside skin resistances. The total R equals 7.7 for this roof. From Figure 57, the annual cost of energy lost through this roof, based on those heat flux readings and a fuel cost of \$3.85/MBtu, is \$0.12/ft².

Figure 57. Curves that relate heating costs to thermal resistance for various fuel costs (\$/MBtu) for Concord, New Hampshire.
