FINAL REPORT  
INVESTIGATION AND IMPROVEMENT OF THE  
RELIABILITY OF THE C-141A AIRCRAFT  
MASTER CAUTION CONTROL UNIT

JULY 1976

ARINC Research Corporation  
a Subsidiary of Aeronautical Radio, Inc.  
2551 Riva Road  
Annapolis, Maryland 21401  
Publication 1904-01-1-1524

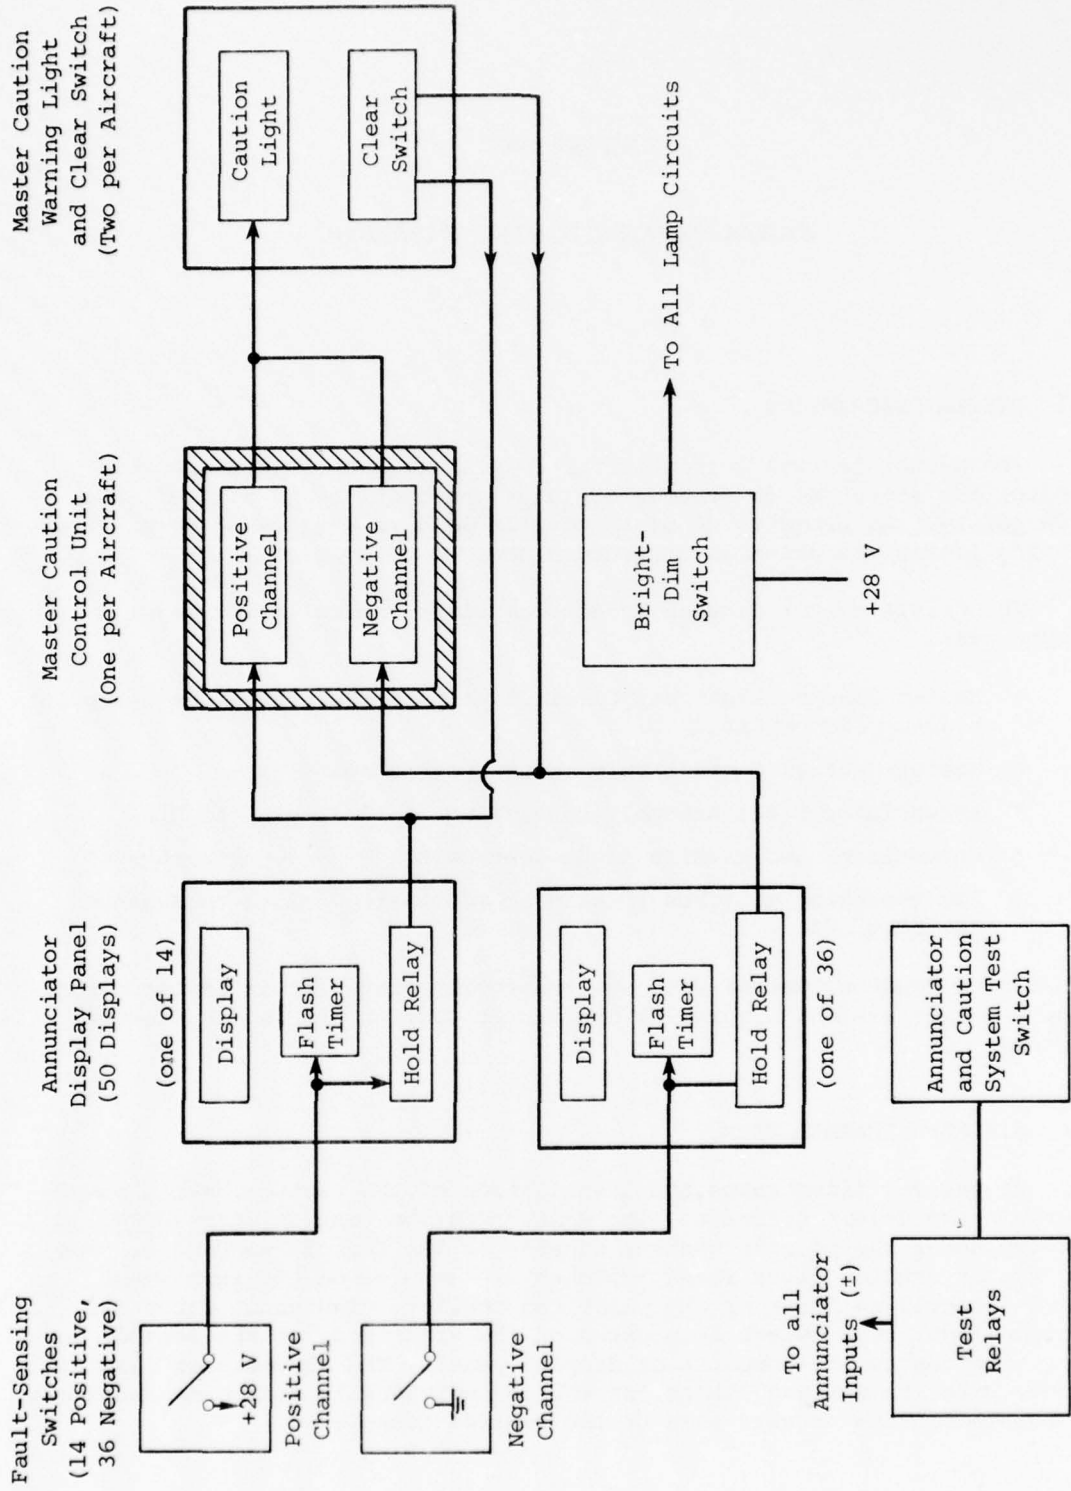
Figure 2-1. BLOCK DIAGRAM, MASTER CAUTION WARNING AND CONTROL SYSTEM

The Master Caution Control Unit was the focal point of this investigation. Figure 2-1 is a block diagram of the Master Caution Warning and Control System.

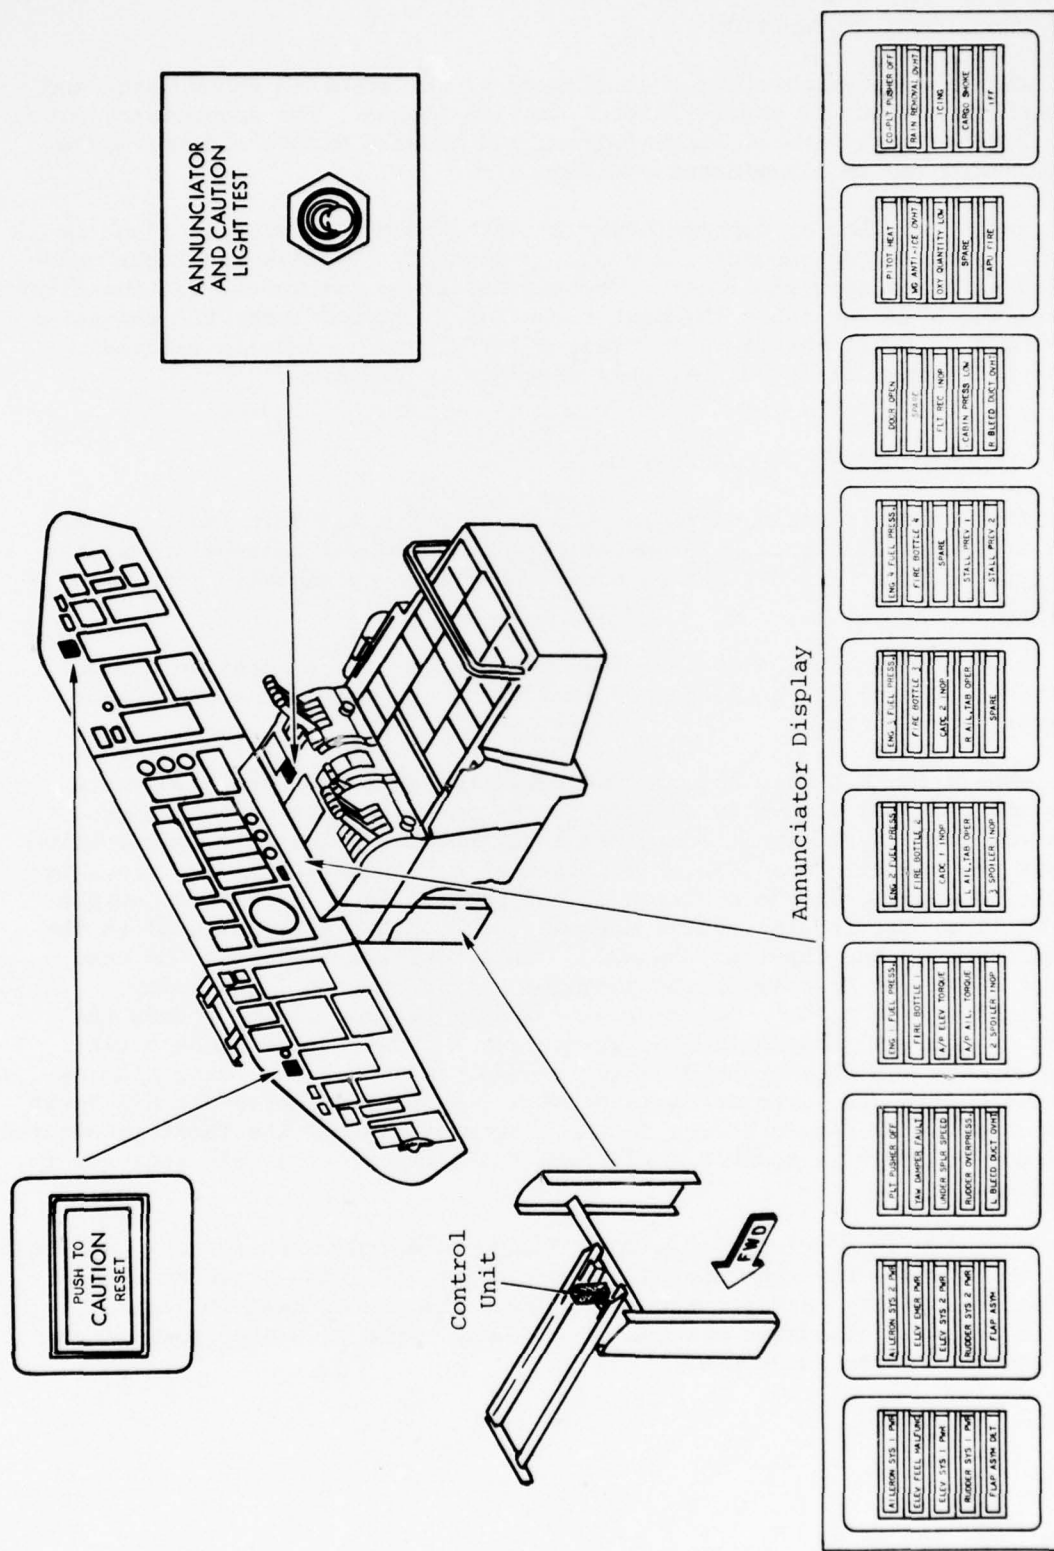
Figure 2-2. INSTALLATION OF CAUTION WARNING SYSTEM COMPONENTS

Figure 2-2 illustrates the installation of the caution system components in the C-141A aircraft. The Master Caution Control Unit (MCCU) is mounted under the pilot's control console on the left forward side. The two master caution light reset switches are mounted on the instrument panel directly in front of the pilot and copilot. The annunciator and caution light test switch is mounted on the right side of the control console, just below the annunciator display panel. The annunciator display panel, with its warning lights for the 50 individually monitored functions, is mounted on the forward edge of the control console.

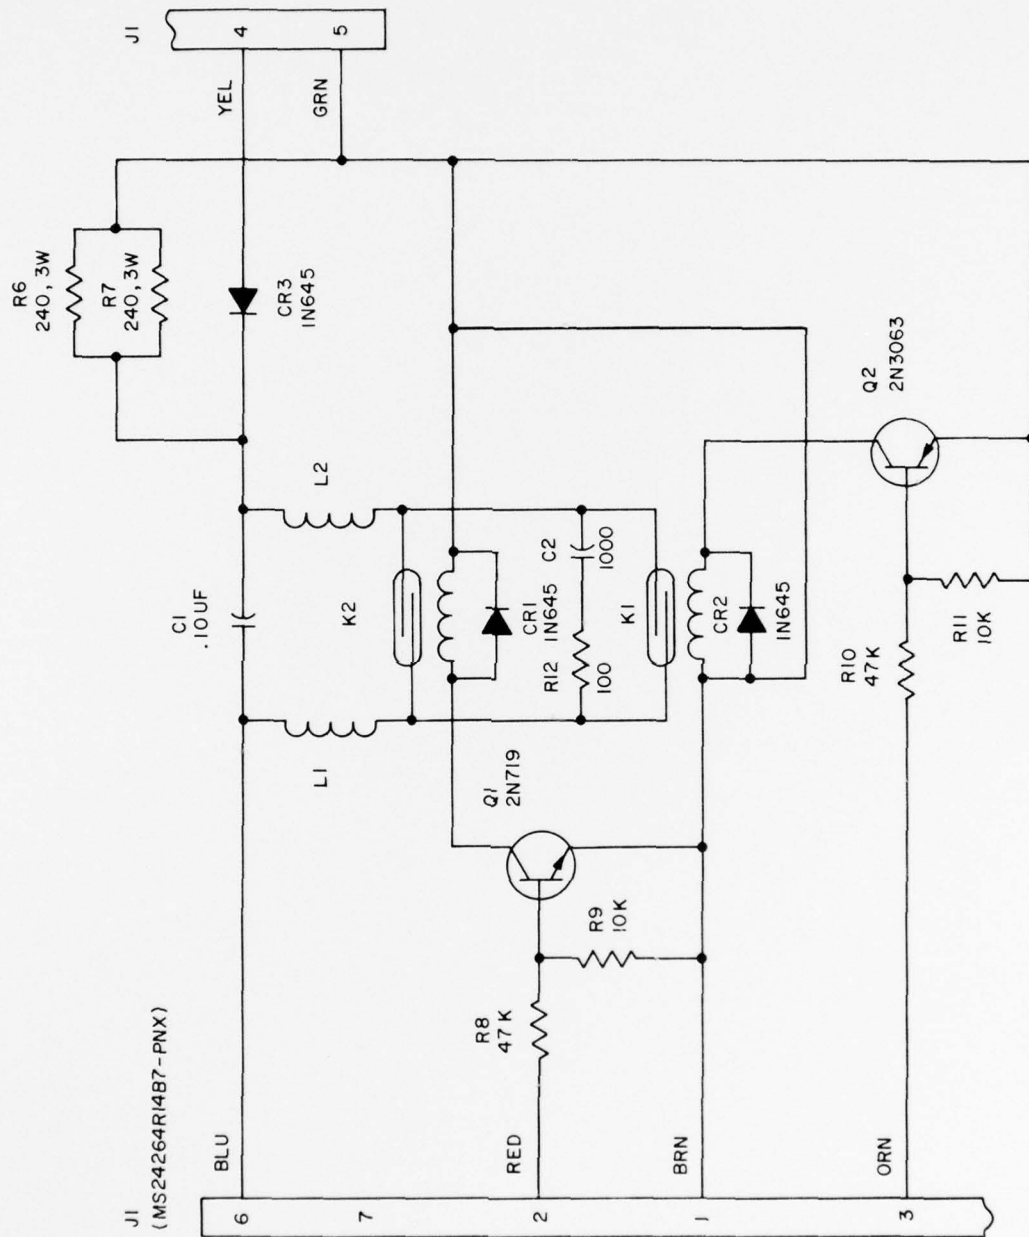
Figure 2-3. MCCU SCHEMATIC DIAGRAM

The MCCU is a relatively simple design using two transistors: an NPN type 2N719 and a PNP type 2N3063. Two reed relays, each actuated by one of the transistors, are provided to control the master caution lights. Figure 2-3 is a schematic diagram of the unit. The MCCU uses power from the +28 volt isolated dc bus.

The MCCU was instrumented with thermistor probes so that component operating temperatures could be measured. The components initially selected for operating temperature measurement were Q1-2N719, Q2-2N3063, R6 and R7 240-ohm resistors, and K1 and K2 reed relays (see Figure 2-3). Preliminary surface-temperature measurements comparing Q1 and Q2, R6 and R7, and K1 and K2 showed that the similar components exhibited nearly identical temperatures. On this basis, Q1, R6, and K2 were selected for measurement. Three thermistor probes were then attached to the selected components in the unit, and interconnecting wiring was routed to the measurement bridge through the opening created by removing connector pin 7.

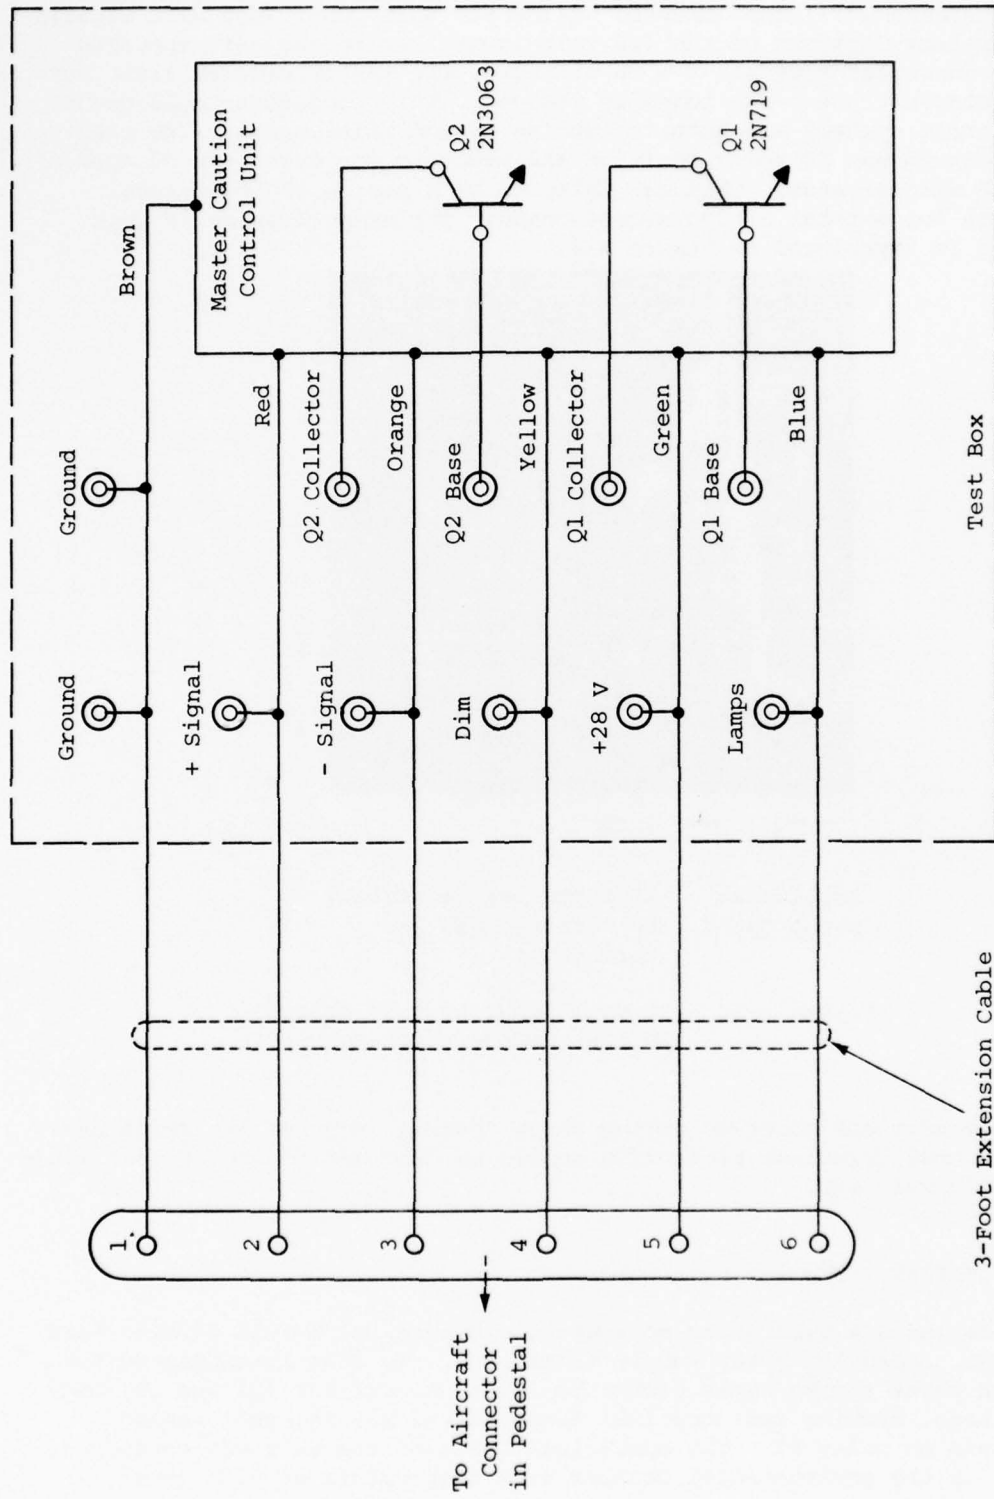
Figure 3-1. SPECIAL TEST FIXTURE FOR AIRCRAFT MEASUREMENT

For this effort, we built a special test fixture (see Figure 3-1) designed to plug into the aircraft MCCU connector. With this fixture, it was possible to monitor all input lines to the MCCU, as well as the collector and base terminals of both transistors in the unit. Utilizing aircraft power, we made aircraft measurements with a dual-trace portable storage oscilloscope (Tektronix Type 466) in conjunction with the test fixture.

The peak detectors recorded both positive and negative transient spikes with amplitude between 200 volts and 400 volts at the input to the positive channel of the MCCU. These peaks occurred when the caution control reset switch was actuated the first time to clear the flashing annunciator displays, following the application of aircraft power.

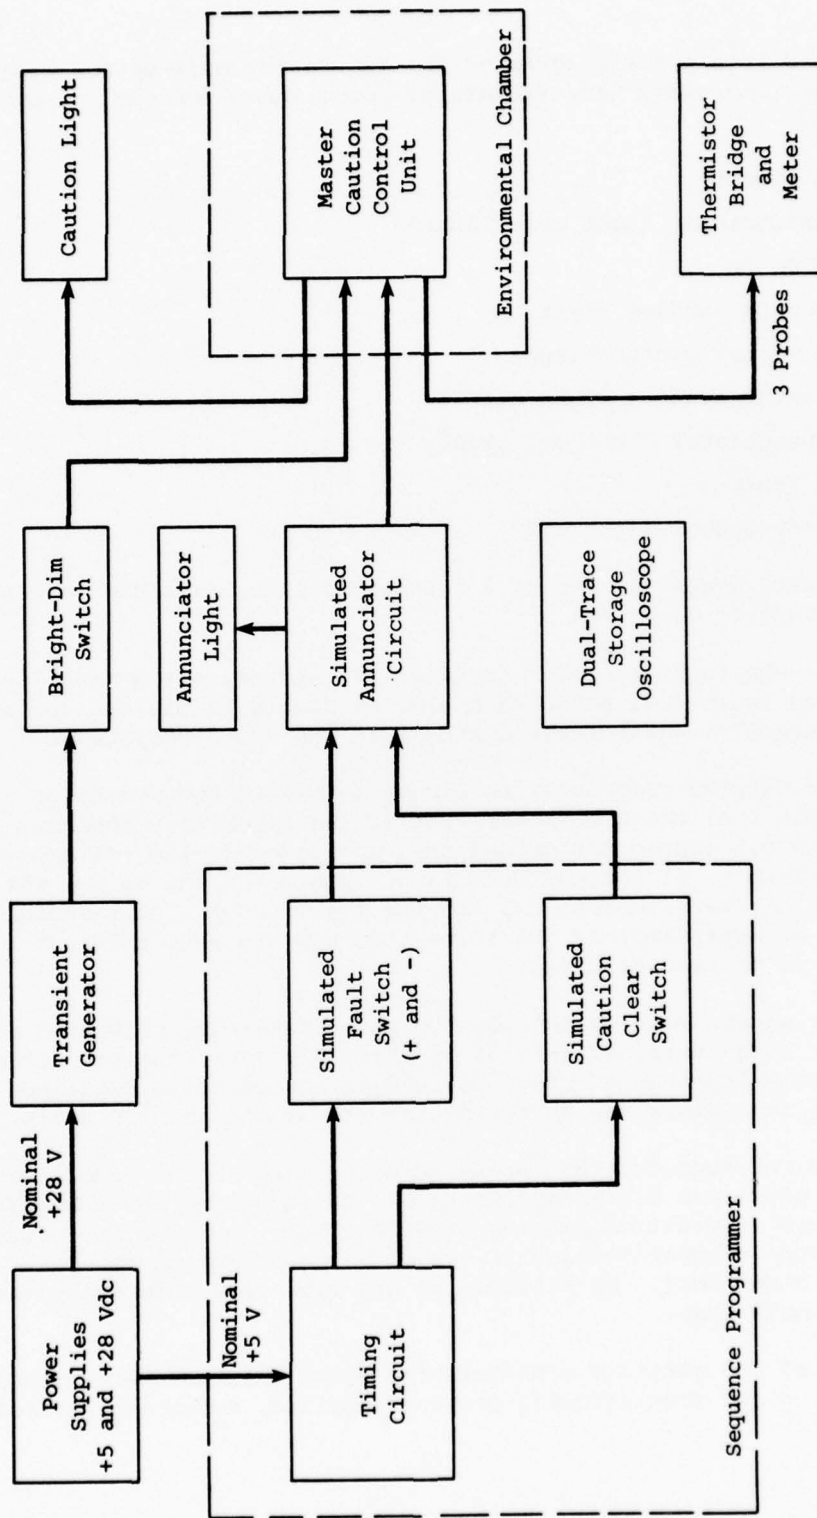
Figure 3-3. LABORATORY MOCK-UP, C-141A CAUTION WARNING SYSTEM

Figure 3-3 is a block diagram of the laboratory mock-up for testing the MCCU. The laboratory test fixture was programmed for the following events:

All MCCUs received for this study were operated in the laboratory mock-up both before and after modification. We subjected one unmodified unit to 24 hours' repetitive cycling at 85°C in the environmental chamber with a power-supply input voltage of 34 volts, representing the most severe set of conditions. No failures of any type were induced by the extreme test conditions.

This configuration permitted operation of the MCCU in its normal housing. The unit was operated in the environmental chamber with the laboratory mock-up as shown in Figure 3-3 (Section 3.3). The environmental chamber was operated for five hours each at 25°C and at 85°C to assure thermal stabilization of all components.

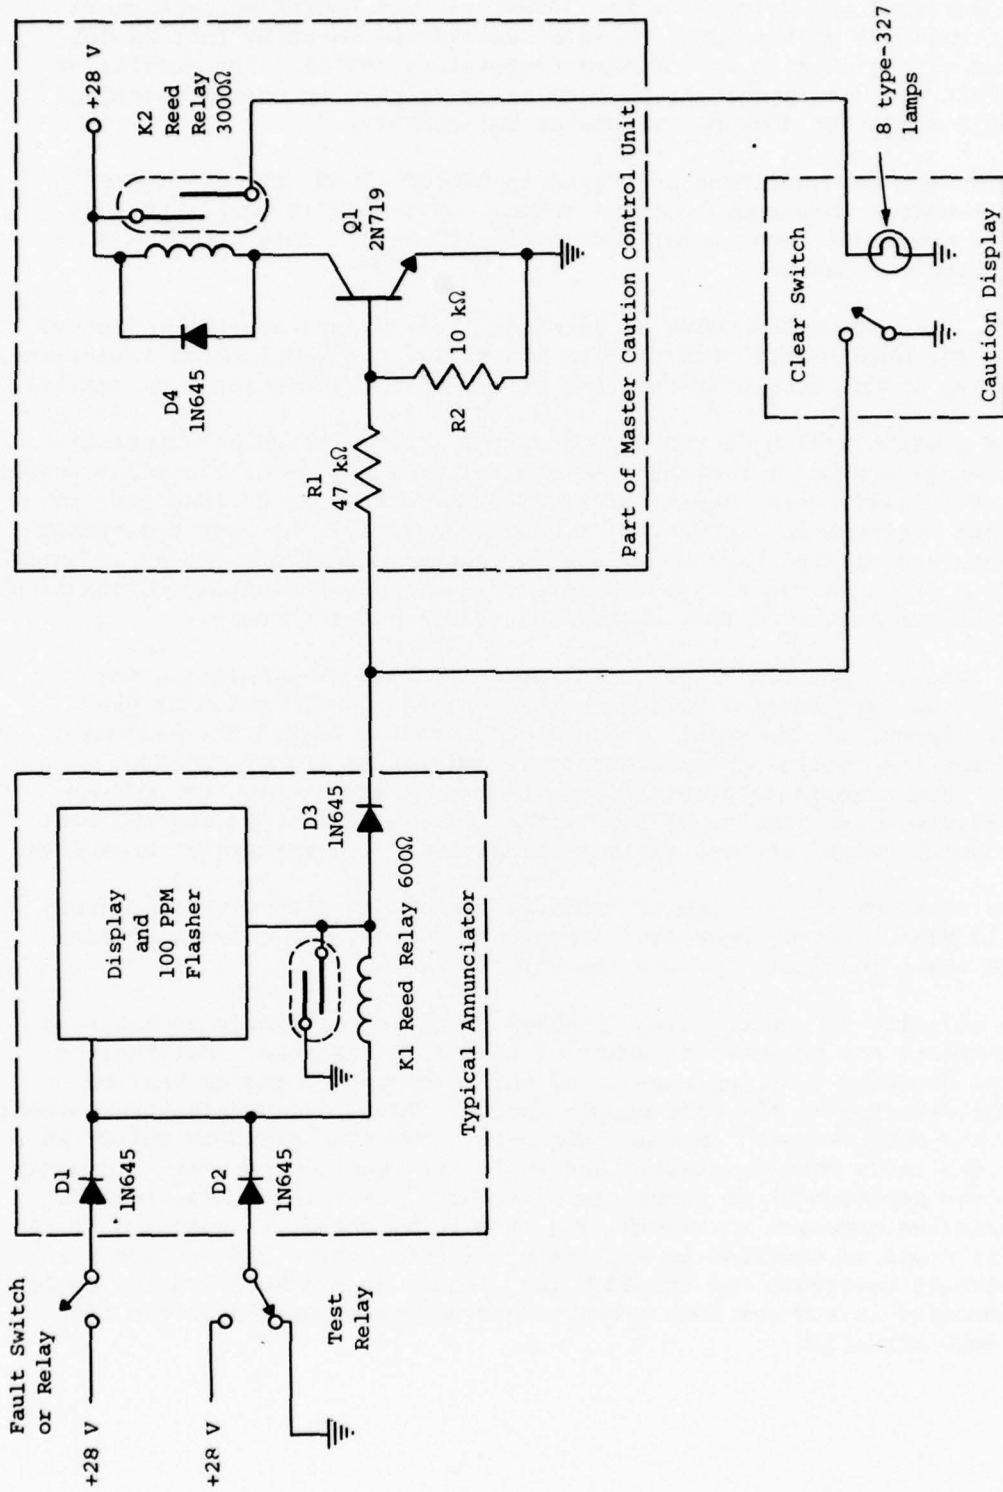
Figure 3-5. POSITIVE CHANNEL, CAUTION WARNING SYSTEM

Figure 3-5 is a simplified diagram of the positive channel. RFI filters and dimming circuits have been deleted for clarity, and only one channel is shown. (The negative channel functions in essentially the same way except for its reversed polarities and the use of a 2N3063 PNP transistor in the MCCU.) The functions of the various circuit elements are described in the following paragraphs.

To clear the master caution display, the pilot or copilot "clear" switch is energized. This grounds the input to the MCCU and also energizes K1. When K1 is energized, it latches and switches the annunciator from a flashing to a steady display, removing the +28 volt input signal to the MCCU. Transistor Q1 turns off, relay K2 deenergizes, and the MCCU is then free to respond to a new annunciator (fault) signal. Diode D4, which is connected across relay solenoid K2, provides transient protection for Q1 at turn-off. There are 14 positive annunciator channels connected in parallel to the MCCU (there are also 36 negative channels).

We measured and calculated the normal circuit operating parameters for both channels of the MCCU. We also considered derating factors for operation of the unit at an elevated temperature (85°C). The results of this effort did not reveal any problem areas related to normal deratings that would appear to degrade transistor reliability.
