HONEYWELL INC HOPKINS MN DEFENSE SYSTEMS DIV
XM587E2/XM724 ELECTRONIC TIME FUZES SYSTEM VERIFICATION TEST PH--ETC(U)
JAN 78 J C RAVIS

HDL-CR-78-157-1

Prepared by
HONEYWELL INC.
DEFENSE SYSTEMS DIVISION
600 SECOND STREET NE
HOPKINS, MINNESOTA 55343

4. TITLE (and Subtitle) XM587E2/XM724 ELECTRONIC TIME FUZES SYSTEM VERIFICATION TEST PHASE,		5. TYPE OF REPORT & PERIOD COVERED Final Report. 31 Mar 1975 - 30 Jun 1977

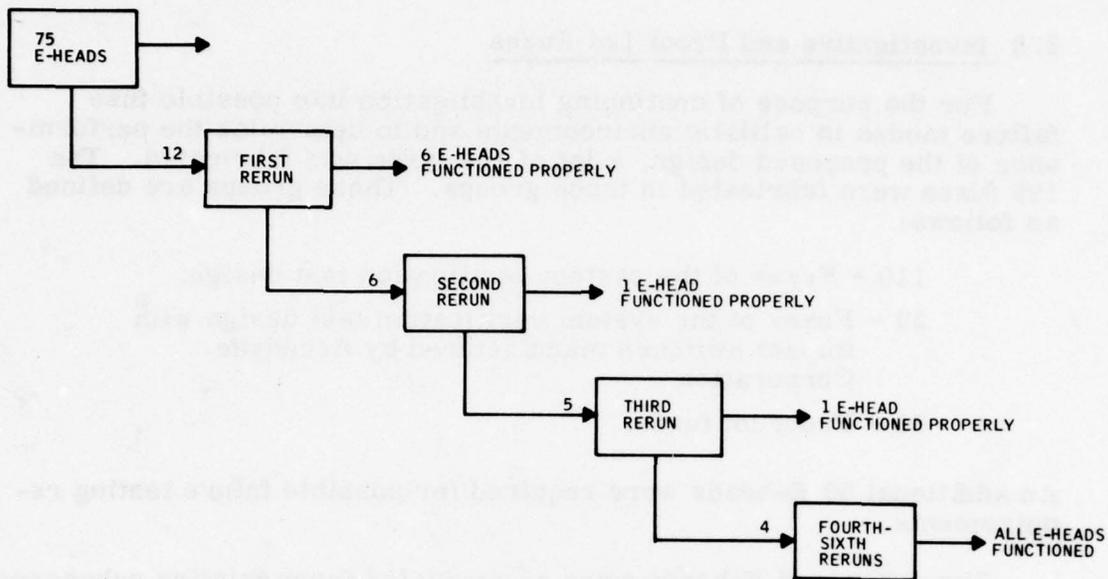
In addition to the in-process failures, only about 80 percent of the electronics (encapsulated) passed the required point detonating lot sample test. The test was repeated on all units which failed, and some had been rerun up to six times before they functioned. The exact cause of this problem is unknown, but the impact switch was suspected since prior failure analysis on this device indicated foreign material inside the switch housing. A summary of point detonating switch testing is shown in figure 16.

Functional testing and failure analysis of switches supplied by the manufacturer of the first article acceptance sample impact switches (Kaupp) confirmed that the problem was one of problem with the Kaupp switches. The failure analysis report on the impact switches is contained in appendix A.

Figure 16. Impact switch test results

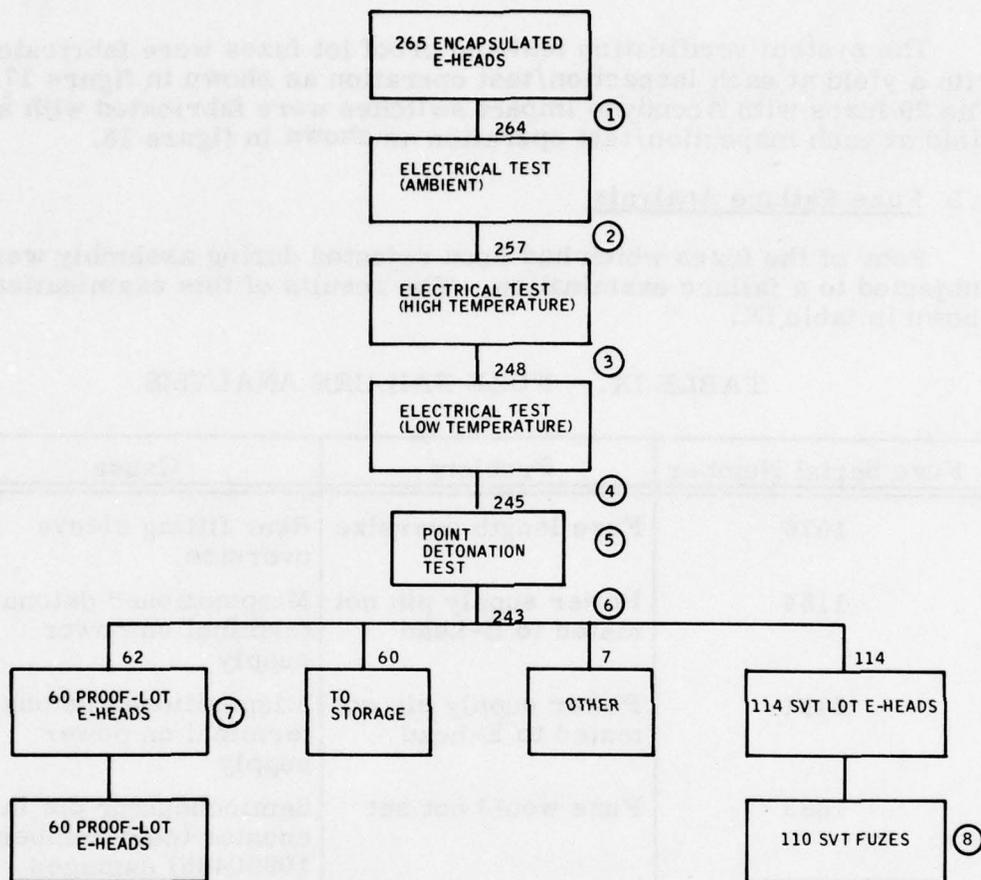
- ① ONE E-HEAD WAS LOST DURING THE STAKING AND POTTING PROCESS
- ② SEVEN E-HEADS WERE REJECTED AT ROOM AMBIENT TEMPERATURE BY THE AUTOMATIC TESTER. HOWEVER, FOUR OF THEM MAY BE ACCEPTED ON A WAIVER FOR TEST 1-5 (B).
- ③ NINE E-HEADS WERE REJECTED DURING HIGH TEMPERATURE TESTING.
- ④ THREE E-HEADS WERE REJECTED DURING LOW TEMPERATURE TESTING.
- ⑤ 241 E-HEADS WERE SUBJECTED TO THE PD TESTING. 75 FAILED THE TEST. ONLY 10 OF THE 241 E-HEADS WERE REQUIRED TO PASS THE PD TEST.
- ⑥ TWO E-HEADS WERE REJECTED DURING POST PD TEST INSPECTION, ONE WITH A LOOSE ORIENTATION CUP AND ONE WITH A LOOSE CENTER PAD IN THE NOSE PLUS ASSEMBLY.
- ⑦ COIL CONTACTS WERE DAMAGED ON TWO E-HEADS DURING REWORK; i.e., MILLING OF A SLOT TO ACCOMMODATE THE ADDED EXTERNAL POWER SUPPLY WIRE.
- ⑧ FOUR FUZES WERE REJECTED AFTER CRIMPING; THREE WITH IMPROPERLY SEATED O-RINGS, AND THAT COULD NOT BE SET WITH THE FUZE SETTER.

Figure 17. Flow diagram, fuze yield data (Kaupp impact switches).

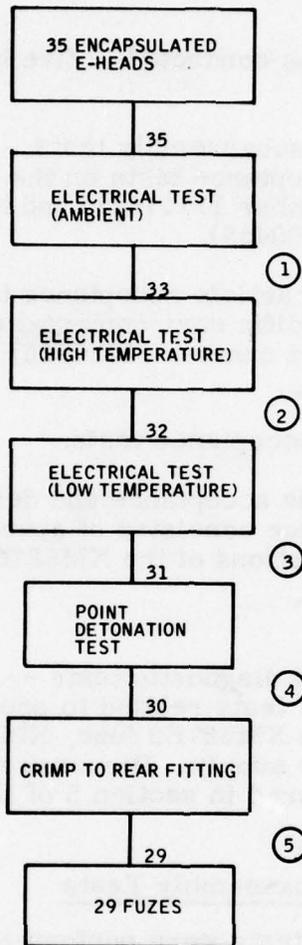
- ① TWO E-HEADS WERE REJECTED FOR PARAMETRIC FAILURES DURING ROOM AMBIENT TEMPERATURE ELECTRICAL TESTING.
- ② ONE E-HEAD FAILED HIGH TEMPERATURE ELECTRICAL TESTING.
- ③ ONE E-HEAD FAILED LOW TEMPERATURE ELECTRICAL TESTING.
- ④ ONE E-HEAD FAILED PD TESTING, BUT PASSED THE POST PD ELECTRICAL TEST.
- ⑤ ONE FUZE WAS REJECTED AFTER THE CRIMPING OPERATION FOR EXCEEDING THE 3.76-INCH MAXIMUM DIMENSION.

Figure 18. Flow diagram, fuze yield data (Accudyne impact switches).

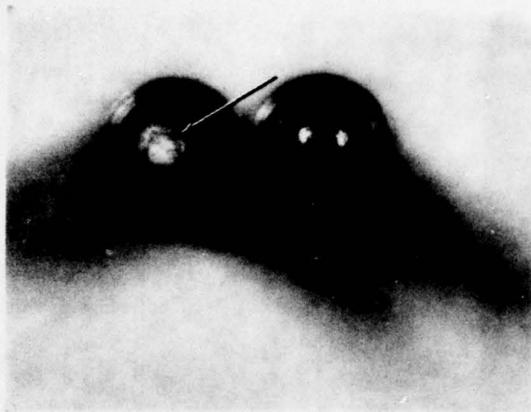
Photo 3 - 12X

The contact cones from two Kaupp switches. The arrow indicates contamination on the tip of the cone for device #8. This switch malfunctioned 88.8% of the time. The remained cone is clean and did not malfunction.

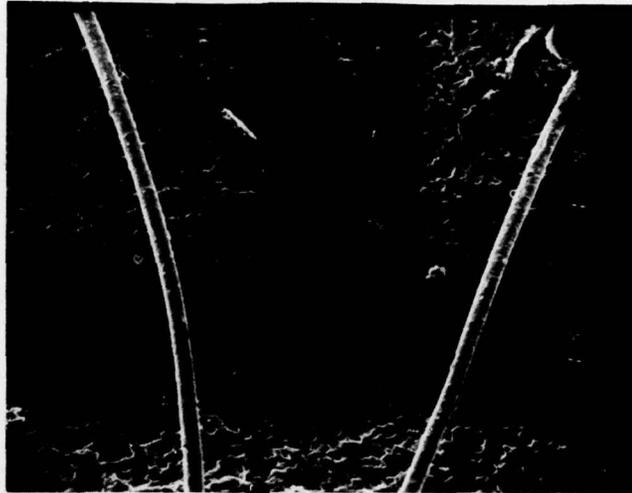
Figure 1.

The hybrid was carbon coated to prevent charging during SEM analysis. Figures 1 through 4 show areas of dendrite formation which can be seen more readily by a light microscope than on the SEM. The x-ray map of Figure 3 clearly shows the silver dendrite shape. Figure 2 (secondary mode) shows the same area, but the photo must be studied carefully to see the dendrites as they are largely obscured by a residue film on the substrate. The sulfur distribution, Figure 4, shows a slight sulfur enhancement in the dendrite area, so that the dark visual appearance of the silver dendrites could be due to a sulfide layer.

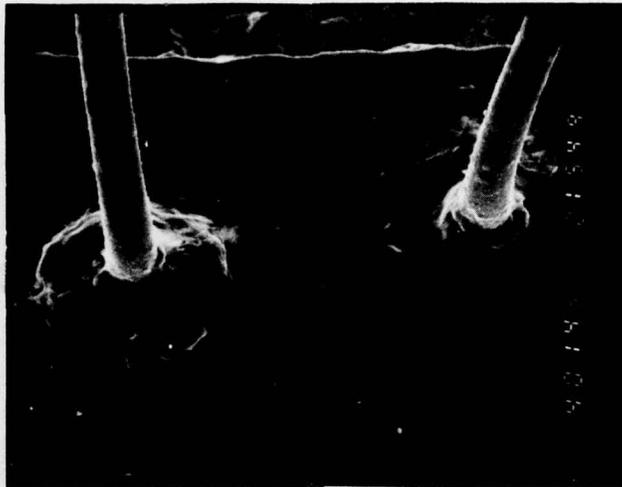
Figure 5.
400 X

X-ray analysis of area A of Figure 5 shows major sulfur, trace aluminum, silicon, silver and nickel. Area B of Figure 5, a discolored ball bond, shows major sulfur and gold; minor silver and aluminum; trace nickel.

Figures 5 and 6 give some idea of the silver distribution on transistor Q3. The discoloration of the ball bond could be due to sulfided silver since both these elements are present on the ball bond. The same seems to be true for the discolored bonds on Q2, but the high gold peak obscures the sulfur peak so that it is not possible to tell how much sulfur is present, if any.

FIGURE 5. Q3, transistor with ball bonds. Some silicone coating still present, obscuring active area. 6. Q3, Map for silver on the area of Figure 5. There is some silver on the ball bonds and on the transistor in the center region.

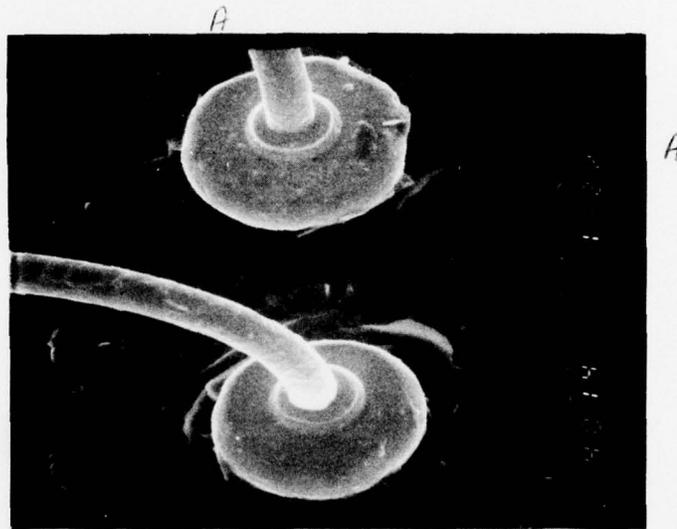
Figure 7.
400 X

X-ray analysis of the discolored ball bond on Q2 (Figure 7), shows major gold (and possibly sulfur), minor silver and trace aluminum.

DEVICE/PART NO. XM-587 Hybrid CUSTOMER B. Goblisch
ENGINEER D.J. Hajicek MODE Secondary and X-ray
FIGURE 7. Q2, ball bonds which were discolored.

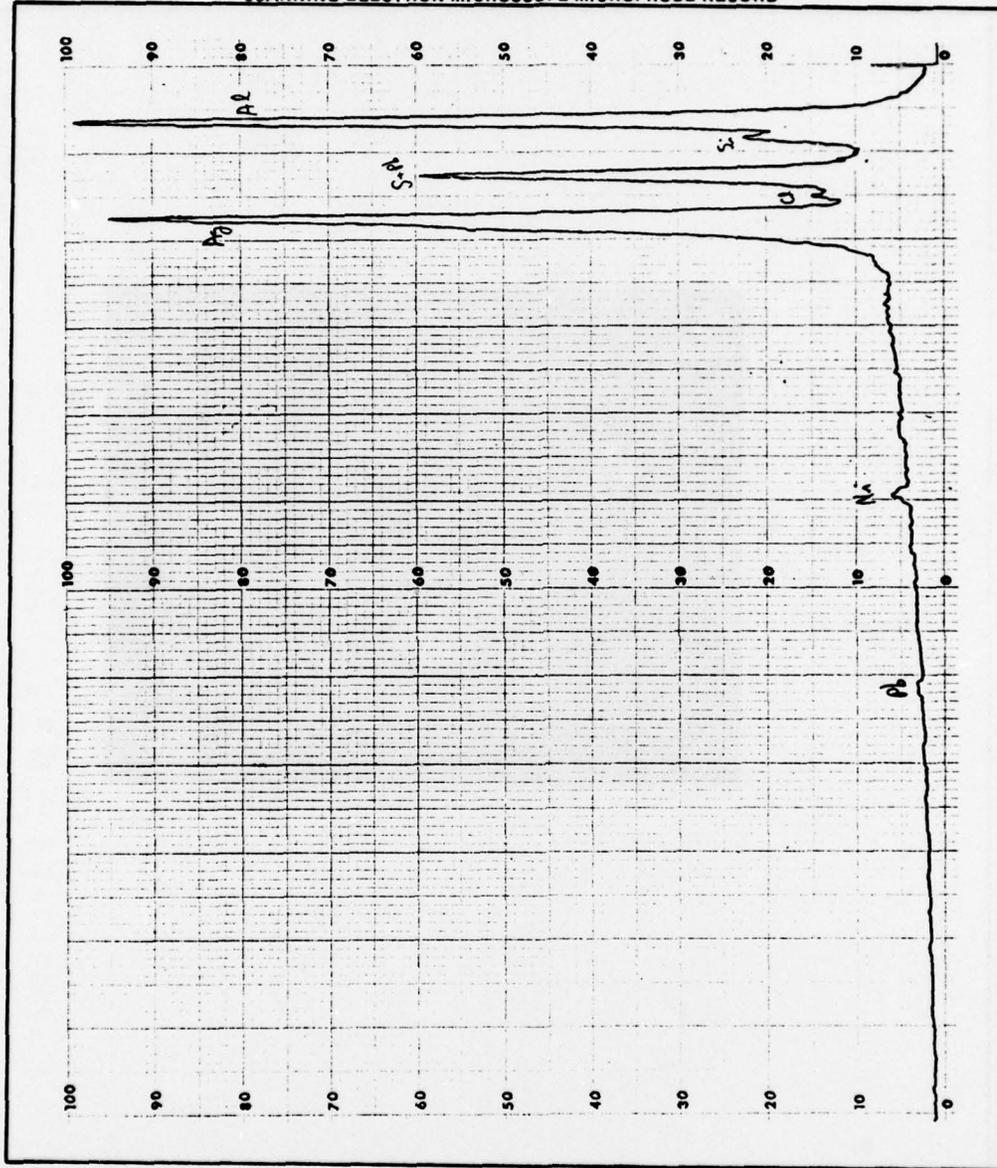
DEVICE/PART NO. XM-587 Hybrid CUSTOMER B. Goblisch
ENGINEER D.J. Hajicek MODE X-ray
FIGURE 8. Analysis of dendrite of Figure 2. 21KV.

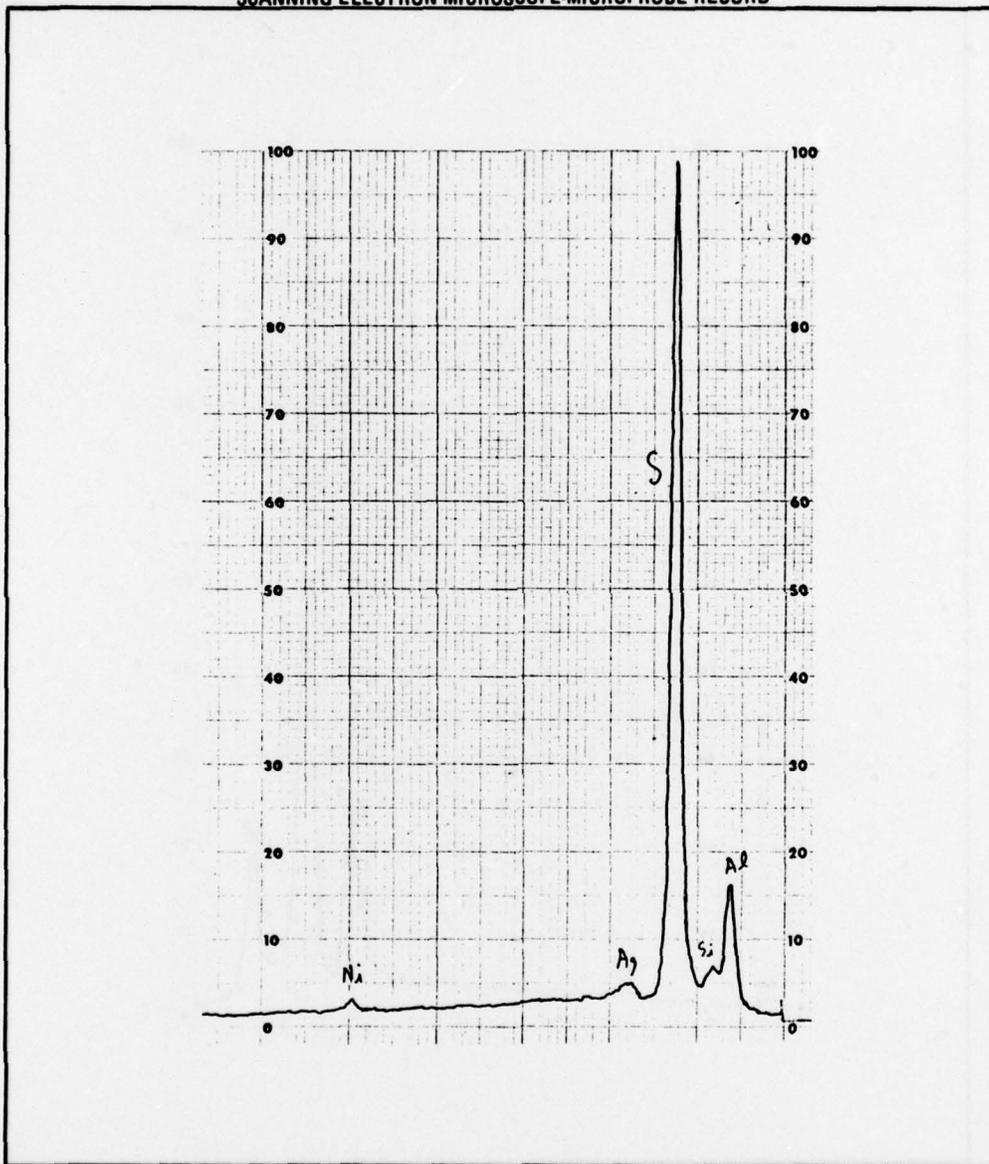
DEVICE/PART NO. XM-587 Hybrid CUSTOMER B. Goblisch
ENGINEER D.J. Hajcek MODE X-ray
FIGURE 9. Analysis of area A on Figure 5.

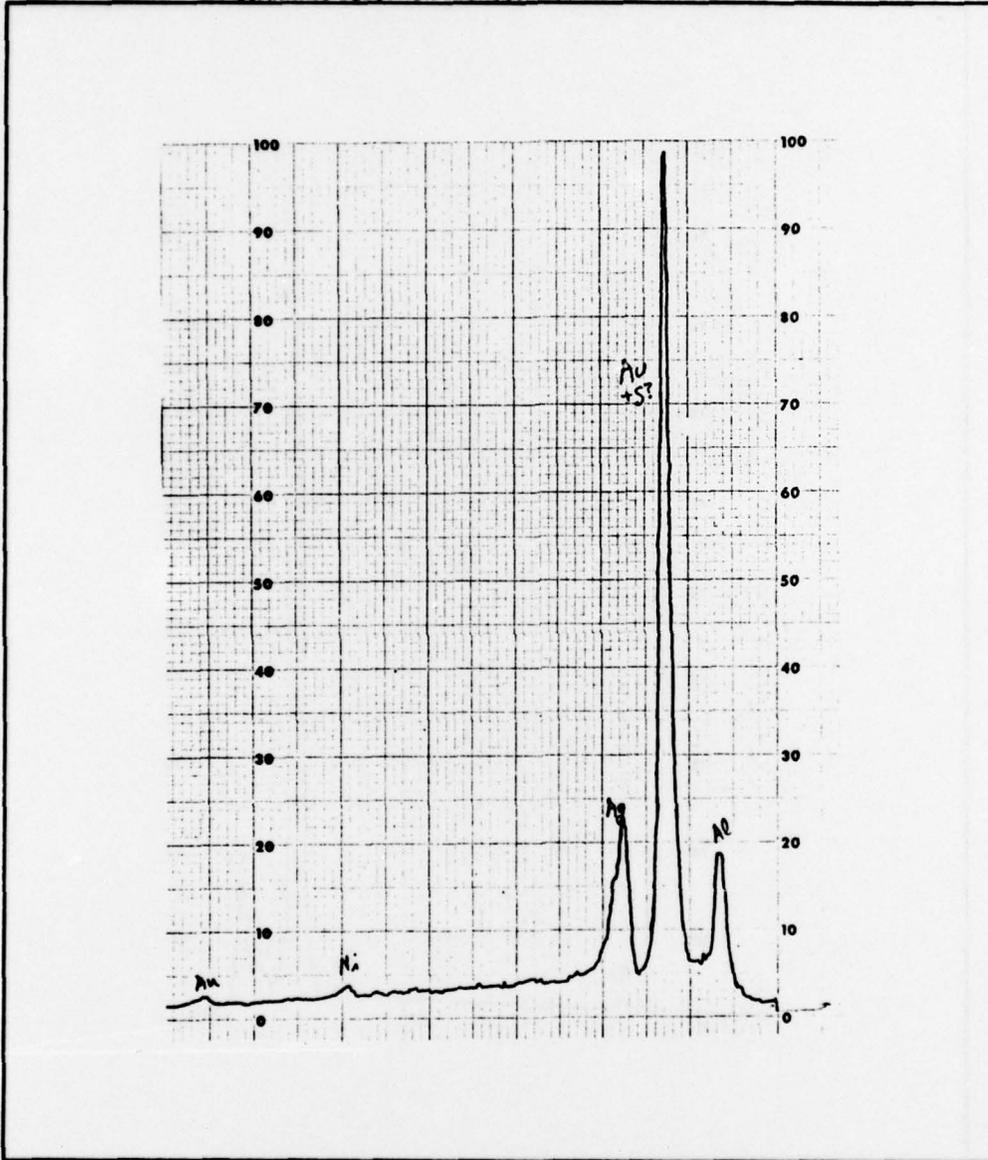
DEVICE/PART NO. XM-587 Hybrid CUSTOMER B. Goblisch
ENGINEER D.J. Hajcek MODE X-ray
FIGURE 10. Analysis of area B of Figure 5.

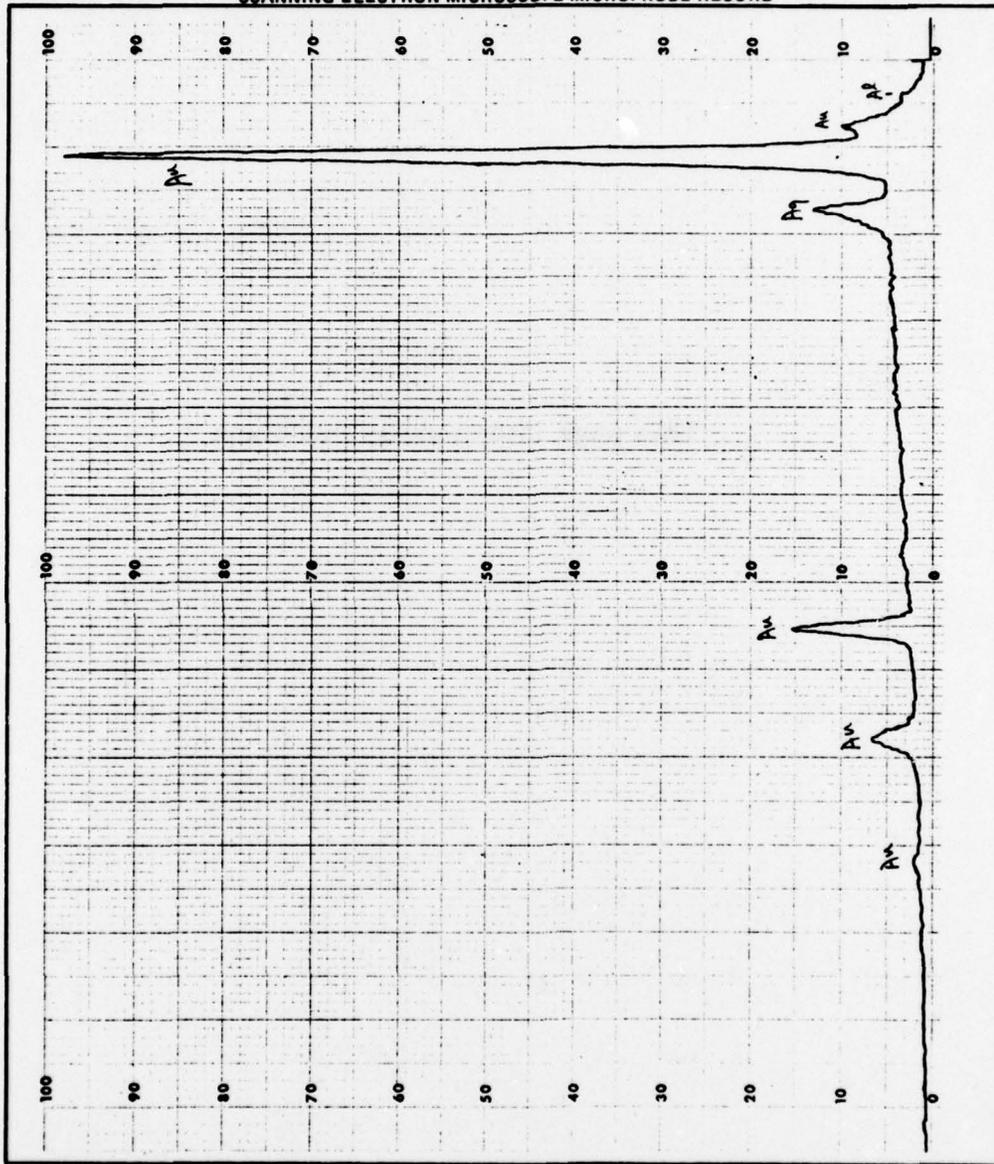
DEVICE/PART NO. XM-587 Hybrid CUSTOMER B. Goblisch
ENGINEER D.J. Hajcek MODE X-ray
FIGURE 11. Analysis of ball bond.

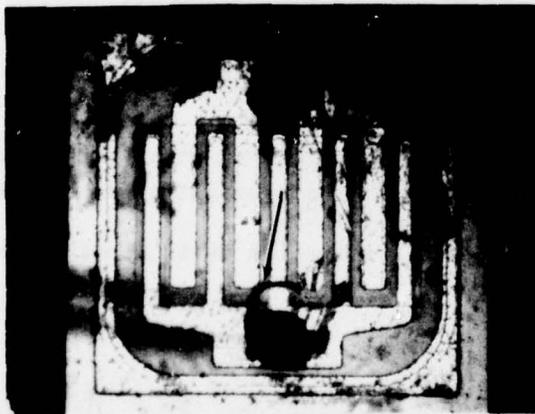
Figure 1 - Mag. 27X

Ball bond lifted off
the CR23 die.
