ACCESSION for E.E.S. Report C-3599-A(1) ATIS White Section ) NS-623-071 000 Butt Section D BWARNOUNCED D U. S. NAVAL ENGINEERING EXPERIMENT STATION JUSTIFICATION. Annapolis, Maryland 27. DISTRIBUTIOR / AVAILABILITY CODES VENGRX STA . C. 3599-A AVAIL. and/or SPECIAL bist. 25 Mar 49 TEST OF PHILIPS MODEL 1/4D EXTERNAL COMBUSTION ENGINE 100501 toublie: Alan R. Schrader Small Diesel Engine Branch קות תחק Internal Combustion Engine Laboratory 16 1978 Approved to Submitted by W. F. Joschim W. D. Legge Captain, USN Superintendent Director I. C. E. Laboratory

A Model 1/4D Philips external combustion engine was delivered 18 May 1943 under Contract NObs-34195 for test. Wariable load tests were conducted and attempts were made to obtain endurance runs. The test operation was generally unsatisfactory due to numerous casualties and to the inadequate delivery capacities of the gasoline nozzle and air compressor. The test of the first engine was discontinued after 86 hours operation. A replacement engine embodying numerous modifications was subsequently furnished for test. It was operated a total of 79 hours. Test operation again was generally unsatisfactory due to numerous minor casualties and

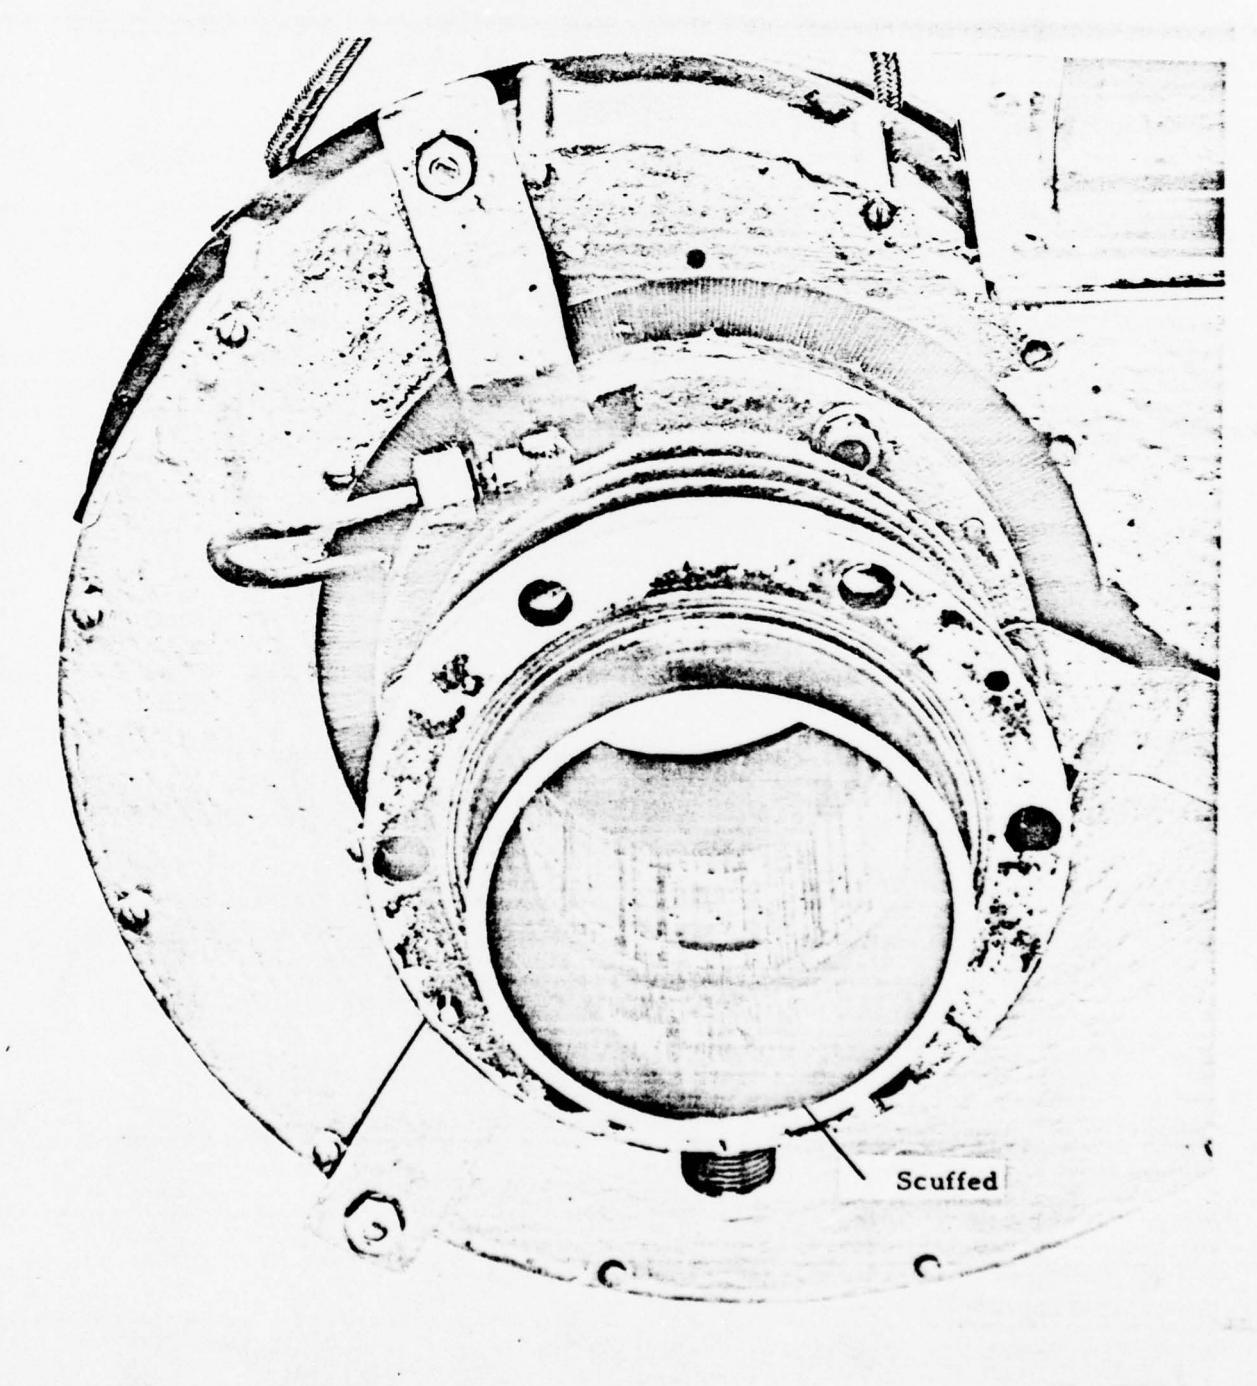
PLATE 3

- (a) The inner race of the crankpin needle bearing was spalled near the edge of the bearing roller travel, Plate 2. The bearing race was replaced by the contractor before re-assembly of the engine.
- (b) The lower end of the cylinder, below the ports, had a scuffed appearance, Plate 3. The damage was not sufficient to indicate the probability of piston seizure.
- 14. A weight analysis of the dry unit follows:

34. The foregoing infers that the rate of wear in the engine may be excessively high, possibly due to inadequate lubrication. No internal disassemblies of the two engines were made following the test operation at this Station. However, the pre-trial condition of the cylinder of the original engine, Plate 3, would indicate that its lubrication was not fully satisfactory. It is pointed out that lubrication in this type engine is a difficult problem in that lubricating oil must be prevented, as far as practicable, from reaching the regenerator or heat transfer surfaces.

# LOWER END OF CYLINDER, PRE-TRIAL INSPECTION ORIGINAL ENGINE
