USARTL-TR-78-11

**ENGINE/AIRFRAME/DRIVE TRAIN DYNAMIC INTERFACE
DOCUMENTATION**

Boeing Vertol Company
P.O. Box 16858
Philadelphia, Pa. 19142

April 1978

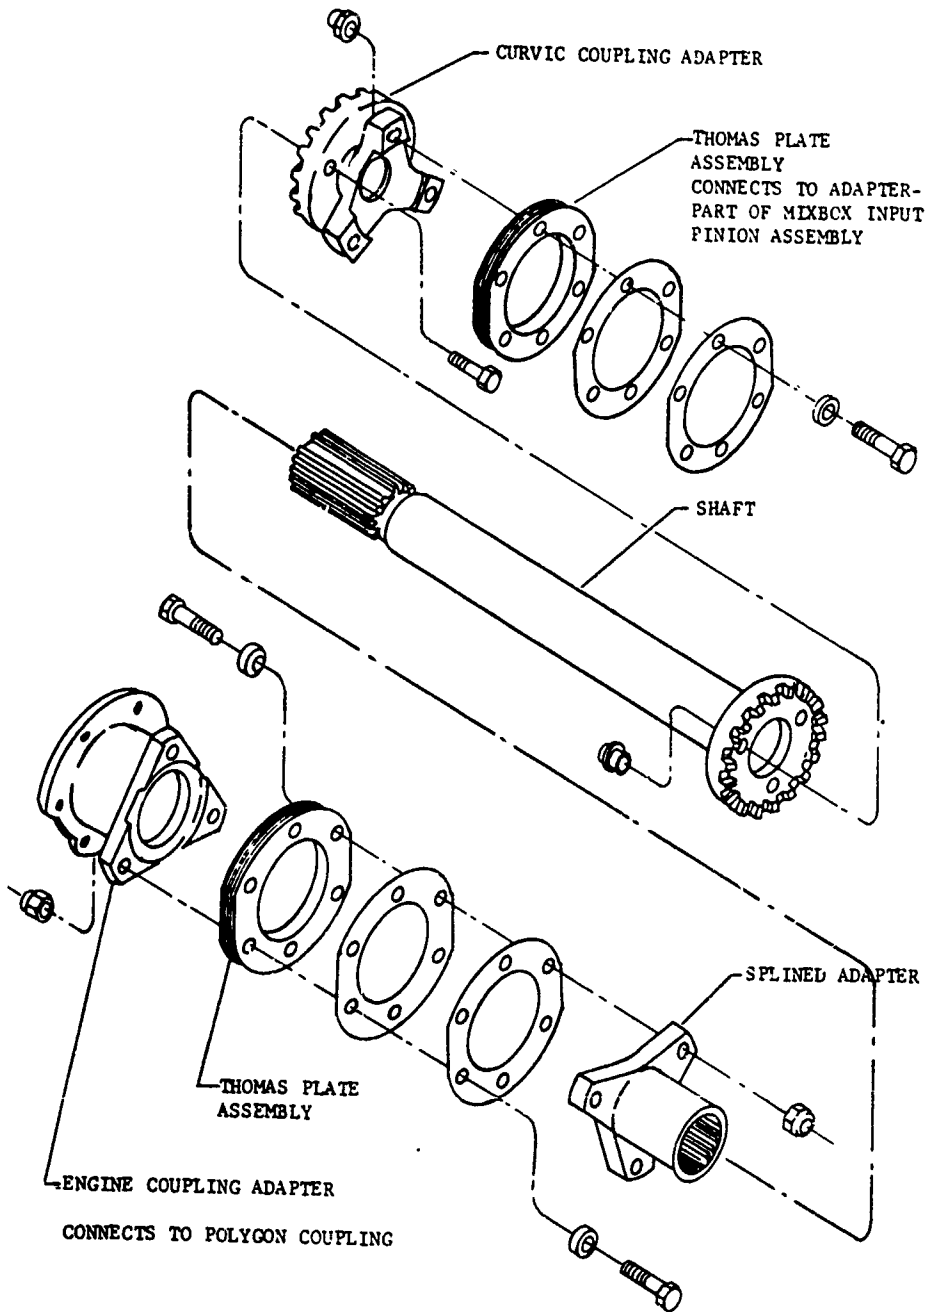
Figure 1. Engine Drive Shaft Assembly.

Despite the care taken in balancing the shaft components and assembly, when the shafts were installed in the aircraft there were numerous instances when the 16g limit was exceeded; there was no straightforward procedure for correcting the condition.

There are five sets of bolts which are part of the rotating shaft assembly: engine coupling adapter to Thomas coupling, Thomas coupling to splined adapter, curvic coupling, curvic coupling adapter to Thomas coupling, and Thomas coupling to input pinion adapter (Figure 1). The investigation of the effect of improper torque applied to some of these bolts constituted the succeeding portion of the test program. Having either one or two of the input pinion adapter bolts undertorqued by 50% had no effect on shaft vibration level as measured at the engine crotch and aft torque tube.

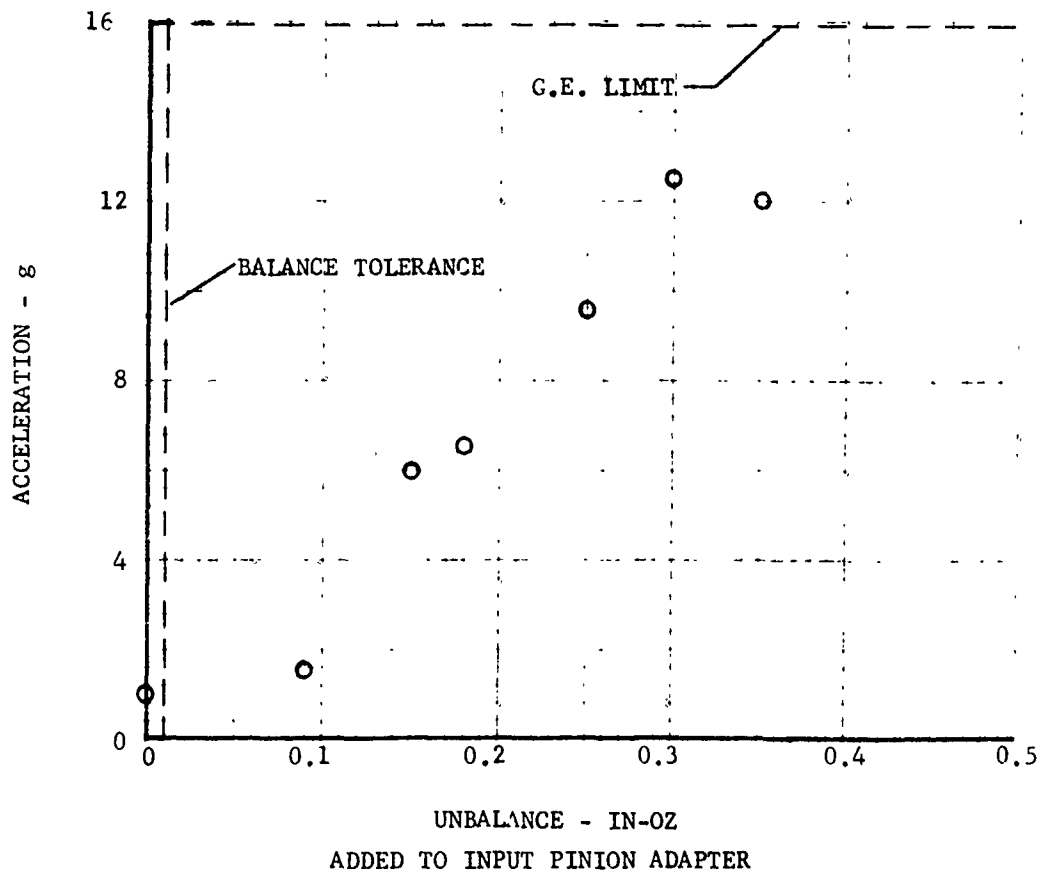
Figure 15. Engine Lateral Acceleration.

With the balanced shaft, the lateral responses at the engine and at the transmission were $+ 1g$ and $+ .5g$. Vertical response at both locations was $+ .25g$. The effects at the engine and at the transmission of unbalancing the shaft at the transmission are shown in Figures 15 and 16. Similar data on unbalance at the engine end of the shaft and at the curvic coupling are shown in Figures 17, 18, 19 and 20. Unbalance at the curvic coupling produced higher "g" levels than unbalance at the other locations.

ENGINE CROTCH LATERAL ACCELERATION WITH
 INCREASED UNBALANCE AT INPUT PINION ADAPTER
 325 CPS

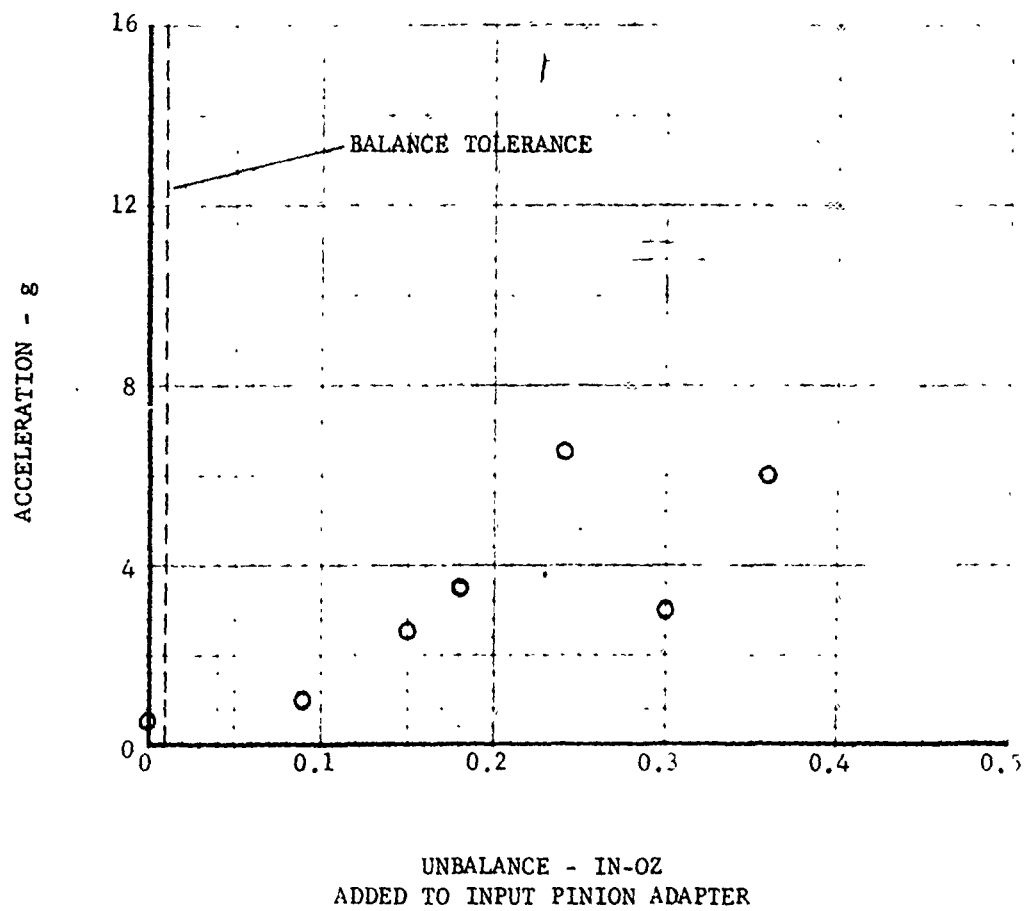
Figure 16. Torque Tube Lateral Acceleration.

AFT TORQUE TUBE LATERAL ACCELERATION
WITH INCREASED UNBALANCE AT INPUT PINION ADAPTER
325 CPS

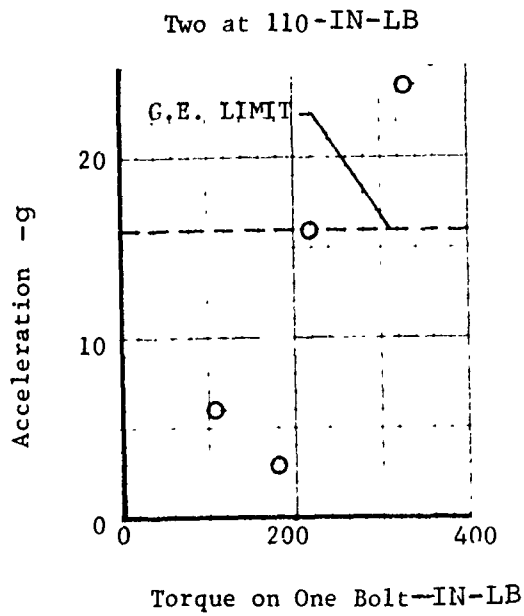
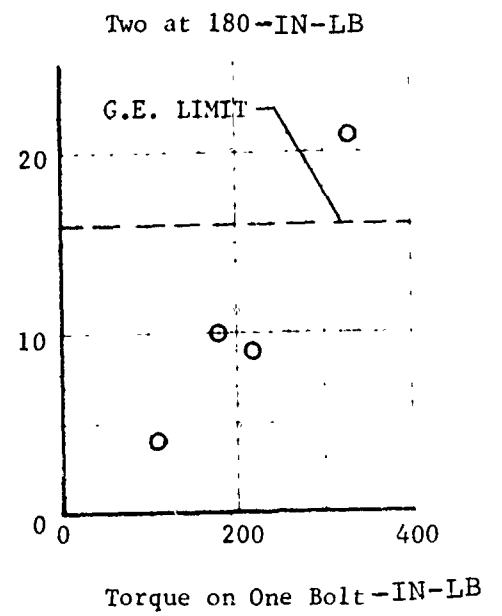
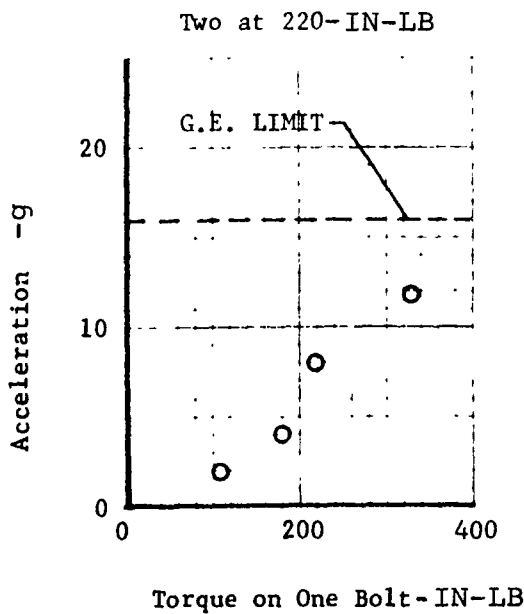
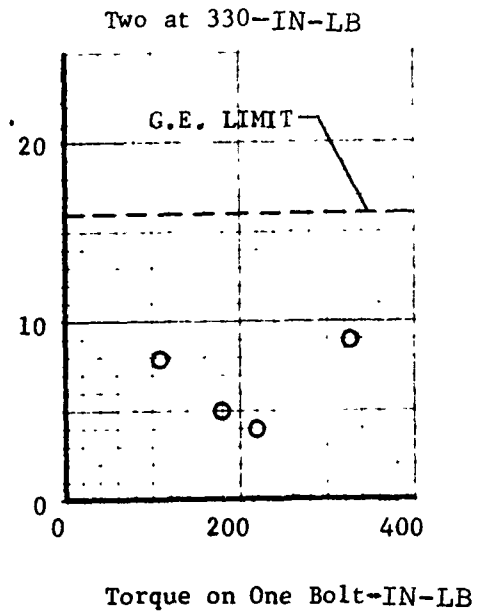
Figure 21. Coupling Bolt Torque Effect,

Unlike the previous couplings, the curvic coupling proved to be very sensitive to changes in bolt torque and torquing sequence. Numerous combinations of torque were evaluated in an attempt to correlate bolt torque with crotch acceleration. Figures 21 and 22 show the results. This one variable can be responsible for the total allowable "g" level.

CURVIC COUPLING BOLT TORQUE EFFECT ON ENGINE CROTCH VIBRATION

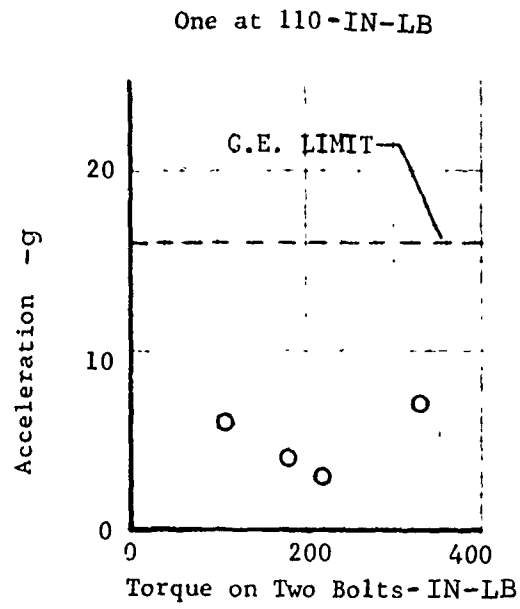
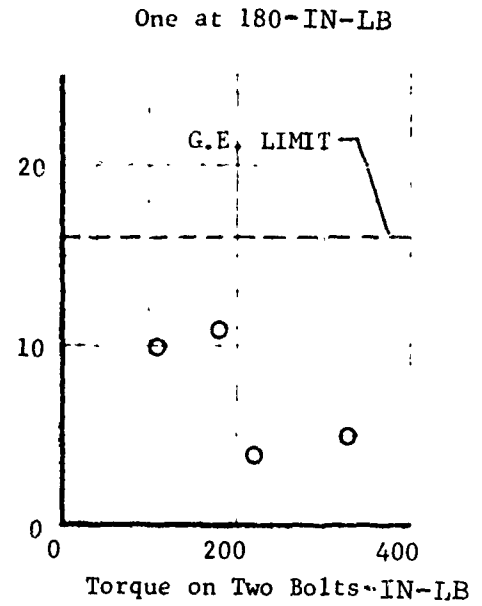
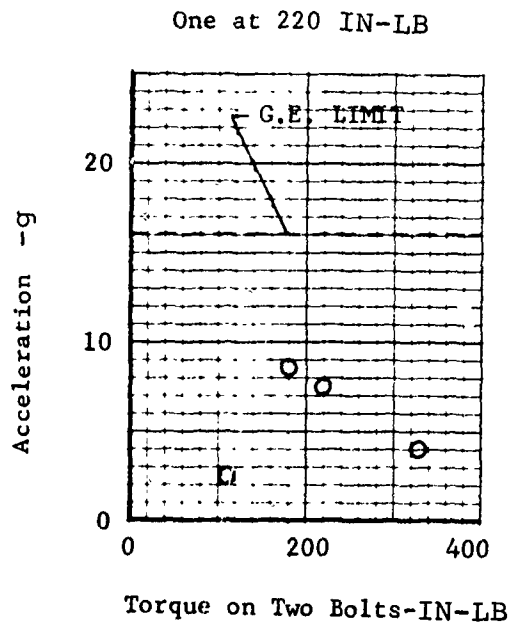
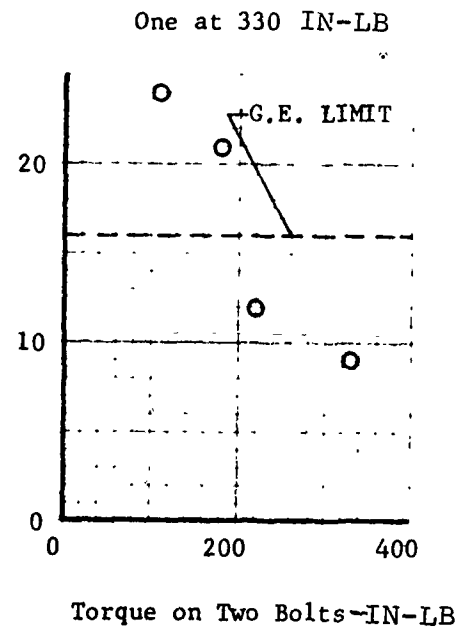
Figure 22. Coupling Bolt Torque Effect.

CURVIC COUPLING BOLT TORQUE EFFECT ON ENGINE CROTCH VIBRATION

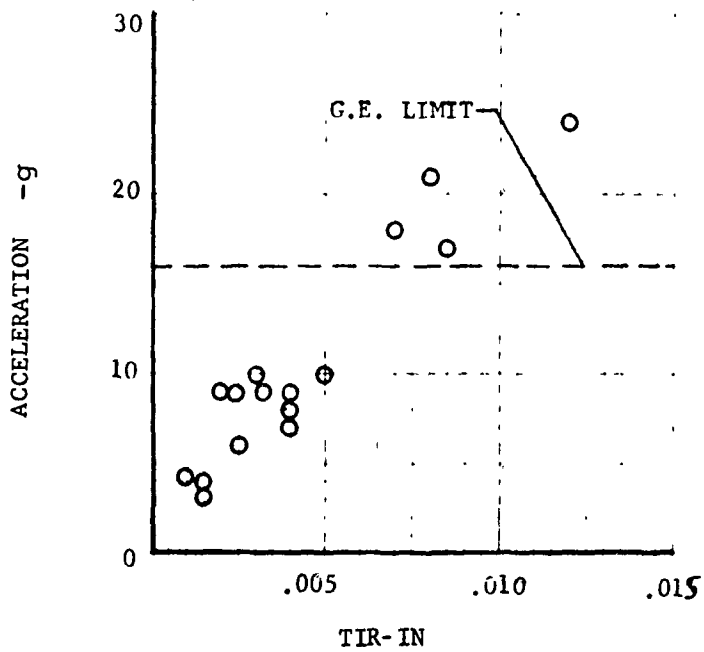
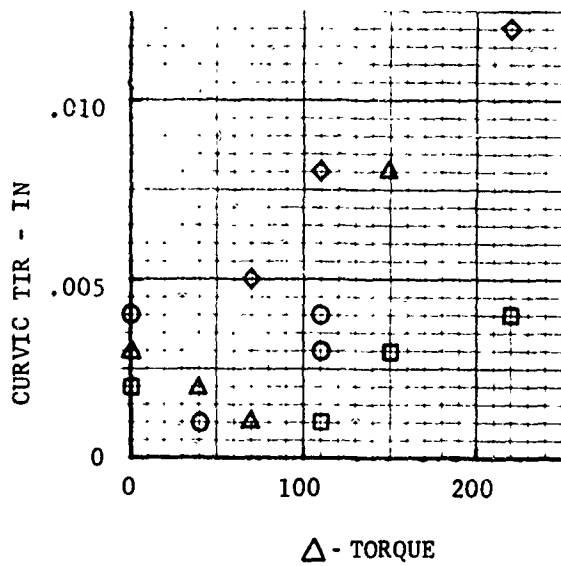
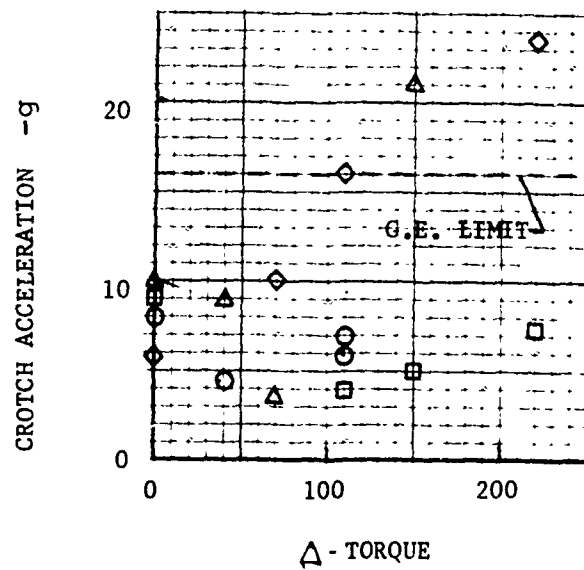
Figure 23. Curvic Coupling TIR vs Vibration.

It was presumed that the torque variations were causing the curvic coupling to cock. If this were true, the TIR as measured at the curvic coupling should be related to the vibration level. Since the TIR at each condition had been recorded, the data was reviewed from this aspect.

A plot of the TIR of the curvic coupling compared with crotch acceleration measured at operating speed is shown in Figure 23. It can be seen that there is a linear relationship, allowing for some degree of scatter, between the vibration and TIR. A TIR of .005 or .006 in. would be sufficient to cause the GE limit to be exceeded. The tolerance at the time of the balancing operation is .004 in.

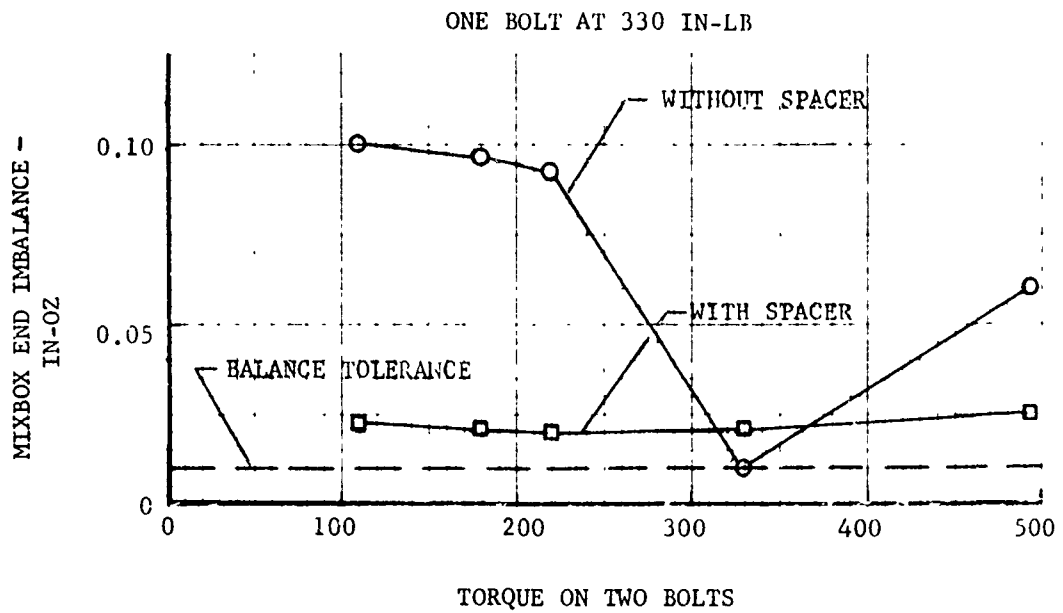
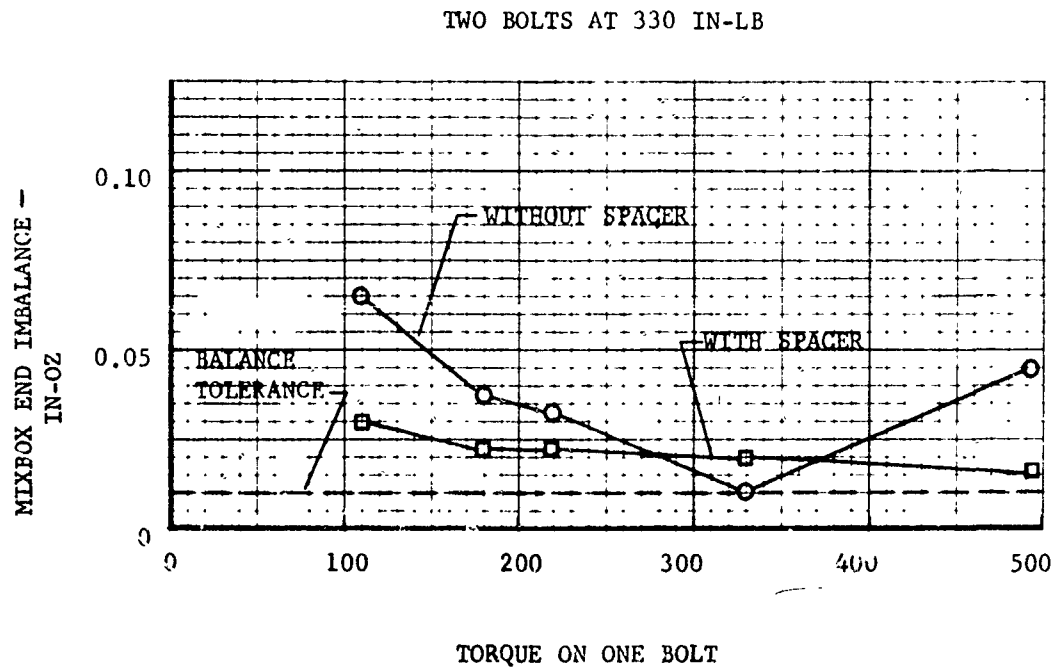
Figure 24. Spacer Evaluation.

CURVIC COUPLING SPACER EVALUATION
BALANCE MACHINE INVESTIGATION
WITH AND WITHOUT SPACER

This arrangement was evaluated on the GISHOLT balance machine and found to be less sensitive to bolt torque, as shown in Figure 24. This was confirmed by tests in the test rig and by ground tests in a flight aircraft (Figure 25).

After the washer was installed in service aircraft, field reports showed that 90% of the shaft order vibration problems were eliminated. Since a supercritical shaft is relatively sensitive, small asymmetric desultory variations which have not been defined could still be present which unbalance the shaft.

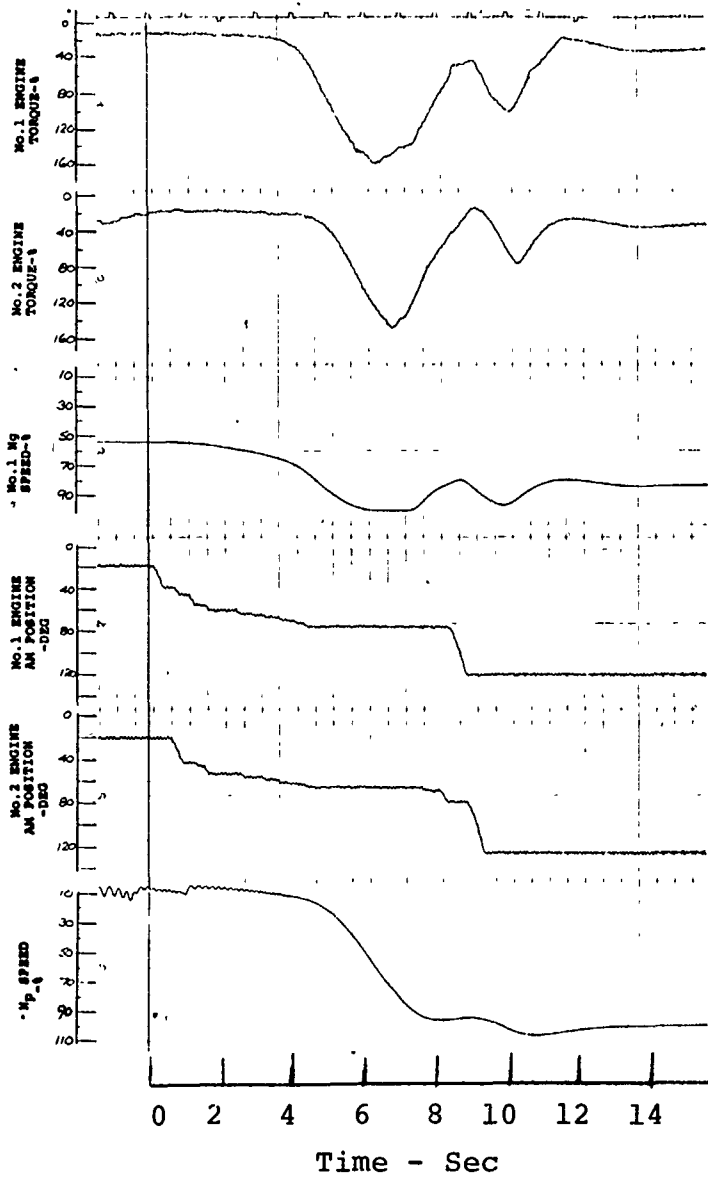
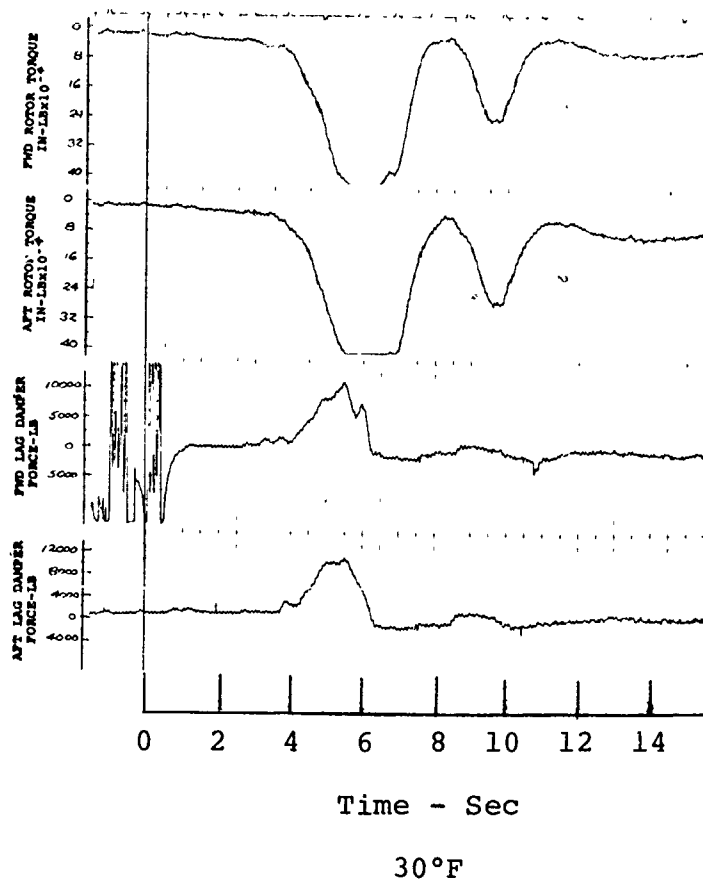
Figure 27. Rotor Startup, 30°F.

Figure 27 shows a rapid rotor startup transient during which three lag dampers were damaged.

The very fast condition lever increase (up to the FLY detent in less than 5 seconds) coupled with the low ambient temperature (30°F) and the low initial rotor speed (10%) contributed to the failure.

It was decided to provide a detent, or gate, between the GI and FLY positions to enable the pilot to accurately dwell at a safe engine power setting, and thereby reduce the possibility of an overtorque. From the data presentation (Figure 28), a detent set at 40° AM position will maintain torque below the continuous twin-engine transmission torque limit of 100% down to 0°F ambient.

In addition, it was required that the rotors be at a speed of 80 rpm (30%) prior to advancing the condition levers from the GI detent. This ensures that the blades develop sufficient CF to eliminate the possibility of overstressing the lag dampers when rotor shaft torque is applied.

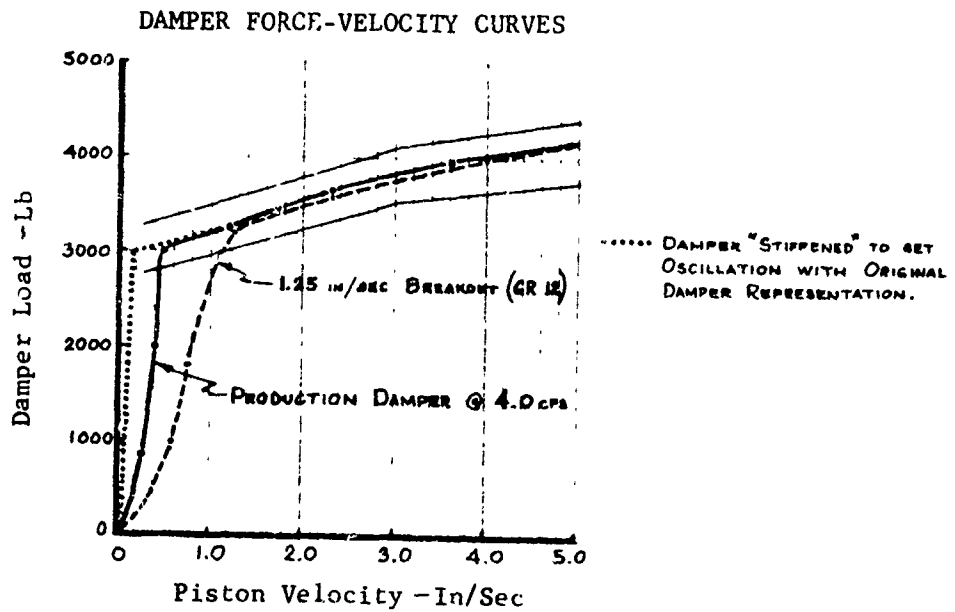
Figure 30. Lag Damper Characteristics.

A ground run was made to investigate the effect of a "softer" lag damper on torque oscillation. Torque instability was reproduced on the computer analysis only by "stiffening" the damper by reducing the preload breakout velocity. Hence, it seemed feasible that a "softer" damper, i.e., one with a higher breakout velocity or a shallower preload slope, might be an effective torque oscillation fix. The standard production dampers reach breakout force at approximately .50 inch per second; the dampers tested in ground run 12 attained breakout force at 1.25 ips (see Figure 30). This was accomplished by means of a small orifice directly across the piston to increase leakage. The pertinent findings from ground running are as follows:

- d. Therefore, the "soft" lag damper fix for torque oscillation is unacceptable due to the degradation of ground stability characteristics.

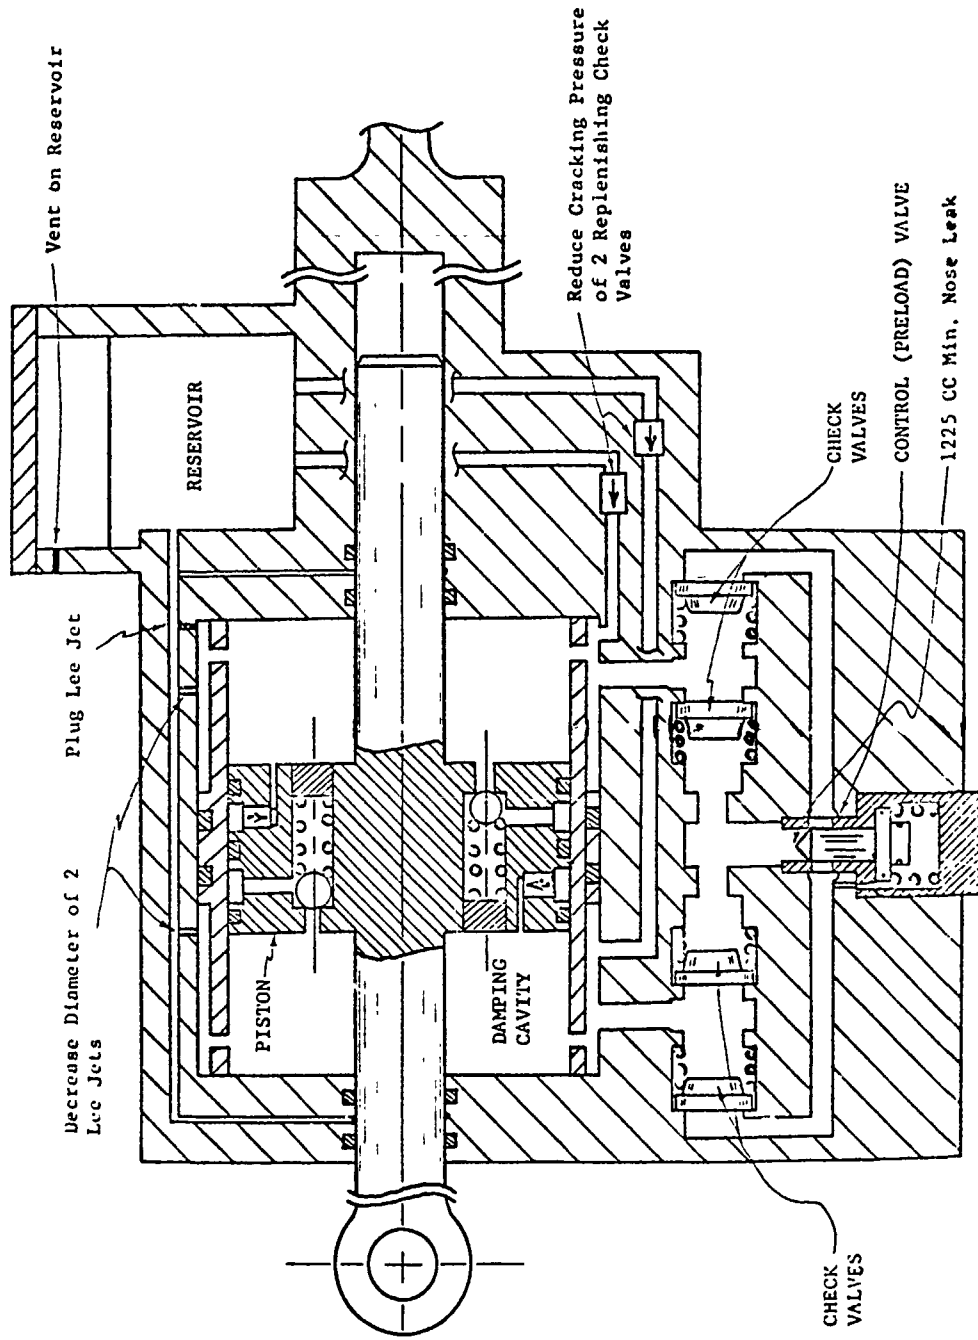
Figure 33. Lag Damper Schematic.

An investigation into the cold temperature operation of the lag damper showed that the decrease in damper force output was apparently due to cavitation caused by flow of hydraulic fluid from the damping chamber into the reservoir, with no replenishing flow of fluid from the reservoir back to the damping cavity. Fluid flow to the reservoir was decreased by plugging one Lee jet and decreasing the diameter of the remaining two, and fluid flow back to the damping chamber was improved by reducing the cracking pressure of the two replenishing check valves from 5 psi to 3 psi. The resulting damper configuration provided satisfactory damping output down to -65°F (see Figure 33).

A set of fuel controls with 70% gain and .10 sec time constant were flown with lag dampers which incorporated these low temperature modifications.

- a. No torque oscillation was audible to the pilot or crew. Recorded data showed that maximum alternating torques were \pm 1.8% on No. 1 engine and \pm 2.0% on No. 2 engine.
- b. Vigorous collective pitch pulses yielded alternating torques of \pm 4% on both engines, which were quickly damped.
- c. A rotor speed droop of 4 rpm was experienced during rapid collective inputs.

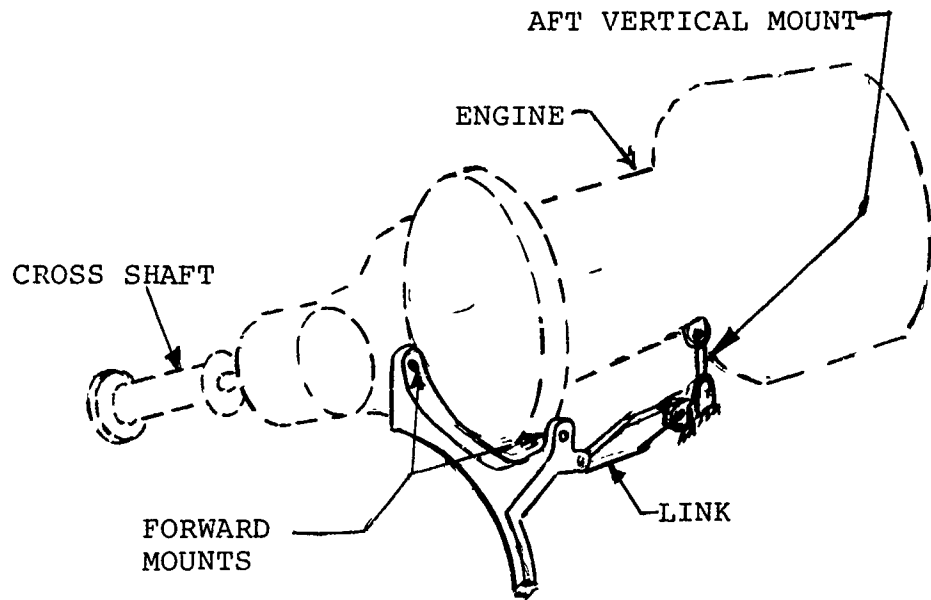
Figure 34. Engine Mount Schematic.

In August through October 1970, a flight vibration and strain survey of the engine was conducted. A CH-47C engine was instrumented with accelerometers and strain gages. Rpm and speed sweeps were made in the basic configuration and with modifications. The engine mount (Figure 34) consists of two forward engine mounts, both of which react vertical and longitudinal loads (one of which also reacts lateral loads), and a vertical link at the aft end which reacts vertical loads only. To brace the forward outboard engine mount support, a link connects the forward outboard engine mount to the fuselage structure aft of the forward mounts.

The rotor rpm sweeps showed no specific trend in accelerations or stresses except that the No. 1 engine drag link 3/rev loads nearly doubled in going from 230 to 250 rpm.

Because of this large change, it was felt that a change in stiffness might be significant. The production drag link is made from aluminum alloy. It was replaced with a steel link. This resulted in nearly halving the No. 1 engine drag link load at high airspeeds (the No. 2 engine link load which was low with the aluminum link did not change).

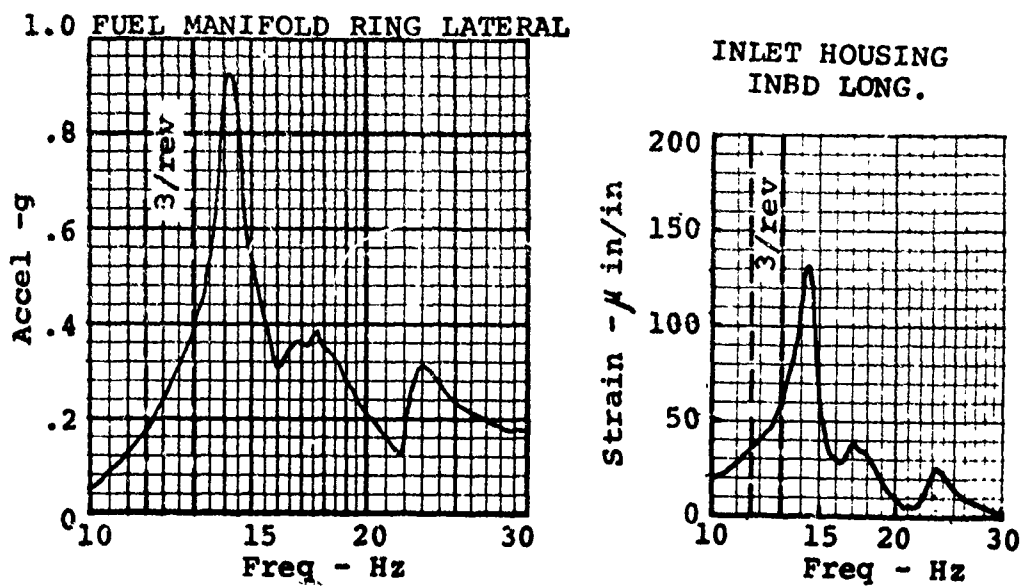
Figure 35. Baseline Engine Vibration,

Lateral shaking forces were applied to an engine installed in a CH-47 helicopter. The engine responded as a rigid body at 14.2 Hz causing high inlet housing strains near the engine mounting pads where the service revealed cracks had occurred. Figure 35 shows frequency sweep results in accelerations at the fuel manifold and the strain at the inlet housing.

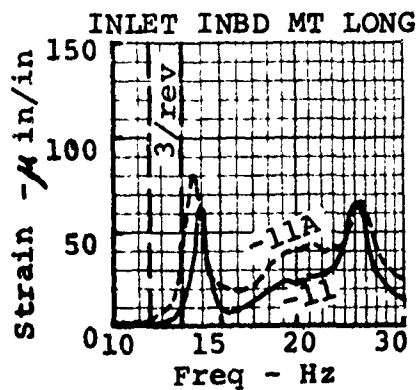
Figure 38. T55-11 Compared to T55-11A.

Growth of the -11 engine to the -11A configuration increases the engine weight 40 pounds. The effect of additional weight and inertia on the yaw mode is to lower the natural frequency 0.39 Hz. Moving the yaw mode closer to the 3/rev frequency results in a significant increase in the inlet housing strains (Figure 38).

Inlet Housing Mount	-11 @ 3/rev	-11A @ 3/rev
Outbd Long.	30 in/in	65
Outbd 45°	30	70
Outbd Vert.	5	25
Inbd Long.	15	40
Inbd 45°	25	60
Inbd Vert.	10	25

- T55-11A ENGINE WEIGHS 40 POUNDS MORE THAN THE T55-11.

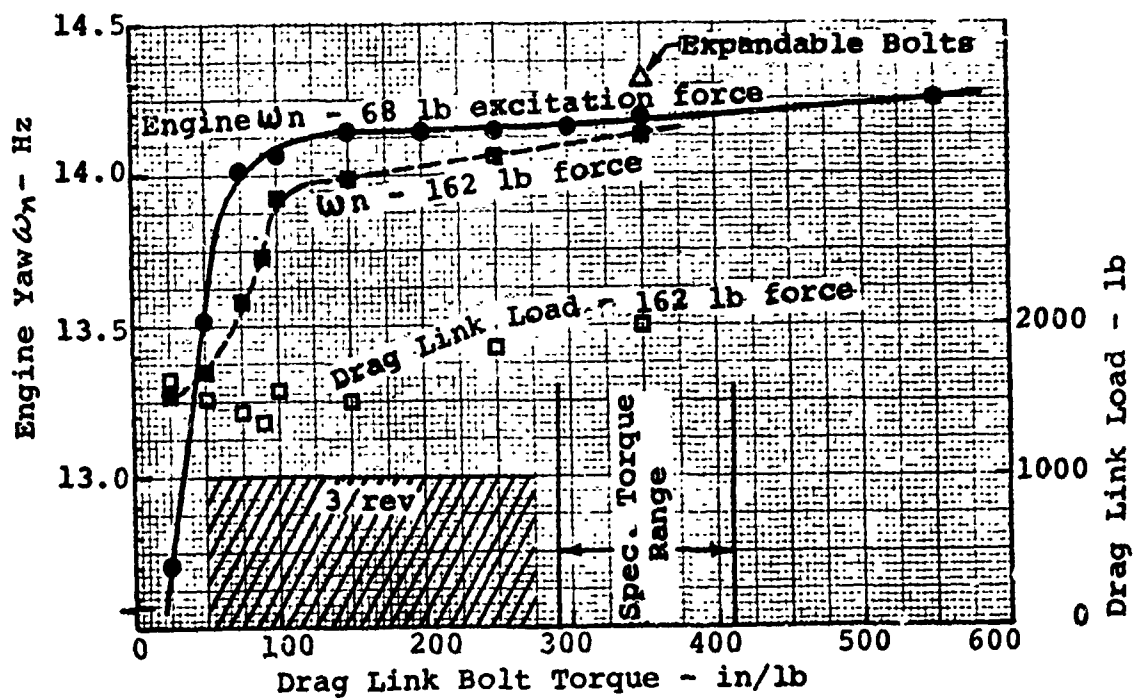
Figure 39. Effect of Drag Link Bolt Torque.

Lowering of the drag link bolt torques from specification values to below 100 in/lb causes a significant reduction in the yaw mode frequency (Figure 39).

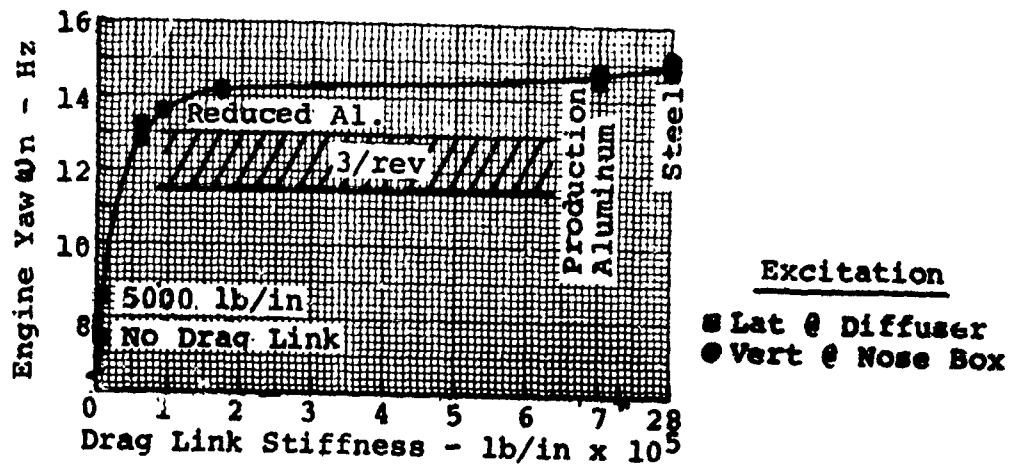
Figure 40. Effect of Drag Link Stiffness.

Reducing drag link stiffness can lower the yaw mode frequency well below 3/rev. With no drag link the frequency drops to 7.5 Hz. A large stiffness increase with a steel drag link raises the modal frequency only slightly (Figure 40).

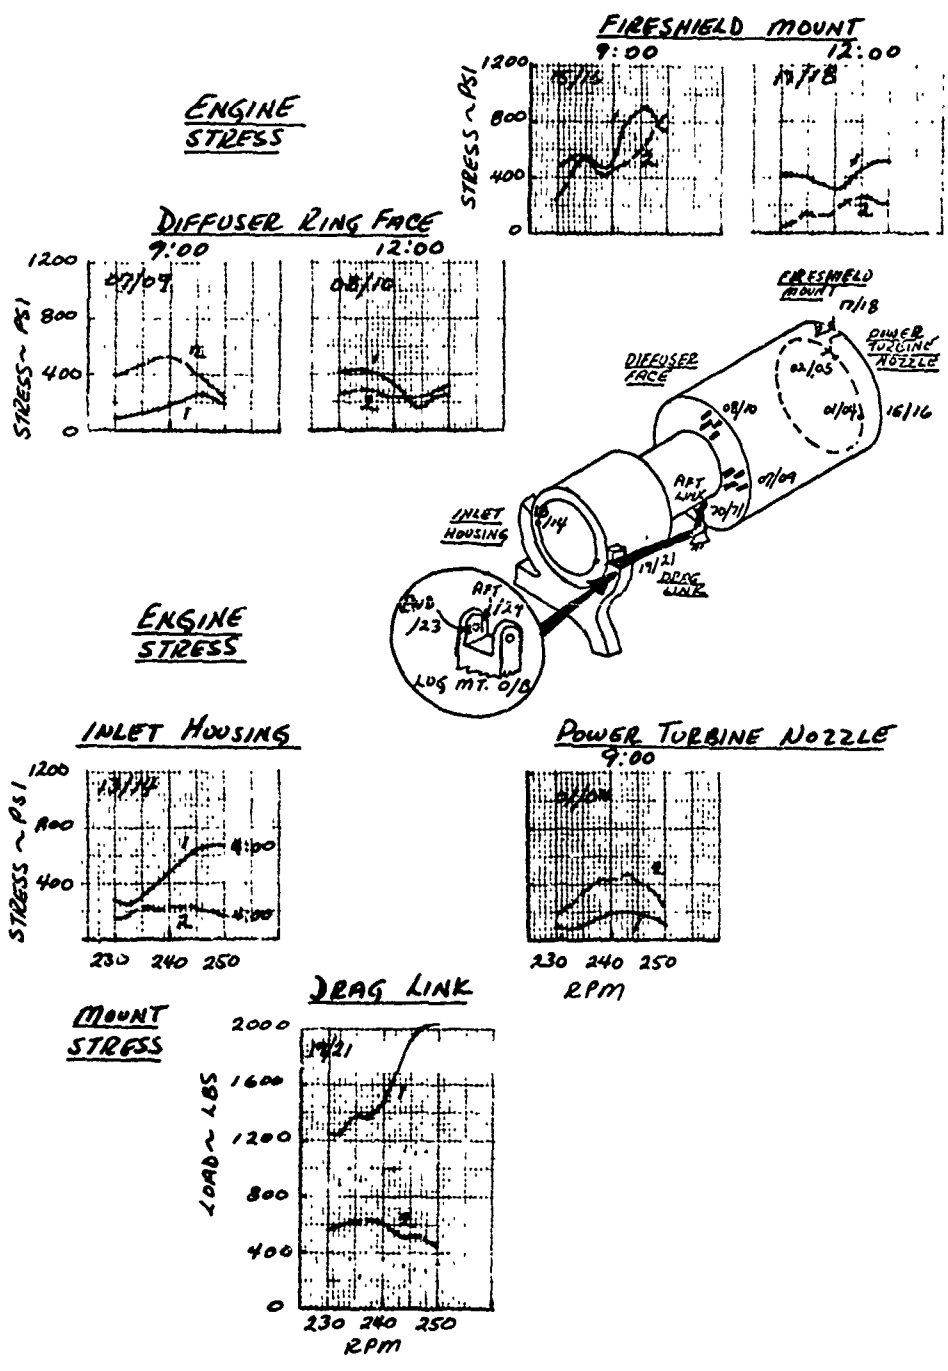
Figure 42. Baseline 3/Rev Stress vs RPM.

During the flight vibration/stress survey there were significant differences in the vibration/stress levels between the two engines. Figure 42 shows a comparison in the baseline configuration.

FLIGHT DATA ENGINE NO. 1 COMPARED TO ENGINE NO. 2
 GROSS WEIGHT = 35,500 POUNDS, SPEED = 151 KTAS

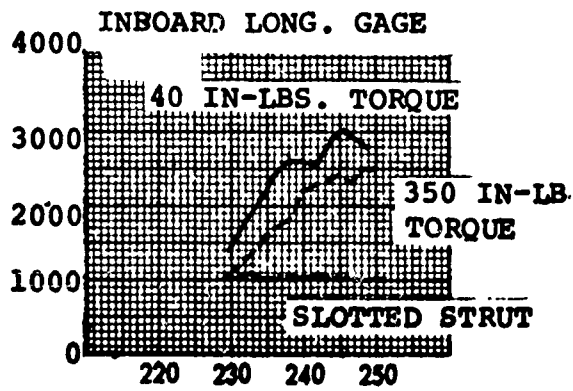
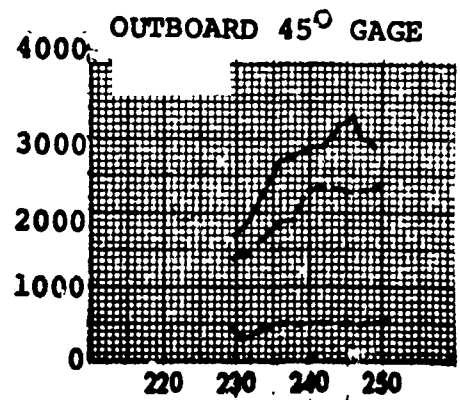
Figure 43. Inlet Housing Stress.

A set of these slotted drag struts was evaluated in a flight program. The results are shown in Figures 43 and 44. The No. 1 engine inlet housing 3/rev stress levels, the prime component of the absolute stresses, show as much as a 90% reduction at the higher rotor speeds with the installation of the slotted drag strut. The slotted drag strut does not produce increases in vibration from other prime rotor harmonics (1, 6, 9, 12/rev). The 7.5 Hz yaw mode does not produce any significant 3/rev engine response during start procedure (150 rpm). No rise in stresses occurred when the slot bottomed. (Probably no severe bottoming occurred.) The slotted drag strut eliminates yaw mode effect on 3/rev engine response.

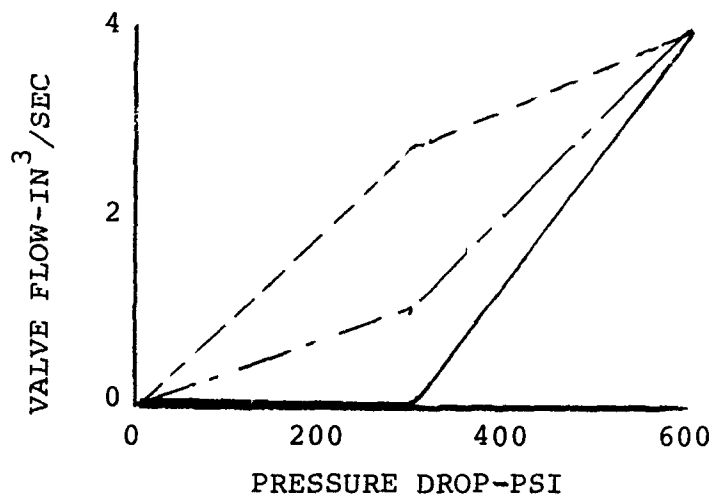
Figure 59. Lag Damper Valve Characteristics,

- (a) ——— NORMAL
- (b) - - - .000613 IN²
VALVE AREA AT
300 PSI
- (c) - - - .001871 IN²
VALVE AREA AT
300 PSI

As a result of these analyses, the engine controls were modified to include a nominal lag of .5 sec to provide acceptable transient behavior. The blade lag dampers were modified to provide additional leakage across the piston at low force levels to provide damping to eliminate oscillations.

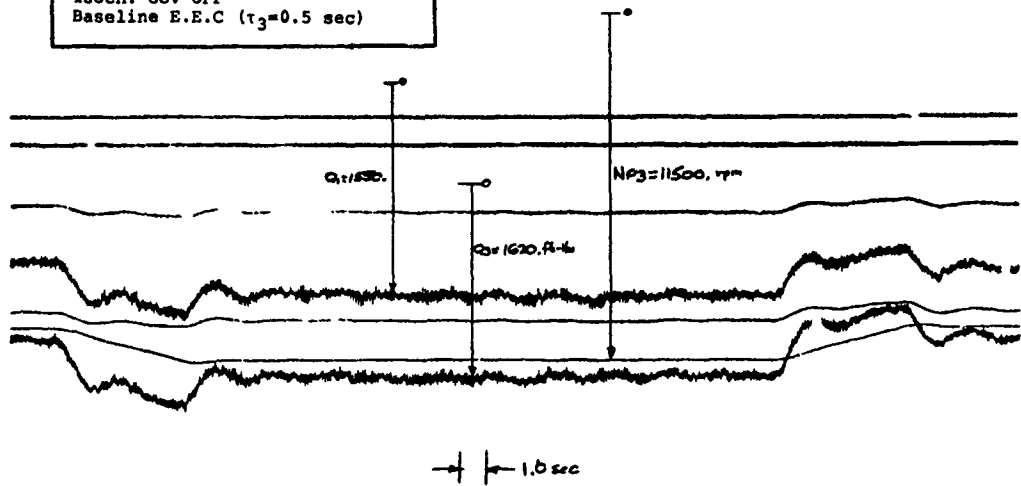
A master beeper increase/decrease transient, with the $T_3=0.5$ sec lag compensation baseline DSTR system at high power, is presented on Figure 65. The relatively slow oscillatory nature of the transient at about 0.4 Hz is apparent.

Figure 65. Master Beeper Transient, Baseline
 ($T_3 = .5$ Sec).

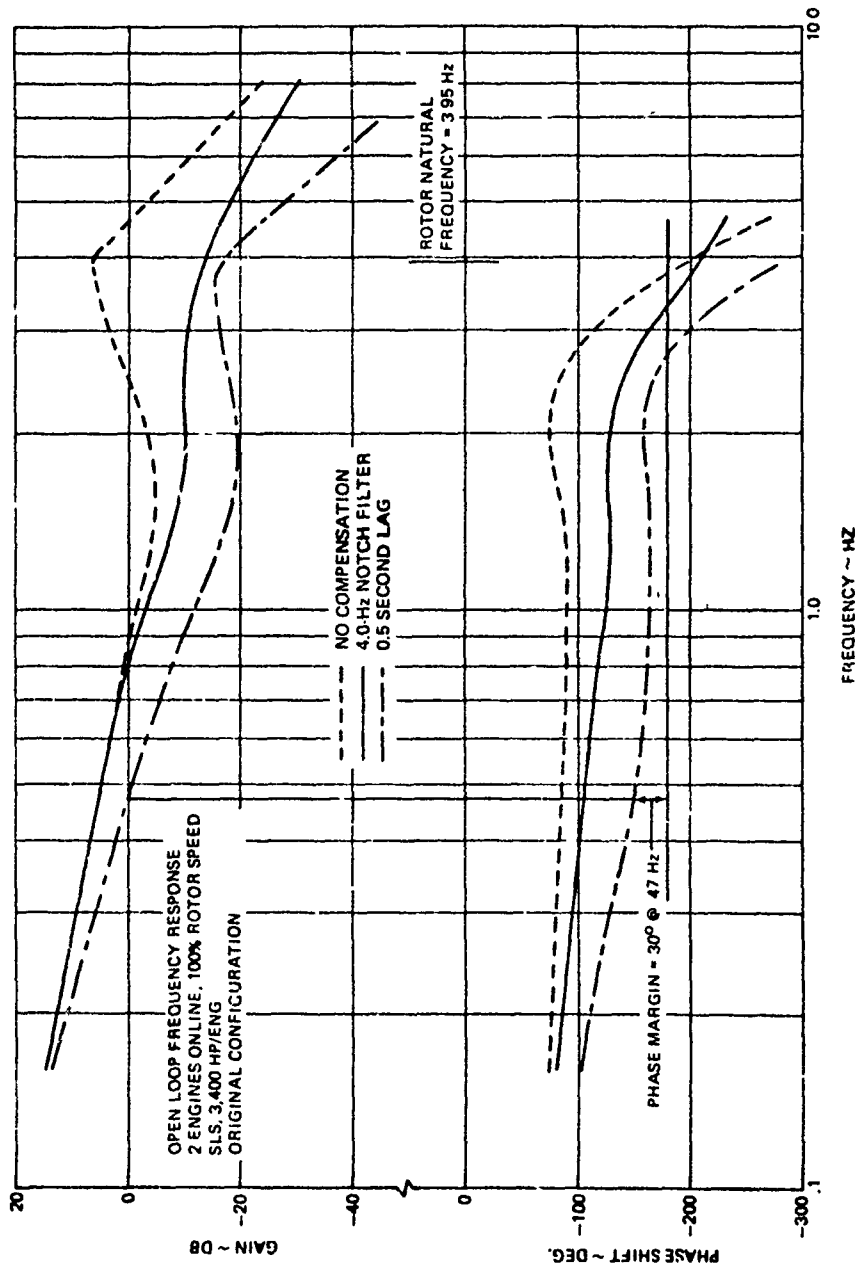
First order lag compensation of 0.5 sec can adequately reduce the gain near rotor drive resonance to a peak of -16 dB as shown in Figure 68. But the additional phase shift at gain crossover associated with this lag, reducing the phase margin to 30 degrees, causes a tendency toward slow response and underdamped low frequency fluctuations (0.47 Hz).

Figure 68. Effect of Compensation on Open Loop Frequency Response.

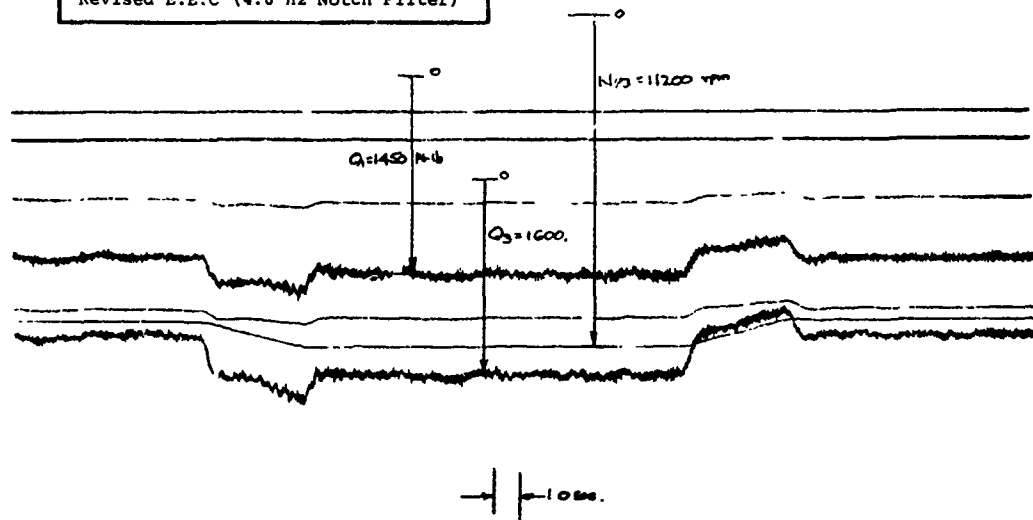
Figure 72 shows a master beeper transition with the notch compensation tuned at a frequency of 4.0 Hz. Stability is good and compares favorably with the 3.0-Hz configuration. There is, however, a slight tendency to oscillate at about 3.0 Hz, indicating that this compensation is approaching the upper allowable limit.

Figure 72. Master Beeper Transient, 4.0 Hz Notch Filter Compensation.

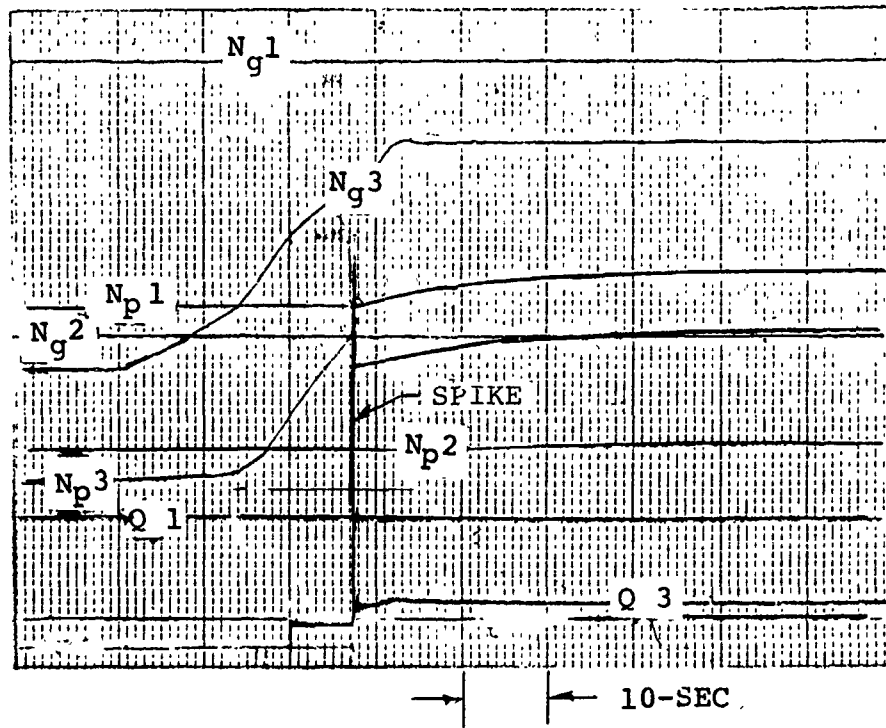
During DSTR checkout on 28 and 30 August 1974, there were two incidents that highlighted the existence of high levels of alternating torque in the drive system. The first incident was a delayed engagement on the No. 3 engine, where the clutch engaged with a 1000 rpm split between the engine input speed and the drive system. This caused a severe torque spike and was subsequently shown to be due to clutch wear. The second incident was a complete disengagement of the No. 3 clutch and consequently an automatic overspeed shutdown on the No. 3 engine; the engine overspeed protection system prevented any secondary damage. These events are shown on Figures 78 and 79.

Figure 78. DSTR Engine Engagement and Torque Spike.
