USARTL-TR-78-11

**ENGINE/AIRFRAME/DRIVE TRAIN DYNAMIC INTERFACE
DOCUMENTATION**

Boeing Vertol Company
P.O. Box 16858
Philadelphia, Pa. 19142

April 1978

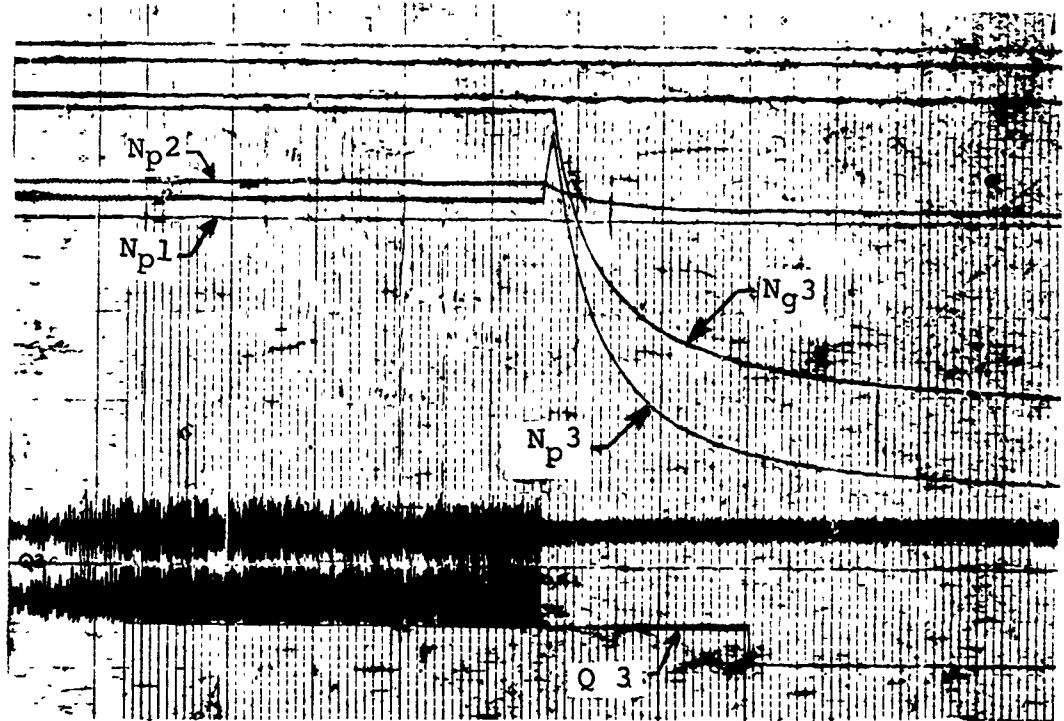
During DSTR checkout on 28 and 30 August 1974, there were two incidents that highlighted the existence of high levels of alternating torque in the drive system. The first incident was a delayed engagement on the No. 3 engine, where the clutch engaged with a 1000 rpm split between the engine input speed and the drive system. This caused a severe torque spike and was subsequently shown to be due to clutch wear. The second incident was a complete disengagement of the No. 3 clutch and consequently an automatic overspeed shutdown on the No. 3 engine; the engine overspeed protection system prevented any secondary damage. These events are shown on Figures 78 and 79.

Figure 79. DSTR Clutch Disengagement and Overspeed.

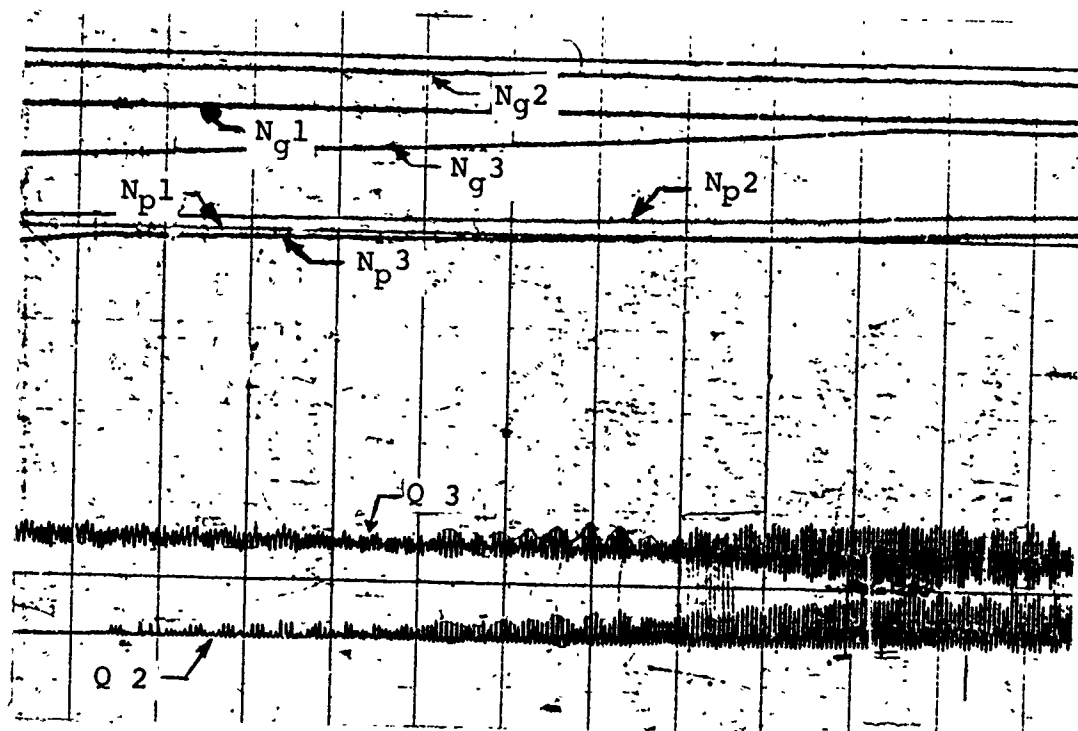
Inspection of all three clutches showed extensive clutch sprag wear, while review of oscillograph records showed large amplitude alternating torque. Figure 80 illustrates the characteristics of the torque oscillation with one and then two engines driving. With one engine (No. 2) driving the rotor at approximately 130 rpm, the No. 2 engine torque was 1315 lb-ft steady with a + 125 lb-ft alternating content at approximately 20 Hz. As the second engine (No. 3) was brought on line, the rotor speed increased to 140 rpm with the No. 2 engine torque at 1250 lb-ft steady + 360 lb-ft alternating; the frequency remained at approximately 20 Hz with a 90° phase shift between engines. Because of the low level of positive torque experienced during each cycle, it is likely that the intermittent engaging of the No. 3 clutch resulted in its failure.

It was concluded that a resonance in the drive system was excited by the engine torque output which, in turn, was forced by the fuel control oscillation. Since elements of the dynamic system were tuned close to a single frequency, each

Figure 80. DSTR Torque Oscillation with One and Two Engines.

component tended to oscillate at an amplitude greater than it would as a separate unit due to the magnification effect at resonance and various direct and indirect feedbacks.

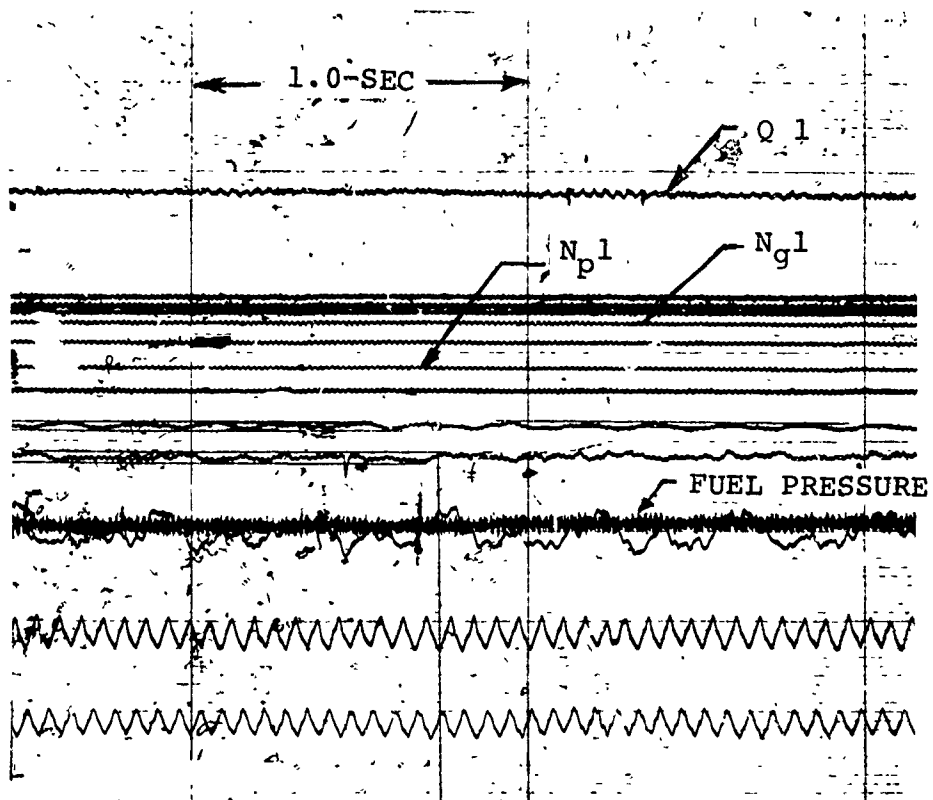
Further DSTR testing on 11 September was directed toward evaluating the effectiveness of an accumulator in the fuel pump discharge to damp the torque oscillations to a level acceptable for continued DSTR operations. The 15-cubic-inch flow-through accumulator tested during engine development was installed on No. 1 engine. The results (Figure 82) showed that the 17-20 Hz oscillation was effectively eliminated, though fuel manifold pressure did show a ± 12 psi high frequency content (approximately 230 Hz) corresponding to 1/rev of the gas generator. Maximum torque variation was ± 15 lb-ft and was random at a power output of 3370 hp (1753 lb-ft torque).

Figure 82. DSTOR Torque Oscillation Investigation with 15-Cubic-Inch Accumulator.

As a result, accumulators were installed in each engine position with satisfactory results. It was found that it was necessary to maintain the charge pressure on the accumulator at close to the recommended 275 psi; otherwise, the torque oscillation would reappear.

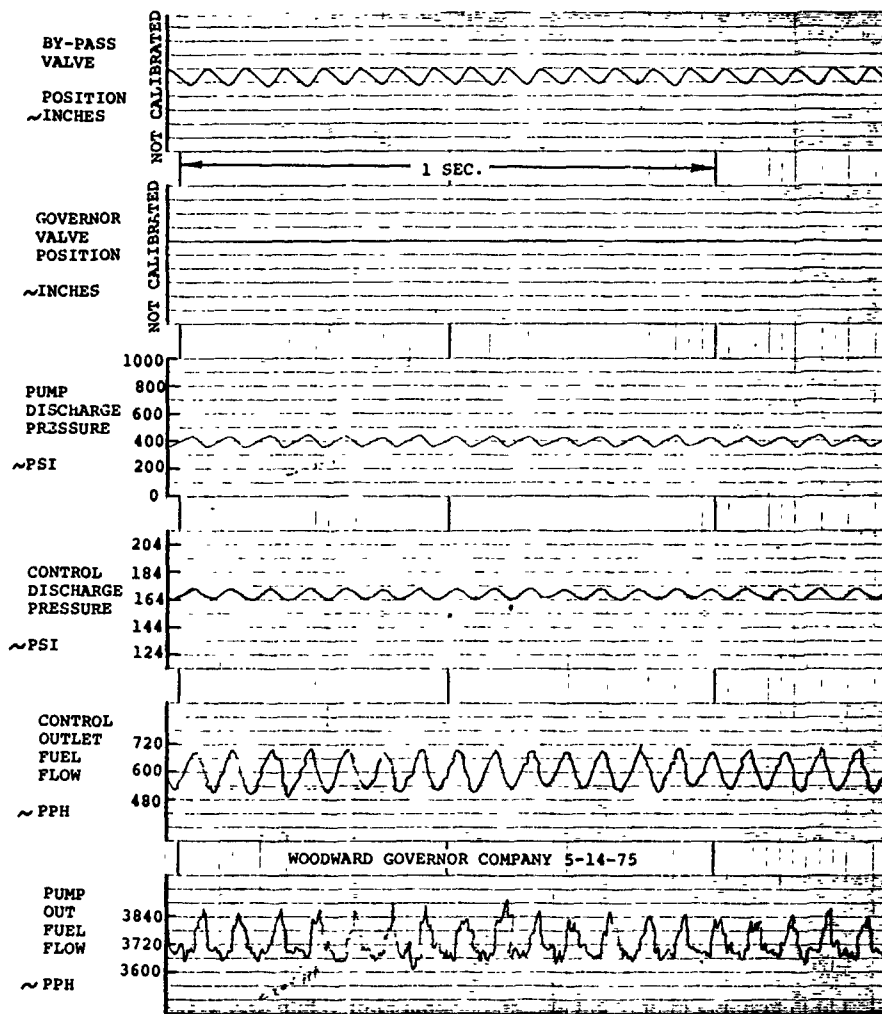
Figure 83 shows that a DSTR control plus DSTR pump exhibits 15 Hz oscillation, while Figure 84 shows that a DSTR control with a flight engine pump and plumbing is stable.

Figure 83: 15-Hz Oscillation DSTR Control with DSTR Pump,

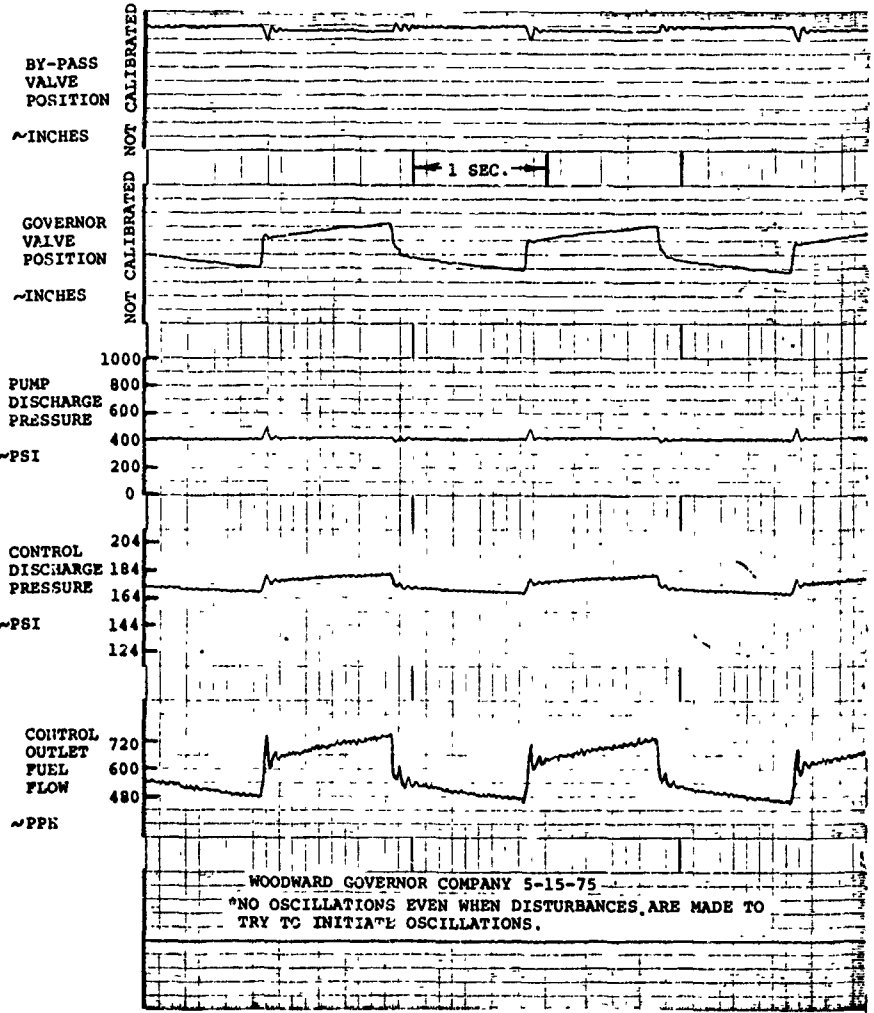
Figure 84. DSTR Control with Flight Engine Pump and Plumbing.

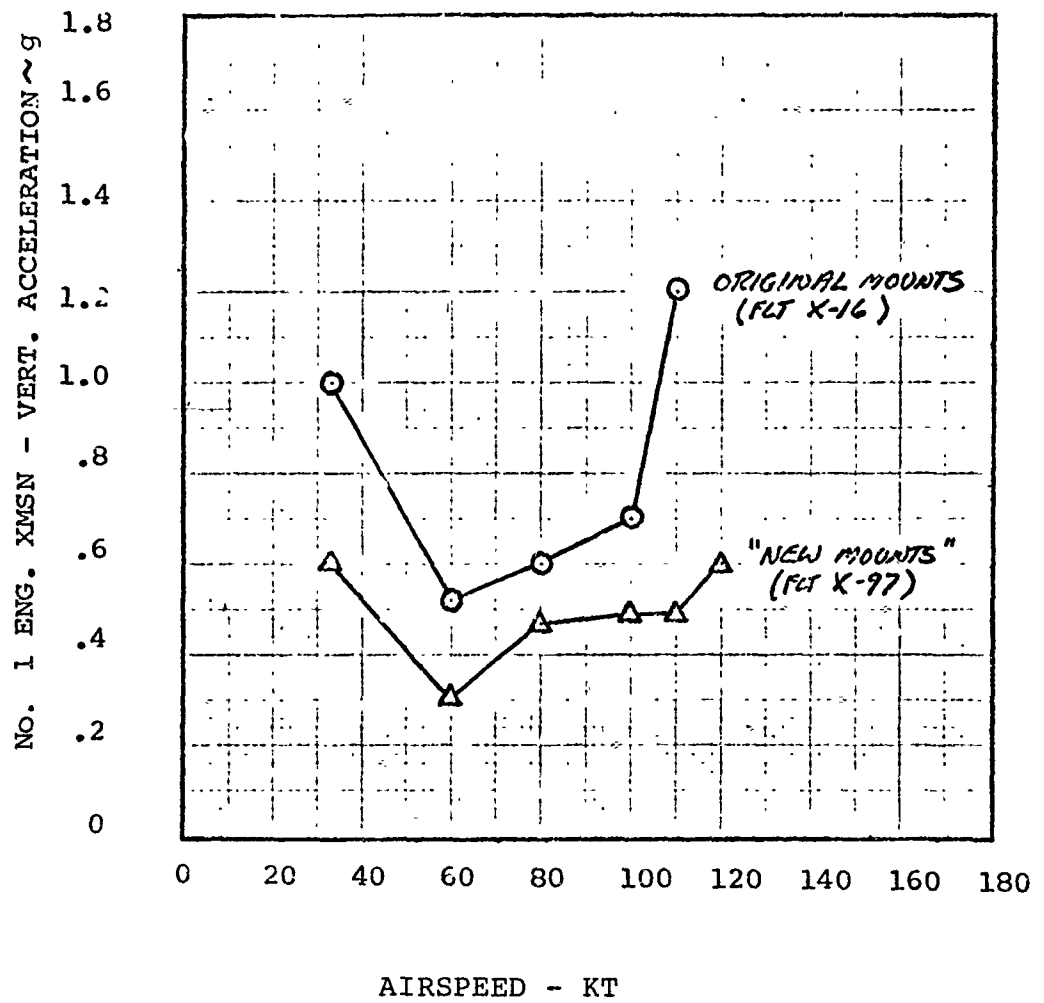
Figure 95 shows a comparison of the engines before and after the engine mount change. While the data is somewhat limited (due to limited instrumentation on the early baseline flight of A/C 002), an improvement in the engine vibration levels is shown.

Figure 95. Effect of Mount Change on 4/Rev Vibration.

As indicated, both mount systems had levels below the engine spec of 1.6 g, but the trend of the original mount data at only 110 knots was toward exceeding the spec at higher speed. Also, both of these flights had no 4/rev vibration treatment in the aircraft. However, data shown in the following section, to much higher airspeeds, does have vibration treatment devices installed.

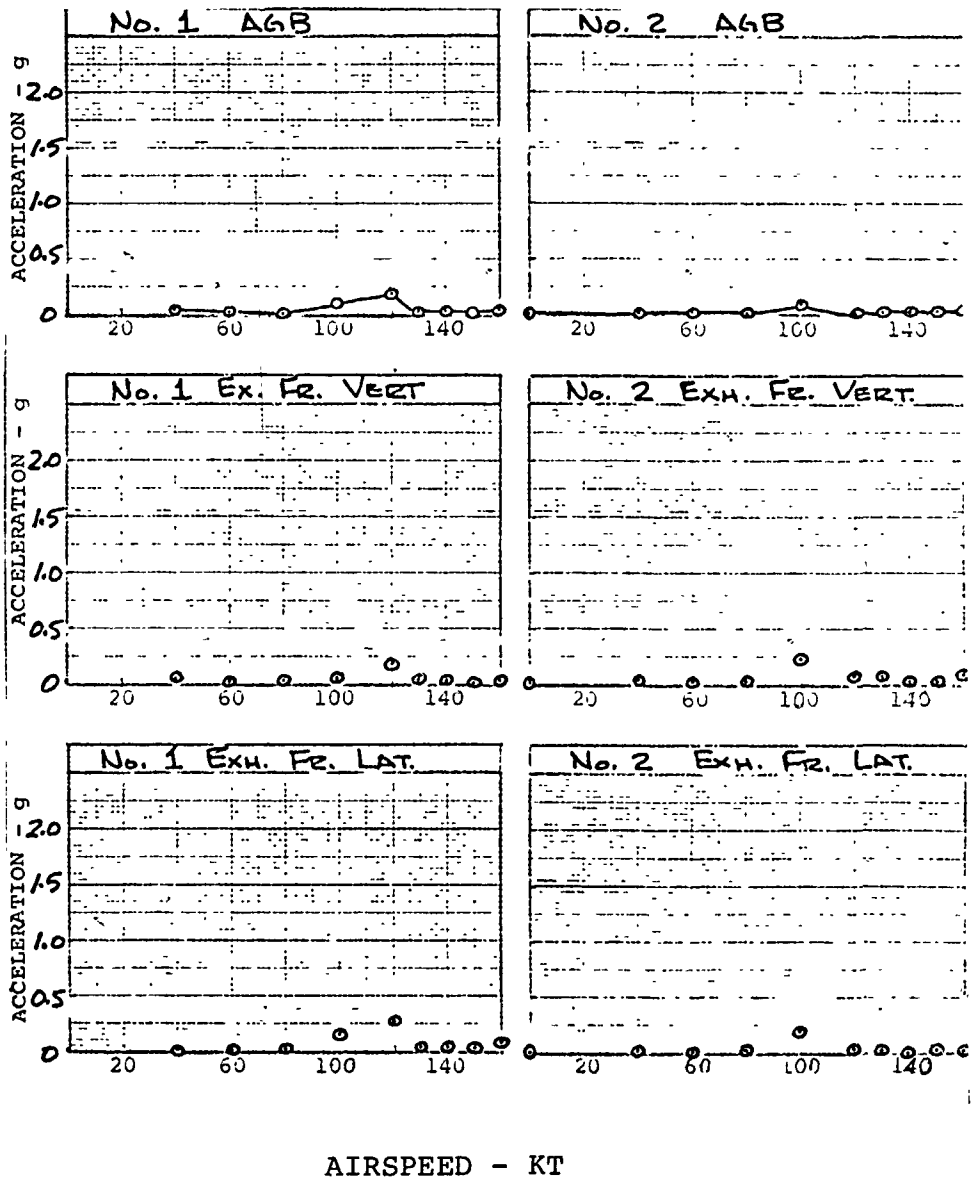
Figure 98. Engine Vibration Survey (1/rev).

For completeness, Figures 98 and 99 show that while providing low vibrations at 4/rev, the levels at 1/rev and 3/rev were also low.

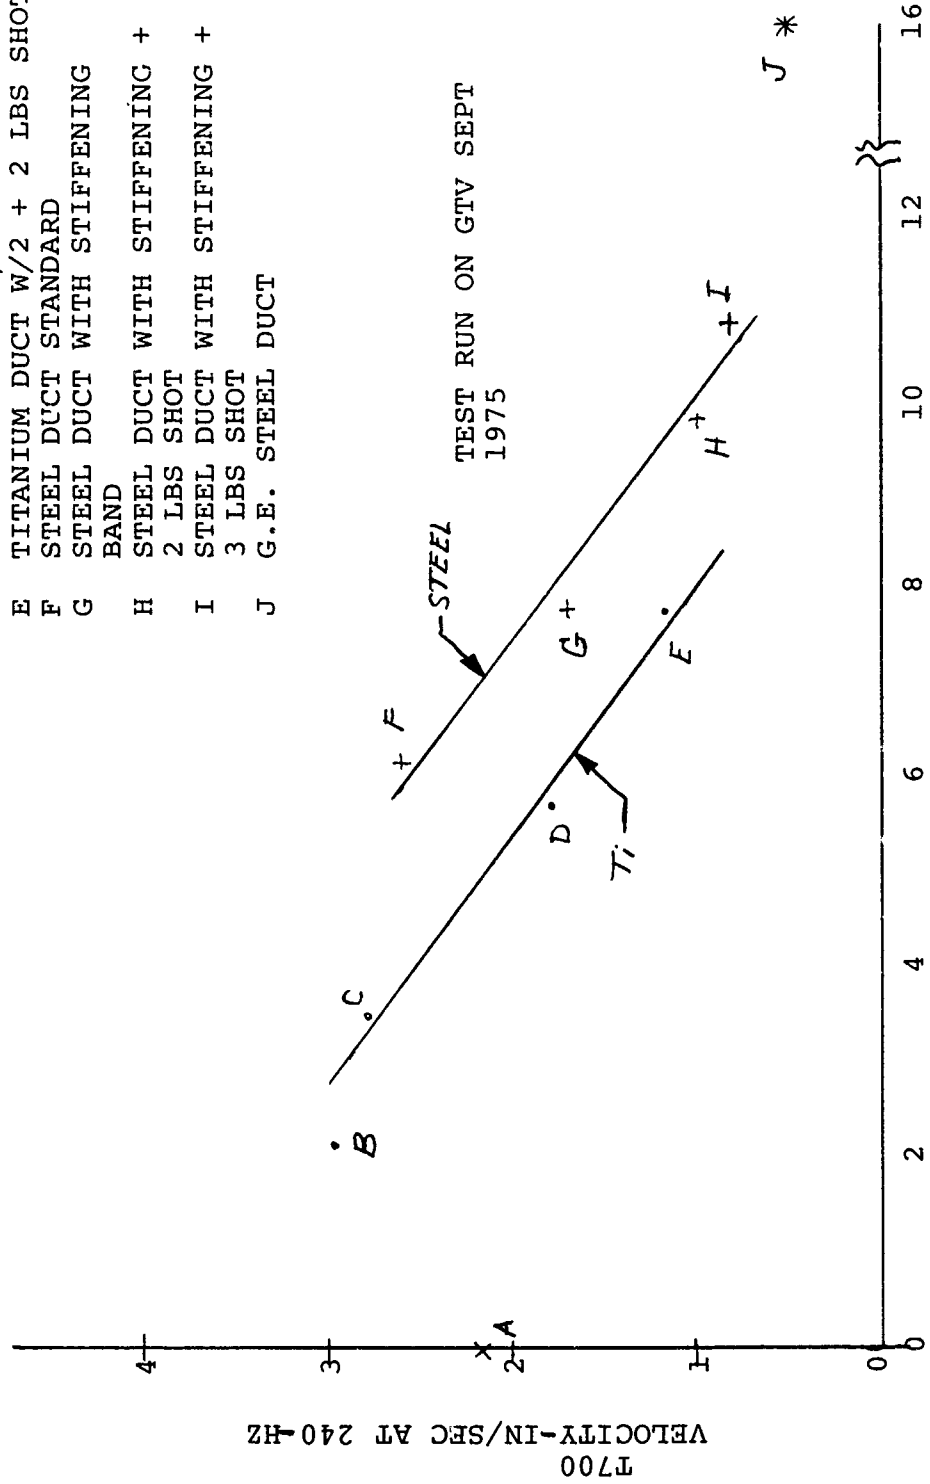
Figure 100. Effect of Exhaust Duct Configuration/Weight on 240-Hz Response.

A variety of configurations of exhaust ducts, both titanium and steel (and no tailpipe), were evaluated on the GTV for their effect on the 240-Hz nonsynchronous whirl vibration. These data (Figure 100) show that solutions to the problem of exceeding the engine vibration limits were achieved by the addition of weight/stiffeners to either the steel or titanium exhaust ducts.

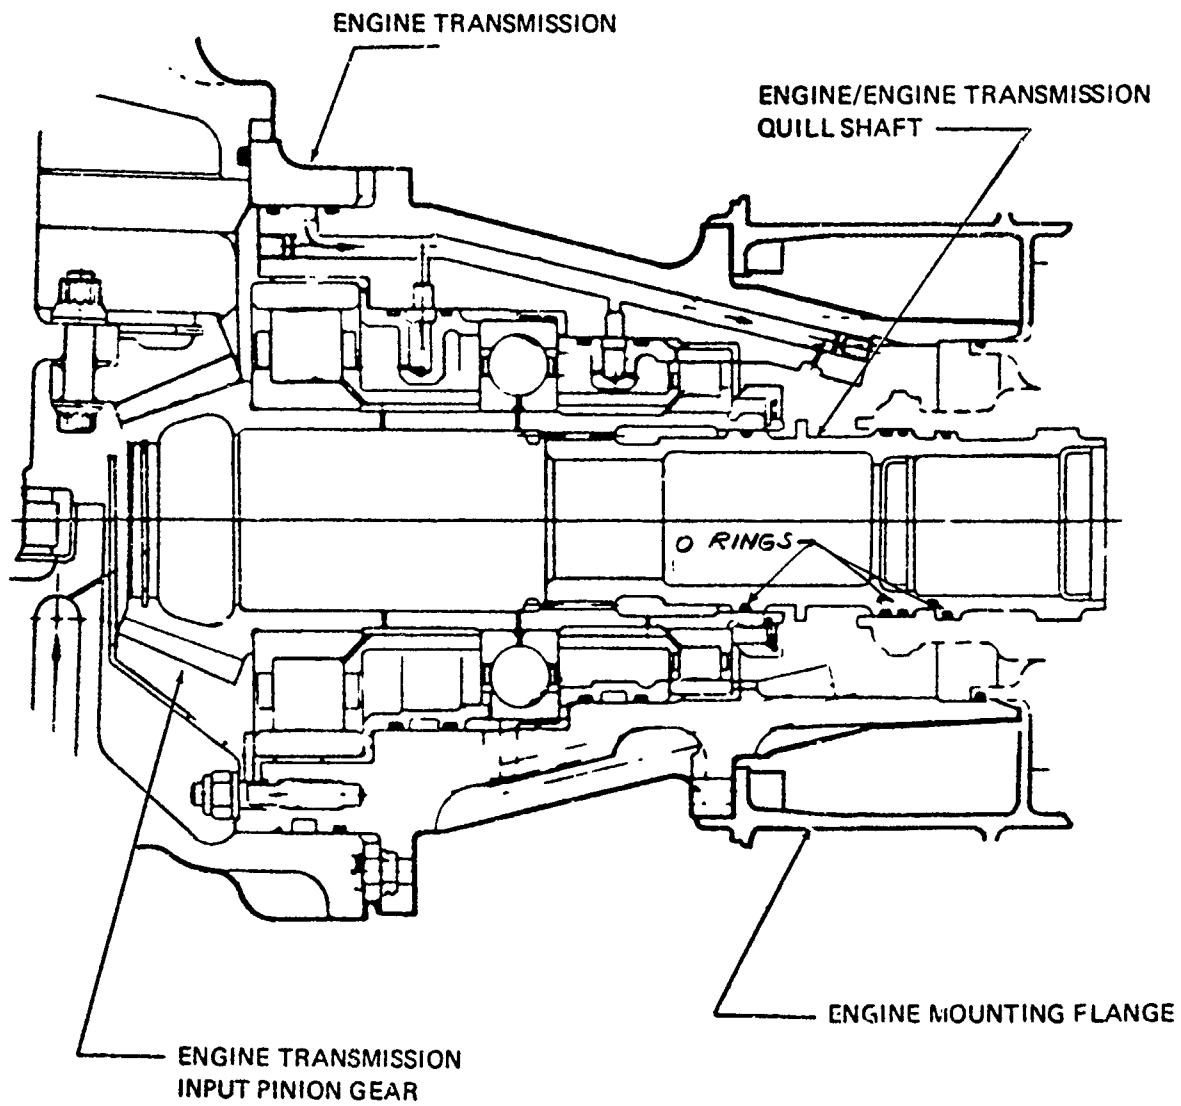
Figure 101. Quill Shaft Location,

The connection between the engine shaft and the helicopter transmission was through a short (6.69 inches long) "quill" shaft with male splines on both ends of the shaft. These splines mate with corresponding female splines in the ends of the engine shaft and the transmission input pinion (Figure 101).

The quill shaft splines used were side fit splines with a root clearance of .005 in and .0082 in/side in the engine spline and .025-.0331 in/side in the transmission. This arrangement was used because of good experience with a similar quill shaft arrangement used to couple an engine to a transmission in another helicopter although the GE installation drawing recommended OD piloting.

Figure 101 shows the splined quill drive shaft which connects the engine transmission spiral bevel pinion to the output shaft of the engine. The drive splines are case hardened and ground.

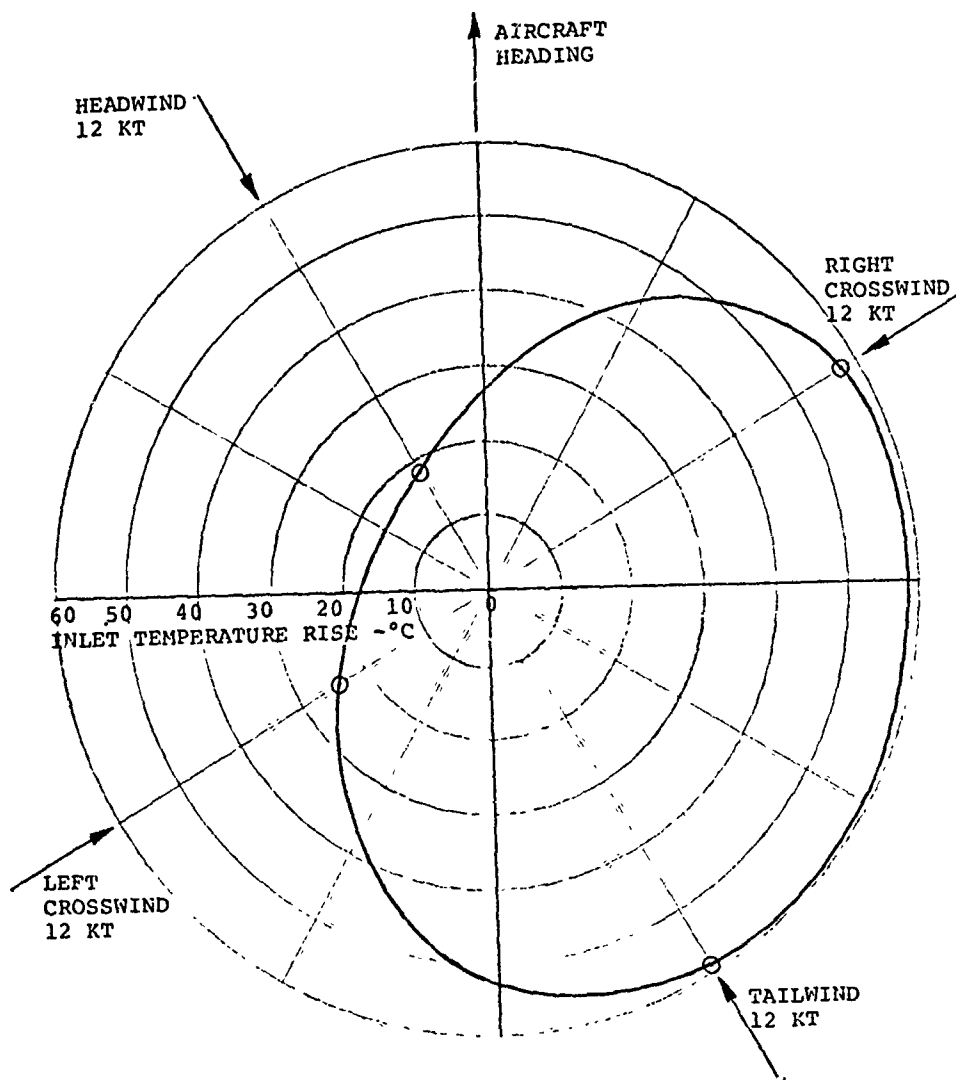
Figure 102. No. 1 Engine Maximum Inlet Temperature Rise Encountered During IGE Decelerations.

Figures 102 and 103 present the maximum inlet temperature rises for the No. 1 and No. 2 engines as a function of wind and flight direction. Analysis of the data indicated that engine power setting had very little effect on maximum temperature reached in the inlet, but helicopter height above the ground had a fairly large effect, with greater heights showing lesser temperatures. Wind direction had a fairly strong overall effect on a given engine inlet temperature rise. Note that the critical wind direction for a given engine is with the wind from the side opposite the engine but is fairly insensitive for that engine over a 90° sector. A summary of the statistical distribution of the recorded temperature rises above ambient is shown in Figure 104. A typical inlet temperature transient which induced a surge is shown in Figure 105.

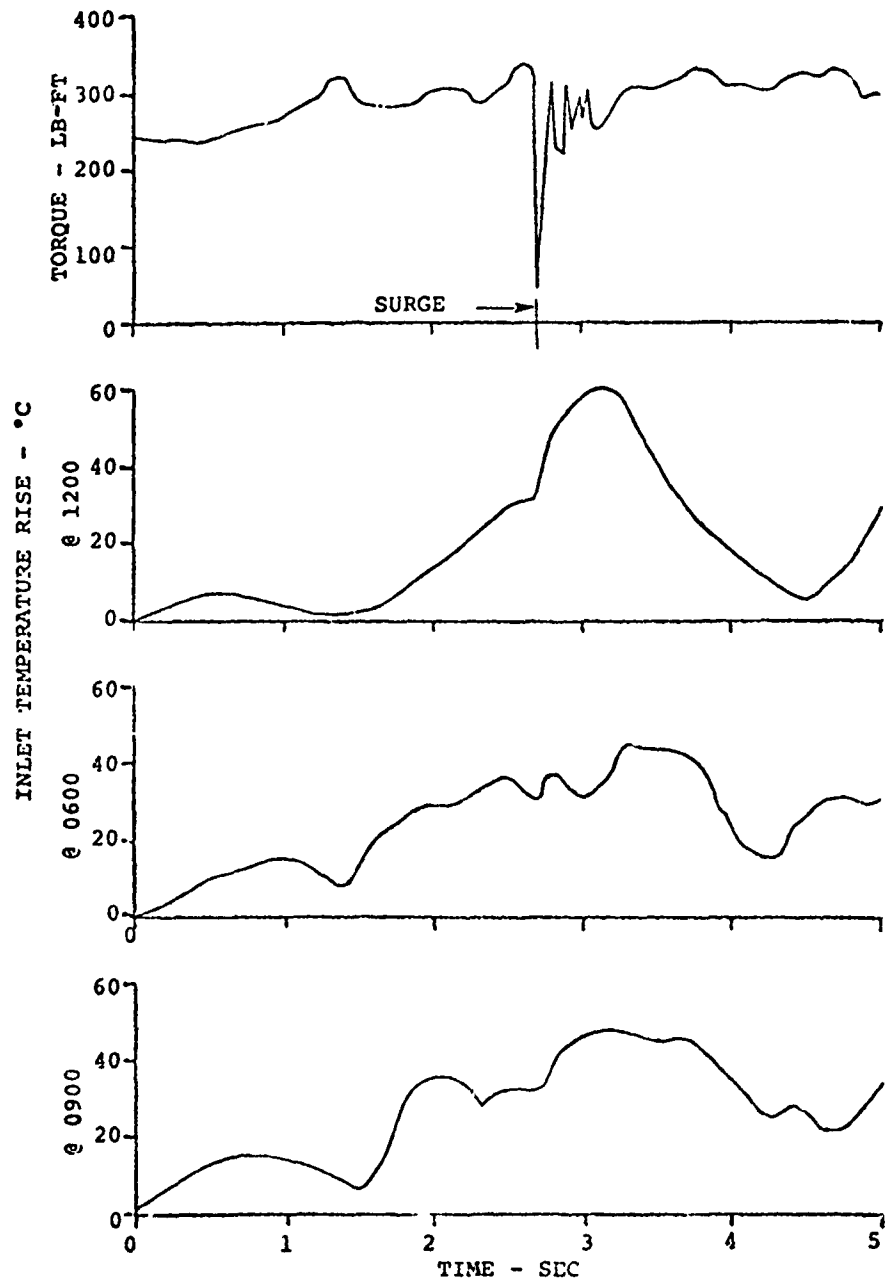
Figure 105. Engine Torque and Inlet Temperature Time History during Stall Event.

The stall is caused by the entrainment of hot gases resulting in a rapid decrease in engine corrected speed ($N_g \sqrt{\theta}$) even though engine mechanical speed is constant or increasing.

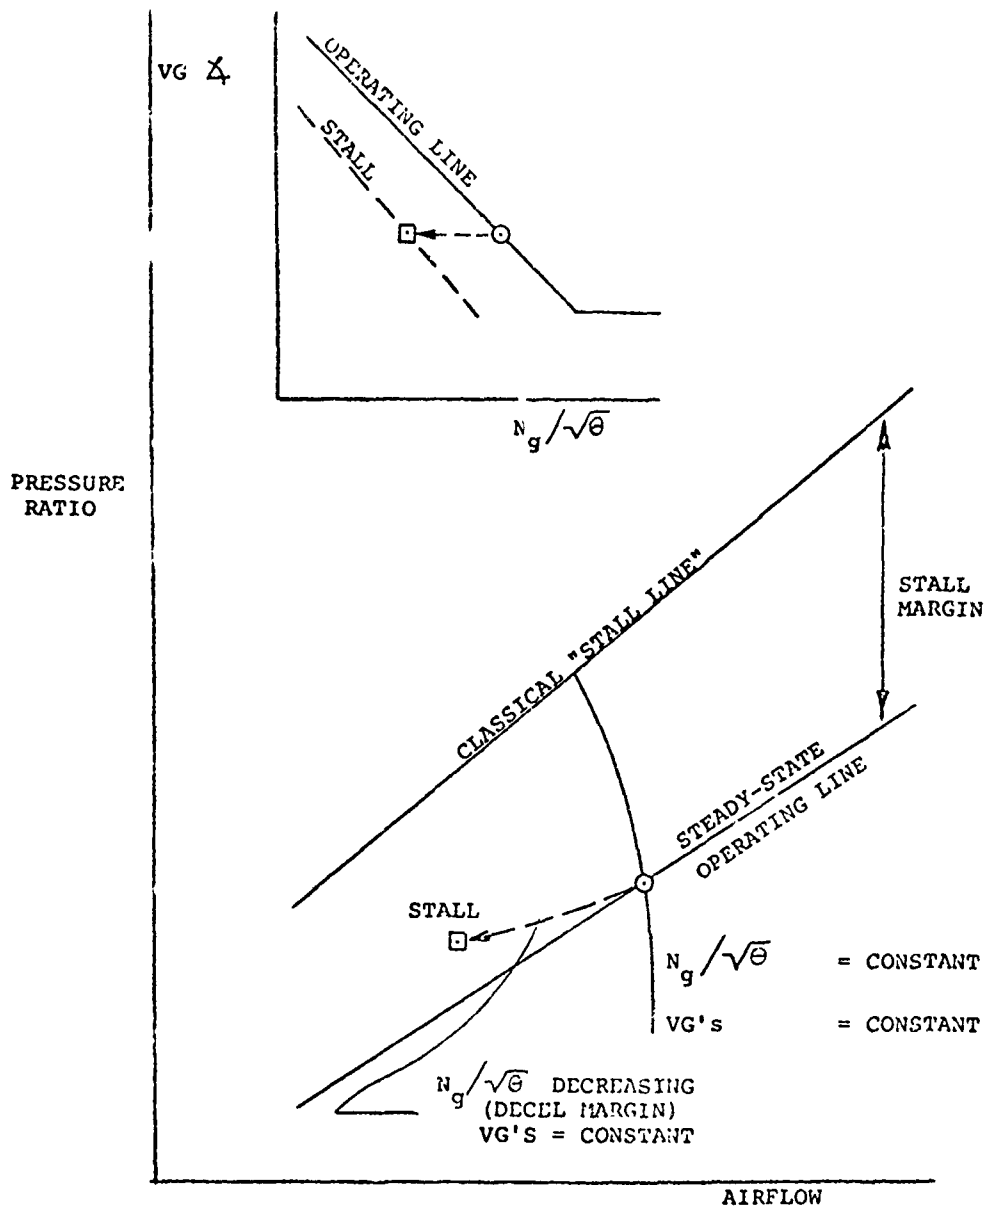
Figure 106. Compressor Stall Line and Paths,

The increase in inlet temperature (and decrease in corrected speed) occurs more rapidly than the inlet temperature sensor (T_2) can detect the change and adjust the axial guide vanes (VG) to match the flow conditions. The T_2 -sensor time constant was approximately 25 seconds. Consequently, the T_2 -sensor cannot respond fast enough to the increase in inlet temperature, which occurs over an interval of 2 seconds or less. The resulting mismatch is greater than can be accepted as angle of attack on the blading and results in flow breakdown or "surge". The path followed by a compressor operating point on the compressor performance map, corresponding to a constant variable geometry excursion, is shown in Figure 106.

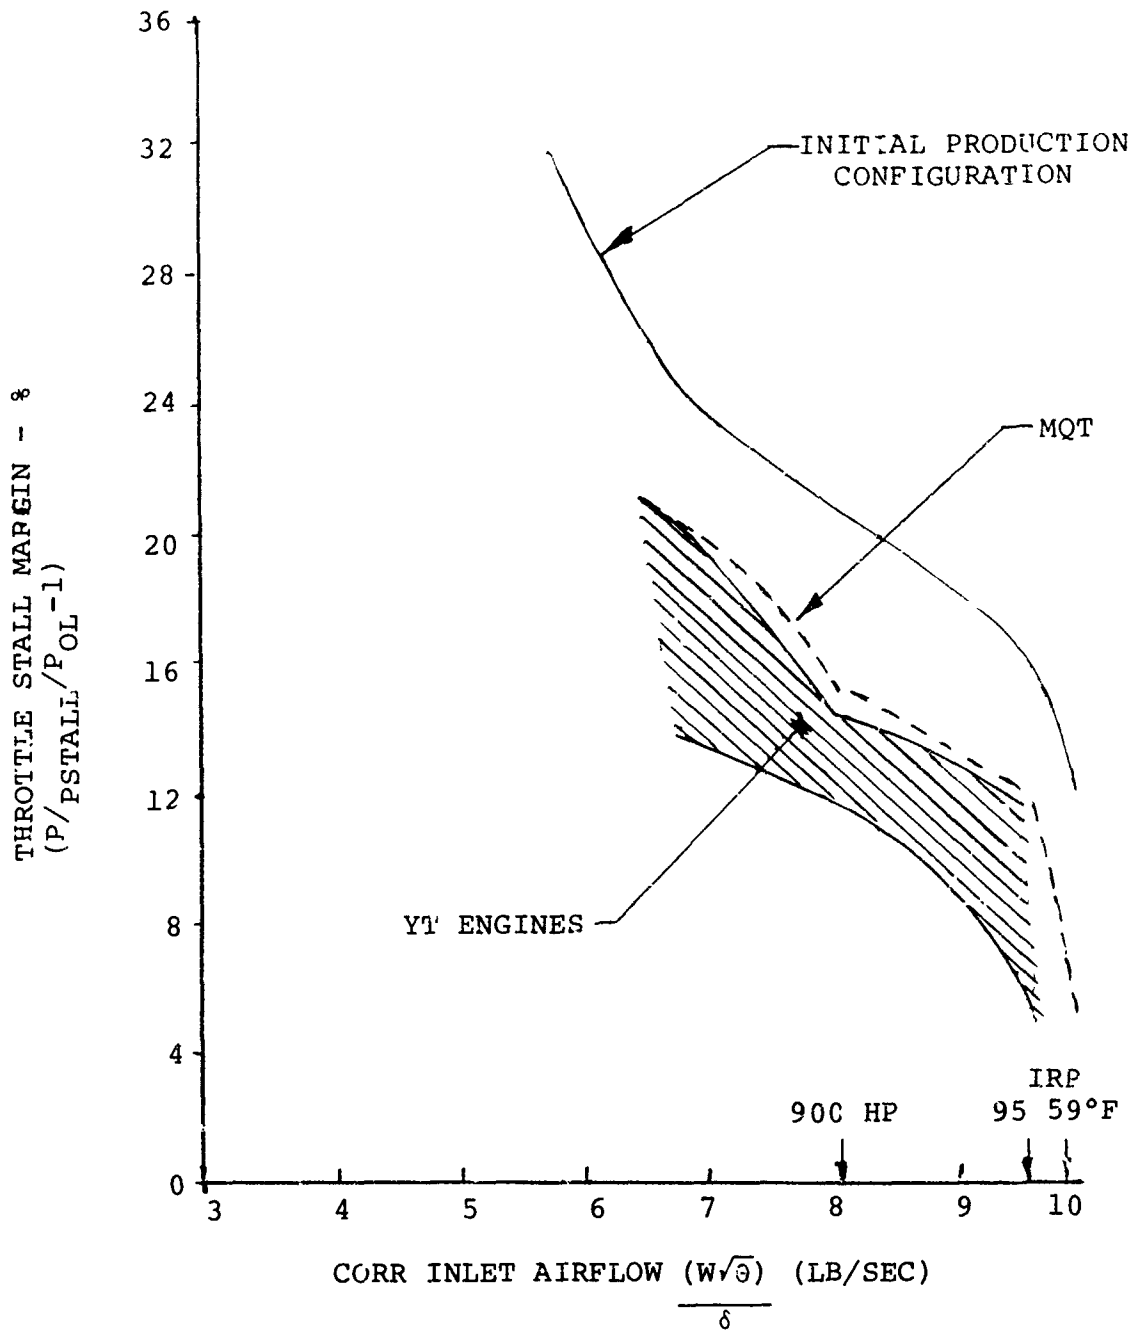
Figure 107. Test Cell Engine Stall Results.

Figure 107 shows the throttle stall margin for the YT, MQT and production engines.

For production, the engine manufacturer has decreased the axial compressor operating line while introducing centrifugal compressor configuration changes to maintain overall compressor pressure ratio. The result of this program has been a marked increase in stall margin and a small efficiency increase. The production engine configuration has not been tested in the YUH-61A aircraft, but factory testing shows this improvement and also shows that the production configuration exceeds the requirement for deceleration stall margin which was added to the engine PIDS in collaboration with Boeing to handle the reingestion problem.

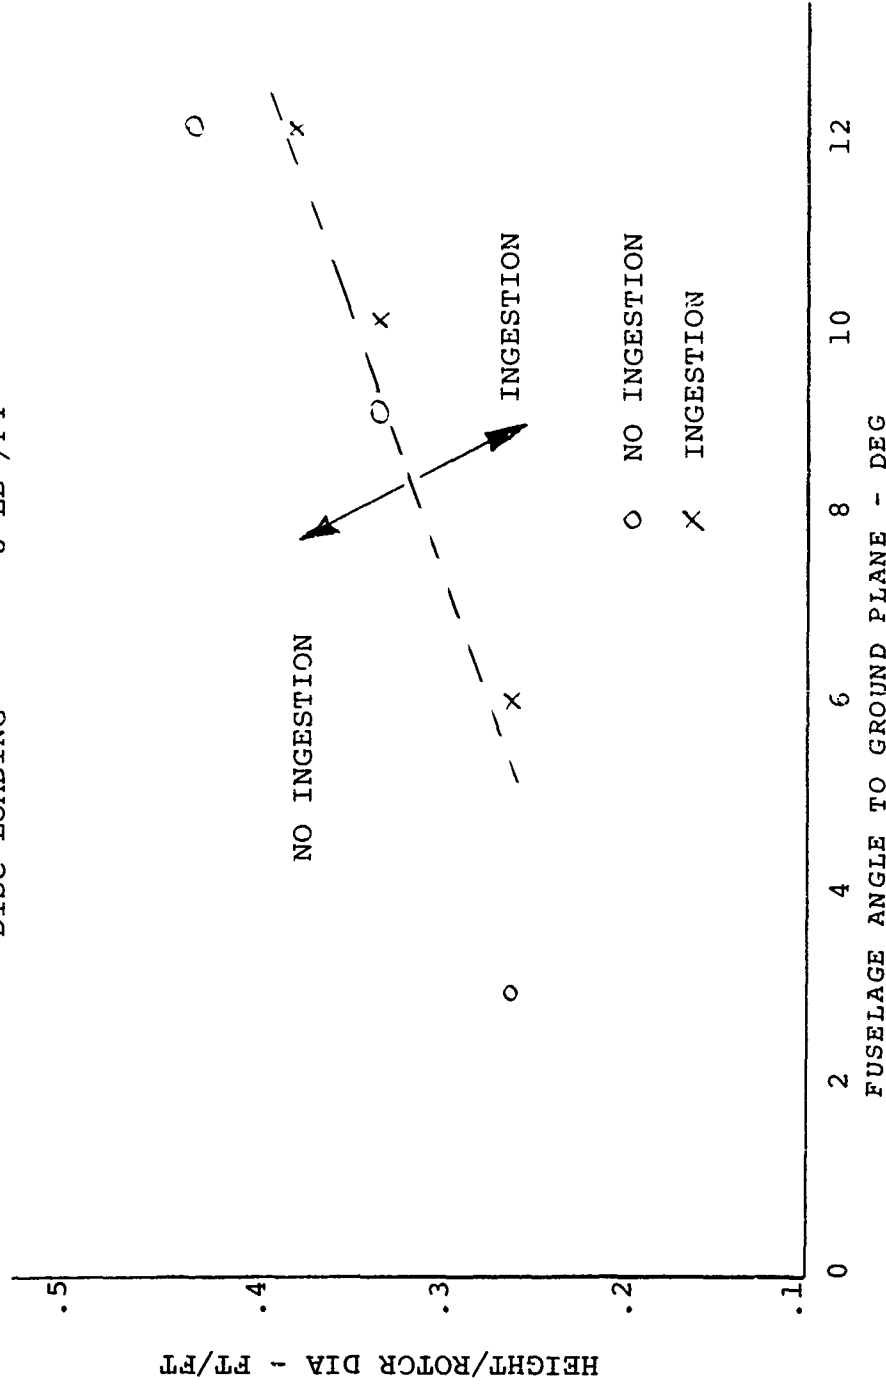
Figure 108. Effects of Fuselage Angle and Rotor Height on Ingestion.

These data obtained from the wind tunnel test are shown in Figures 108, 109 and 110. Flight tests generally confirm that the airspeed at which heavy ingestion occurs is from 20 to 35 knots as shown by the wind tunnel data in Figure 110. Flight test did not confirm that doubling the exhaust velocity would give a 6 to 1 reduction in ingestion as indicated in Figure 109.

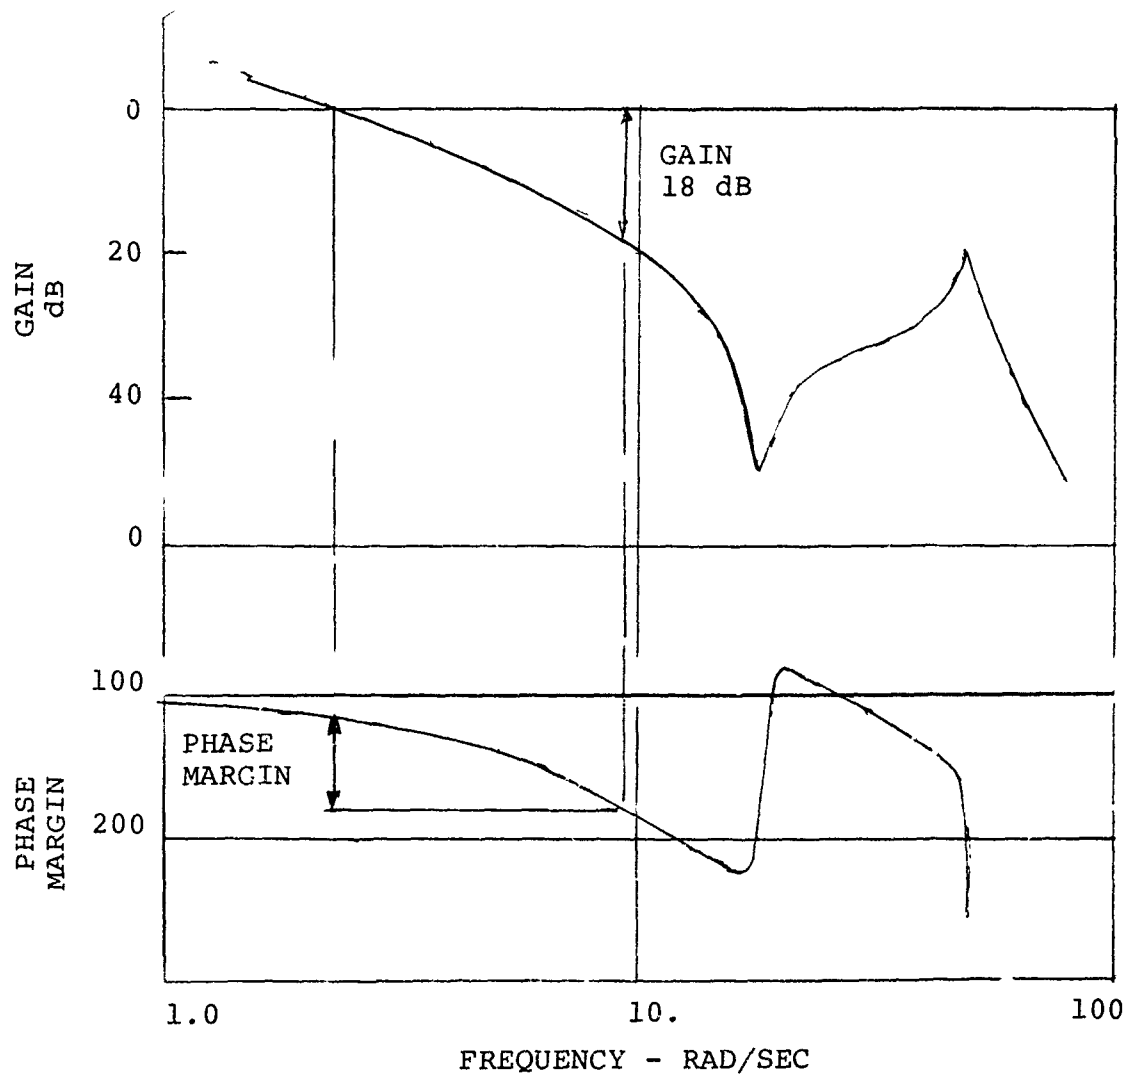
Figure 111. Gain and Lag vs Frequency.

In the area of engine controls, there were no problems with stability with the T700 engines in the YUH-61A helicopter. Figure 111 shows representative phase margins and gain. However, obtaining the desired response required modification of the airframe to the engine control and within the engine control.

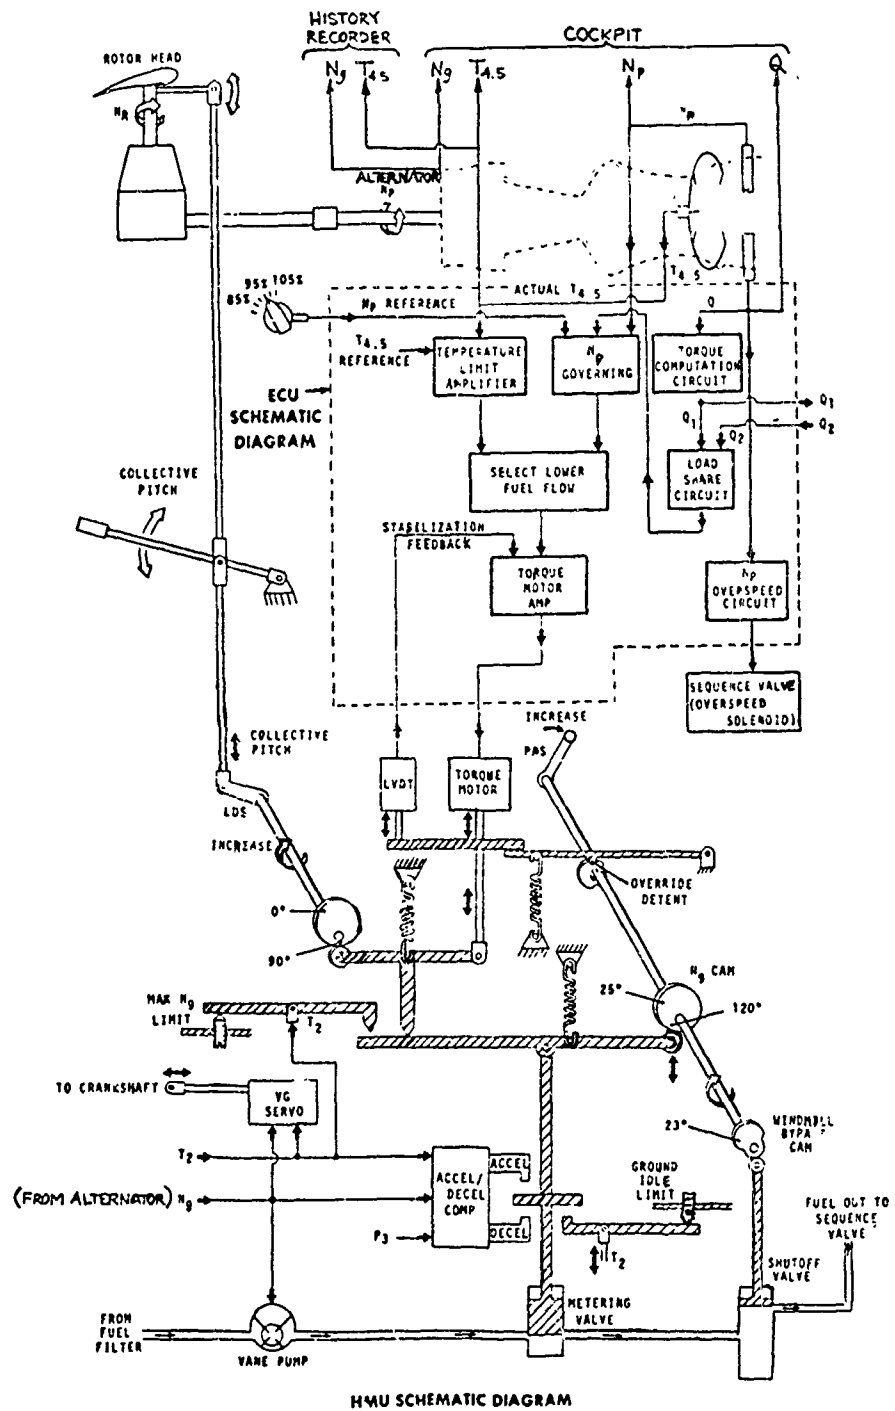
Figure 113. Fuel Control Schematic.

A load demand system had been provided by connecting the collective pitch control to the LDS (load demand spindle) of the HMU (hydromechanical unit) of the engine fuel control as shown in Figure 113.
