CONCRETE AND ROCK TESTS  
REHABILITATION WORK, BRANDON ROAD  
DAM, ILLINOIS WATERWAY  
CHICAGO DISTRICT

Richard L. Stowe

May 1978

Final Report

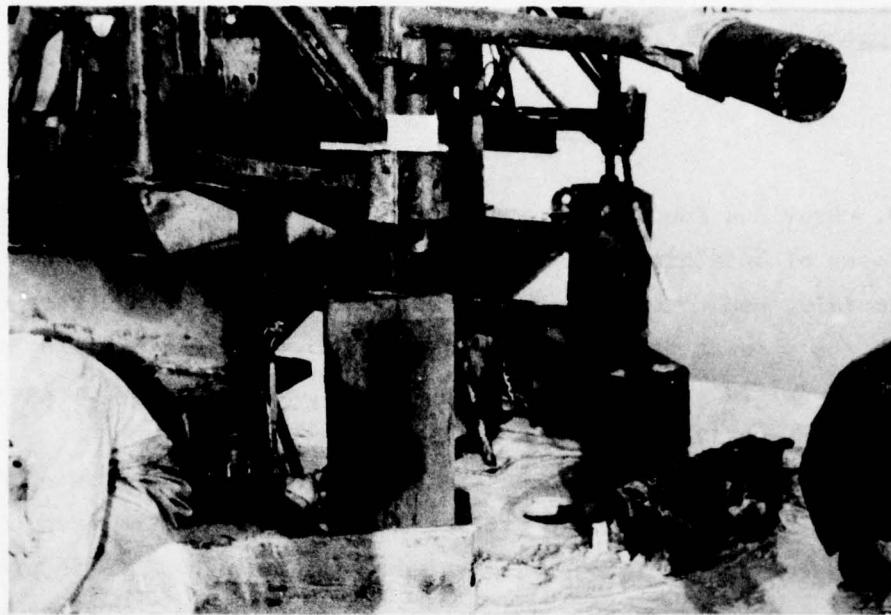
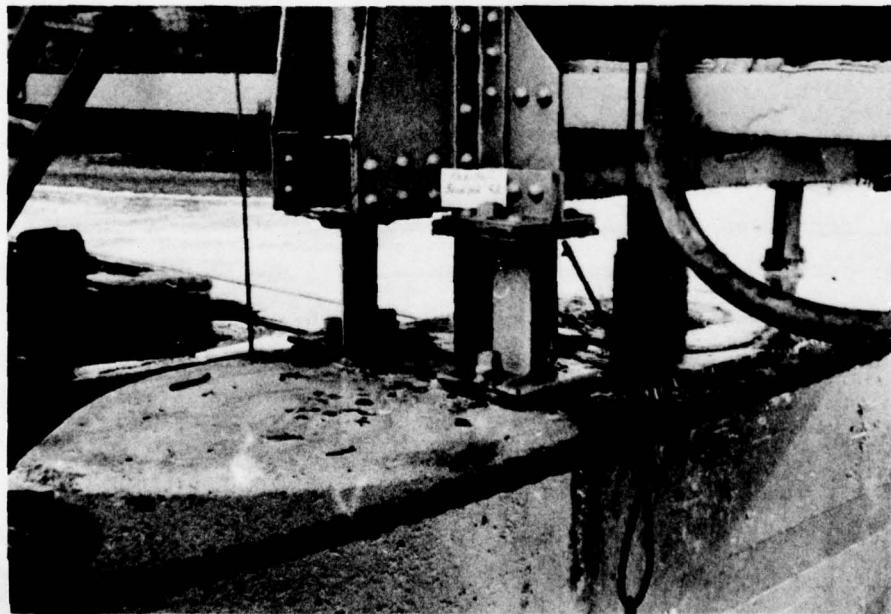
Figure 2. Drill rig setup for holes BR WES-1, 2, and 3-76

a. Drilling on hole BR WES-1-76, headgate section

b. Typical drill rig setup over holes BR WES-2 and 3-76,  
tainter-gate section

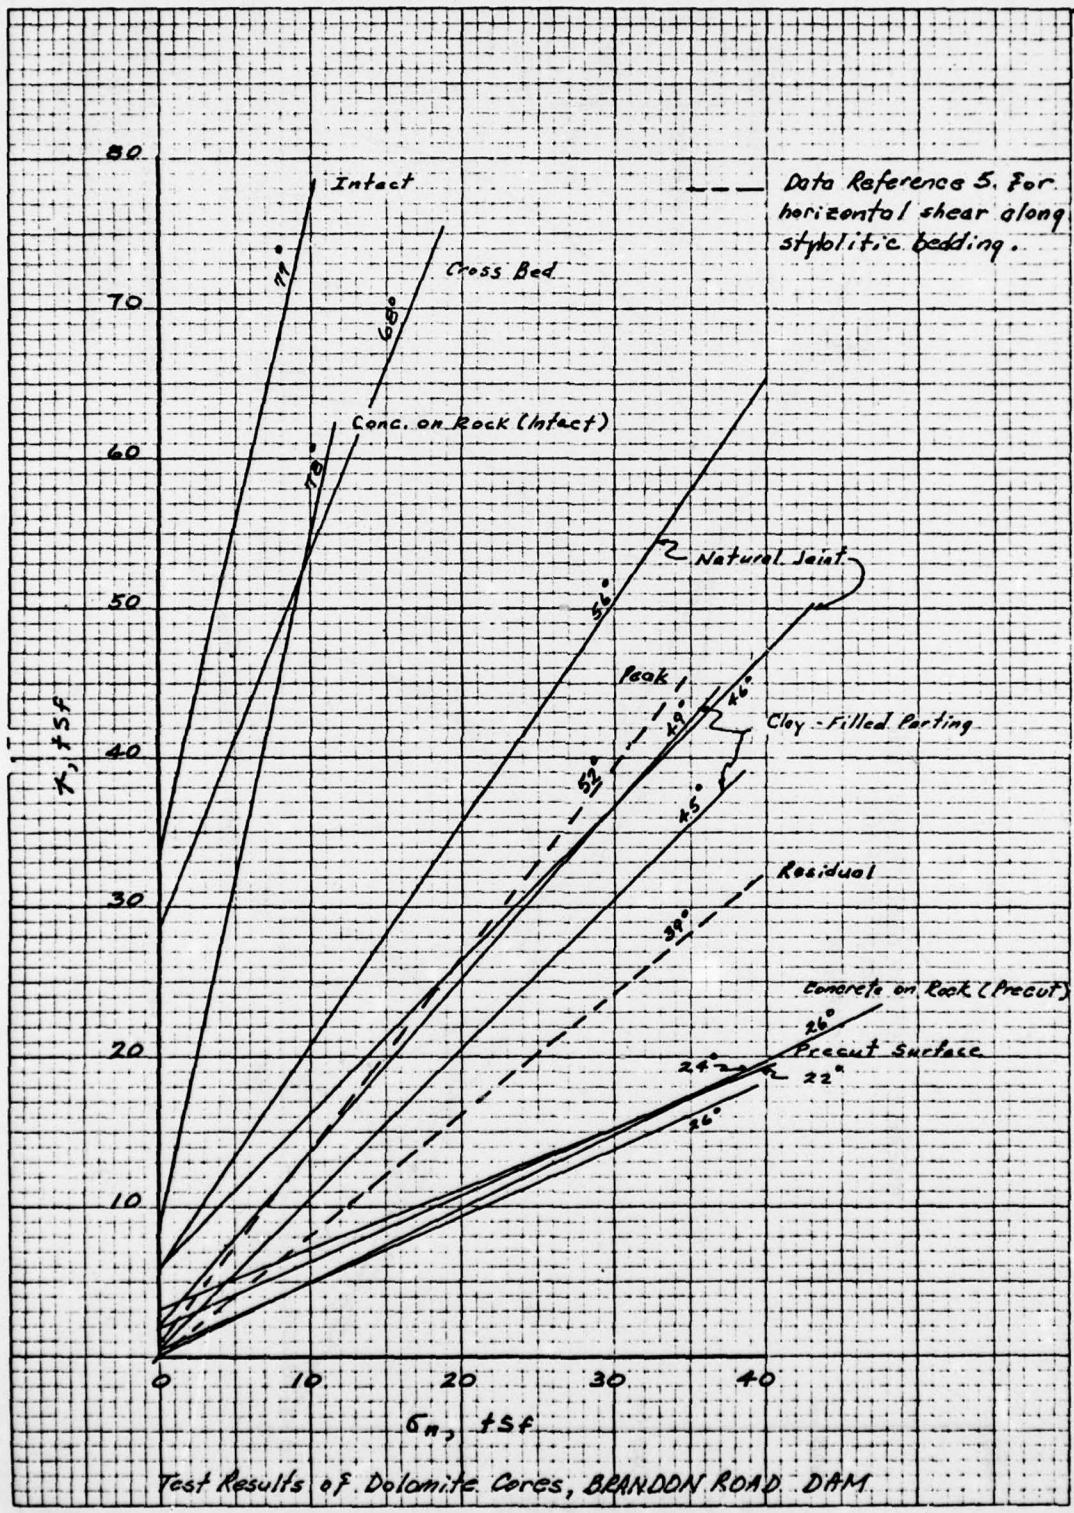
PLATE 32

82. The stress values for the direct-shear tests are presented in Table 7 and plotted on Plate 32. The design parameters suggested in Reference 5 are presented in Table 8 and the direct-shear envelope is plotted on Plate 32.

89. The sliding friction tests were of two kinds: shear of sawed rock surfaces and shear of naturally occurring joints. The respective test results are labeled and presented in Table 6 and Plate 32.

90. From Plate 32 and Table 6, it will be noted that there is a large difference in the angle of friction for the specimens sheared along a natural joint (average  $\phi = 51$  degrees) and those sheared along the precut shear plane (average  $\phi = 24$  degrees). The surface roughness, about 1/4 in. between peaks and valleys for the specimens tested, accounts in large part for the relatively high  $\phi$  for the natural jointed rock.
