**FINAL REPORT
FOR
TF30 THIRD-STAGE COMPOSITE FAN BLADE
SERVICE PROGRAM
Contract No. F33657-70-C-0624**

David G. Randall
Pratt & Whitney Aircraft Group
United Technologies Corporation
East Hartford, Connecticut 06108

15 May 1978

Final Report for Period 1 July 1970 - 31 December 1977

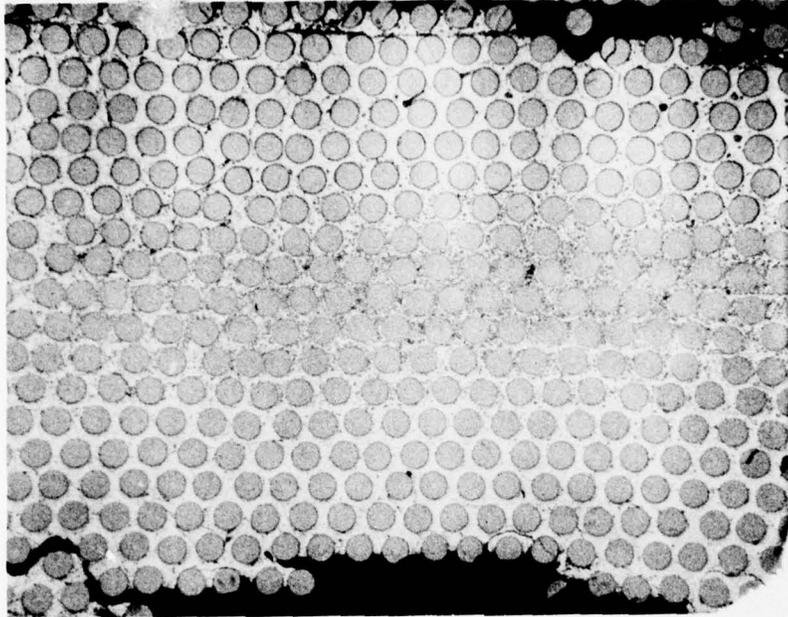
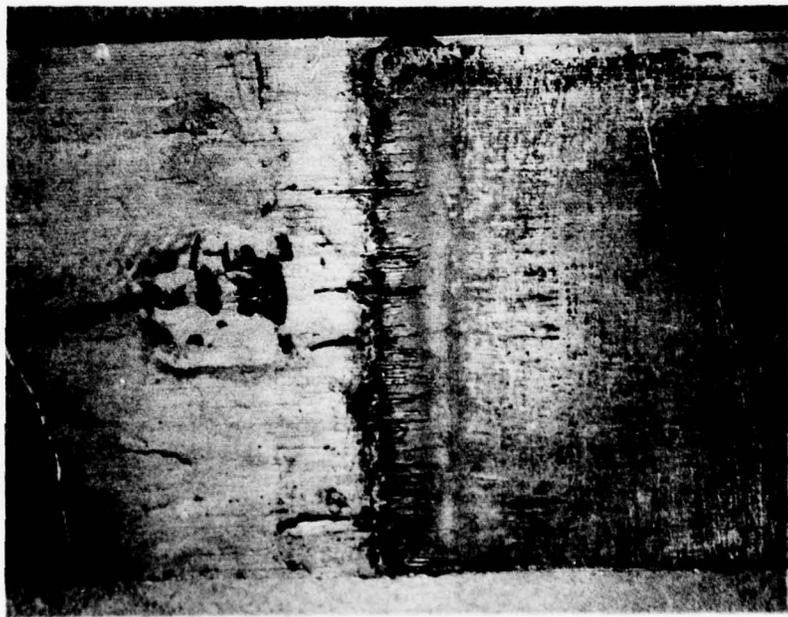
Figure 9.4-6 Surface Appearance and Microstructure of Unidirectional Borsical[®] Specimens that were High Frequency Fatigue Tested at 450° F and 2180 μ in./in. for 10^6 Cycles (11F/u-H1)

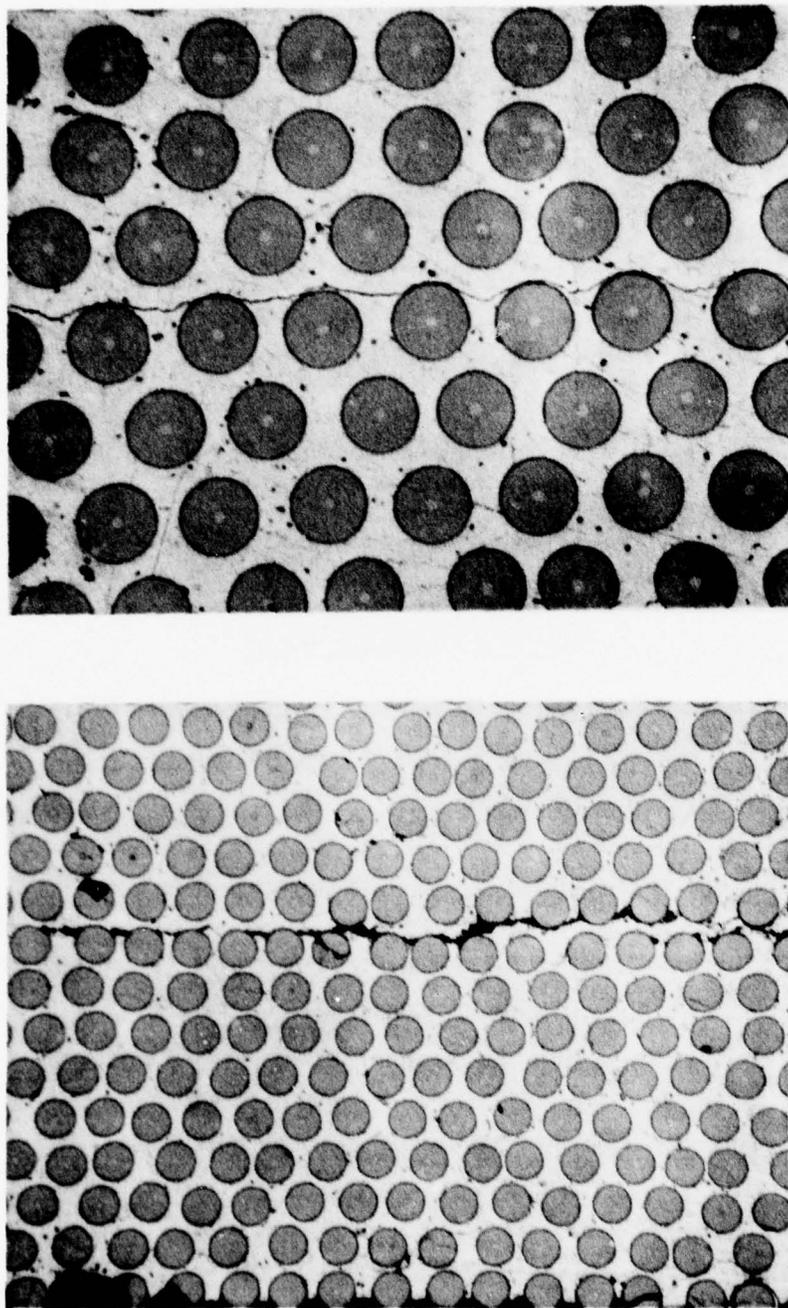
Figure 9.4-7 Microstructure of Unidirectional Borsical[®] Specimens that were High Frequency Fatigue Tested at 450°F and 2100 μ in./in. for 5×10^6 Cycles (3D) u-H3 at Left and 2220 μ in./in. for 2×10^6 Cycles (11E) u-H3 at Right

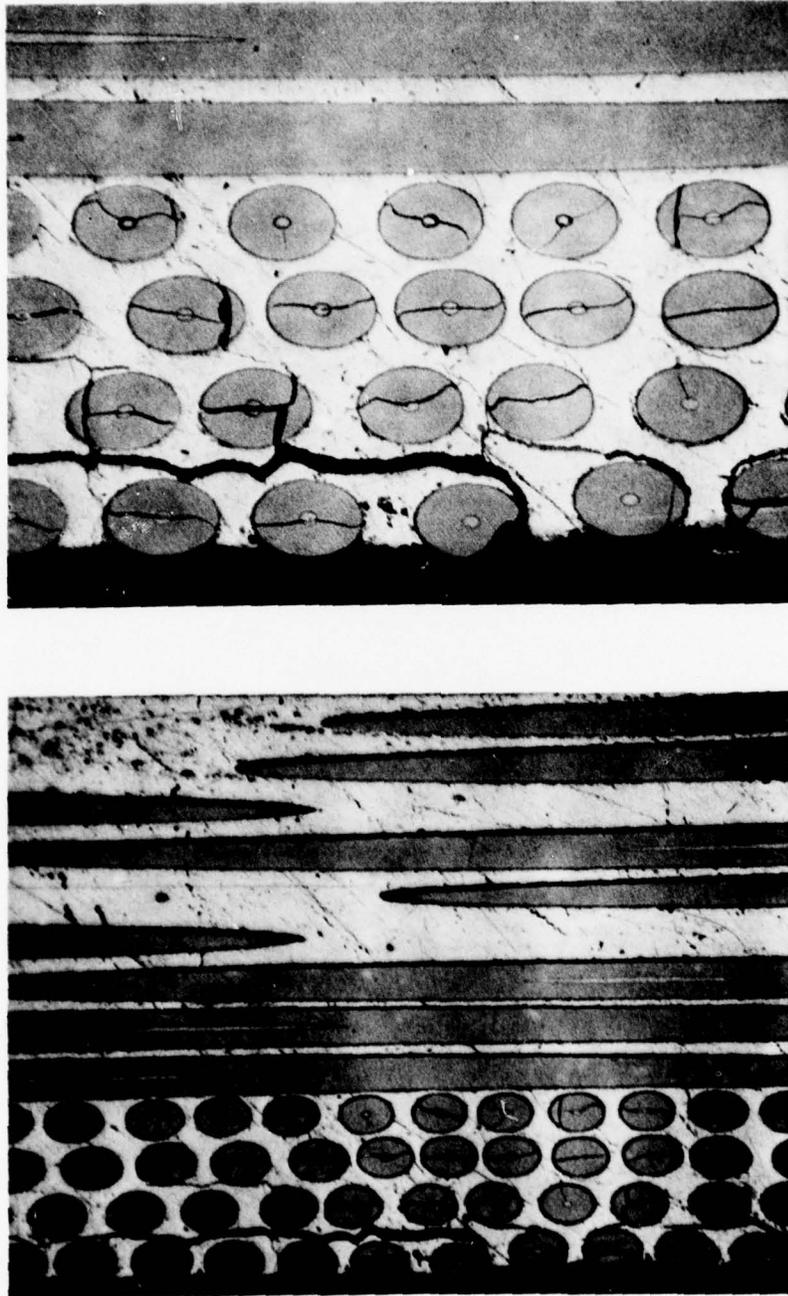
The undamaged component configuration specimens which were HFF tested at 450°F exhibited a very distinctive failure mode in addition to surface delamination. Splitting of cross-ply fibers parallel to the plane of the specimen was detected in every component specimen tested (see Figure 9.4-8). Fatigue cracks and delaminations were noted in some but not all samples. The splitting is believed to contribute to the immediate natural frequency drop detected for all component specimens tested at approximately 1600 $\mu\text{in./in.}$ strain or greater. None of the unidirectional fibers in the core were split and no matrix deterioration was observed around the core fibers. As in the unidirectional material, no real microstructure differences were noted between specimens tested to 20 percent versus 100 percent of their expected HFF life.

Figure 9.4-8 Microstructure of Component Borsical® Specimen (7F/B-H4) that was High Frequency Fatigue Tested at 450° F and 1755 μ in./in. for 2×10^6 Cycles

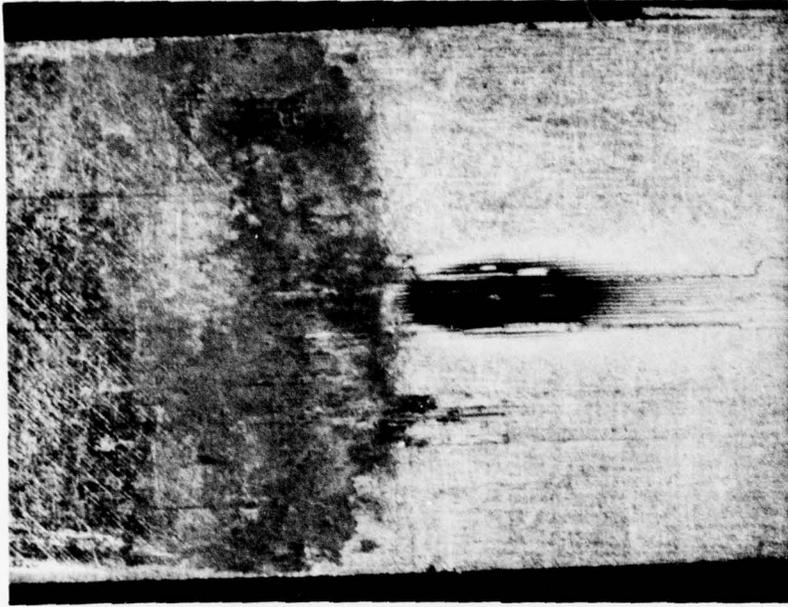
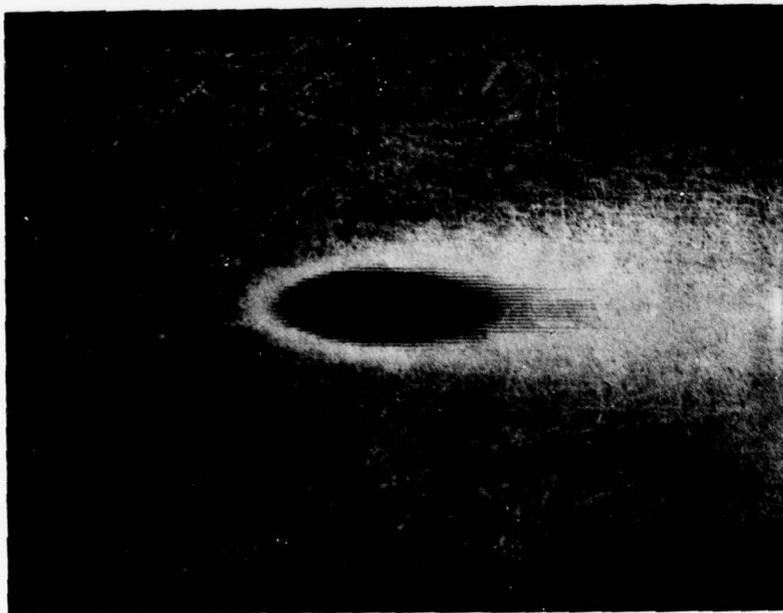
Figure 9.5-3 Surface of Deeply Eroded Unidirectional Borstical[®] Specimen (3E/u-H3) Before (Left) and After (Right) 450° F High Frequency Fatigue Testing at 2100 μ in./in. for 5×10^6 Cycles

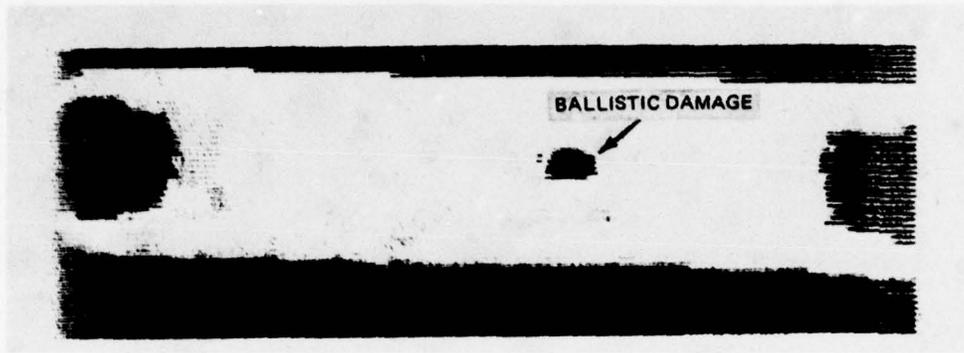
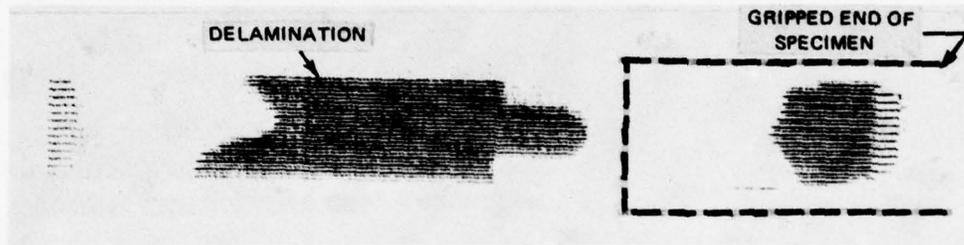
Ballistic impact damage drastically lowered the HFF life of the unidirectional and cross-ply configurations as shown in Table 9.6-II. However, impact damage did not significantly reduce the HFF life of the component material specimens. C-scan results, shown in Figures 9.6-2 and 9.6-3, show that delamination failures in the unidirectional specimens are initiated at the impact area while the delamination failures in the component specimens extend from the grip edge (similar to undamaged specimens) up through the impacted region. This would indicate that the failures do not emanate from the impact area in the component specimens. Cross-ply laminates suffer a drop in natural frequency due to impact damage but no delamination occurs.

Figure 9.6-2 Ultrasonic C-Scan Test Results for Ballistically Impacted Unidirectional Specimen (3A/u-H2) Before and After High Frequency Fatigue Testing Showing Delamination That Occurred During Fatigue Testing.

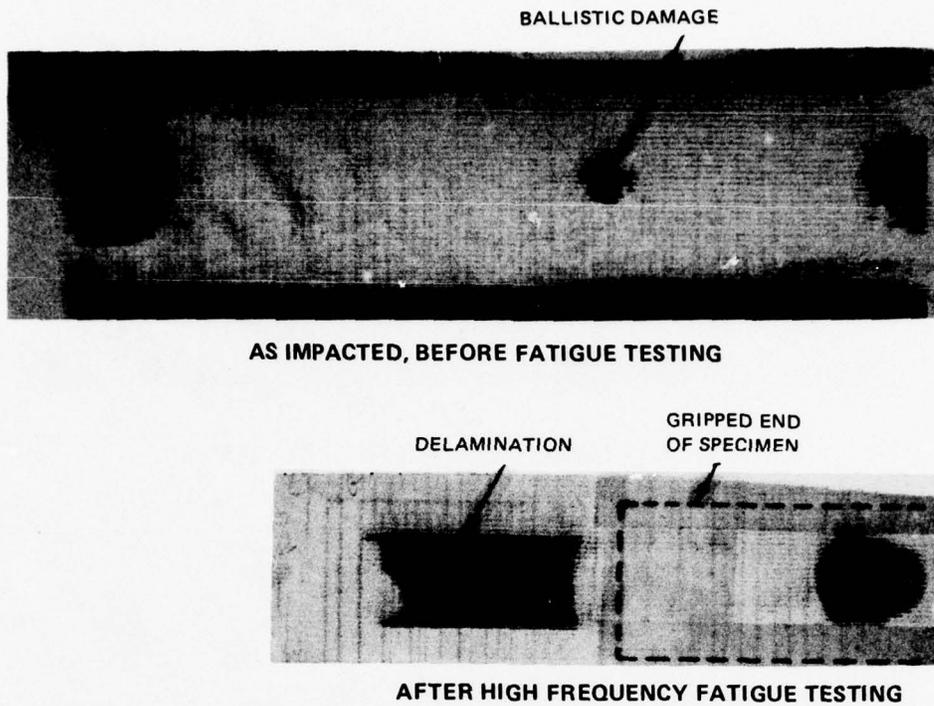
Figure 9.6-3 Ultrasonic C-Scan Test Results for Ballistically Impacted Component Specimen (7B/B-H4) Before and After High Frequency Fatigue Testing Showing Delamination that Occurred During Fatigue Testing

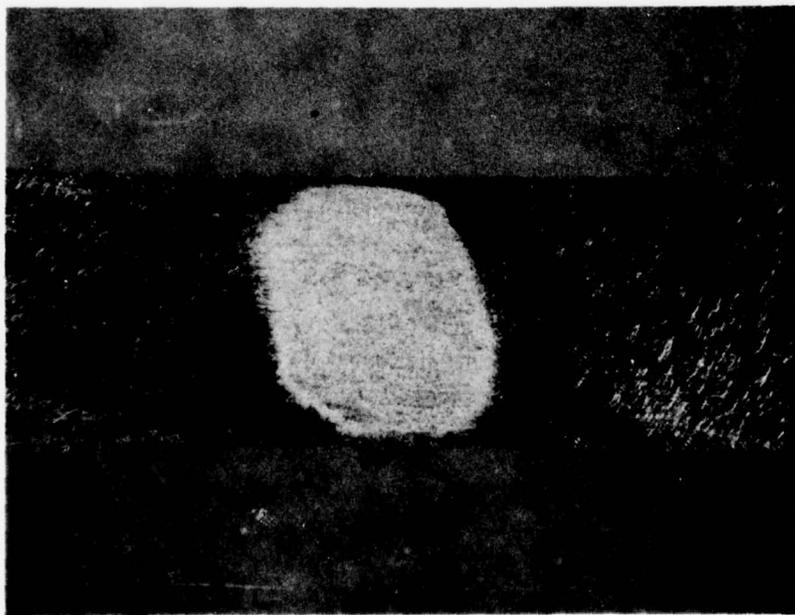
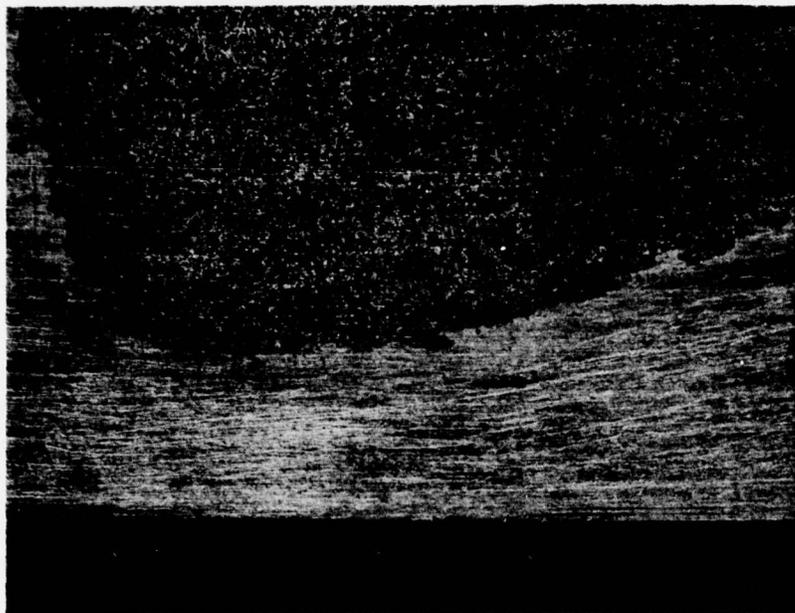
Figure 9.10-3 Twenty-Layer Borsical[®] Test Specimen as Repaired with Aluminum/Silicone Resin (Left), and After 100 Hours at 500° F in Air. Slight Discoloration is Apparent

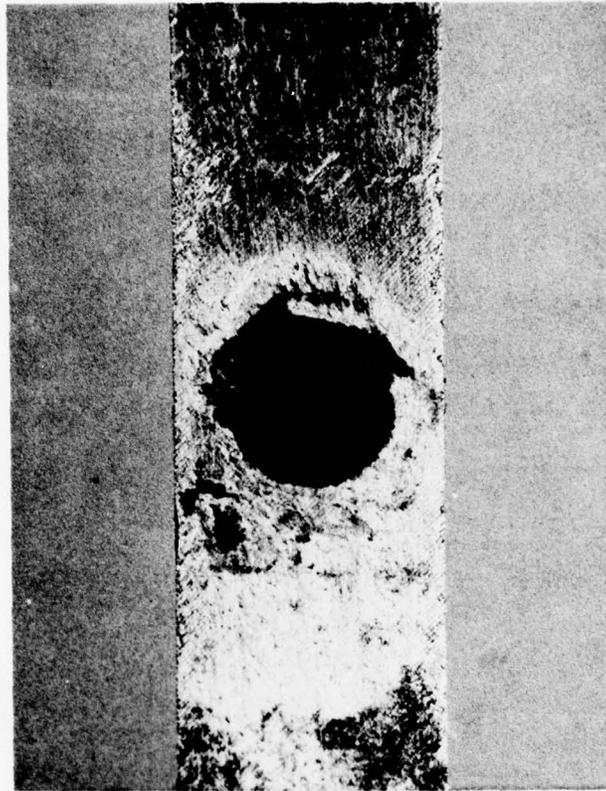
Figure 9.10-4 Typical 20-Layer Borsical[®] Test Specimen After Repair with Polyimide/Graphite Composite

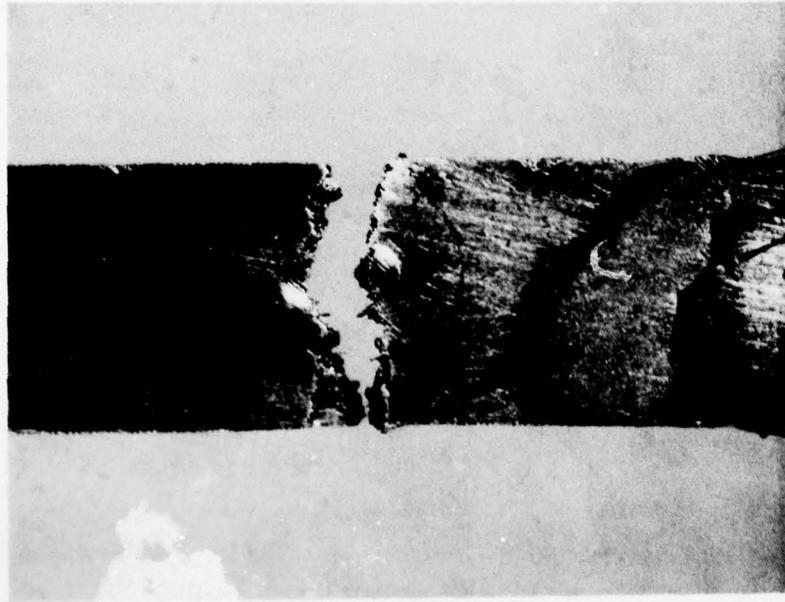
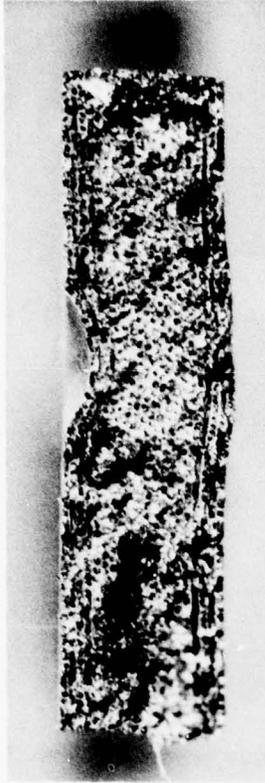
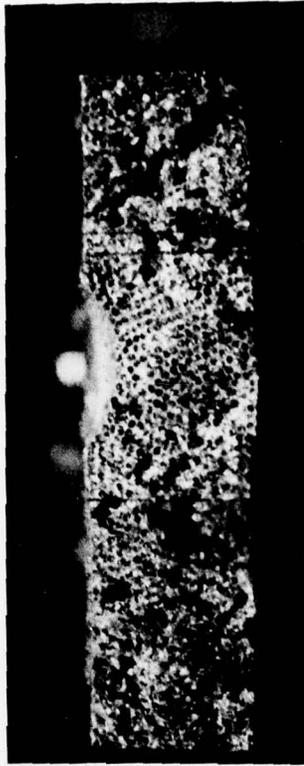
The fracture surfaces of post-tensile test as-damaged specimens versus damaged and aluminum/silicone resin repaired specimens are shown in Figures 9.10-7 through 9.10-11. Examination of these fractures revealed that complete filling with aluminum/silicone is more difficult when the damaged material is leached away. Also note that the failures of the leached and repaired samples resulted in extensive pull-out of the aluminum/silicone filler compared with the samples repaired in the as-damaged condition. Based on ease of repair and retention of the aluminum/silicone filler, no leaching should be done prior to repair.

Figure 9.10-7 Typical 20-Layer Borsical[®] Test Specimens After Testing in the As-Impacted Condition Without Repair

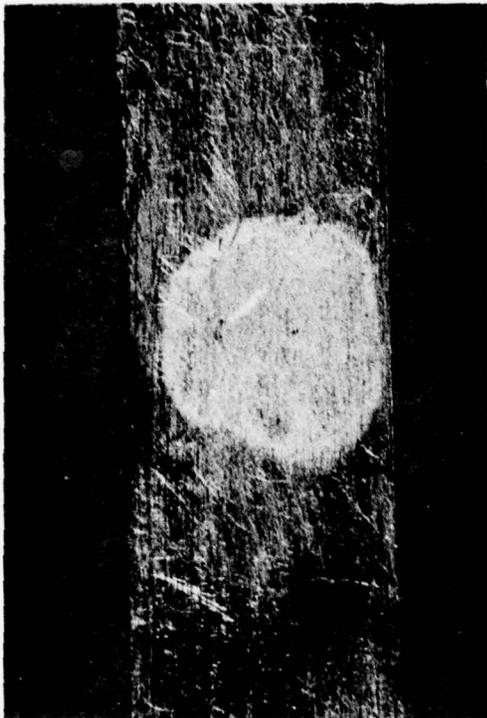
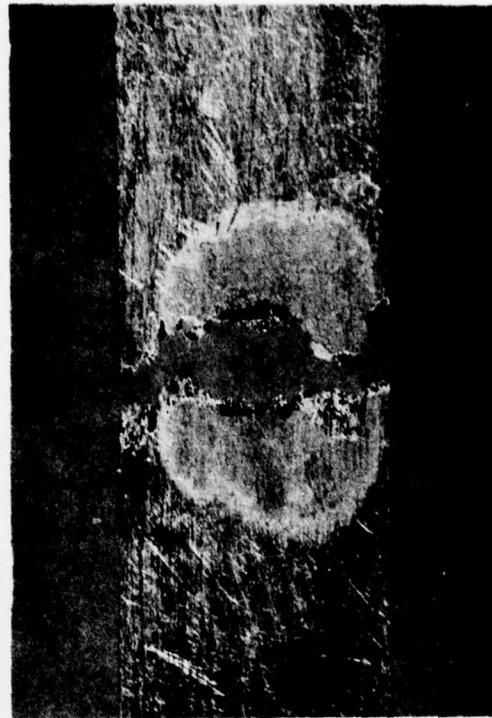
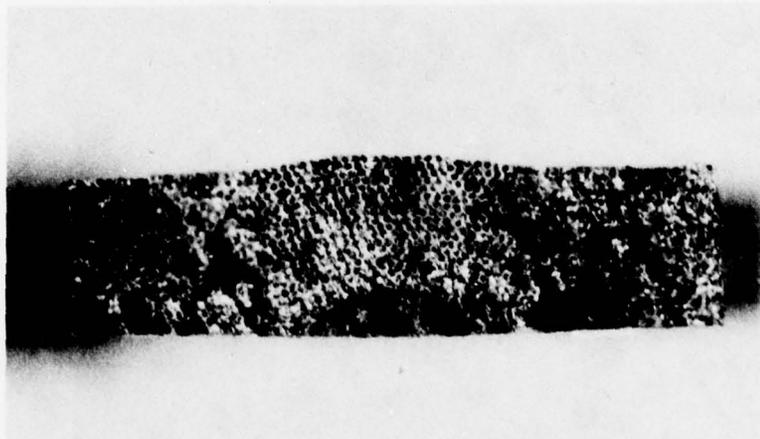
Figure 9.10-8 Typical Unidirectional (0°) 20-Layer Borsical[®] Test Specimen as Repaired with Aluminum/Silicone (Top Left), and as Tensile Tested

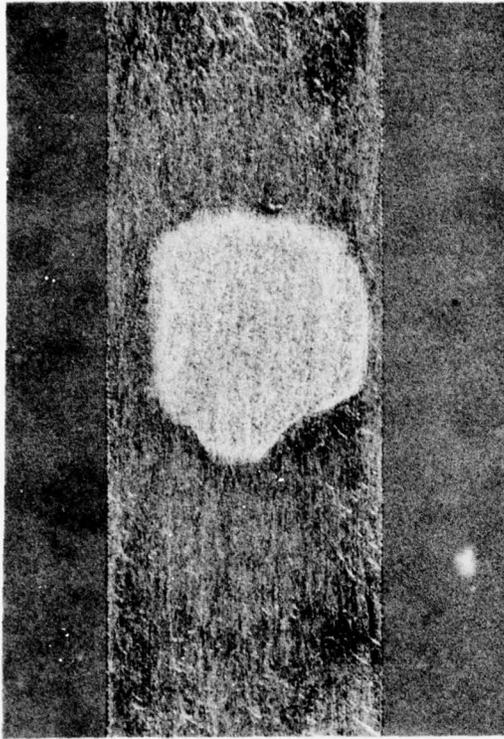
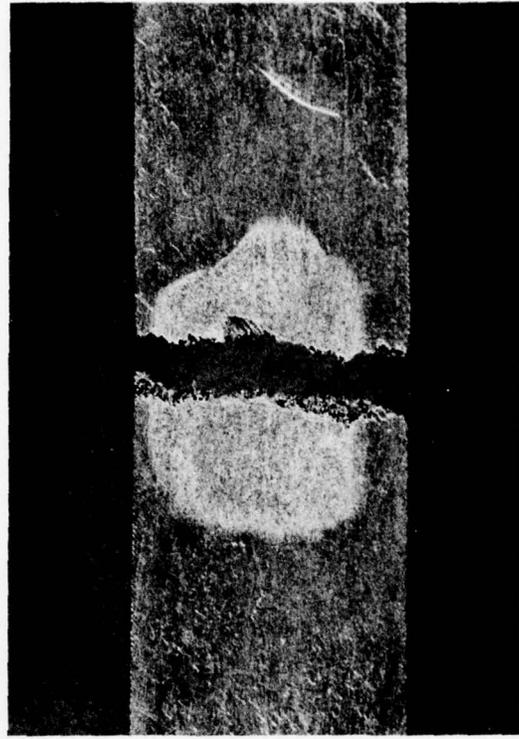
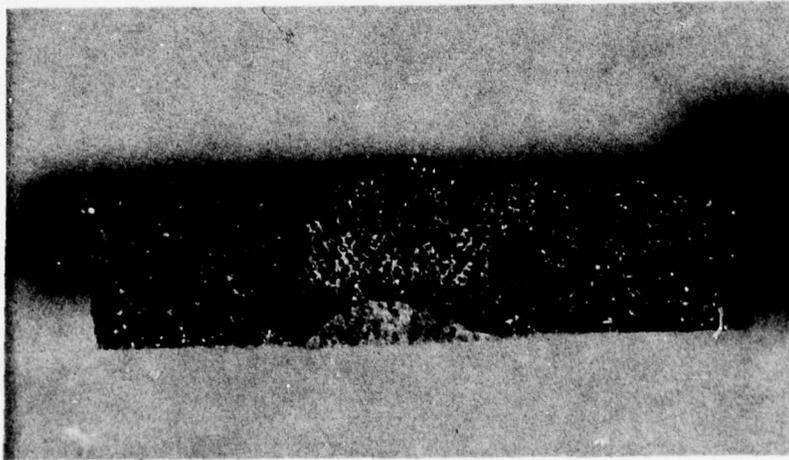
Figure 9.10-9 Typical Component Configuration ($\pm 45^\circ$, 0° , $\pm 45^\circ$), 20-Layer Borsical[®] Test Specimen as Repaired with Aluminum/Silicone (Upper Left), and After Tensile Test. No Leaching Prior to Repair

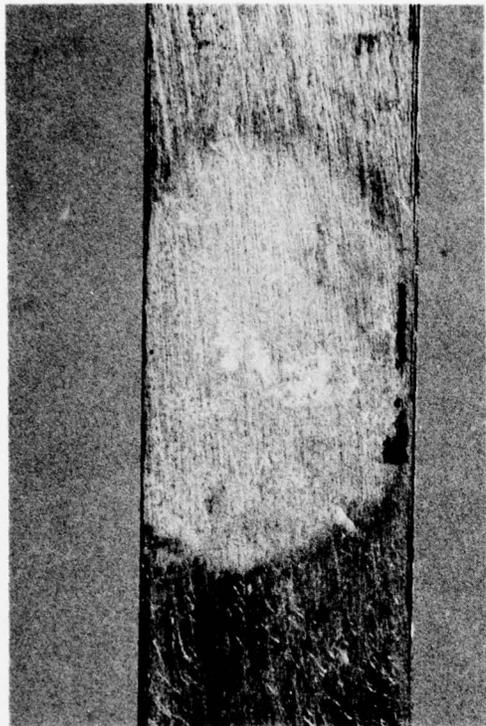
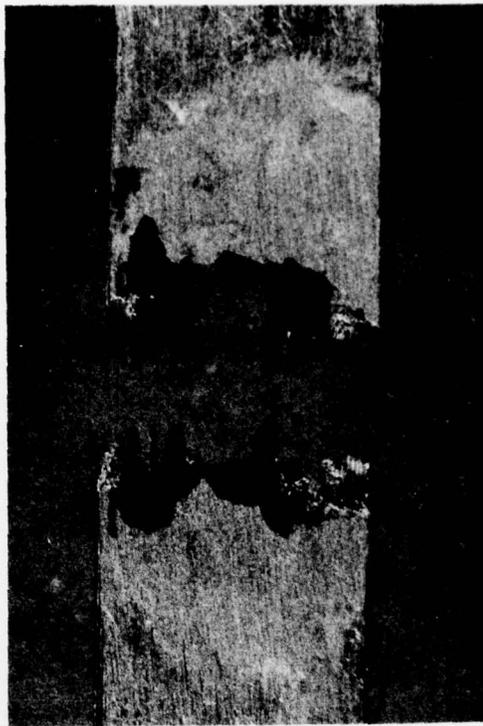
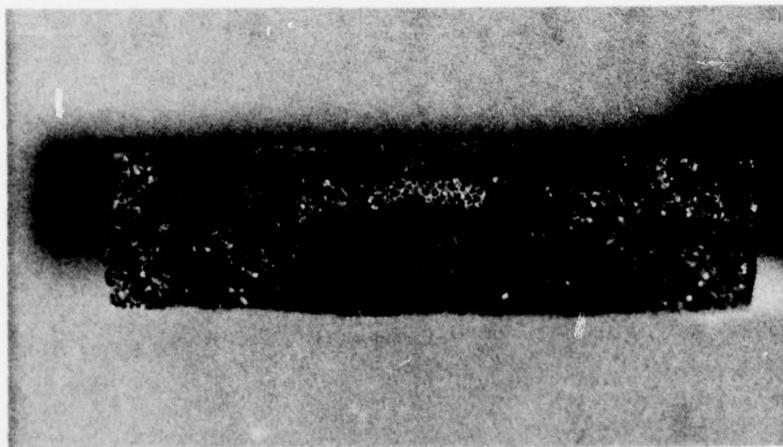
Figure 9.10-10 Typical Unidirectional (0°) 20-Layer Borsical[®] Test Specimen as Repaired with Aluminum/Silicone and After Tensile Test. Damaged Area Removed by Leaching with HCl Prior to Repair

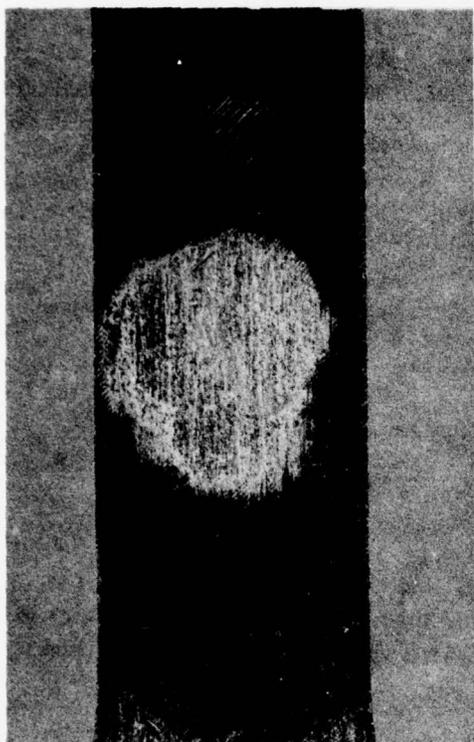
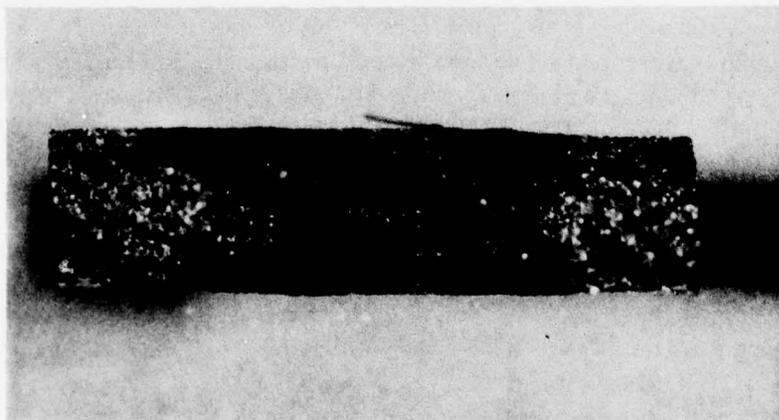
Figure 9.10-11 Typical Component Configuration ($\pm 45^\circ$, 0° , $\pm 45^\circ$), 20-Layer Borsical[®] Test Specimen as Repaired with Aluminum/Silicone and After Tensile Test. Damaged Area Removed by Leaching with HCl Prior to Repair

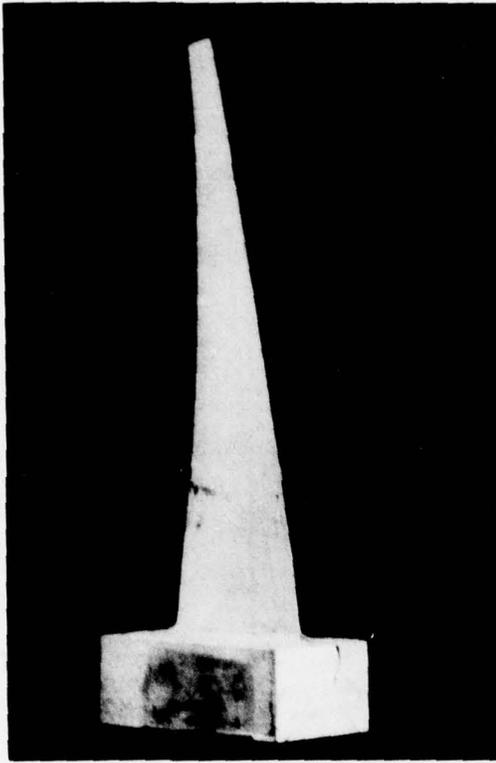
Figure 10.2-1 The BORSIC[®]/Aluminum Blade Showed No Evidence of Significant Salt Corrosion After an Elevated Temperature (500°F), 100-Hour Salt-Stress-Corrosion Test

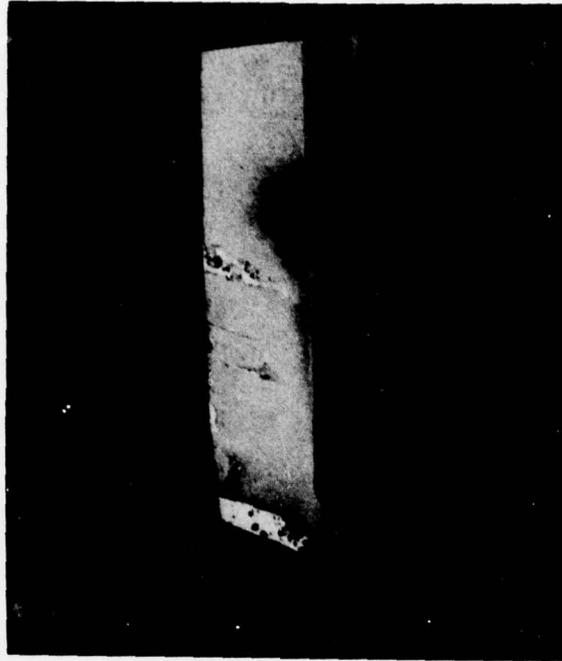
Figure 10.2-5 Concave Side of Composite Fan Blade D-17 Showing Condition After FOD Spin Test. $N = 10,360$ rpm, $T = 70^{\circ}$ F, FOD With 75 grams of Sand (XPN-26814)

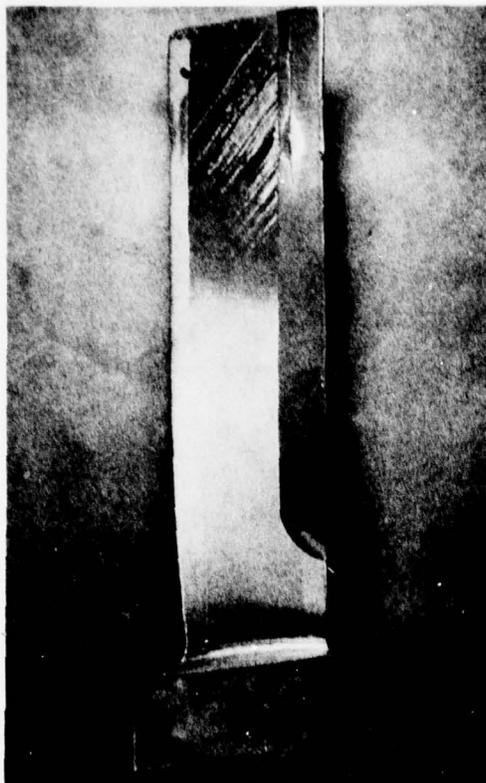
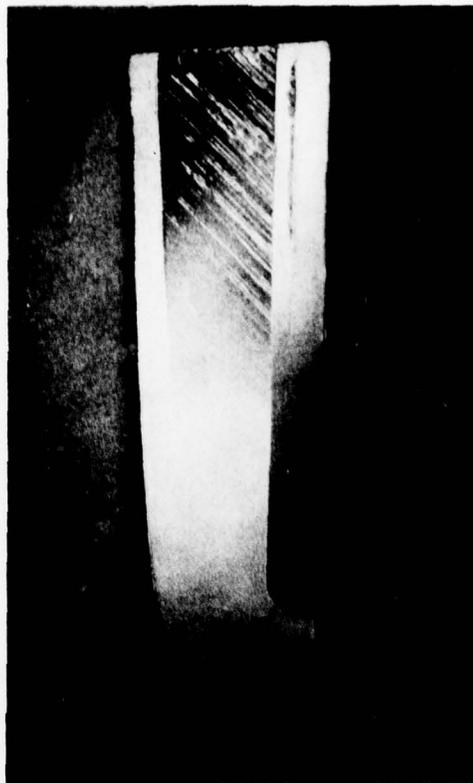
BLADE S-14 ERODED WITH 100 LB
SAND AT 3 LB/MIN

BLADE S-28 ERODED WITH 360 LB
SAND AT 1 LB/MIN

Figure 10.2-7 BORSIC[®]/Aluminum Blades Following Erosion Tests

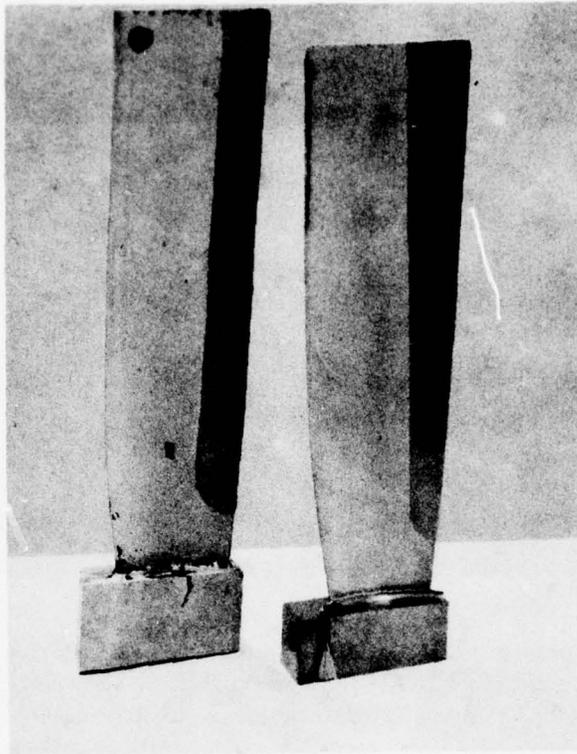
Figure 10.2-8 Comparison of Composite Blades With Nickel-Cobalt Leading Edge Protection; Blade on Right Has Increased Protected Area

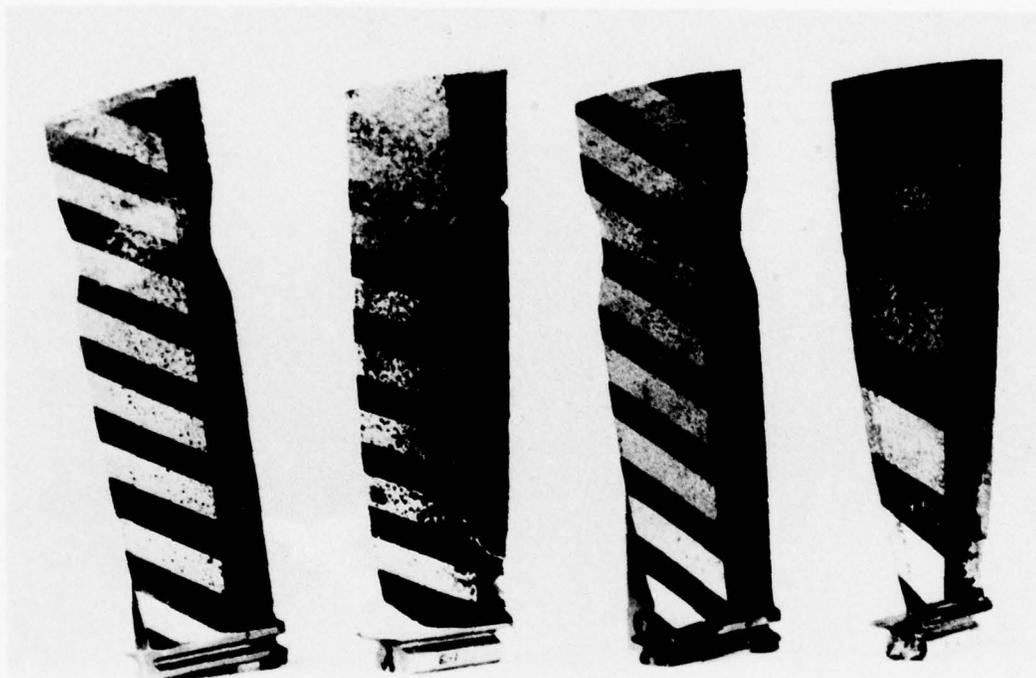
Figure 10.2-13 Comparison of Concave Sides of Bill-of-Material Titanium Fan Blades and BORSIC[®] Fan Blades After 66 Strikes per Blade With 1/4-Inch Quartz Gravel at Room Temperature and at 10,360 rpm

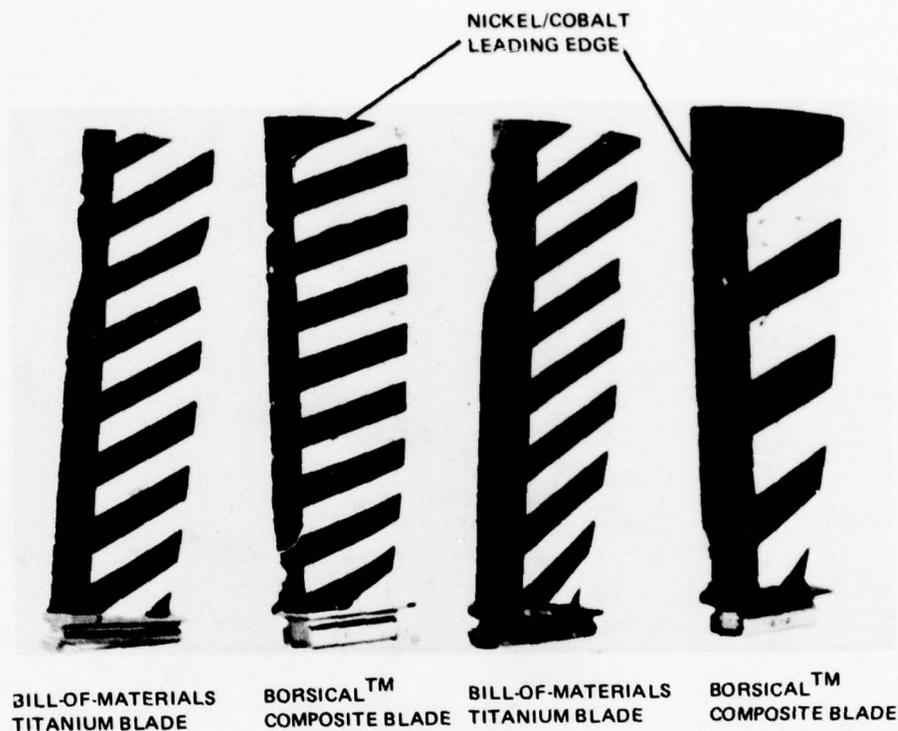
Figure 10.2-14 Comparison of Concave Sides of Bill-of-Materials Titanium Blades and BORSICAL[®] Fan Blades After 66 Strikes per Blade With ¼-Inch Quartz Gravel at Room Temperature and 10,360 rpm

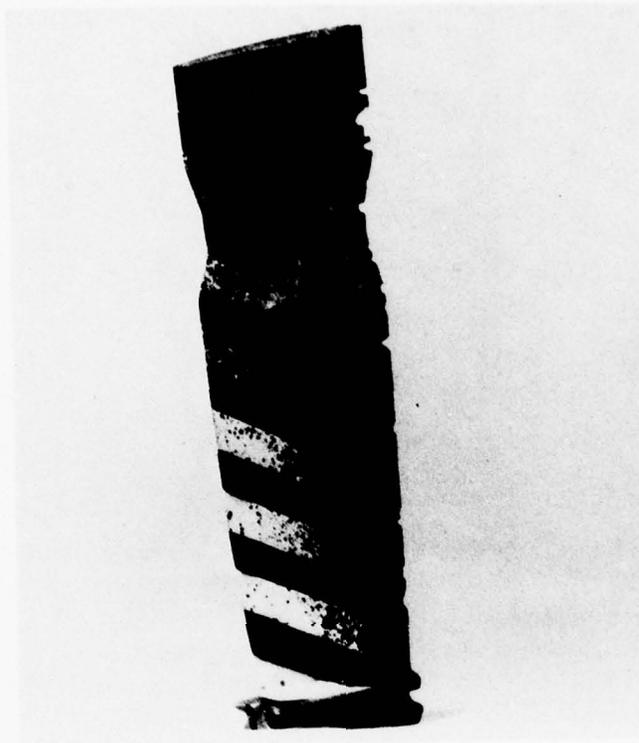
Figure 10.2-15 Appearance of Bill-of-Material Titanium Fan Blade After 23 Strikes With 1/2-Gram Steel Rivet at Room Temperature and at 10,360 rpm.

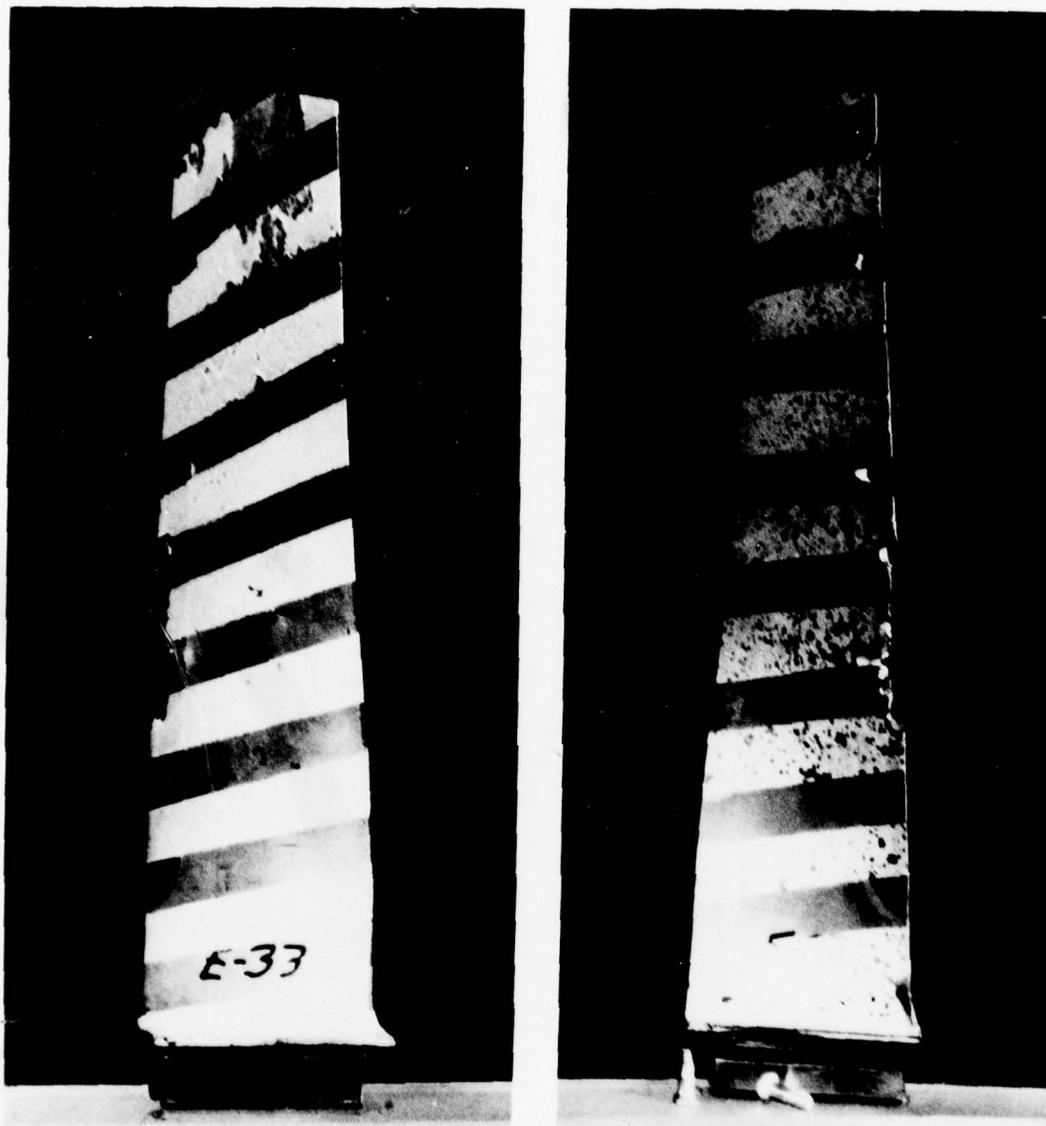
Figure 10.2-16 Appearance of BORSIC[®] Aluminum Fan Blade After 23 Strikes With 1/2-Gram Steel Rivet at Room Temperature and 10,360 rpm. Lost material was about twice that of titanium blade.

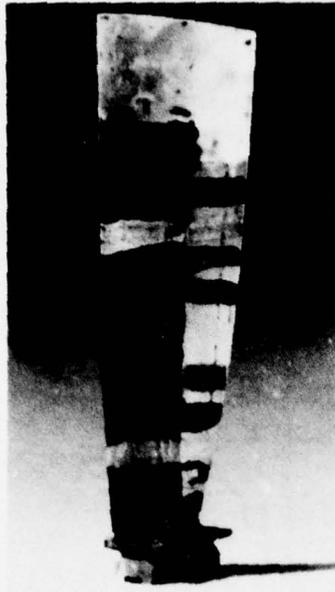
Figure 10.3-10 Blade R-10, an Early Development Blade, Survived an Extensive Spin-Pit Proof Test in Excellent Condition

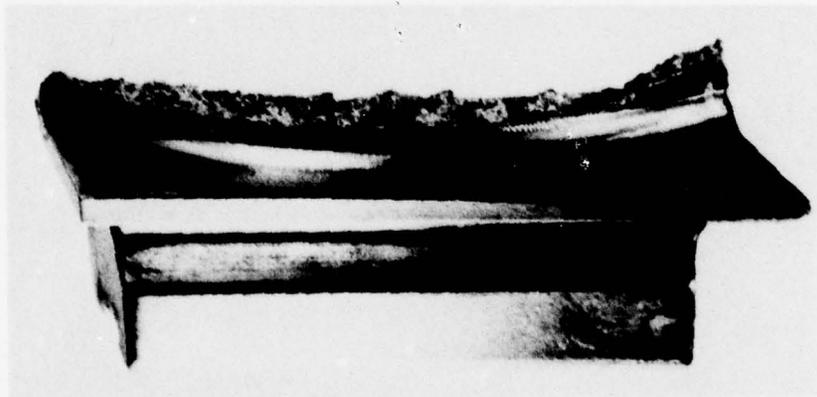
Figure 10.3-11 Typical Failure Mode of BORSIC[®]/Aluminum Fan Blade During Burst Tests

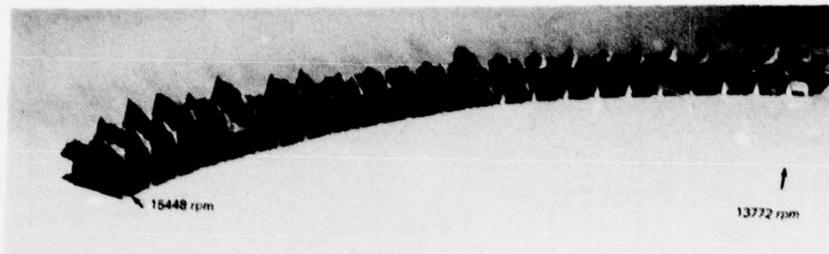
Figure 10.3-12 E-Blade Root Sections Following Burst Test, Arranged in Order of Burst Speed (XPN-31709)

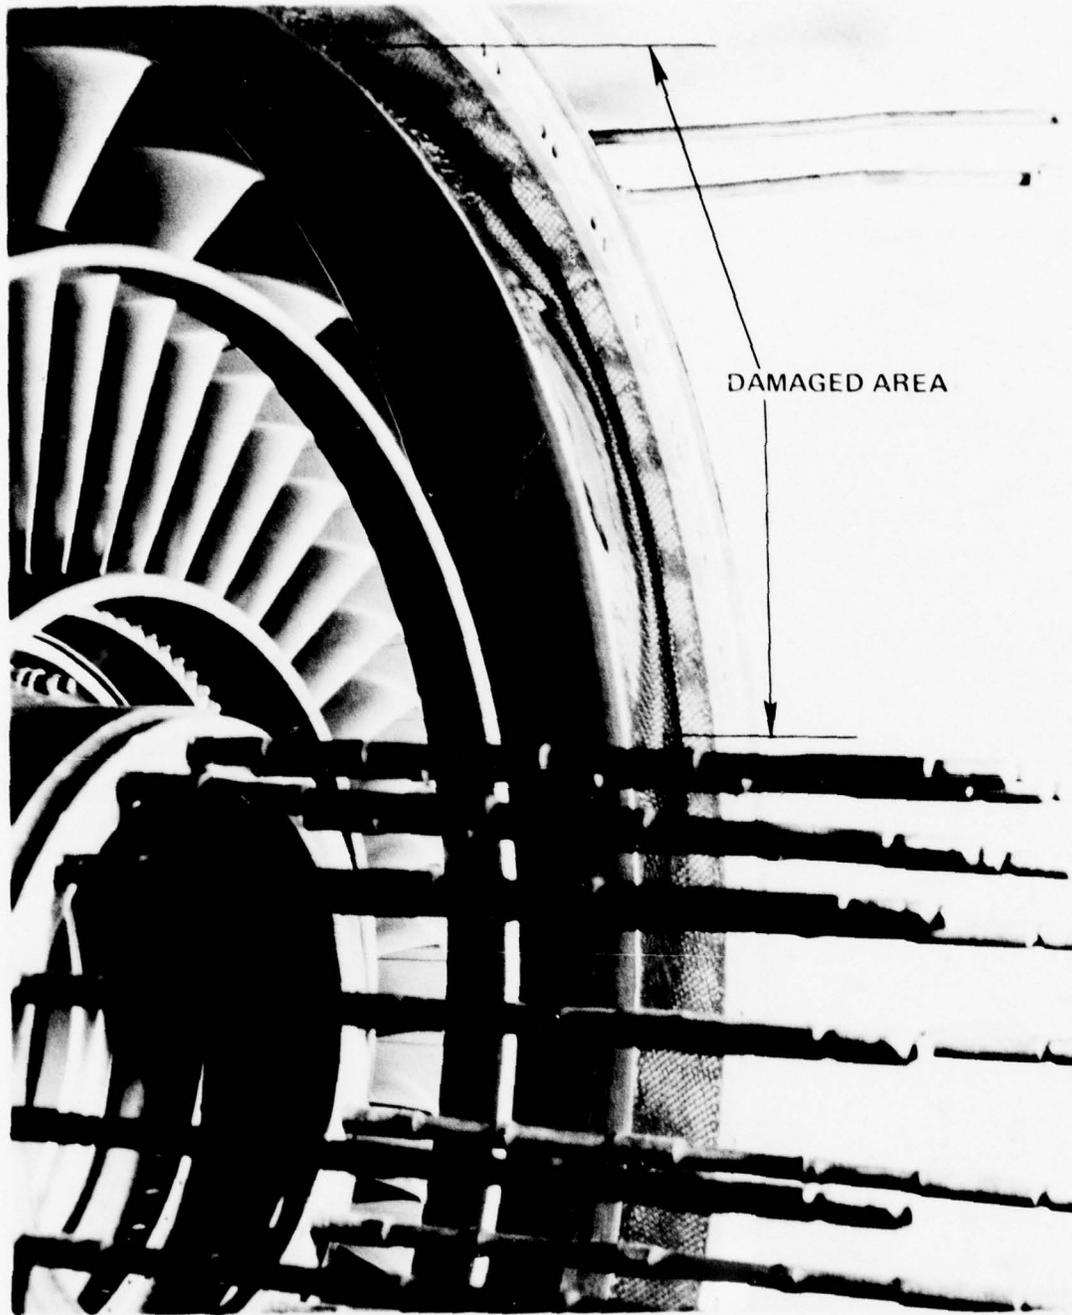
Figure 11.2-4 0.090-Inch Deep Tip Rub Area on TF30-P-9 Engine Fan Case

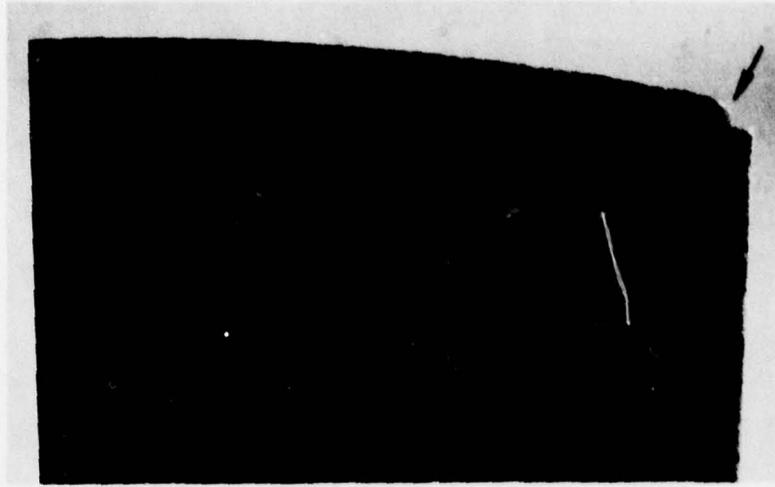
Figure 11.2-11 Damaged Area at Blade Tip Convex Side, Due to Rubbing Contact With Compressor Case

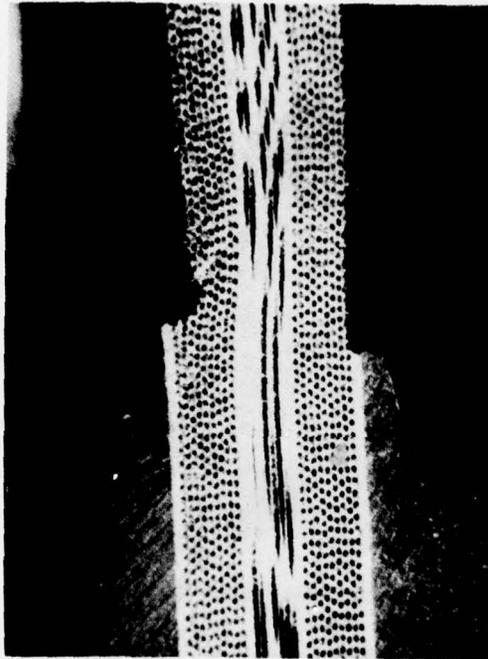
Figure 11.2-14 Vertical Plane Cross-Sectional View Shows the Misalignment of Root Blocks Toward the Leading Edge Area of the Blade as Well as Deformation of Plies Just Above Root Blocks

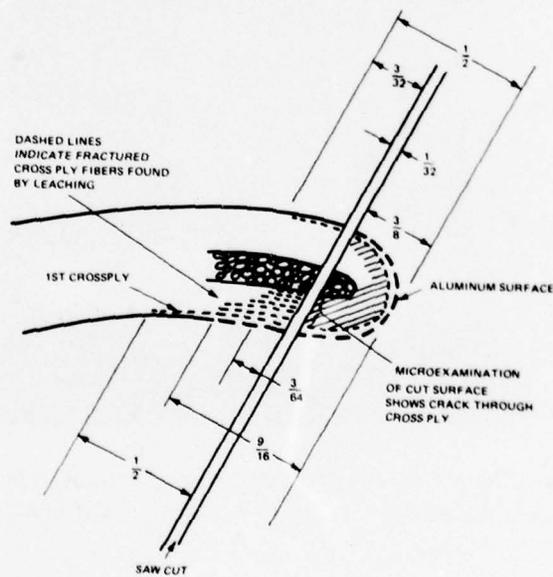
Figure 11.2-15 Nominal Dimensions of Sections Examined by Microexamination and Leaching/ Crossply Removal; Dashed Lines Represent the Extent of Damage Due to Overstressing at the Blade Root; Shaded Area Indicates Probable Damage in Microsection

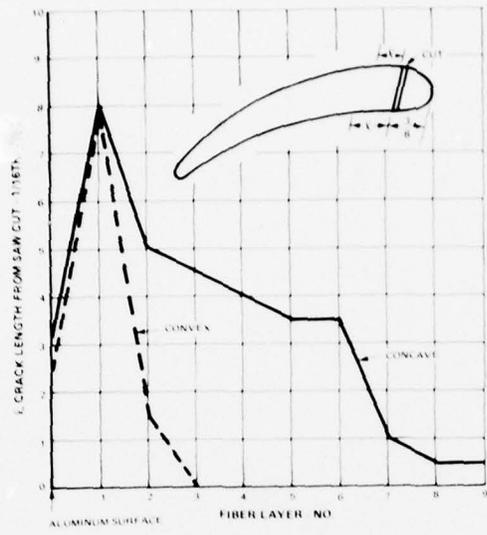
Figure 11.2-16 Correlation of Crack Length and Fiber Layer on Concave Side of Blade

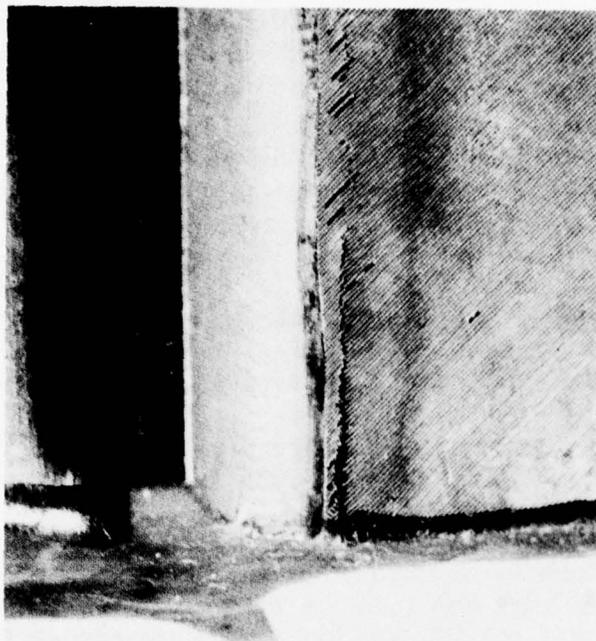
Figure 11.2-18 Fractured Fibers in First Crossply of Concave Side After Leaching and Removing Leading Edge Pieces; Damage Was More Extensive Than on Convex Side

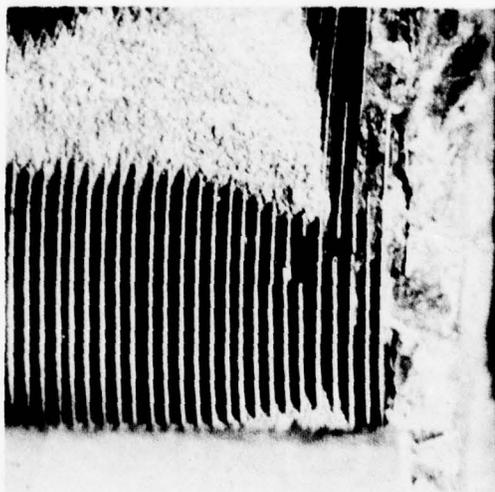
Figure 11.2-19 First Longitudinal Fiber Layer on Concave Side Shows Only Slight Damage Above Plane of Dominant Crack
