**FINAL REPORT
FOR
TF30 THIRD-STAGE COMPOSITE FAN BLADE
SERVICE PROGRAM
Contract No. F33657-70-C-0624**

David G. Randall
Pratt & Whitney Aircraft Group
United Technologies Corporation
East Hartford, Connecticut 06108

15 May 1978

Final Report for Period 1 July 1970 - 31 December 1977

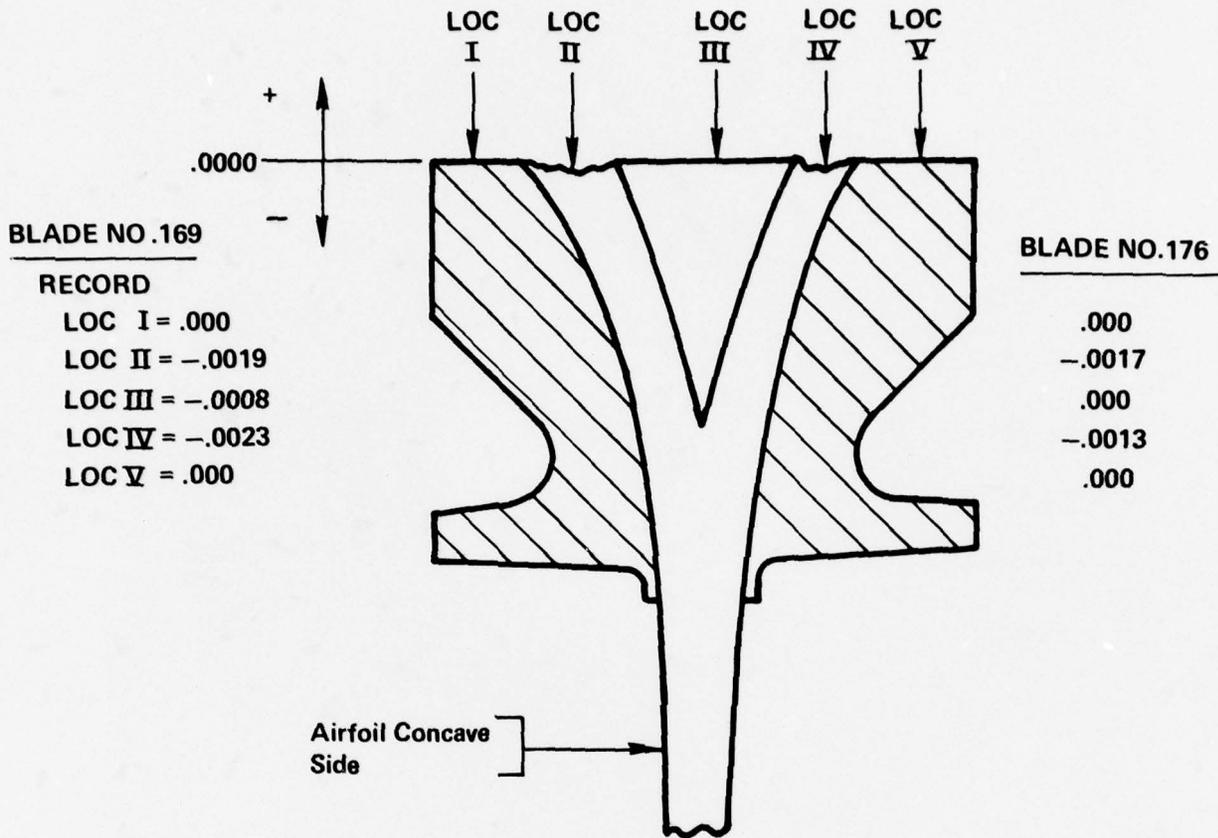
Figure 12-9 Root Deformation

A second indication of structural distress was found on 12 blades at the base of the dovetail (Figure 12-9). This took the form of relative displacement of the composite portion of the dovetail with respect to the root pads and wedge. It might best be described as a shear yielding of the composite airfoil root. In most blades affected, it was very minor, but in two blades it was measurable. These two blades were E-169 and E-176. The maximum measured deformation in these two blades was 2.3 mils in blade E-169, and 1.7 mils in blade E-176 (Figure 12-9).
