ABSECON CREEK WEST BRANCH, ATLANTIC COUNTY

# DOUGHTY POND UPPER

## PHASE I INSPECTION REPORT NATIONAL DAM SAFETY PROGRAM

NJ 00081

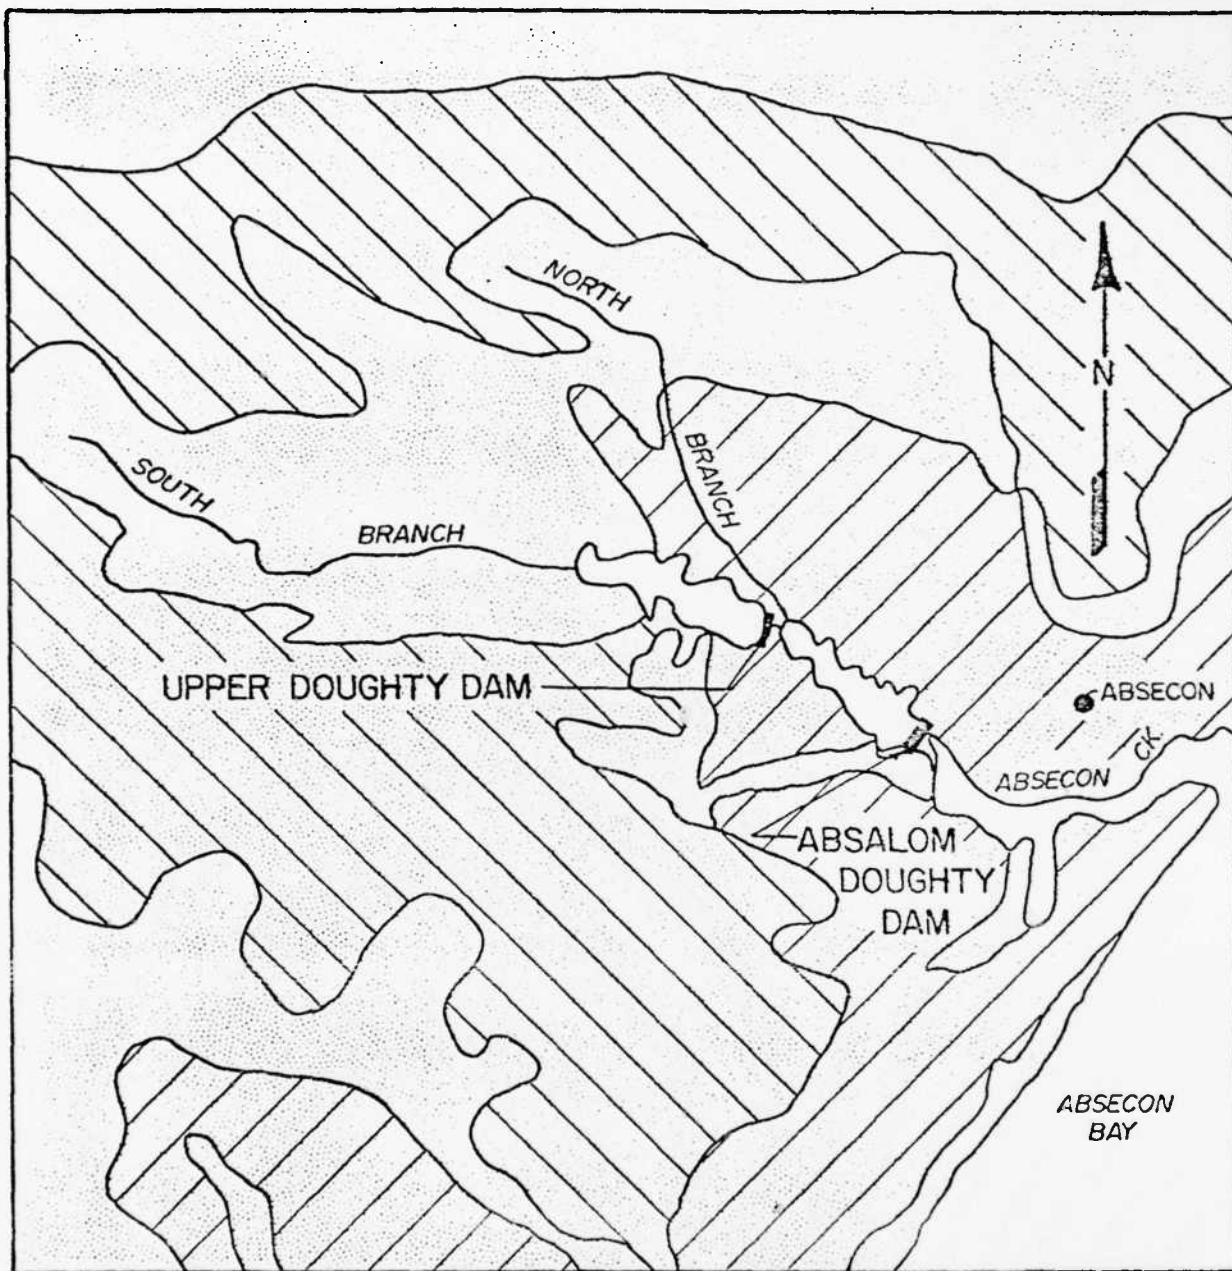
FIGURE 3  
GEOLOGIC MAP

As shown on Figure 3, the dam is physically set and constructed in sands and gravels of the Quaternary Cape May formation indicated on the "State of New Jersey Geologic Map." Underlying this surficial unit, and in unconformable contact are the remnants of the Quaternary Bridgeton formation and the Tertiary Cohansey formation, the latter being the predominant substructure feature which slips very gently east and southeastward. All geologic units involved consist of predominantly cohesionless and erodible sediments with occasional clay units occurring as lenses of variable thickness and erratic areal distribution.
