# WHITE'S POND DAM

## PHASE I INSPECTION REPORT

## NATIONAL DAM SAFETY PROGRAM

NJ00233

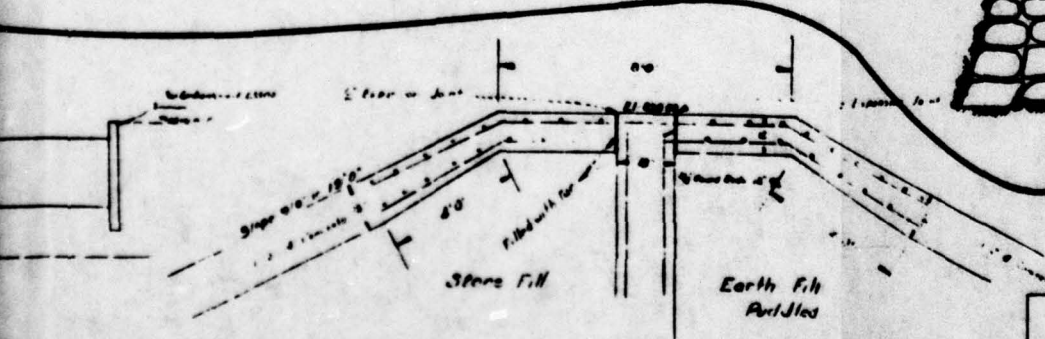
**D-D  
SECTION AT SPILLWAY**  
Scale 1" = 10'

Downstream of the spillway, a short 14-foot stilling basin has been provided in the 1976 reconstruction containing chute blocks, baffle blocks and a sloping end sill, keyed approximately 3 feet into the channel bottom of Hohokus Creek. A short 7-foot wide section of the downstream spillway chute concrete protection slab was replaced in 1976 to provide a proper connection between the original construction and the new stilling basin (see Section D-D on Drawing 7).
