CHARLOTTEBURG DAM

PHASE I INSPECTION REPORT

NATIONAL DAM SAFETY PROGRAM

(NJ00316)

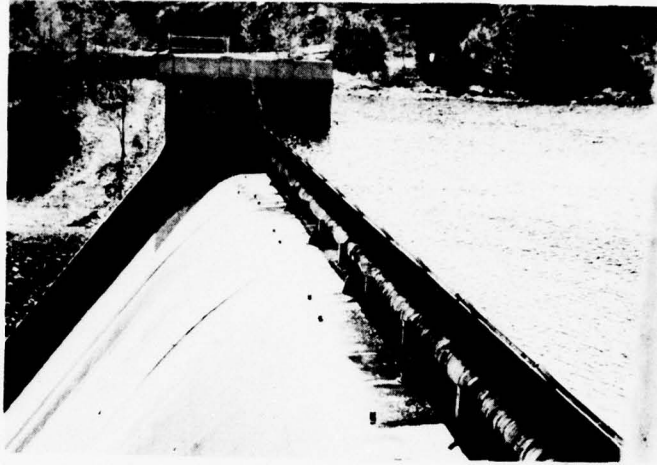
Photo 1 - View of spillway and bascule crest gate
looking toward right abutment

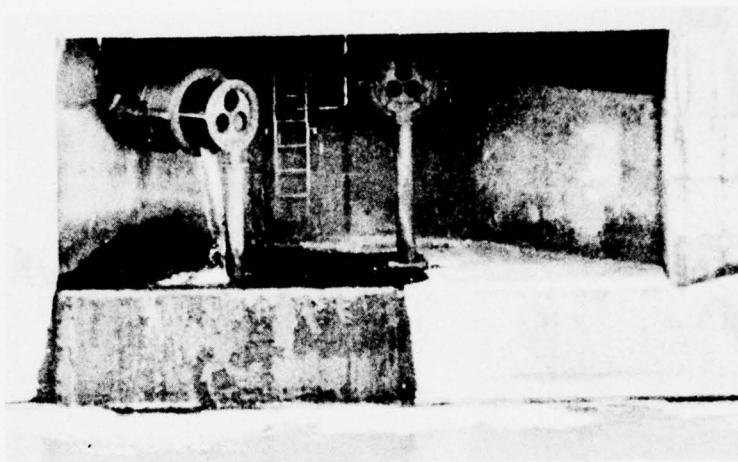
| VISUAL EXAMINATION OF | OBSERVATIONS | REMARKS AND RECOMMENDATIONS |
|--|---|--|
| CRACKING & SPALLING OF CONCRETE SURFACES IN STILLING BASIN | Stilling basin concrete is good on the side walls. The baffle blocks and end sill are not visible for inspection due to normal tailwater. The hollow cone discharge valve recess in the left stilling basin wall has concrete sur-faces in good condition. | Recommend owner dewater and inspect stilling basin floor, check blocks and end sill at convenient time for his operations within one calendar year and file report with Corps of Engineers |

Photo 7 - Left stilling basin wall showing recess for 30-inch diameter hollow cone valve from 48-inch diameter by-pass line (left) and 24-inch diameter hollow cone valve for draining of 54-inch diameter raw water line (right)

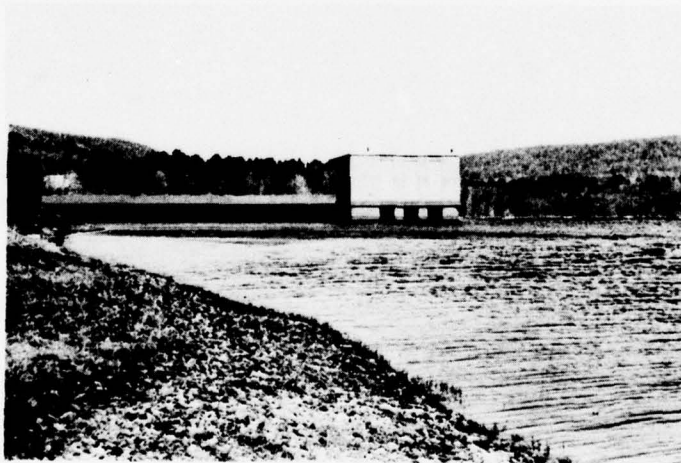
Photo 8 - Upstream view of left abutment, showing the Intake and Gate House

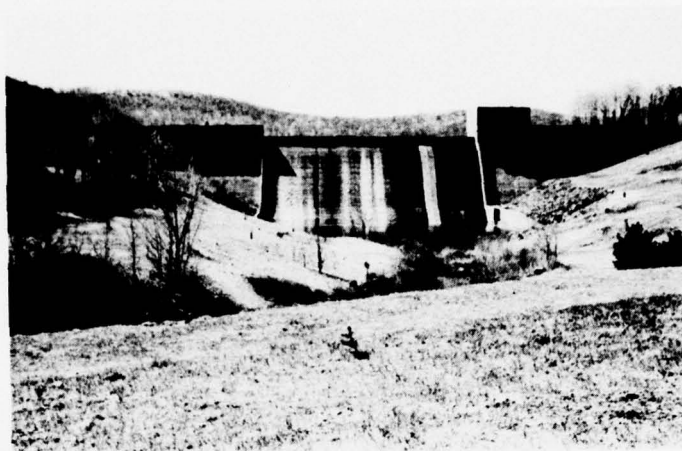
Photo 9 - General view of dam from downstream

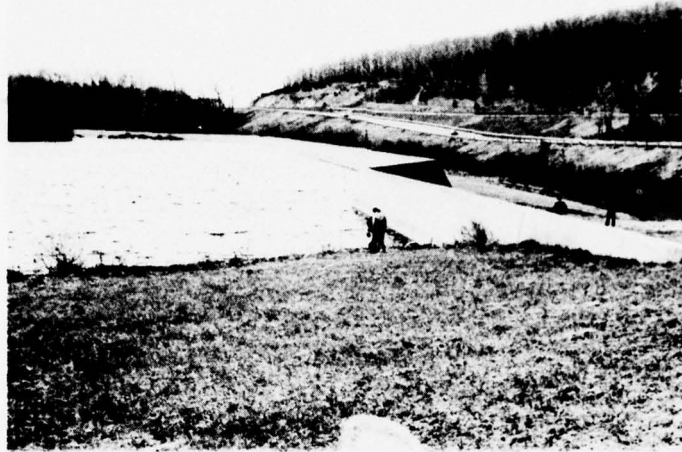
| VISUAL EXAMINATION OF | OBSERVATIONS | REMARKS OR RECOMMENDATIONS |
|---|--|--|
| VERTICAL & HORIZONTAL ALIGNMENT | <p><u>Main Dam:</u> All alignments seem very good.</p> <p><u>River Wall:</u> A slight horizontal misalignment in monoliths approx. 200 ft. from east end of river wall is visible when sighting along the top of the wall.</p> | Cause for misalignment should be investigated further. |

Photo 11 - River Wall - General view of River Wall
looking upstream and north-west along the
Pequannock River

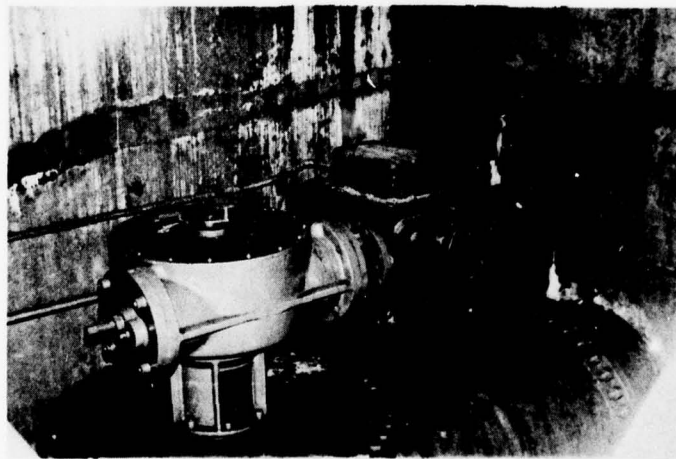
| VISUAL EXAMINATION OF | OBSERVATIONS | REMARKS AND RECOMMENDATIONS |
|--|---|--|
| OUTLET FACILITIES | A 54-inch diameter raw water supply line is served by twin 48-inch diameter passes each with a 30-inch diameter cone valve and a 48-inch diameter emergency slide gate. A 48-inch diameter by-pass outlet is provided to dewater the dam, outletting in a 30-inch diameter hollow cone valve. | No action required. Repair lubricating oil leak in 30-inch diameter hollow cone valve. |

Photo 14 - Valve shaft and 30-inch diameter cone valve
on right side 48-inch diameter pass of raw
water line; looking upstream

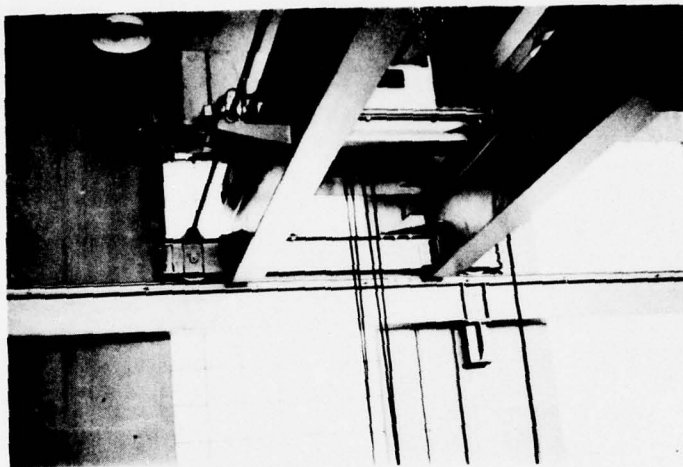
Photo 15 - Intake and Gate House - Overhead crane for lifting of emergency Broome Gate

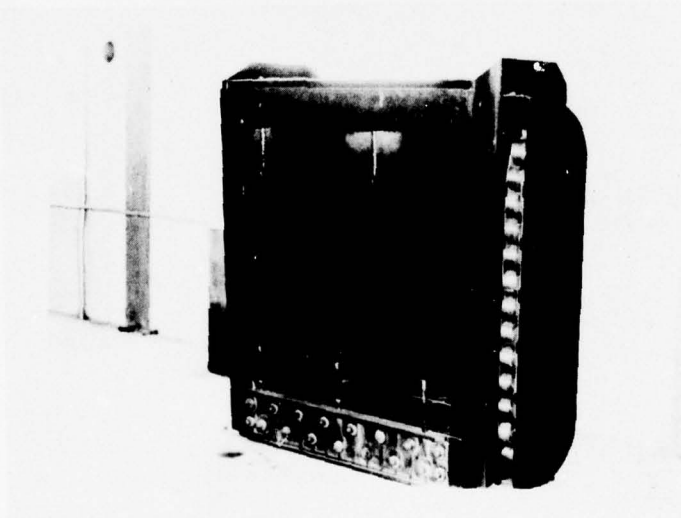
Photo 16 - Intake and Gate House-Floor at Elevation 750.5, Broome gate for emergency closure of the twin 48-inch raw water passes and the 48-inch by-pass line. Lifting beam for the Broome gate is stored below the floor at elevation 750.5.

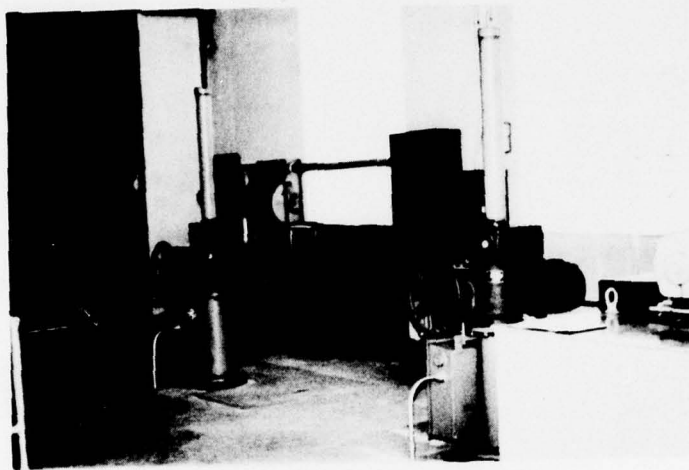
Photo 17 - Intake and Gate House - Floor at elevation 750.5,
Motor operated 48-inch slide gates downstream
of the 30-inch diameter cone valves for closure
of the twin 48-inch passes of the 54-inch raw
water line

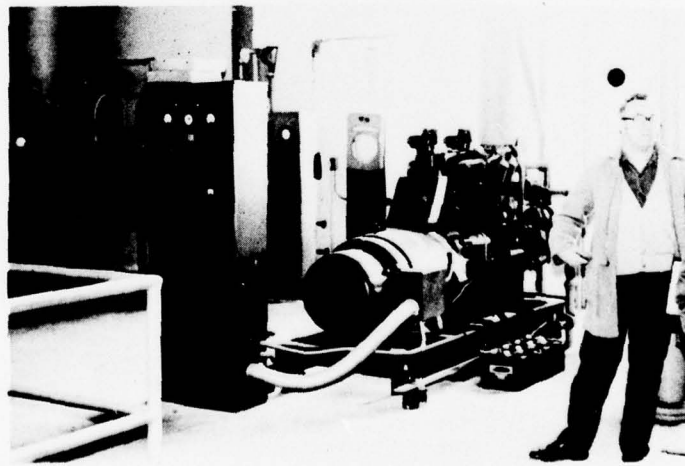
Photo 18 - Intake and Gate House - Floor at elevation 750.5,
Emergency motor generator set

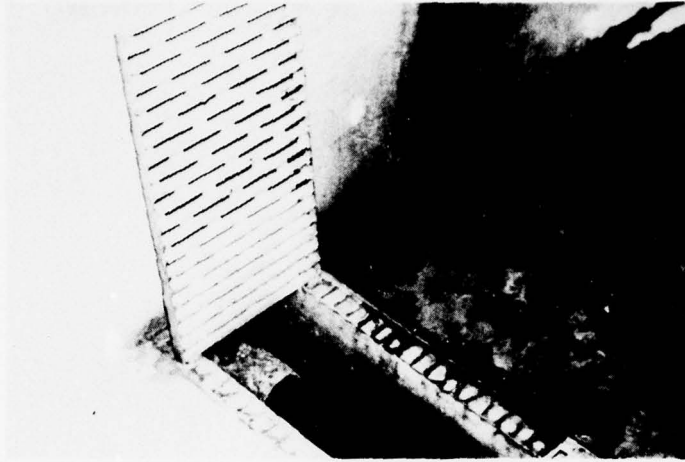
Photo 19 - Lower Inspection Gallery - Typical joint drain;
looking upstream at joint (to left of drain)

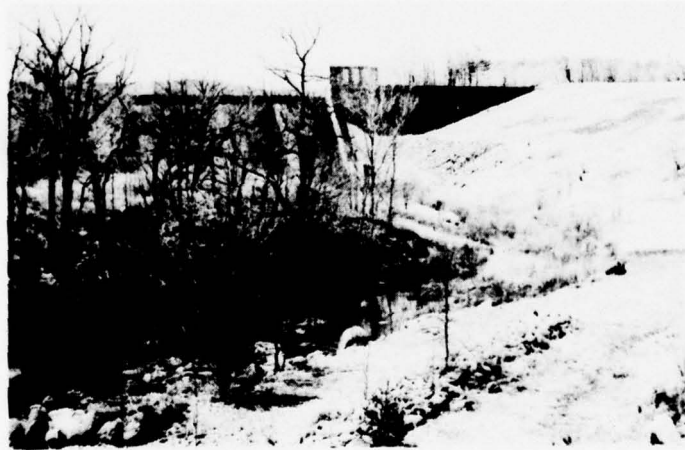
| VISUAL EXAMINATION OF | OBSERVATIONS | REMARKS AND RECOMMENDATIONS |
|--|---|---|
| CONDITION (OBSTRUCTIONS, DEBRIS, ETC.) | There is a well defined channel and overbank valley for 1,000 feet downstream of the dam. Channel has a stony bottom. There are no signs of erosion or undercutting. | No action required. |

Photo 20 - View of downstream channel below dam; stony
invert, well defined overbank valley
