MISPILLION RIVER, KENT COUNTY
DELAWARE, MD

(2) HAVEN LAKE DAM (DE 00042)

(4) PHASE I INSPECTION REPORT

(1) NATIONAL DAM SAFETY PROGRAM

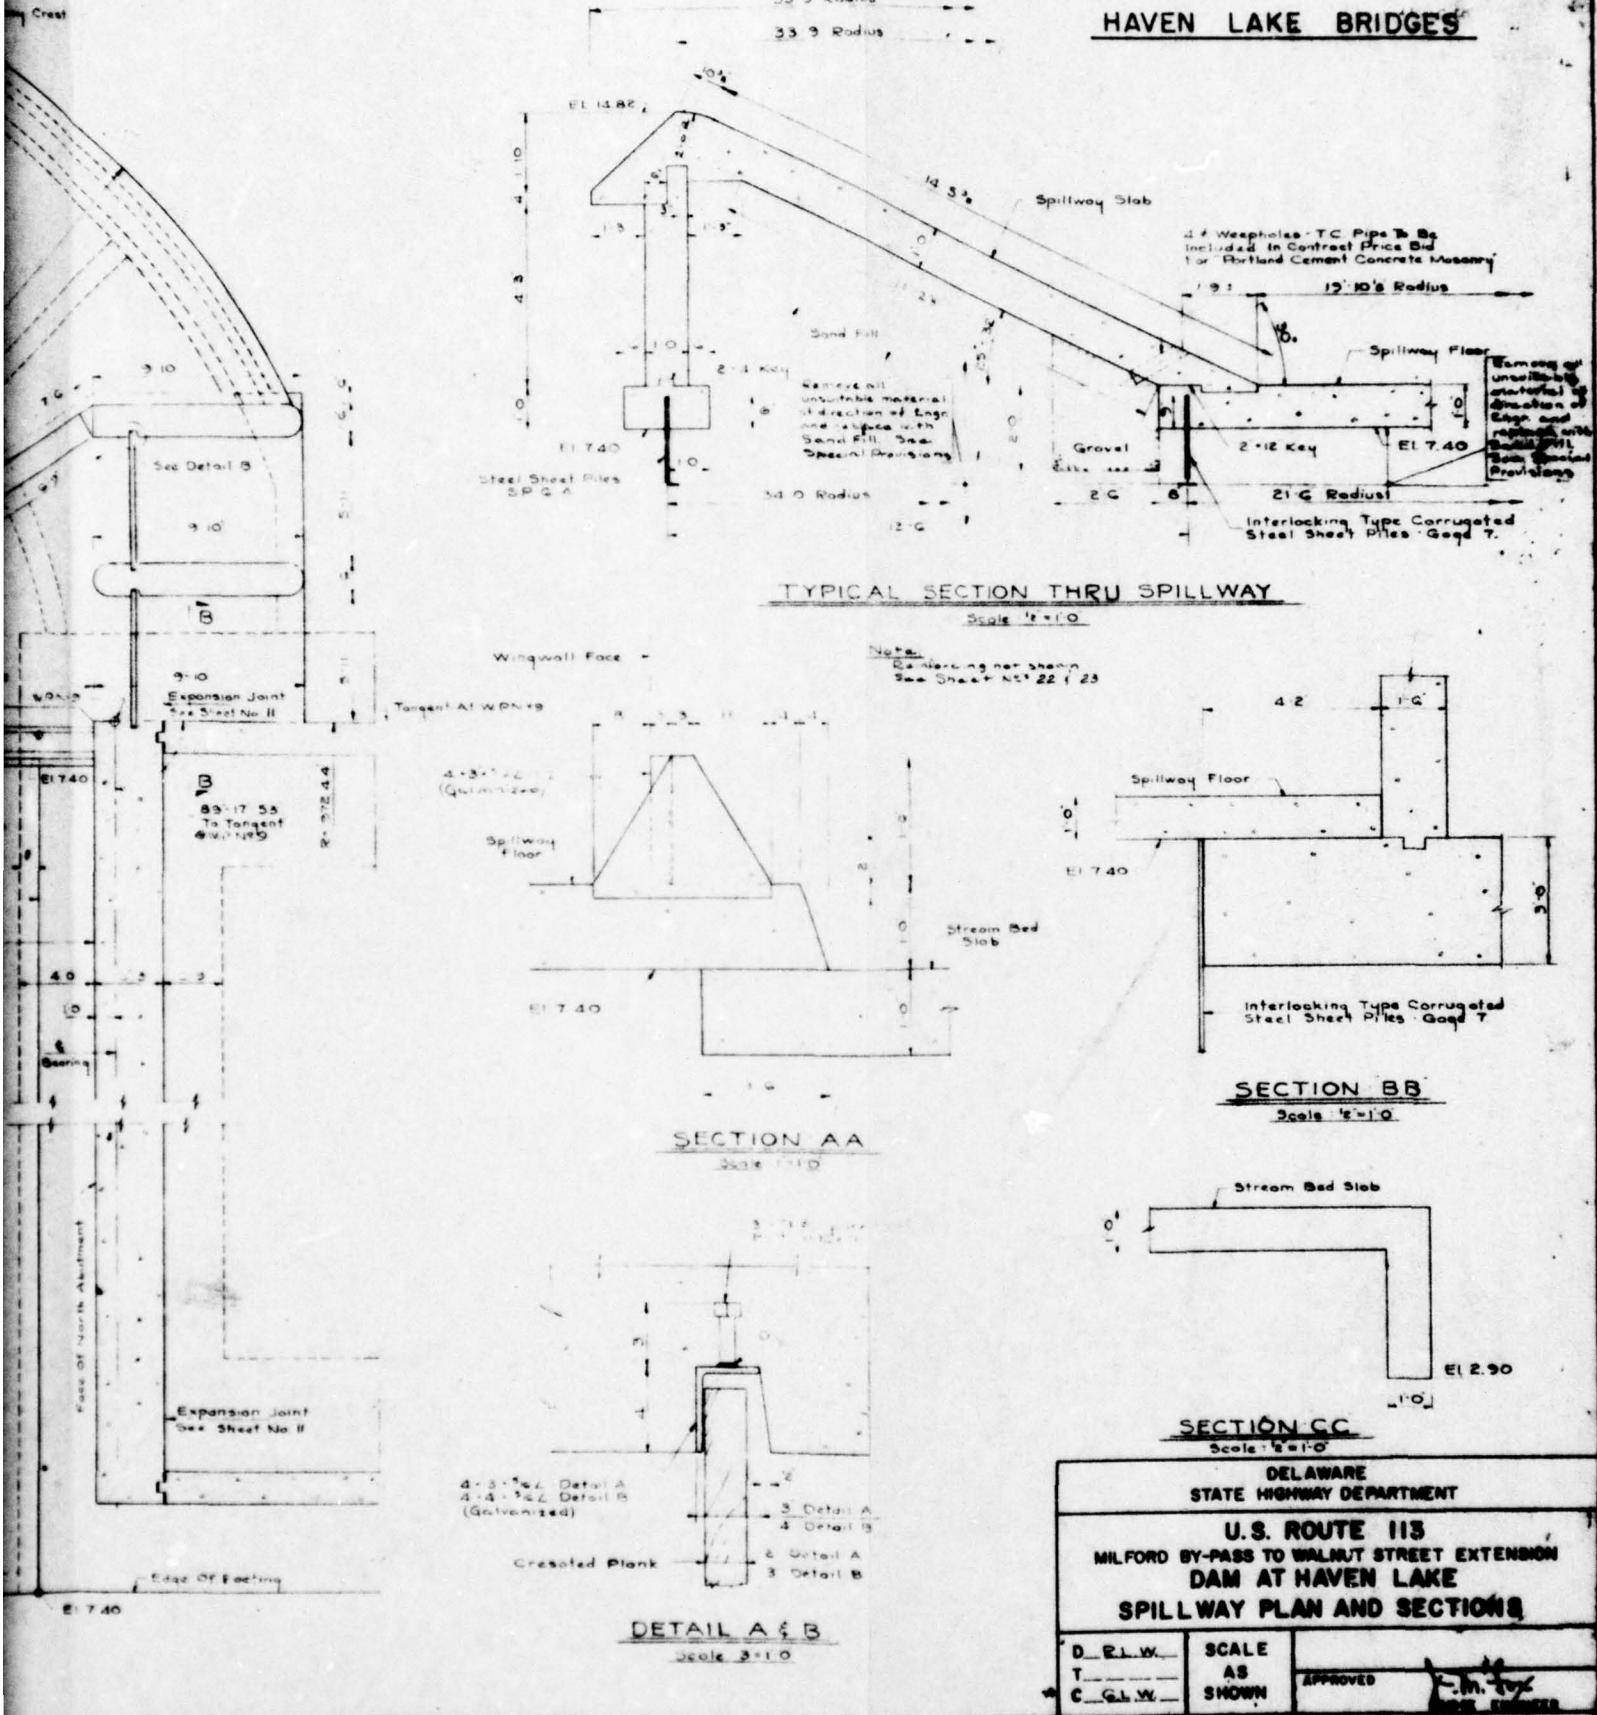
FIGURE 3

b. Design and Construction Data - The spillway is a semi-circular reinforced concrete lined structure with a maximum width at its base of 12.5 feet and a height of 7.42 feet. The inner cavity of the spillway was cleared of all unsuitable material and filled with sand and gravel (see Figure #3). Since the spillway is an integral part of the upstream face of the southbound Route #113 bridge span and the northbound bridge span is immediately downstream, the entire structure appears to be stable under flooding conditions. Four sluiceways are provided for drawdown, two on each end of the spillway. The pool elevation is controlled by seven wooden stop logs in each sluiceway. Each stop log is 6'-5" x 11 $\frac{1}{4}$ " x 3" in size and is creosoted.

Available in As Built Drawings, see Figure #3.
