MISPILLION RIVER BASIN

SILVER LAKE DAM

PHASE I INSPECTION REPORT NATIONAL DAM SAFETY PROGRAM

JUNE 1978

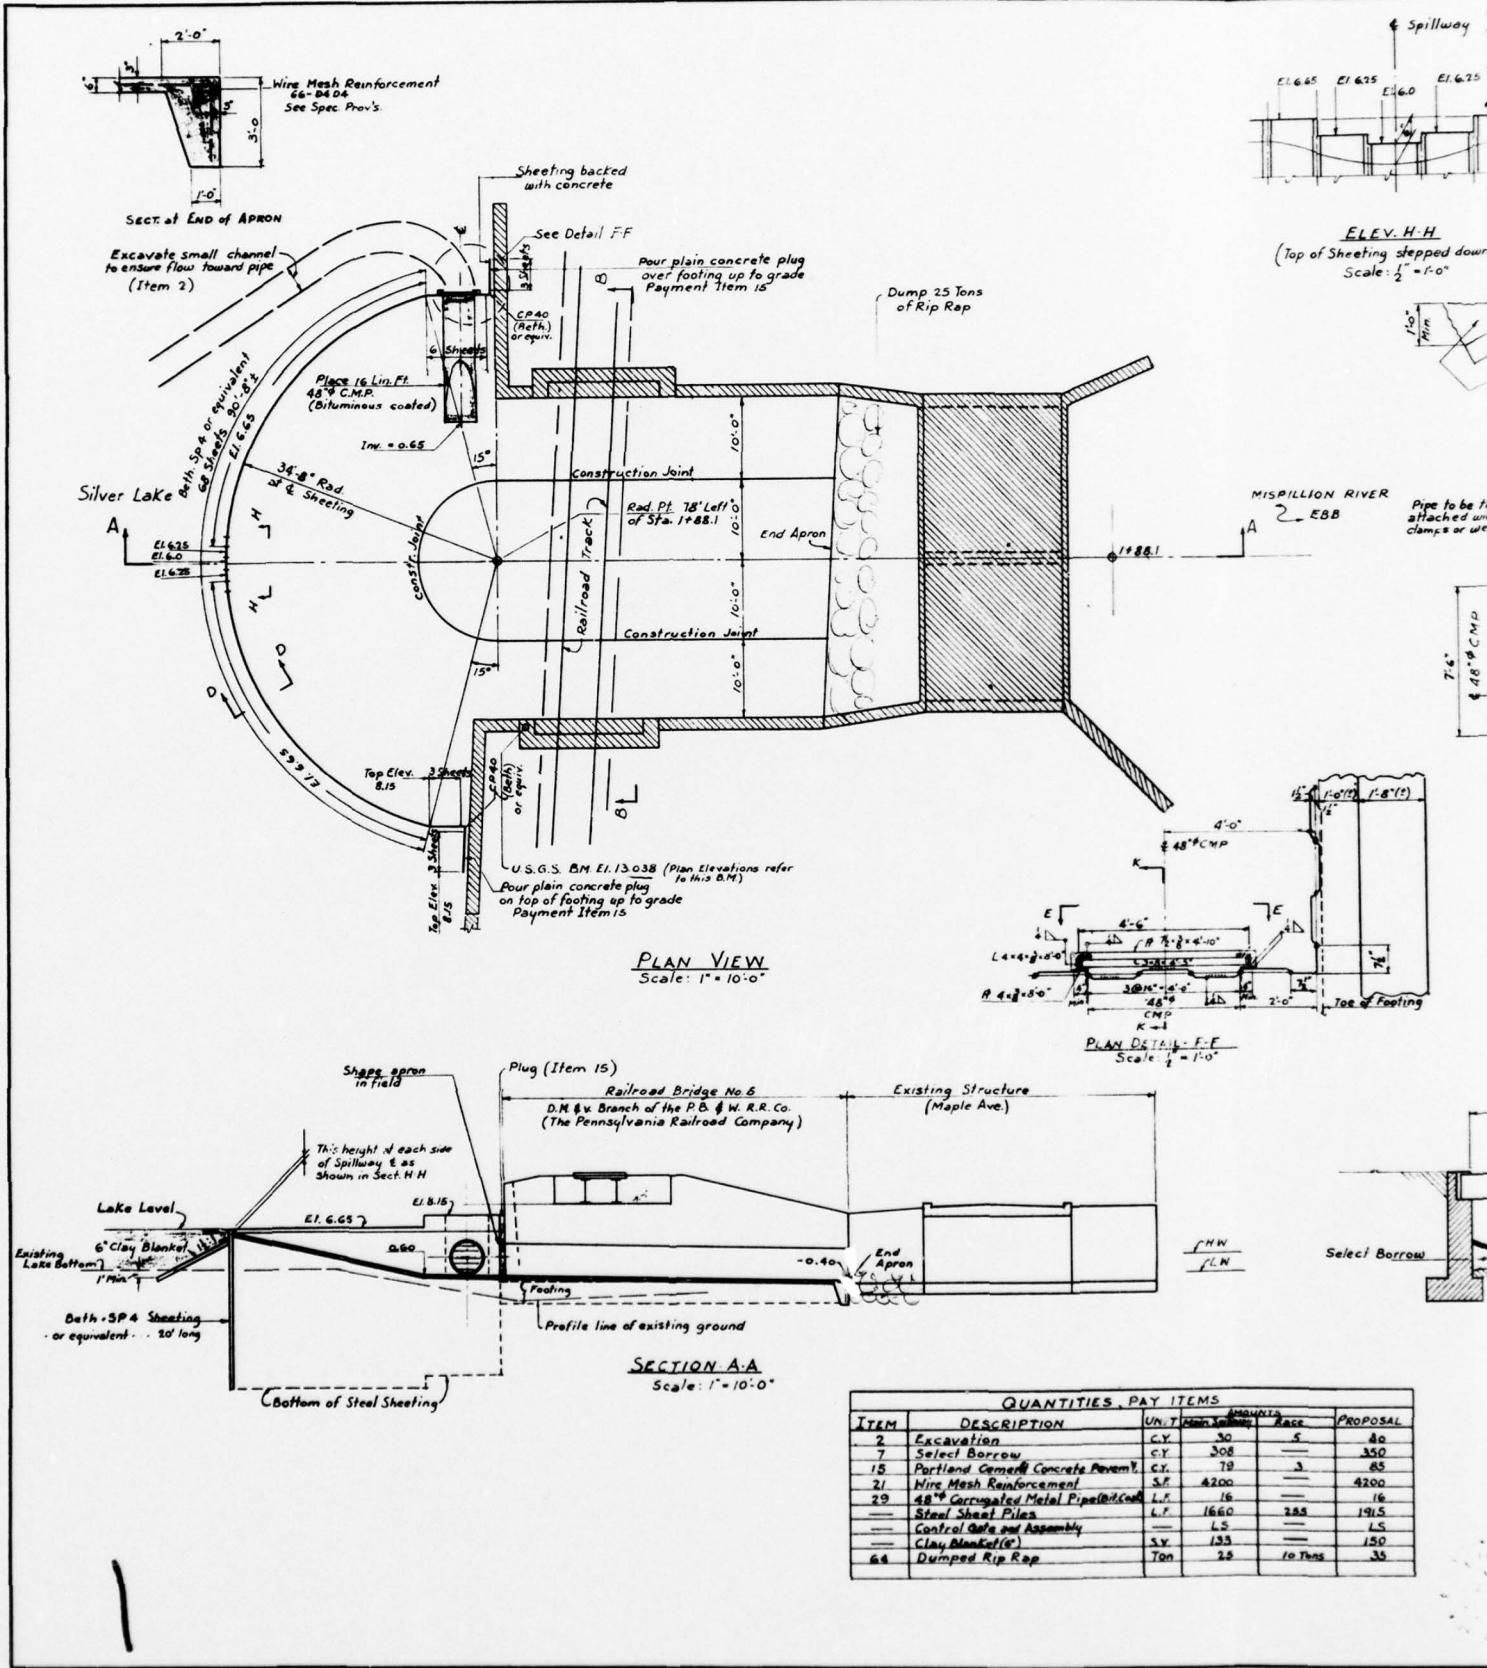
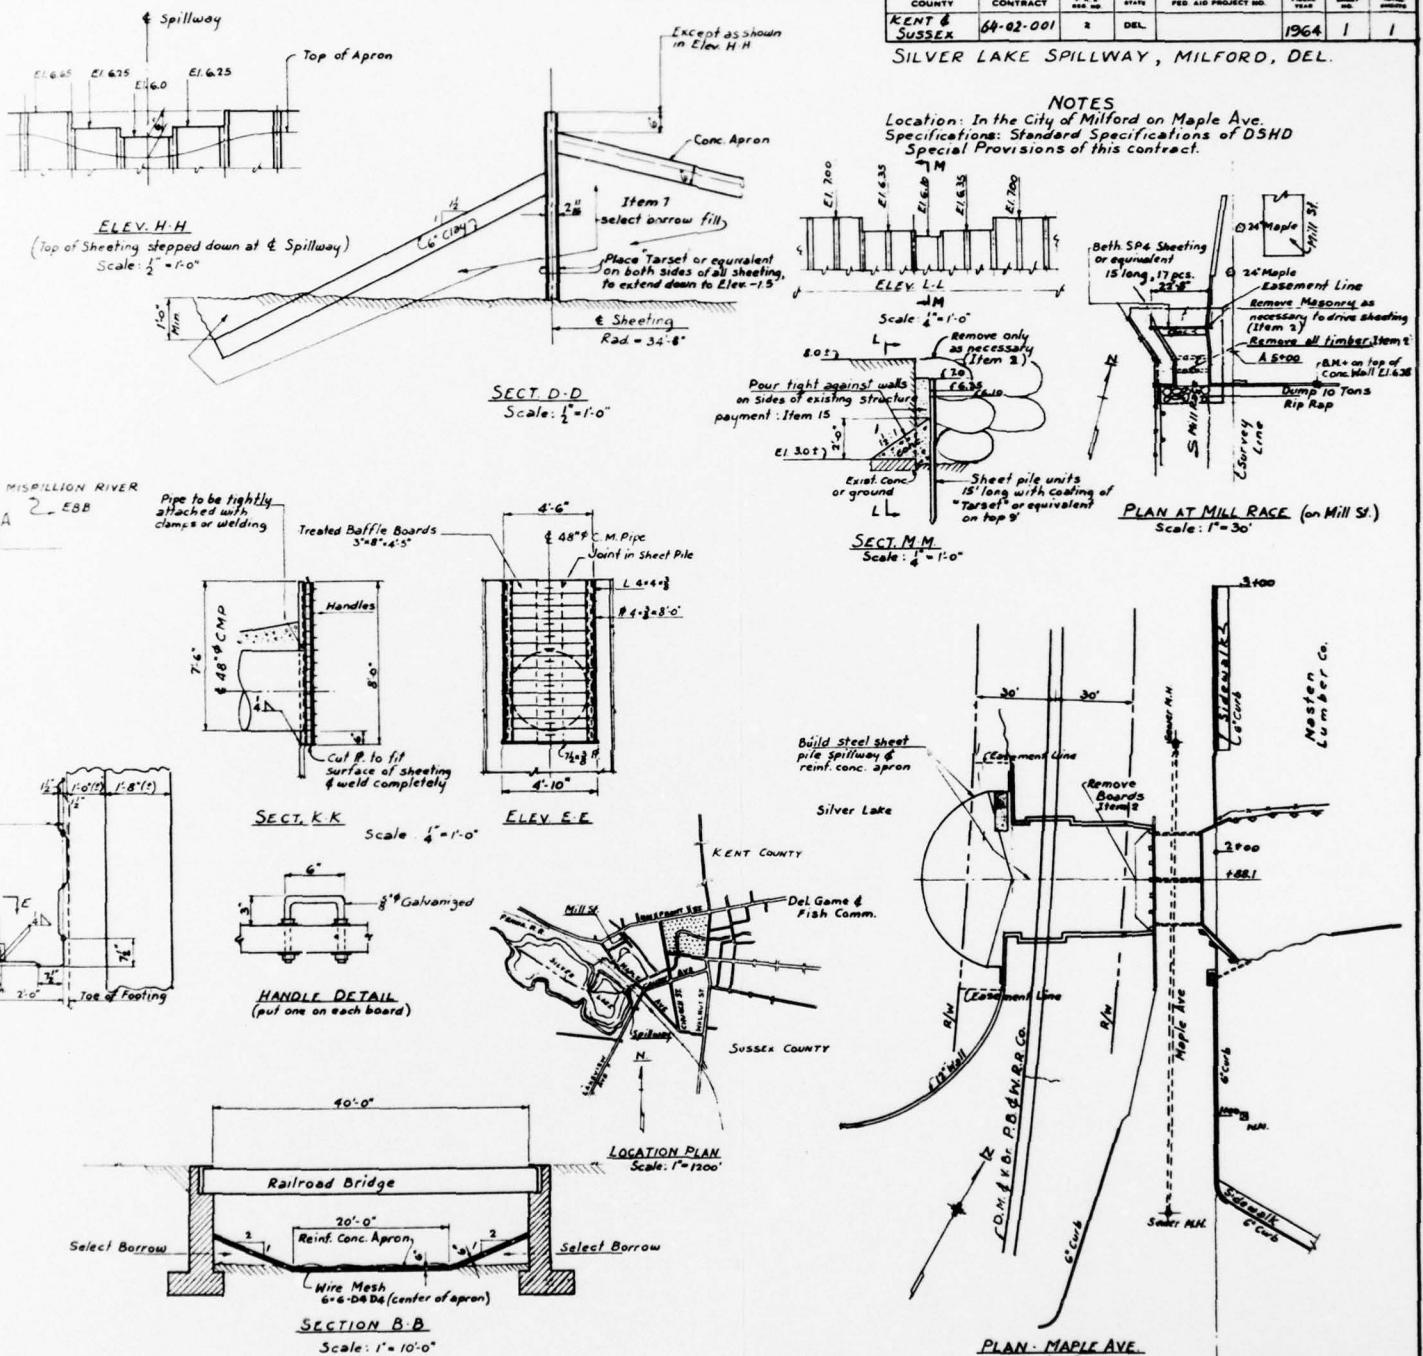
FIGURE 3

According to a design drawing (see Figure 3) provided by the Delaware Department of Natural Resources and Environmental Control (DDNREC), Division of Soil and Water Conservation, a sloping clay blanket rests against the upstream face of the vertical sheeting.
