ABSALOM DOUGHTY DAM

PHASE I INSPECTION REPORT NATIONAL DAM SAFETY PROGRAM

NJ 00080

Date: April 17, 1978

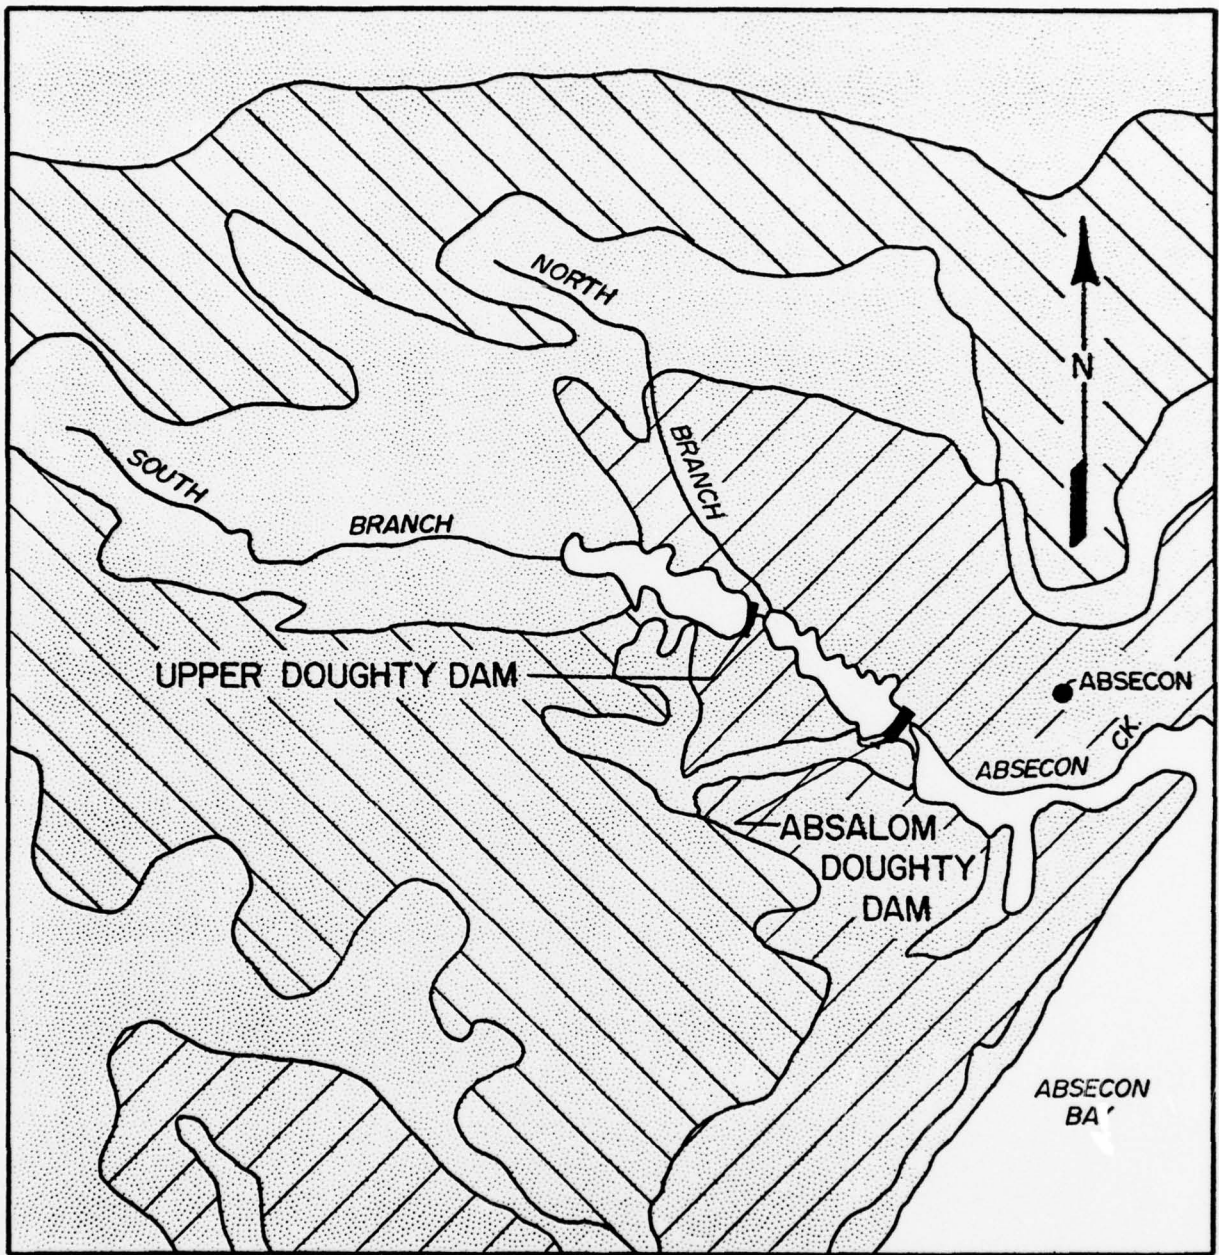
FIGURE 3
GEOLOGIC MAP

As shown on Figure 3, both dams are physically set and constructed in sands and gravels of the Quaternary Cape May formation, as shown on the Geologic Map of New Jersey. Underlying this surficial unit, and in unconformable contact are the remnants of the Quaternary Bridgeton formation and the Tertiary Cohansey formation, the latter being the predominant substructure feature which dips very gently east and southeastward. All geologic units involved consist predominantly of cohesionless and erodible sediments with occasional clay units occurring as lenses of variable thickness and erratic areal distribution.

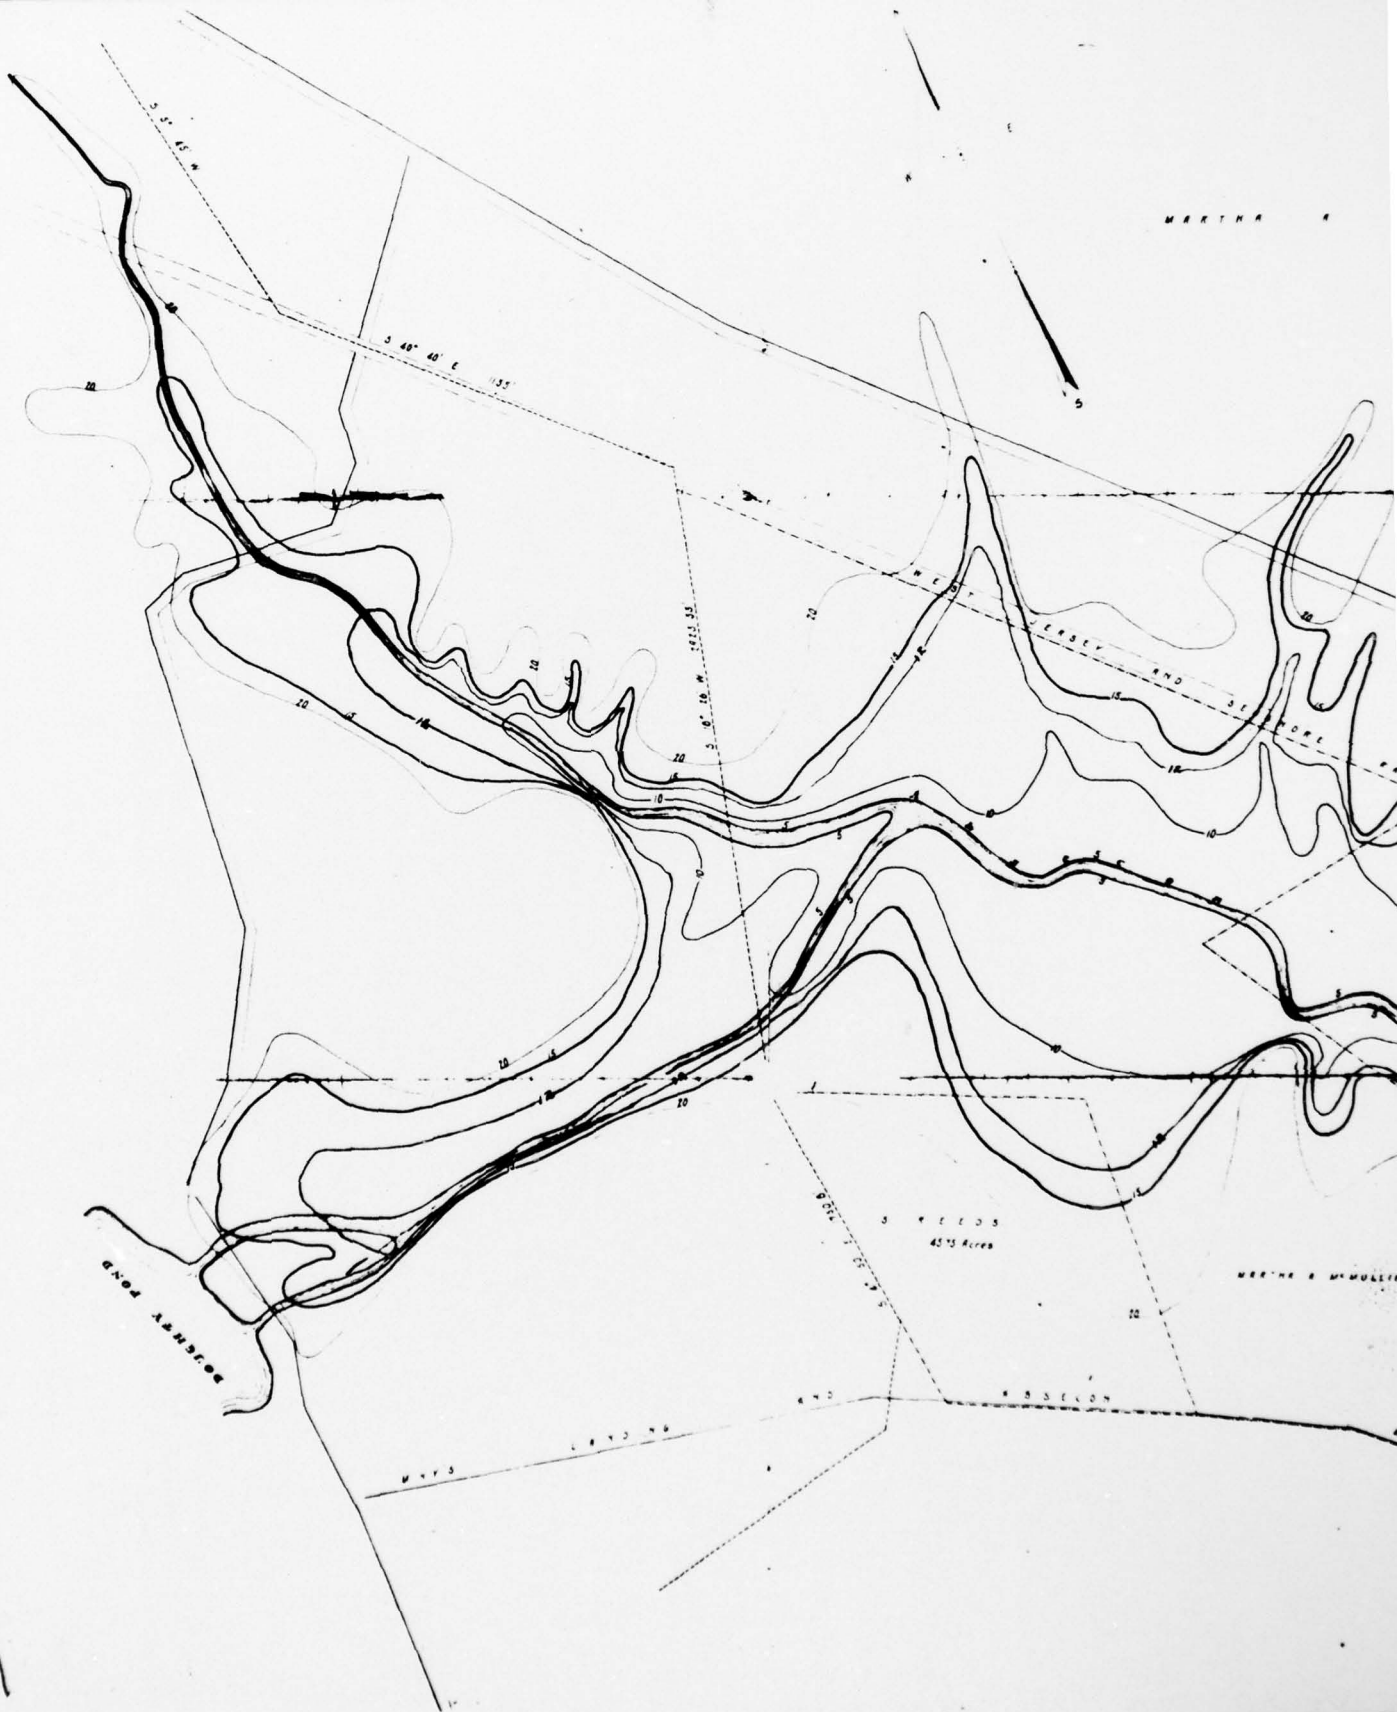
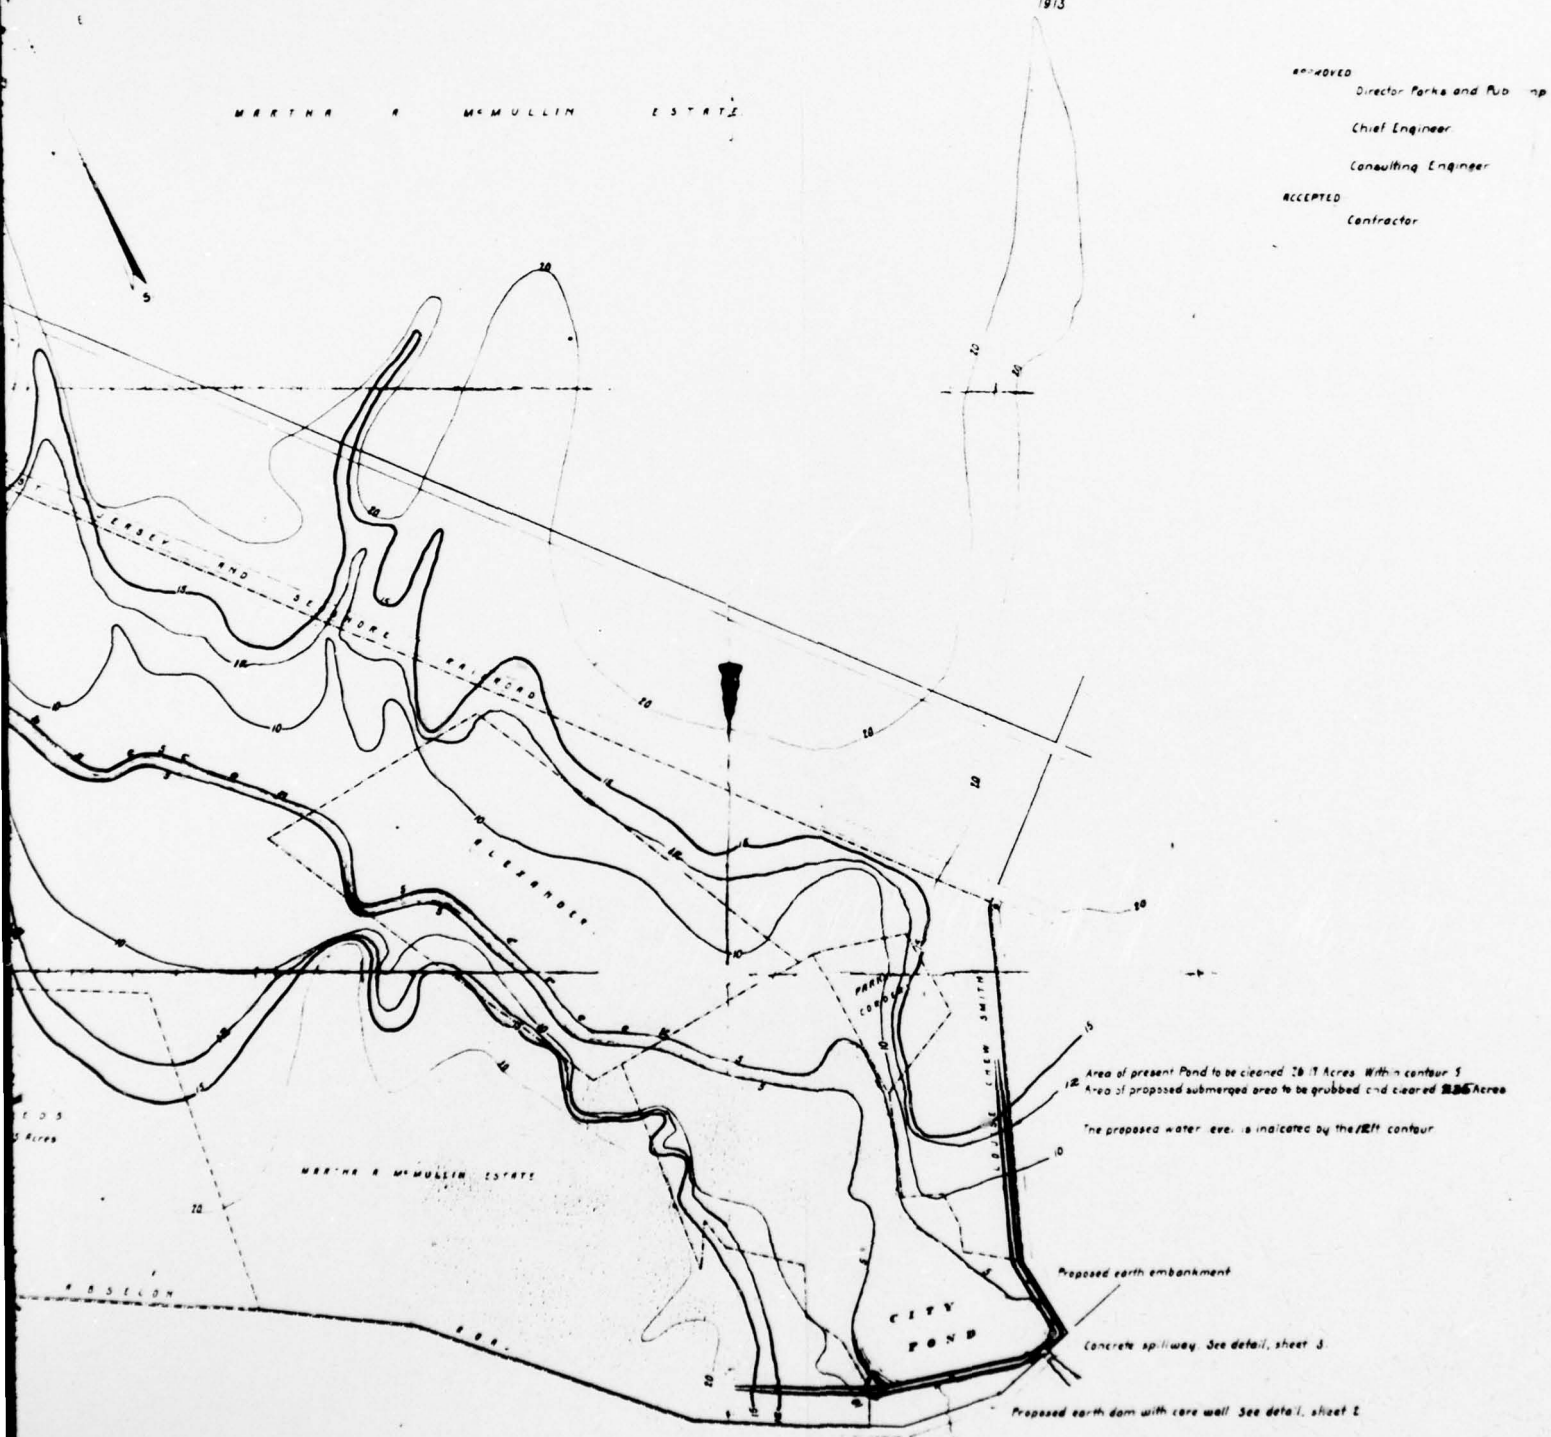
FIGURE 4

Proposed earth embankment
 Concrete spillway See detail, sheet 3
 Proposed earth dam with core wall See detail, sheet 2

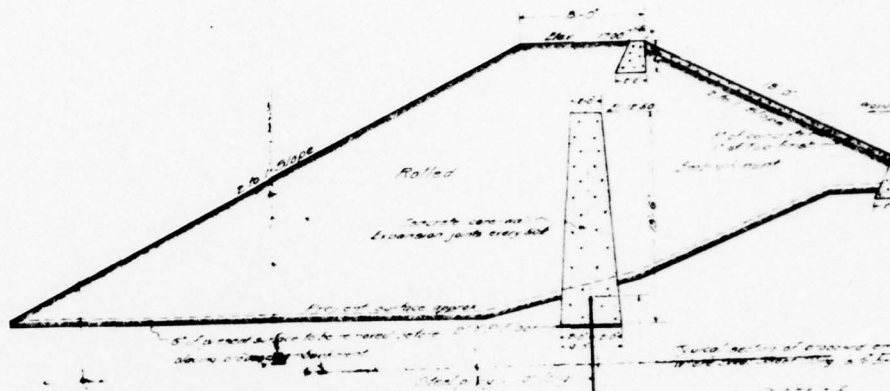
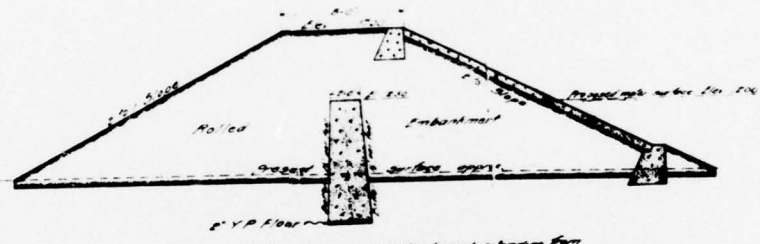
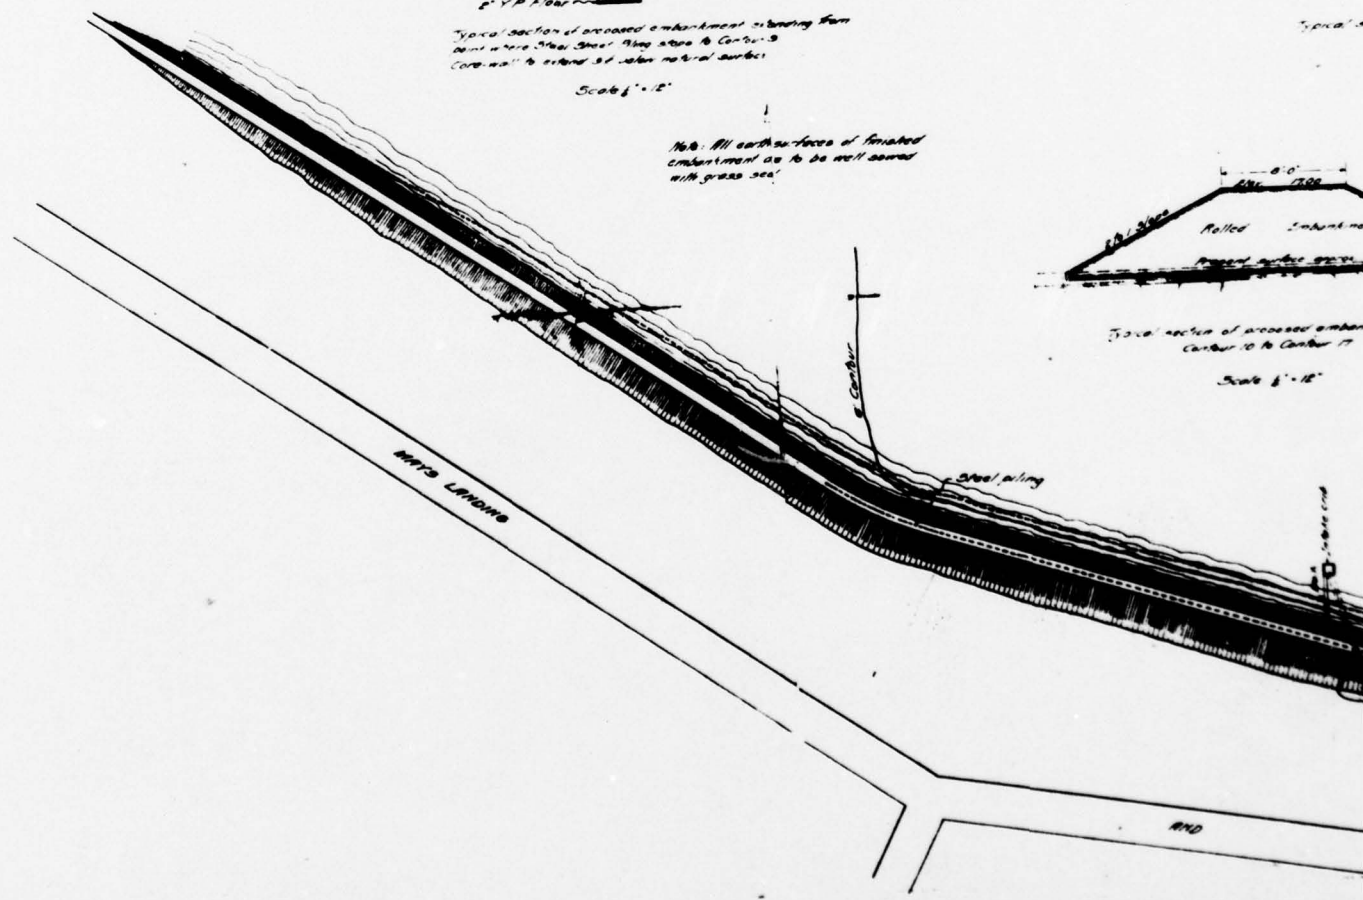
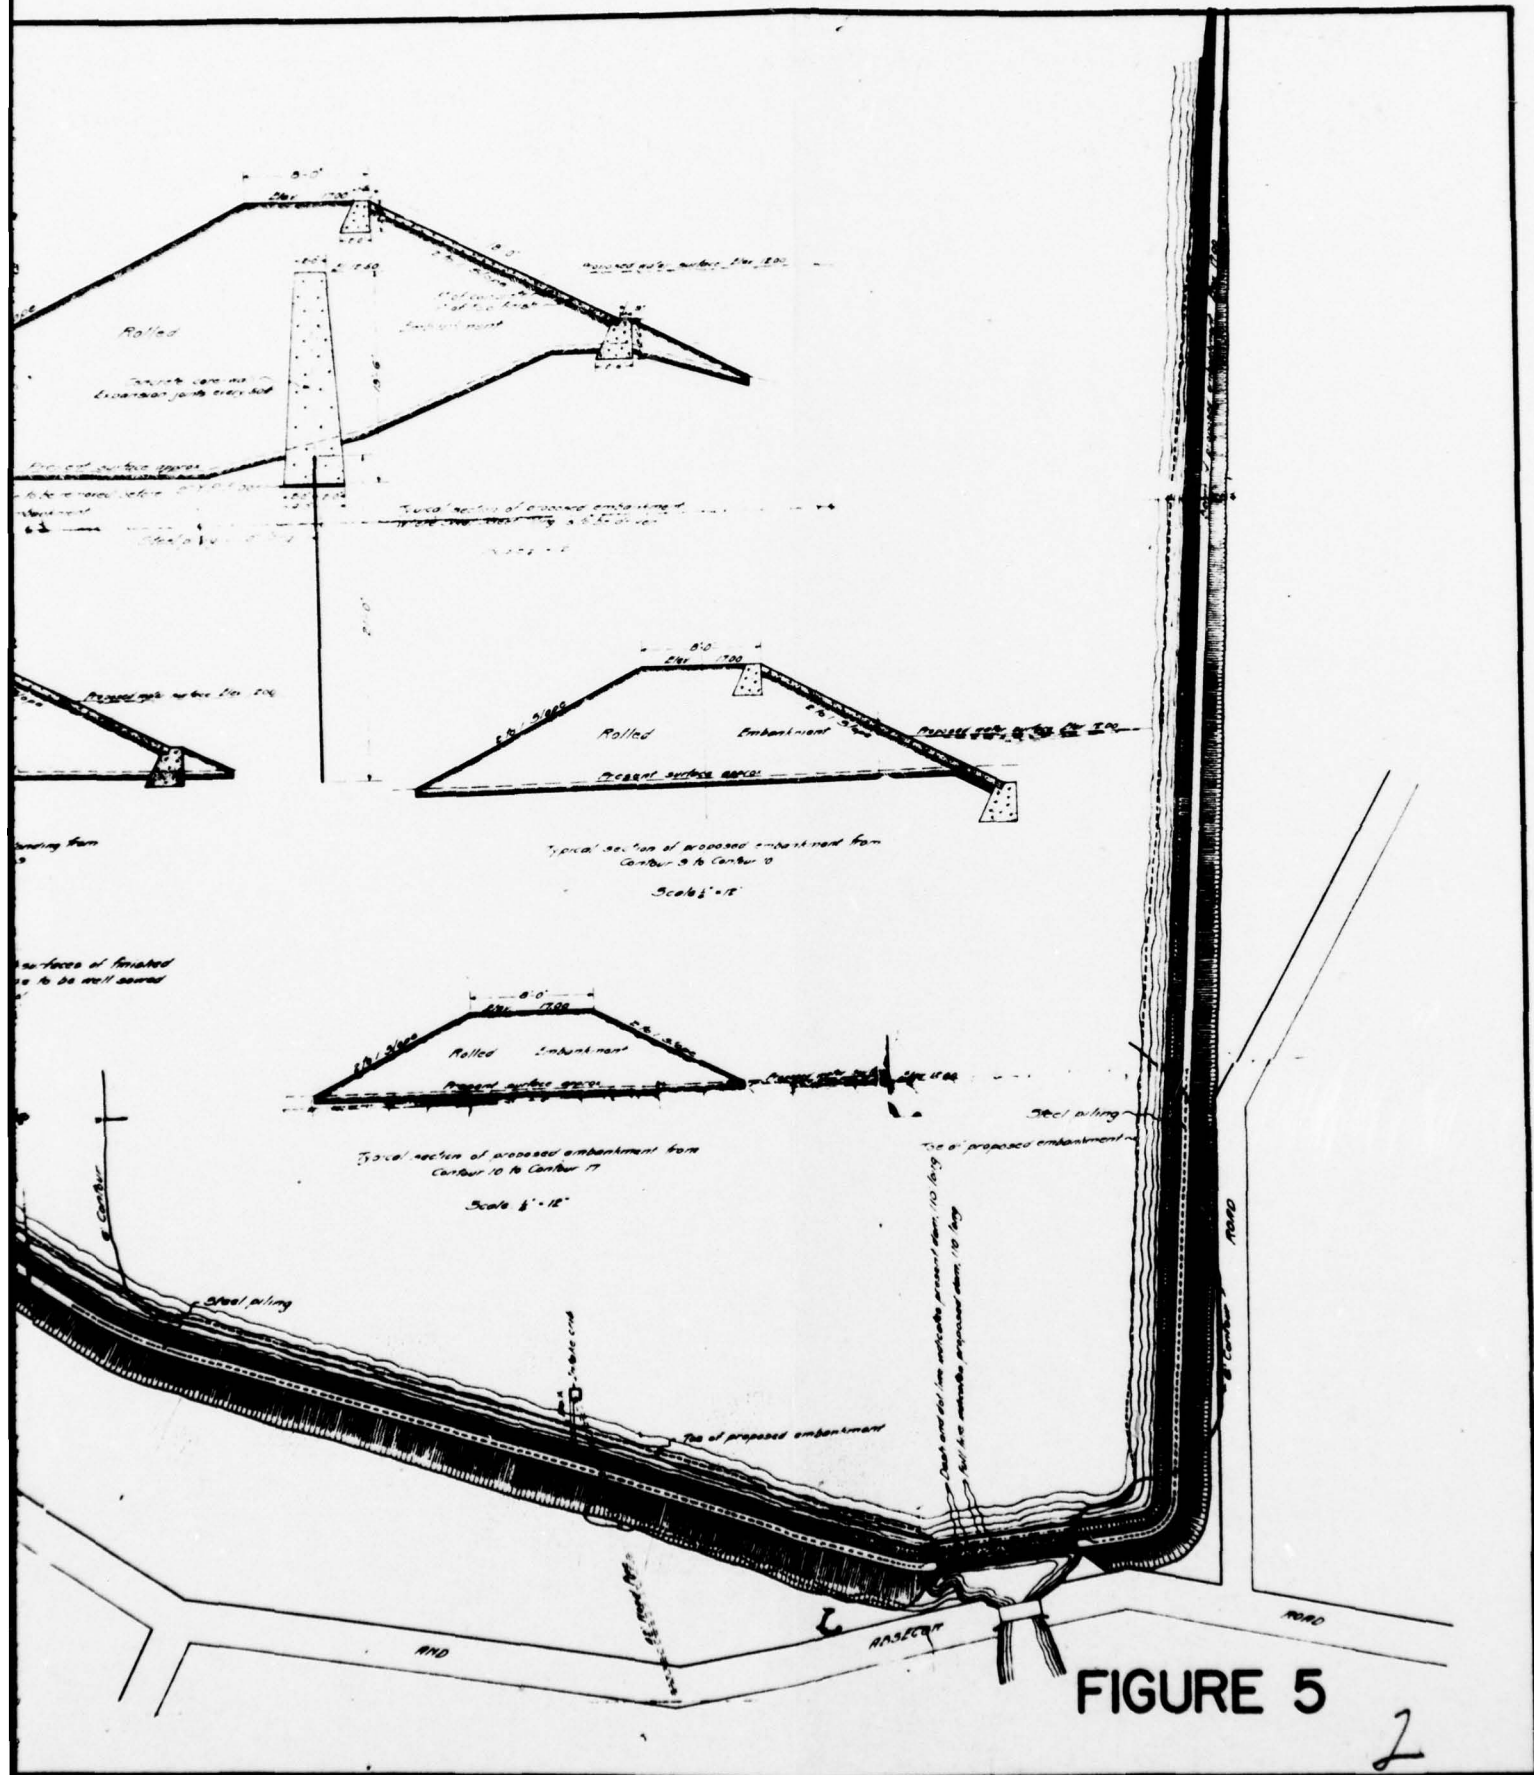
FIGURE 5

Typical section of processed embankment showing form built where Sheet Piles along to Center 9
 Core wall to extend 3' below natural surface
 Scale 1" = 12'

Typical section of processed embankment
 Center 10 to Center 17
 Scale 1" = 12'
