# LAKE VALHALLA DAM

## PHASE I INSPECTION REPORT

NJ 00330

JULY 1978

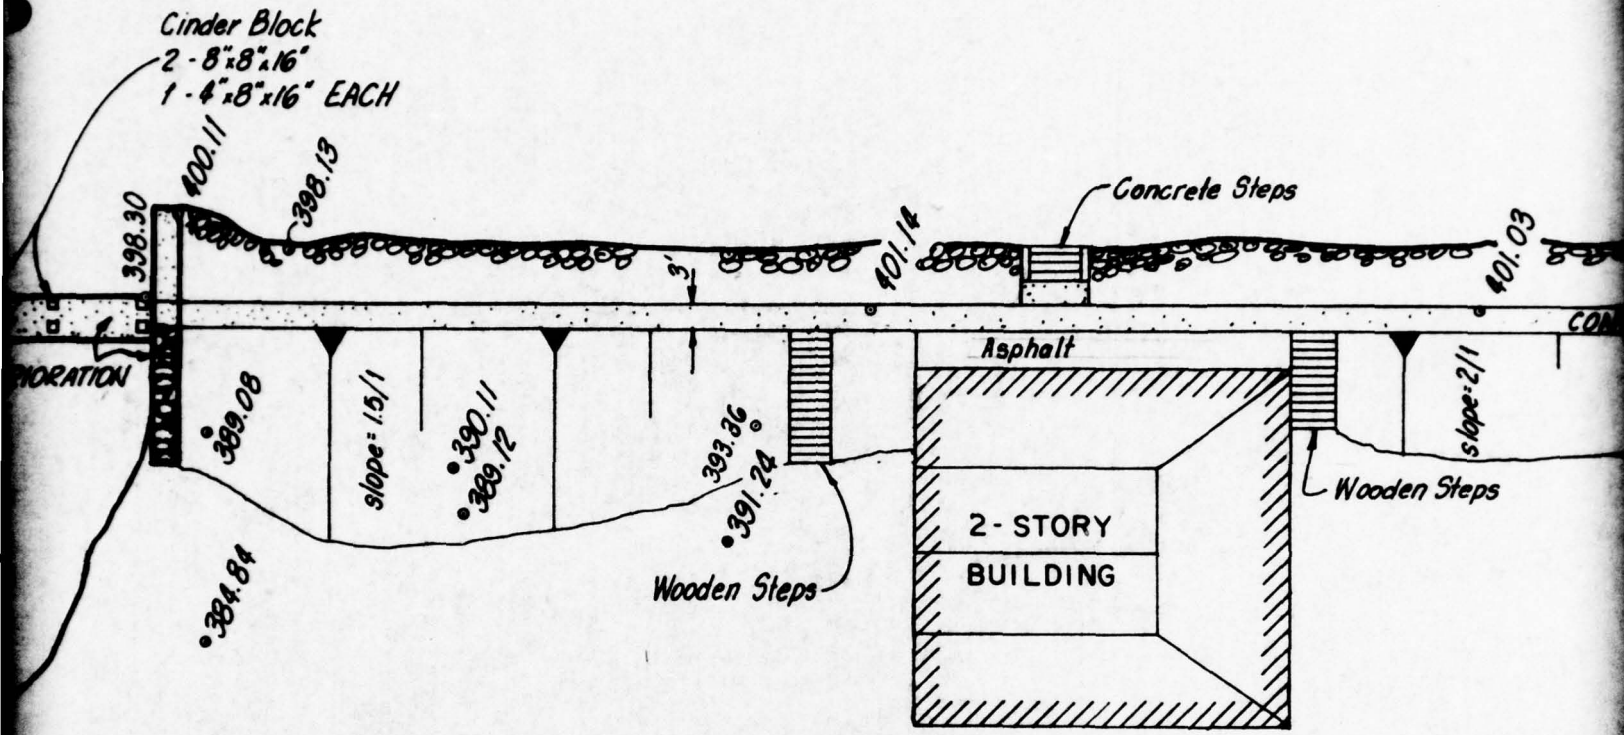
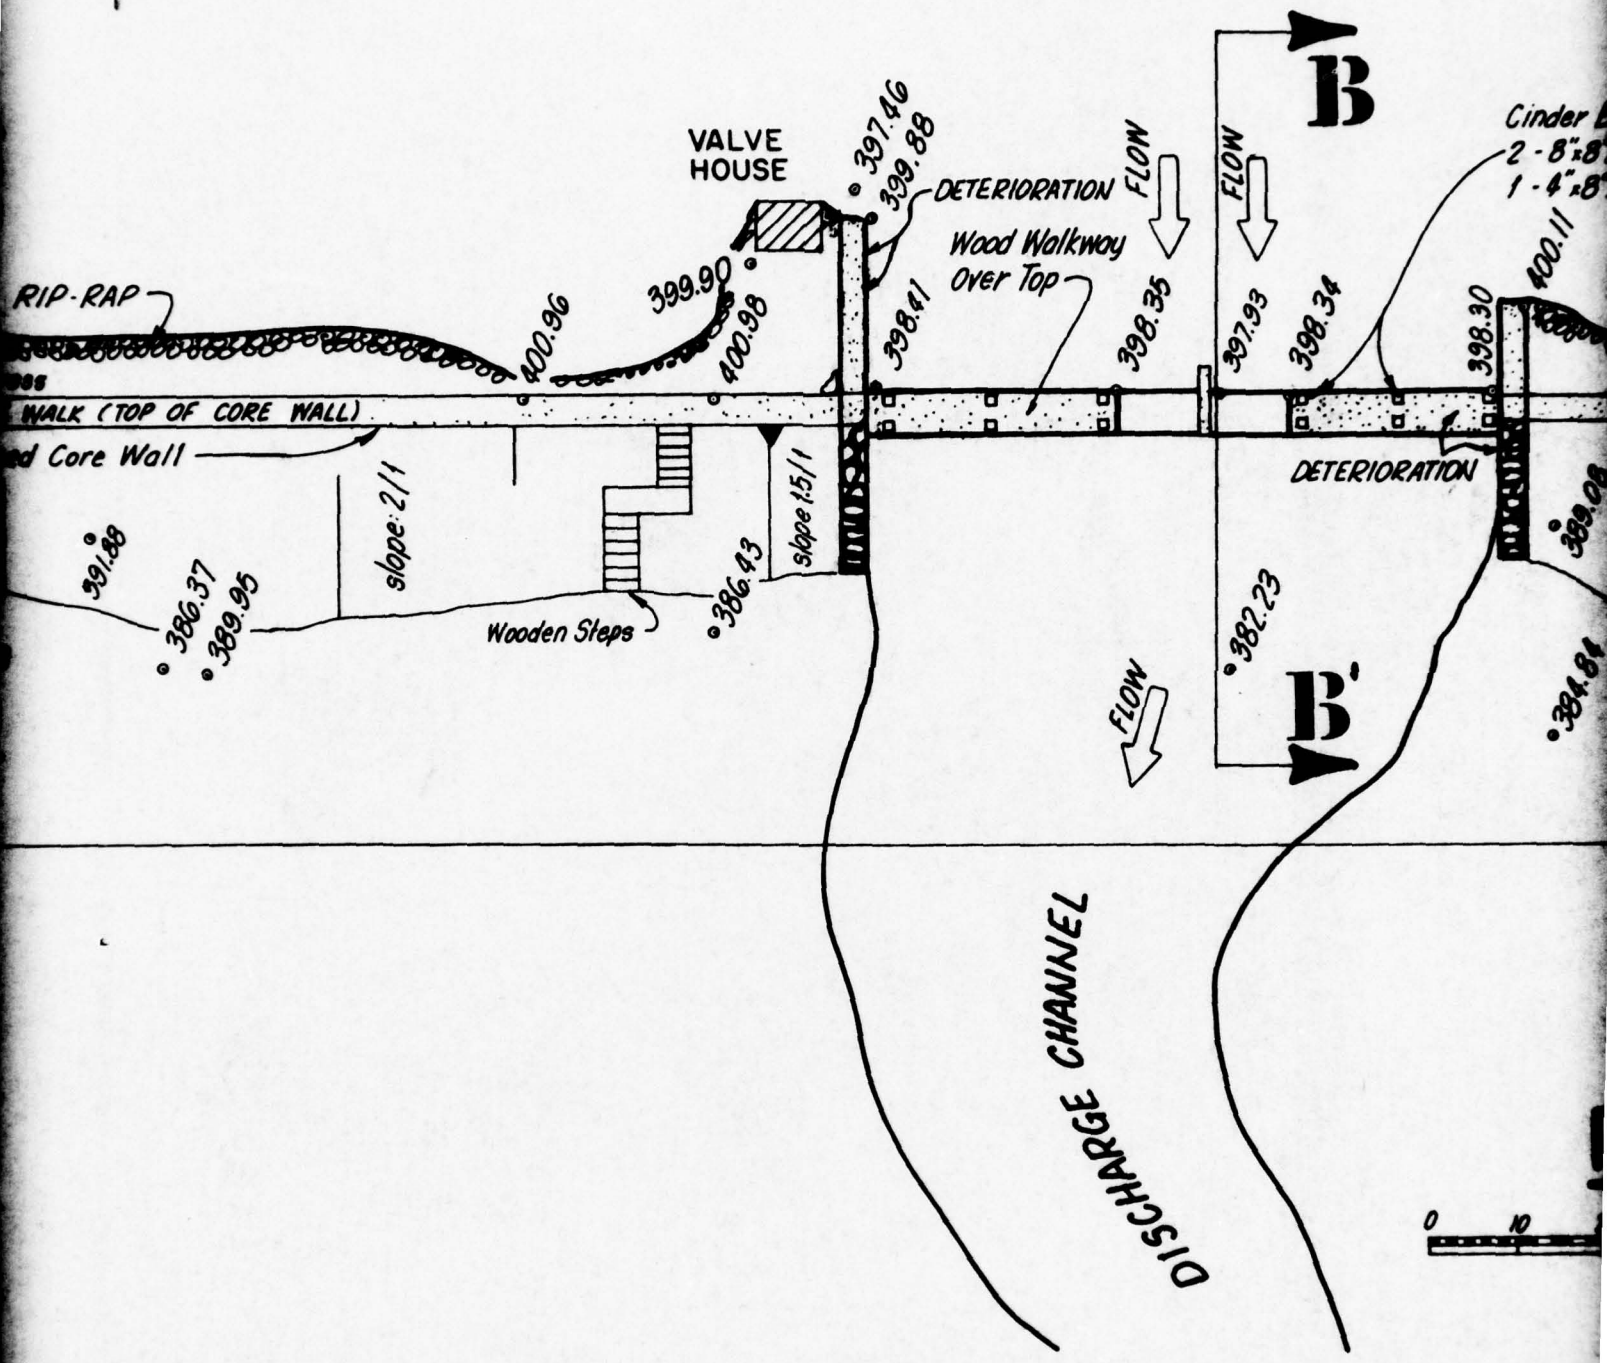
# FIG. 2

NOTE: EARTH ON BOTH SIDES OF CONC. WALL HAS SETTLED ONE TO THREE INCHES BELOW TOP OF WALL.

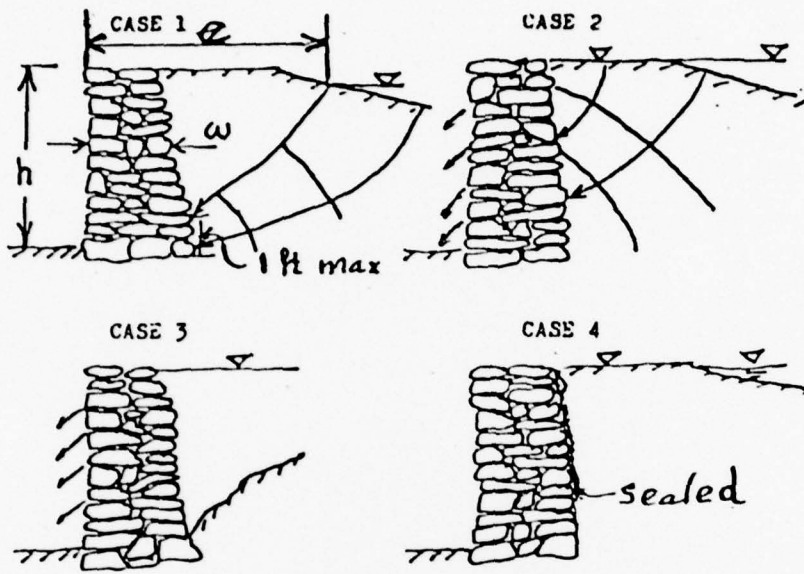
If the ~~max~~ piezometric pressure is a relatively high percentage of the ~~upstream~~ head at the 0.4/1 slope will be too steep to provide enough stability.

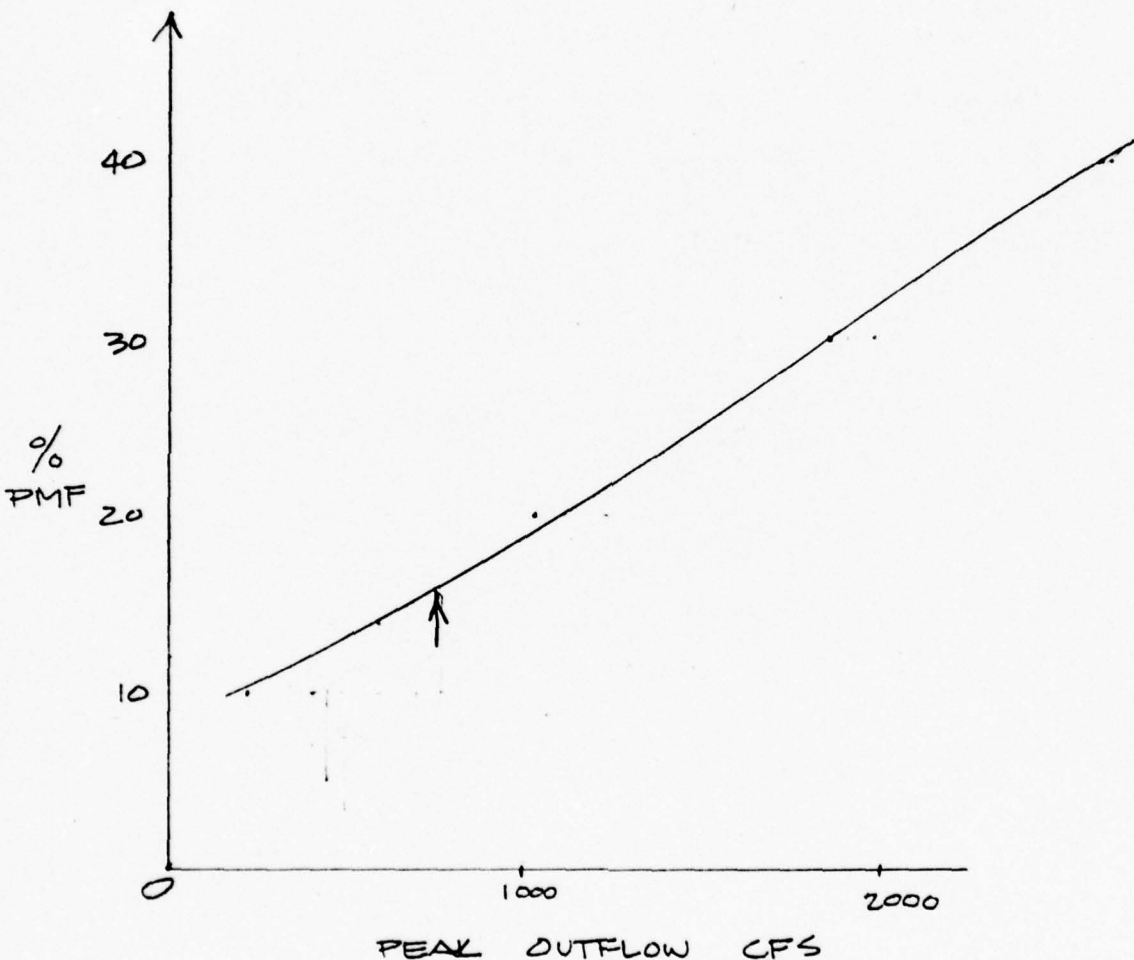
OVERTOPPING POTENTIAL

3. OVERTOPPING OCCURS AT EI 40' or 760 cfs  
 $\therefore$  DAM CAN PASS APPROX 16% OF PMF W/O OVERTOPPING
