APSHAWA MAIN DAM

APSHAWA AUXILIARY DAM

PHASE I INSPECTION REPORT

NATIONAL DAM SAFETY PROGRAM

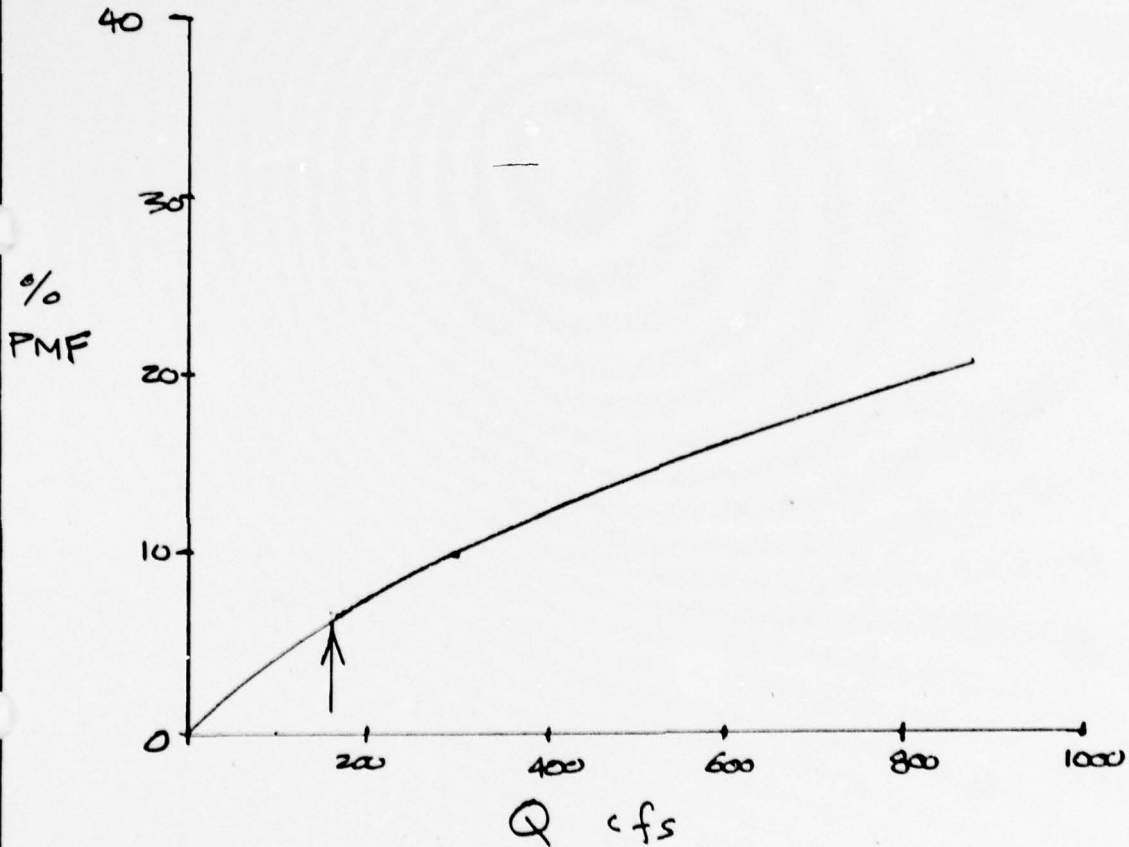
1. Route various % PMF
2. Plot % PMF vs outflow

3. Dam begins to overtop at $d = 772$ with $Q = 155$ cfs
 \therefore dam can pass approx 6% of PMF
