PASSAIC RIVER BASIN

**LIONSHEAD LAKE DAM**

**PHASE I INSPECTION REPORT**

**NATIONAL DAM SAFETY PROGRAM**

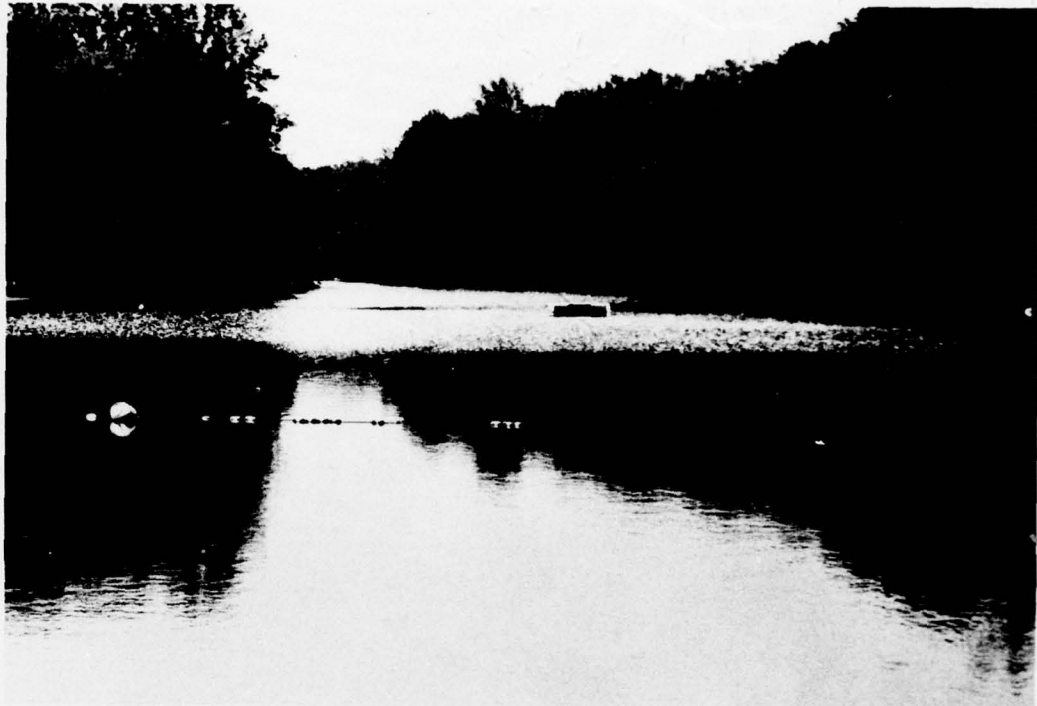
**PHOTO 1**

Photo 1 - View Upstream (Southeast) Over Lionshead Lake From Left (West) Side of Inlet Weir - 13 June 1978

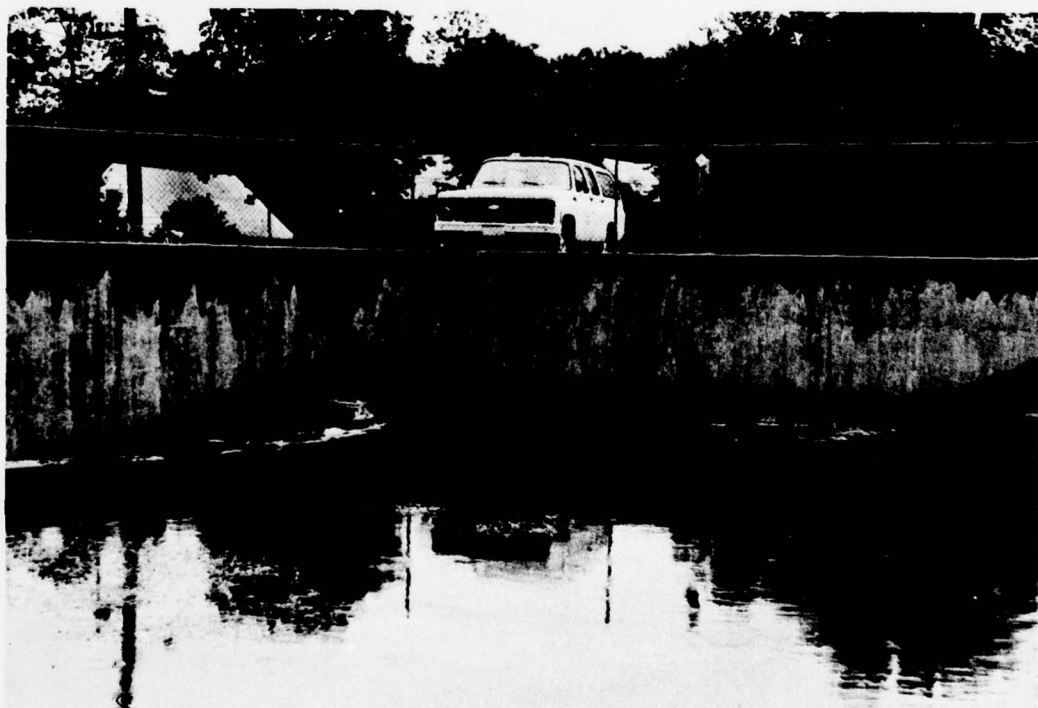
**PHOTO 2**

Photo 2 - View East at Wing Wall on West Side of Parking Area at Right (East) End of Dam (Inlet Weir in Left Center of Photo) - 13 June 1978

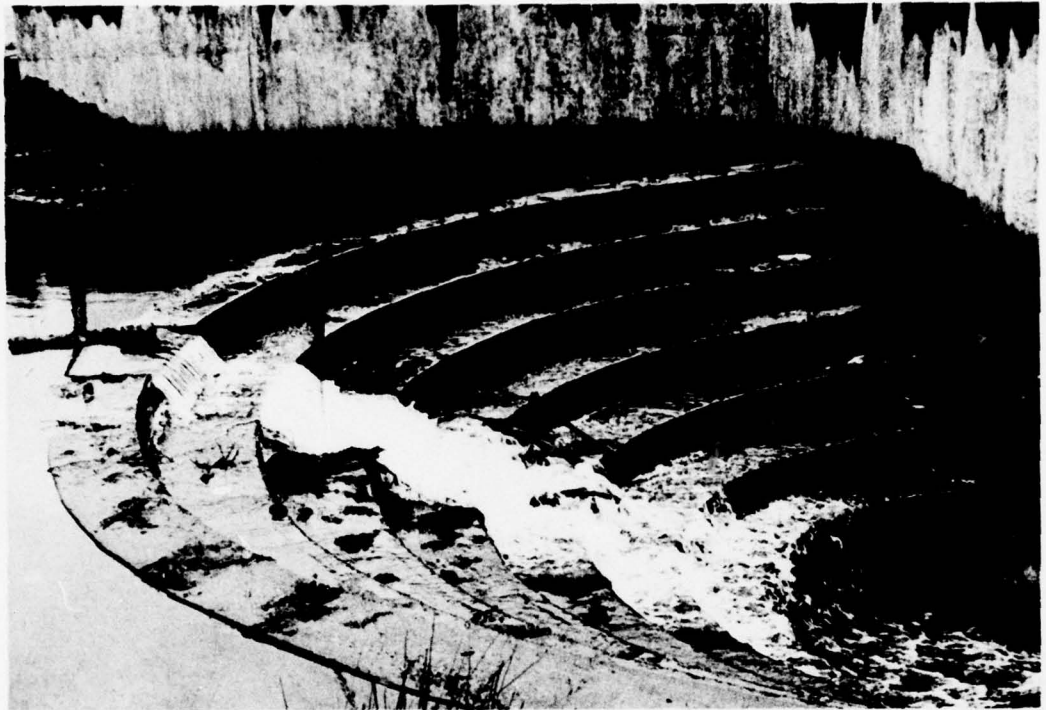
PHOTO 3

- c. Appurtenant Structures - The overflow weir was found to be in good overall condition. Minor spalling has occurred on the third step from the top on the right (east) side. This spalled concrete should be chipped out and patched.

Photo 3 - View East at Inlet Weir (Culvert Inlet off Left Side of Photo) - 13 June 1978

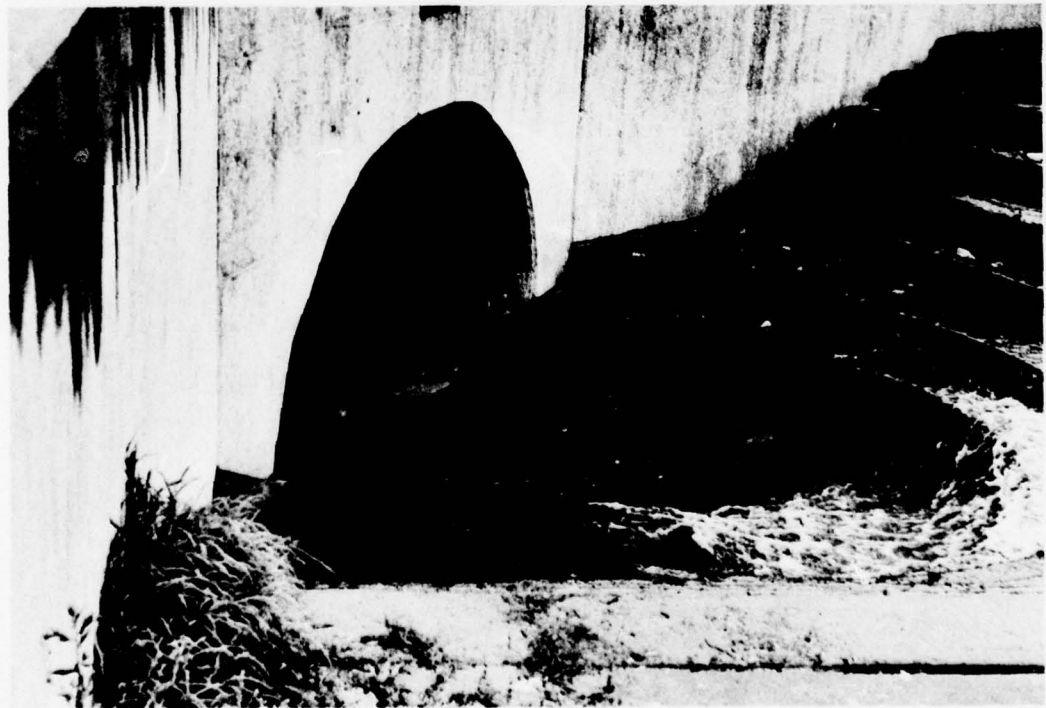
PHOTO 4

Photo 4 - View Northeast at Culvert Inlet - 13 June 1978

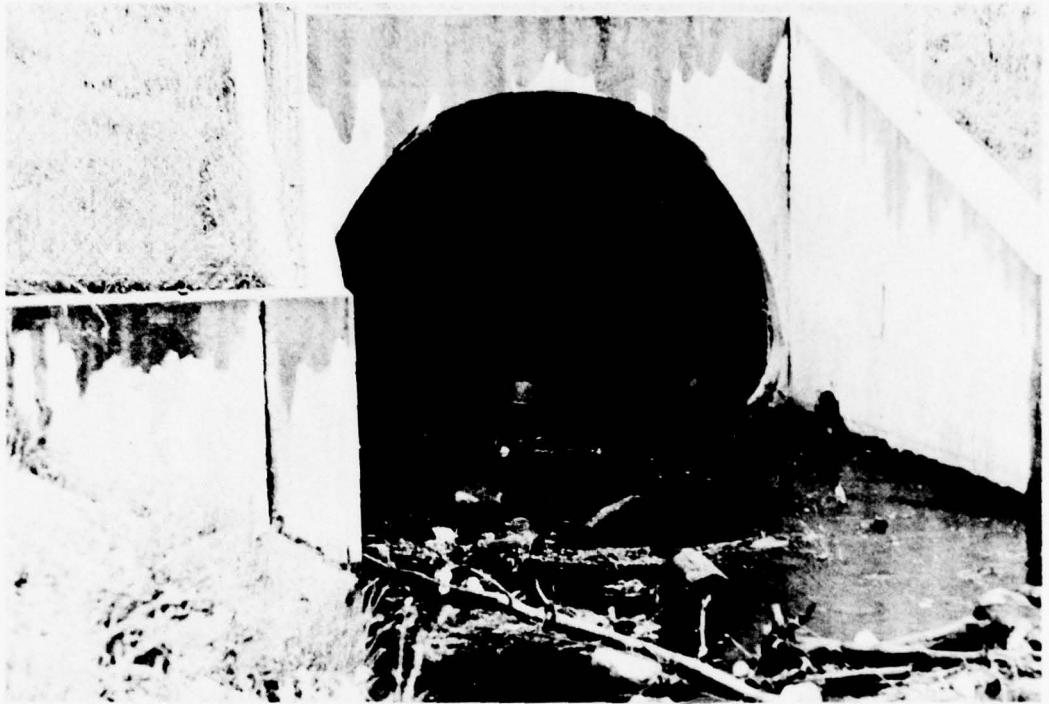
**PHOTO 5**

Minor seepage with a flow less than one g.p.m. was occurring at a culvert joint one foot above the invert on the right (east) side approximately thirty-five feet upstream from the culvert outlet. This seepage is not considered to constitute a problem. The three inch thick asphalt paving on the culvert invert has eroded in an area approximately four feet wide and twelve feet back from the culvert outlet. The culvert joint and the asphalt paving should be repaired as a part of routine maintenance of the culvert. Both the inlet and the outlet culvert head walls were found to be in good overall condition.

Photo 5 - View Upstream (South) at Culvert Outlet Showing Trash and Debris in Outlet Channel - 13 June 1978

b. The eroded portions of the asphalt lining in the downstream portions of the weir outlet culvert pipe should be repaired within nine months from the date of approval of this report.
