DELAWARE RIVER BASIN

# EVANS POND DAM

## PHASE I INSPECTION REPORT

## NATIONAL DAM SAFETY PROGRAM

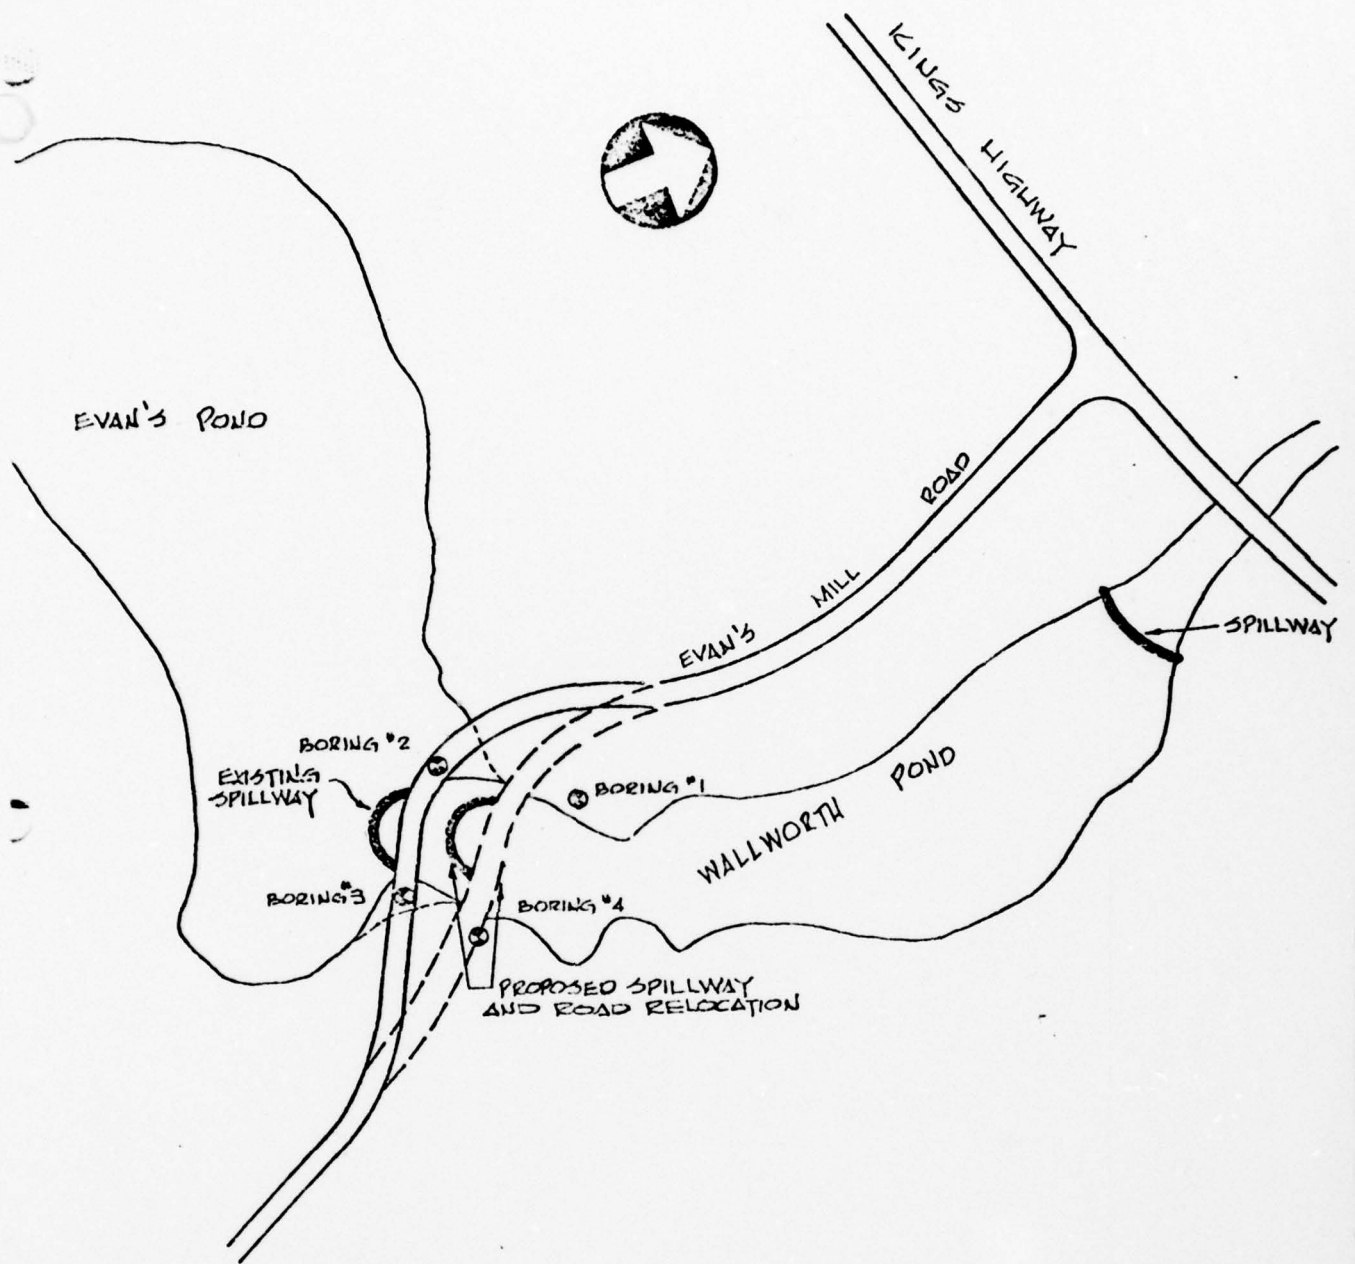
FIGURE 7

EVAN'S POND - DAM AND SPILLWAY  
 PROPOSED SPILLWAY AND  
 ROAD RELOCATION

AS SHOWN ON FIGURE 7, THE PROPOSED REPLACEMENT STRUCTURE AND ROADWAY WOULD  
BE LOCATED APPROXIMATELY ONE HUNDRED FEET DOWNSTREAM (NORTH) OF THE PRESENT  
SITE. THIS RELOCATION PROVIDES FOR A SMOOTHER ROAD ALIGNMENT AS WELL AS  
BETTER SUBSURFACE CONDITIONS TO MINIMIZE FOUNDATION COSTS. TWO ELEVEN FOOT  
WIDE TRAVEL LANES, A FOUR FOOT SHOULDER ON BOTH SIDES AND AN ADJOINING SIX  
FOOT BICYCLE/PEDESTRIAN WAY ON THE SPILLWAY SIDE MAKE UP THE PROPOSED ROAD-  
WAY SECTION. (SEE FIGURE 8.) ALTHOUGH SOMEWHAT NARROWER THAN THE TWELVE  
FOOT TRAVELWAY/TEN FOOT SHOULDER COMBINATION RECOMMENDED BY AASHO, THE  
NEW ROAD WILL BE A MAJOR IMPROVEMENT OVER THE EXISTING ROAD IN SAFETY AND  
CONVENIENCE FOR ALL CLASSES OF USERS. THE SHOULDERS AND BICYCLE/PEDESTRIAN  
PATH SHALL BE CARRIED ACROSS THE PROPOSED REPLACEMENT STRUCTURE. CABLE GUARD  
RAIL, WHICH AFFORDS A MORE UNOBSTRUCTED VIEW OF THE PONDS, IS RECOMMENDED

AN ALTERNATIVE TO REPLACING THE EVANS POND STRUCTURE WOULD CONSIST OF RAISING THE WALLWORTH DAM APPROXIMATELY TWO FEET AND REMOVING THE SPILLWAY AT EVANS POND. EVANS MILL ROAD WOULD STILL BE MORE THAN A FOOT ABOVE THE ELEVATION OF THE FIFTY YEAR FLOOD. EVANS POND WOULD HAVE A NORMAL WATER SURFACE APPROXIMATELY A FOOT LOWER THAN AT PRESENT. HYDROSTATIC PRESSURE AGAINST THE EMBANKMENT WOULD BE ELIMINATED FOR DAILY FLOWS AND GREATLY REDUCED FOR FLOOD FLOWS.

THE DISADVANTAGES TO THIS ALTERNATIVE ARE: THAT EXTENSIVE REMEDIAL WORK WOULD STILL BE REQUIRED ON THE ROADWAY EMBANKMENT; MORE DREDGING WOULD BE REQUIRED BECAUSE OF THE LOWER WATER SURFACE; SOME PRESENTLY UTILIZED LANDS ALONG THE LOWER POND WOULD BE SUBMERGED; THE FLOOD PEAK ATTENUATION EFFECT POSSIBLE WITH TWO PONDS WOULD BE REDUCED; AND THE FIFTY YEAR TRADITION OF TWIN PONDS WOULD BE DESTROYED. THE PREFERABLE COURSE WOULD SEEM TO BE TO REPLACE THE EVANS POND STRUCTURE.
