**JERSEY CITY RESERVOIR  
NO.3 DAM**

**PHASE I INSPECTION REPORT  
NATIONAL DAM SAFETY PROGRAM**

NJ 00524

**AUGUST 1978**

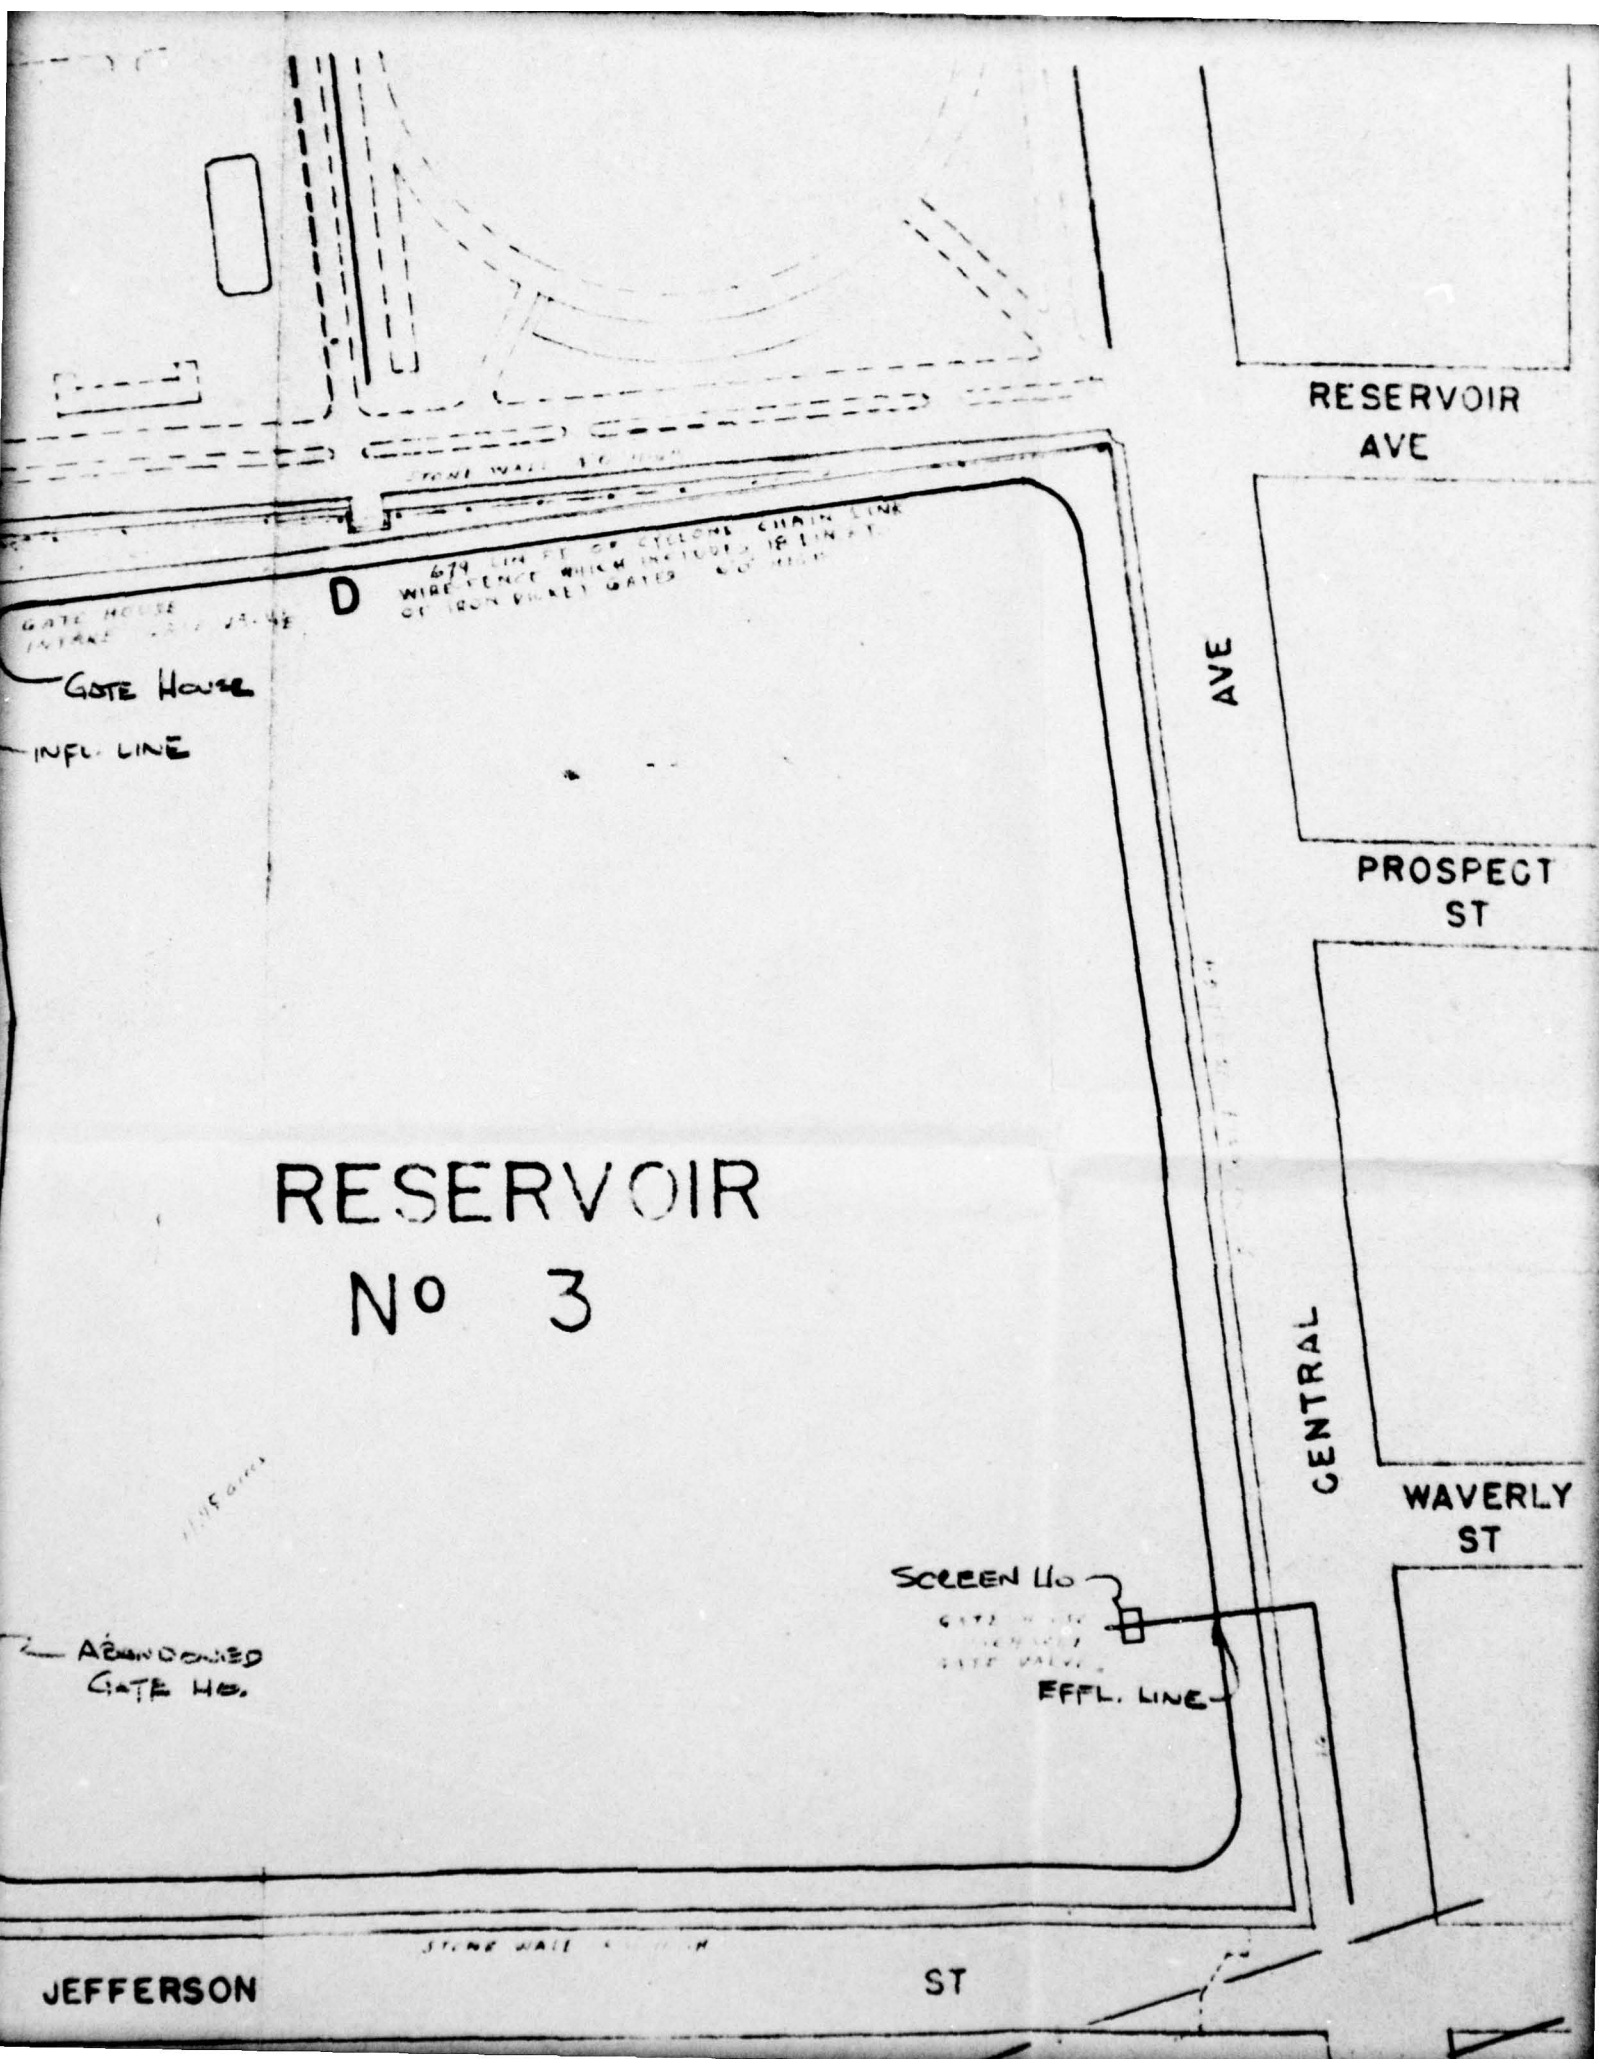
Figure 3

Review of the one structural (see Figure 3) and two construction drawings indicates that the design appears to have been consistent with the prevailing state-of-the-art at the time of construction. The design and construction of the reservoir has obviously withstood the test of time and field inspections indicate that the reservoir was well built and the walls appear to date, to be structurally sound. However, the available data is considered inadequate for design review and further investigations are required to ascertain the physical conditions and assess the structural stability of the entire perimeter wall system.

Design calculations and the original stability analyses were not available for the reservoir. Only one structural drawing (prepared in the 1870's) depicting a section of the walls, core and embankment, was available for review (Figure 3).

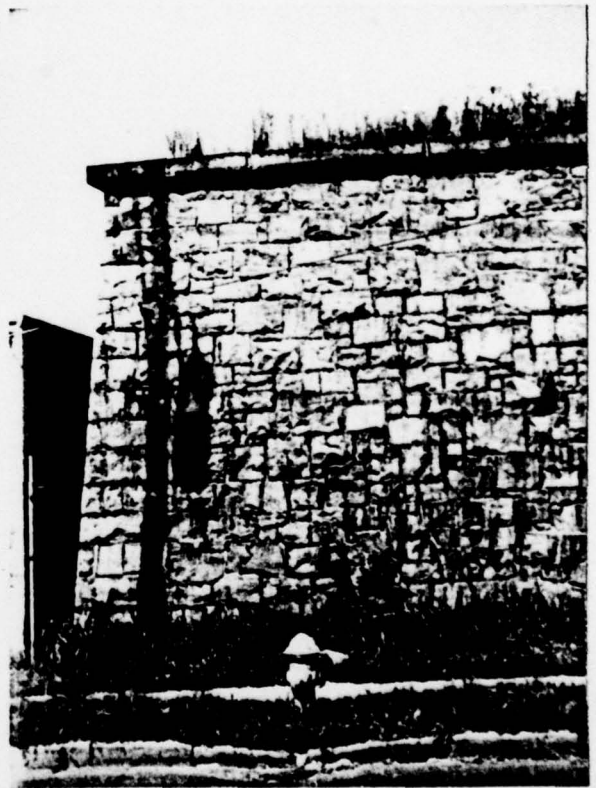
SE CORNER

Jersey City Reservoir No. 3 appears to be in a stable but questionable condition and is in need of wall repair. Escalation of the leak through the west wall could lead to hazardous settlement of the embankment and eventual collapse or breaching of the perimeter walls. Failure could cause significant property damage to surrounding residential areas and result in a major loss of life. Sufficient engineering data was not available to adjudge anything but a questionable assessment and further studies are recommended in the near future.
