# BARBOUR MILL DAM

PHASE I INSPECTION REPORT

NATIONAL DAM SAFETY PROGRAM

NJ 00237

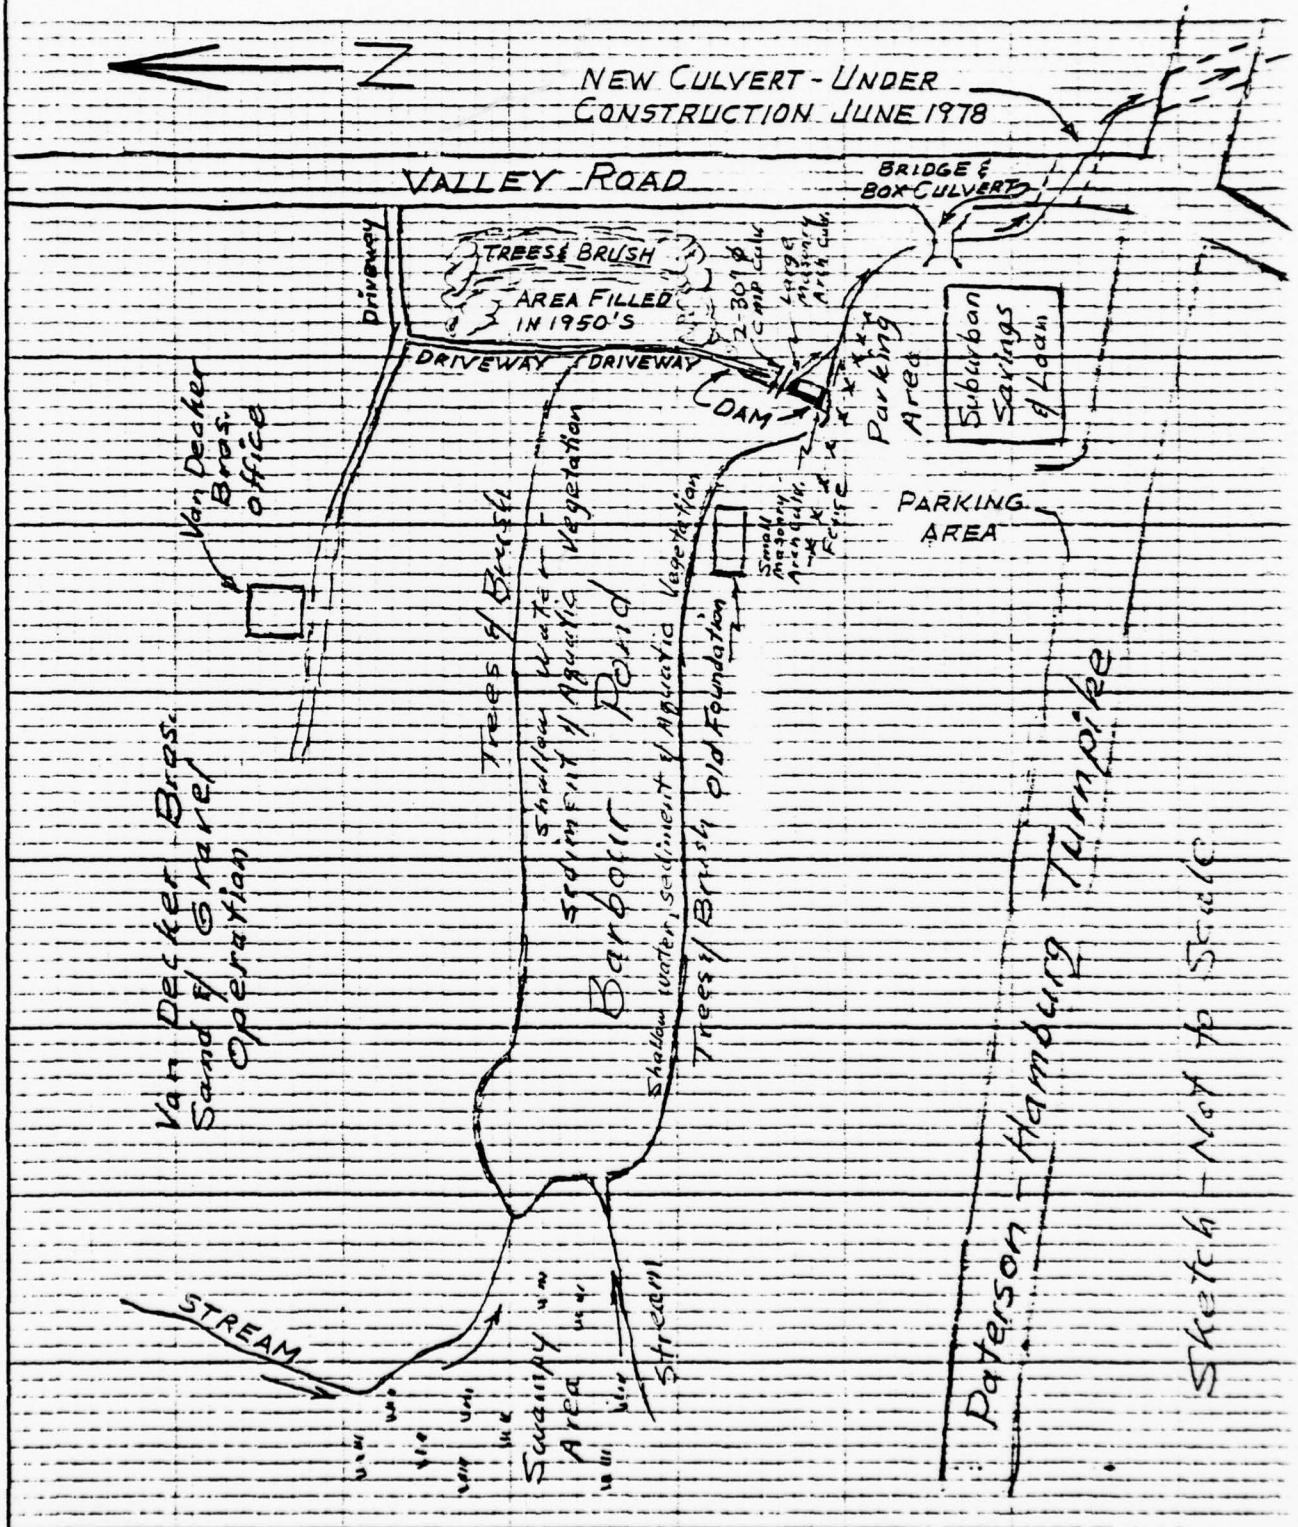
PLATE 1

The dam was acquired in 1950 by its present owner Mr. Gary Van Decker who has a large sand and gravel operation along the hillside north of the pond (Plate 1). Mr. Van Decker indicated that he filled in portions of the area downstream from the dam and constructed a concrete slab over the masonry arch outlet conduits in 1950. He also installed two 30 inch diameter corrugated metal outlet pipes in approximately 1975.

Barbour Pond, which has extensive deposits of silt and muck as well as abundant aquatic vegetation, is rapidly evolving into a swamp (Plate 1). The maximum depth of pond water at the time of inspection was about seven feet at the concrete head wall, and the average depth of pond water was estimated to have been about three feet.

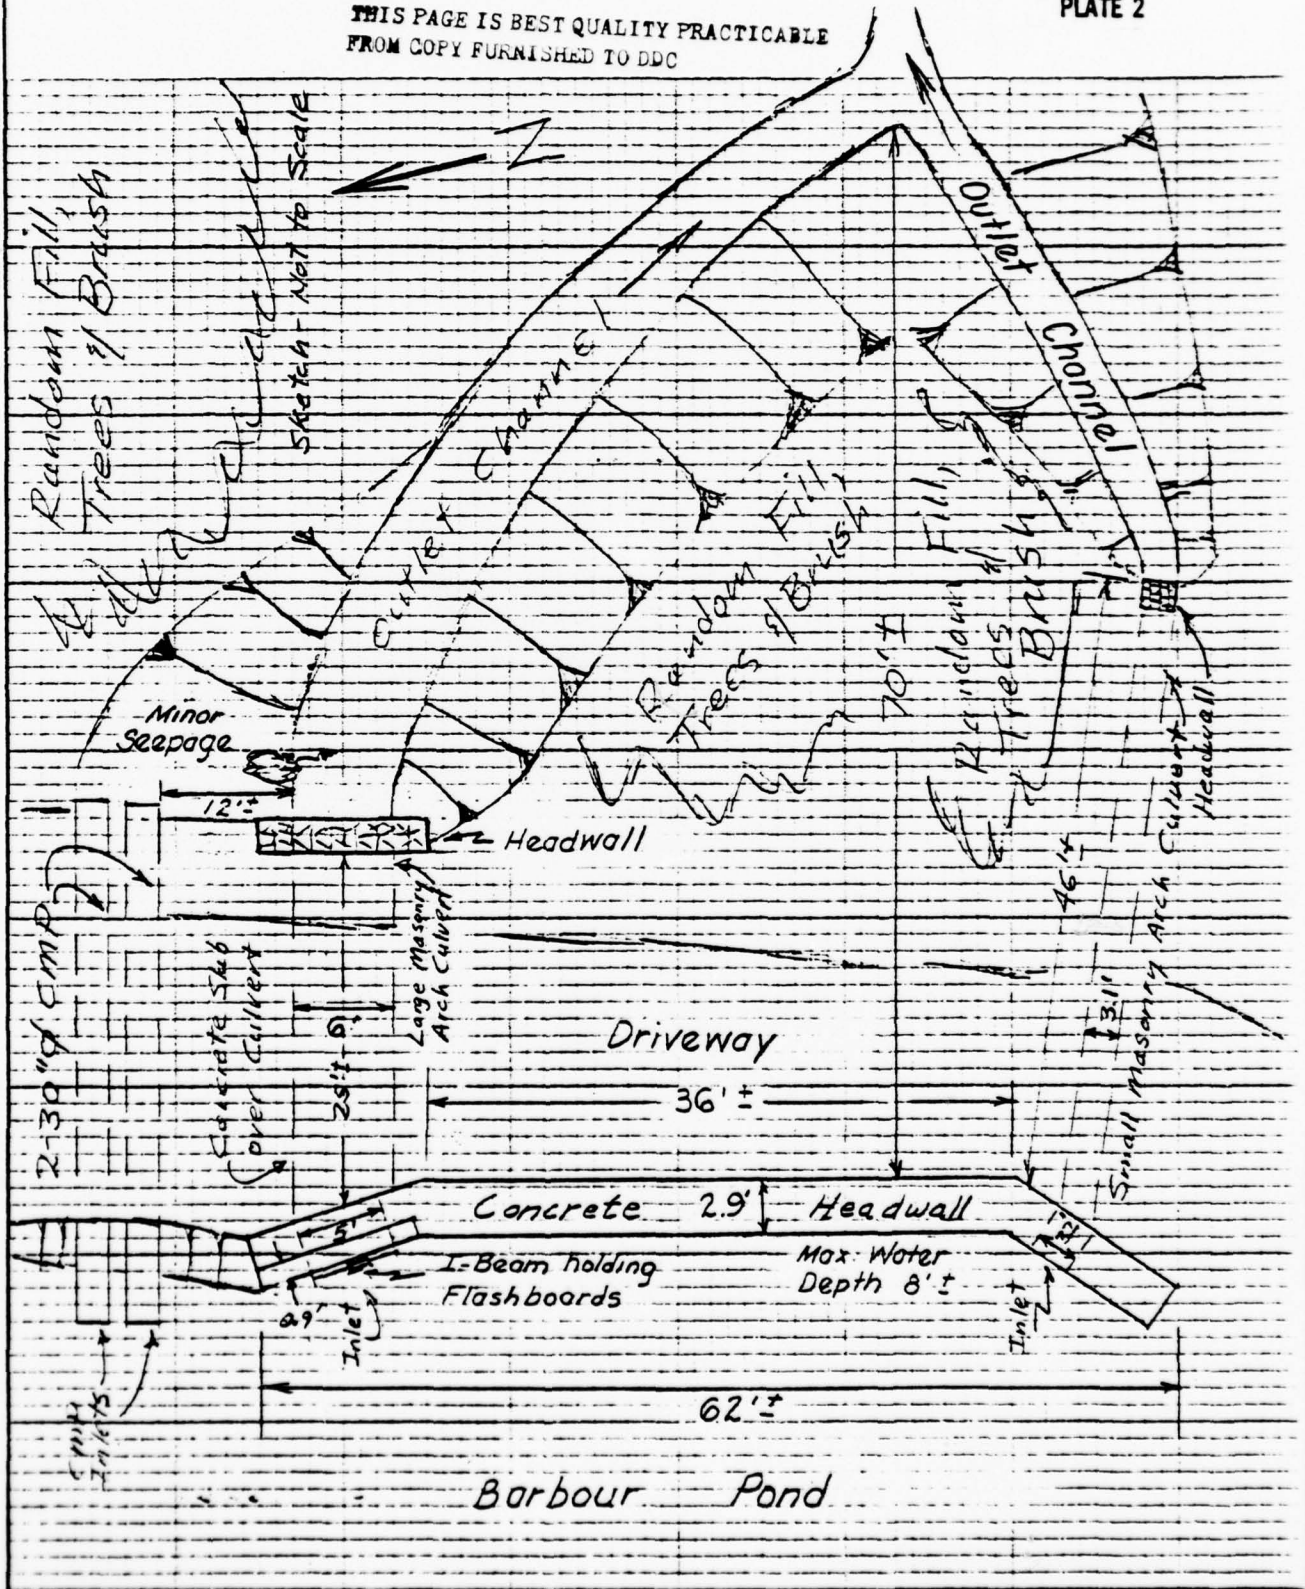
PLATE 2

In addition to the two masonry arch culverts, there are two 30 inch diameter corrugated metal pipes located some 20 feet left of the large masonry culvert (Plate 2). These pipes were reportedly installed by Mr. Van Decker in 1975. The pond level (controlled by flashboards in the masonry arch culvert inlets) was essentially at inlet invert level of the corrugated metal pipes at the time of inspection. Pipe inlet levels are such that the depth of water flow through the pipes will be only about 0.9 foot when the dam is overtopped at a low point on the embankment crest approximately 35 feet left (northeast) of the pipes and also at a low point near the center of the concrete head wall.

Discharge from the corrugated metal pipes flows into the outlet channel for the large masonry arch culvert, and this channel joins the outlet channel for the small masonry arch culvert at a point about 70 feet downstream from the concrete head wall in densely vegetated random fill (Plate 2). From that point, the discharge channel extends about 300 feet further downstream to a bridge from Valley Road to the parking area of the Suburban Savings and Loan Building (Plate 1). This bridge has a clear opening, twelve feet wide by five feet high. Water backed up at the bridge would flow easterly onto Valley Road before overtopping the bridge. A new culvert across Valley Road downstream from this bridge was under construction in June 1978 (Plate 1).

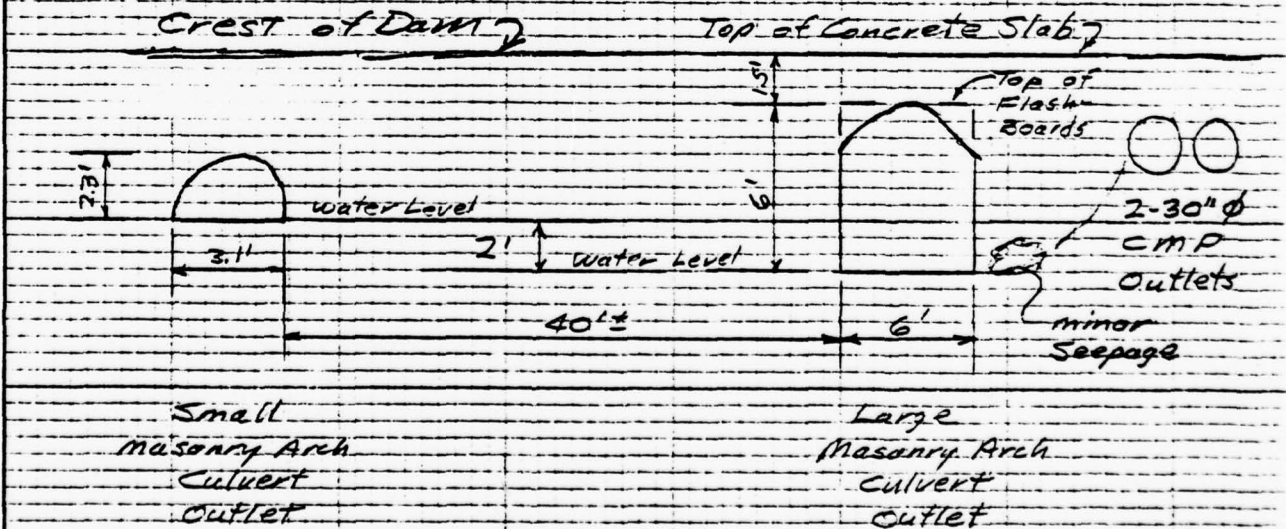
PLATE 3

Low Point on Embankment = 0.9' Free board as at Headwall = is approx 35' left of 30"  $\phi$  CMP.

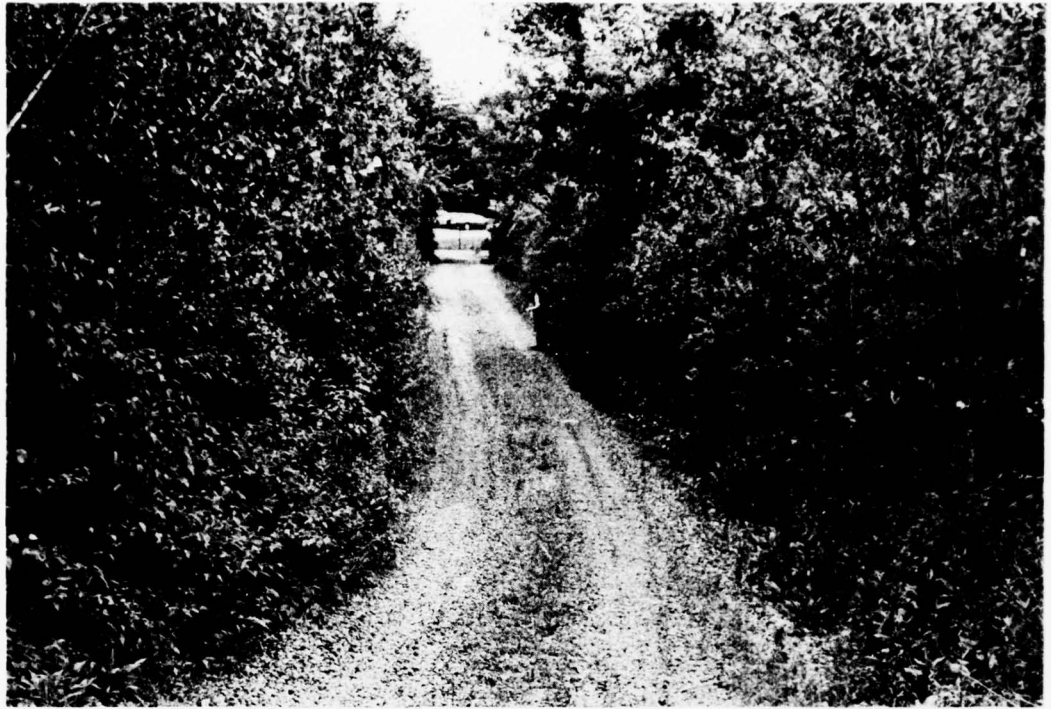
**PHOTO 1**

- Photo 1 View Southwest Along Driveway (From Valley Road, Photo 8) on Crest of Dam; J. V. Hamel Standing at Inferred Left (Northeast) End of Dam Embankment; Suburban Savings and Loan Parking Area (Photo 7) in Top Center of Photo Beyond Outlet Works Portion of Dam - 13 June 1978.

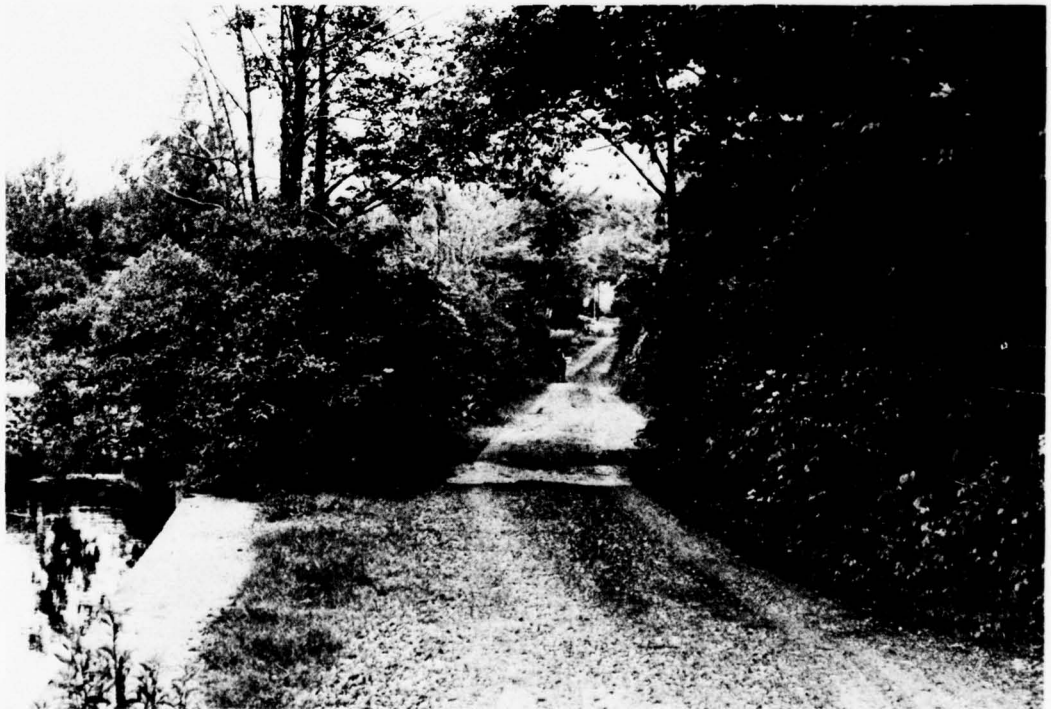
**PHOTO 2**

- Photo 2 - View Northeast Along Crest of Dam From Right (Southwest) Abutment (Adjacent to Suburban Savings and Loan Parking Area, Photo 1); J. V. Hamel Standing at Inferred Left (Northeast) End of Dam Embankment; Concrete Head Wall with Masonry Arch Culvert Inlets in Bottom Left Corner of Photo - 13 June 1978.

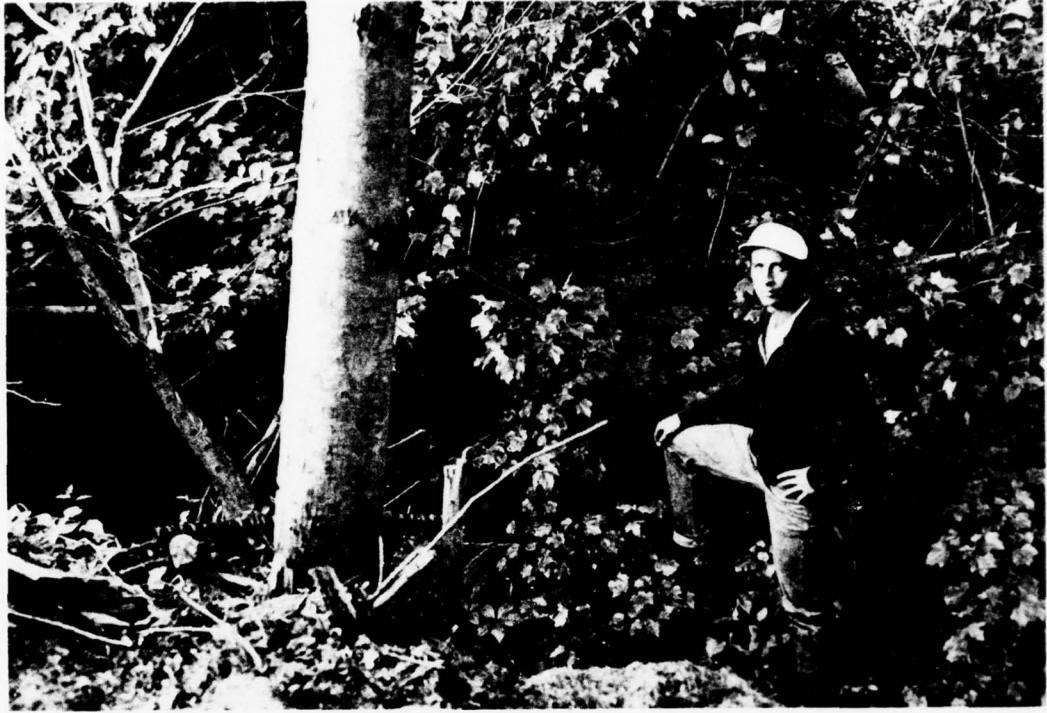
PHOTO 3

- Photo 3 - View East-Northeast at T. J. Dougan in "Jungle and Random Fill" Area Downstream From Center of Dam About 50 Feet Northeast of Two 30 Inch Corrugated Metal Pipe Culverts (Photo 4) - 13 June 1978.

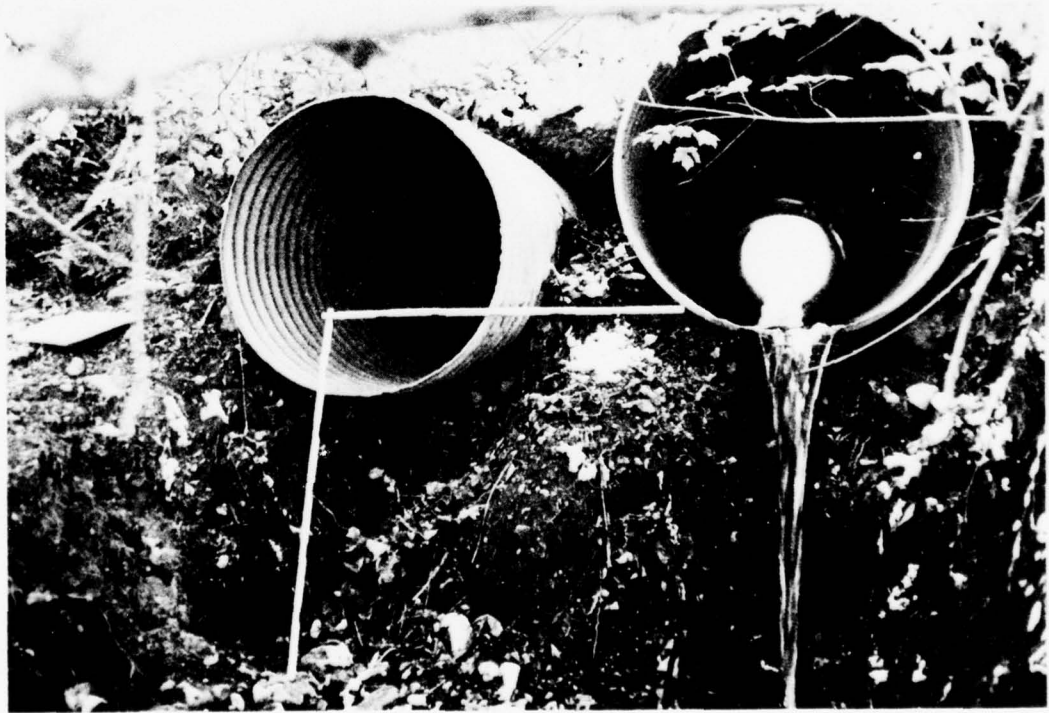
PHOTO 4

- Photo 4 - Close-Up of Outlet Ends of Two 30 Inch Corrugated Metal Pipe Culverts (Left Side of Overall View of Dam) in Downstream Slope of Dam Embankment - 10 June 1978.

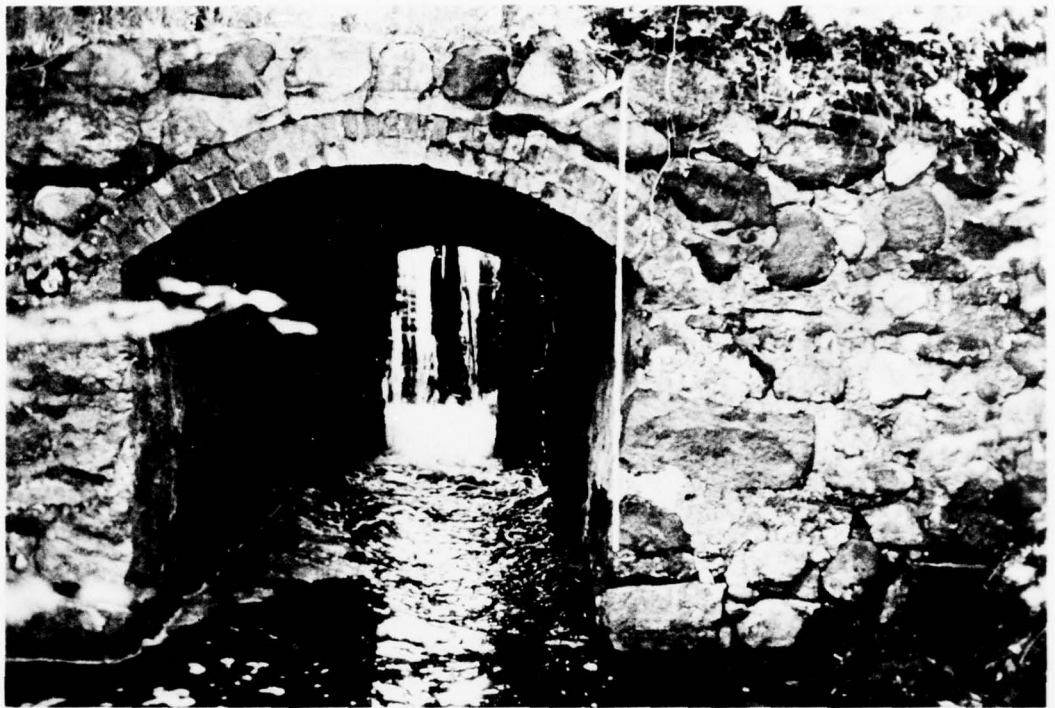
PHOTO 5

- Photo 5 - Outlet of Large Masonry Arch Culvert; Rule is Folded One Foot by Five Feet for Scale; Drop Inlet Visible at Upstream End of Culvert; Minor Seepage From Masonry Wall at Geologists Hammer in Lower Right Corner of Photo - 10 June 1978.

(2) Within six months the owner should patch the loose or open joints in the masonry of the two arch culverts.

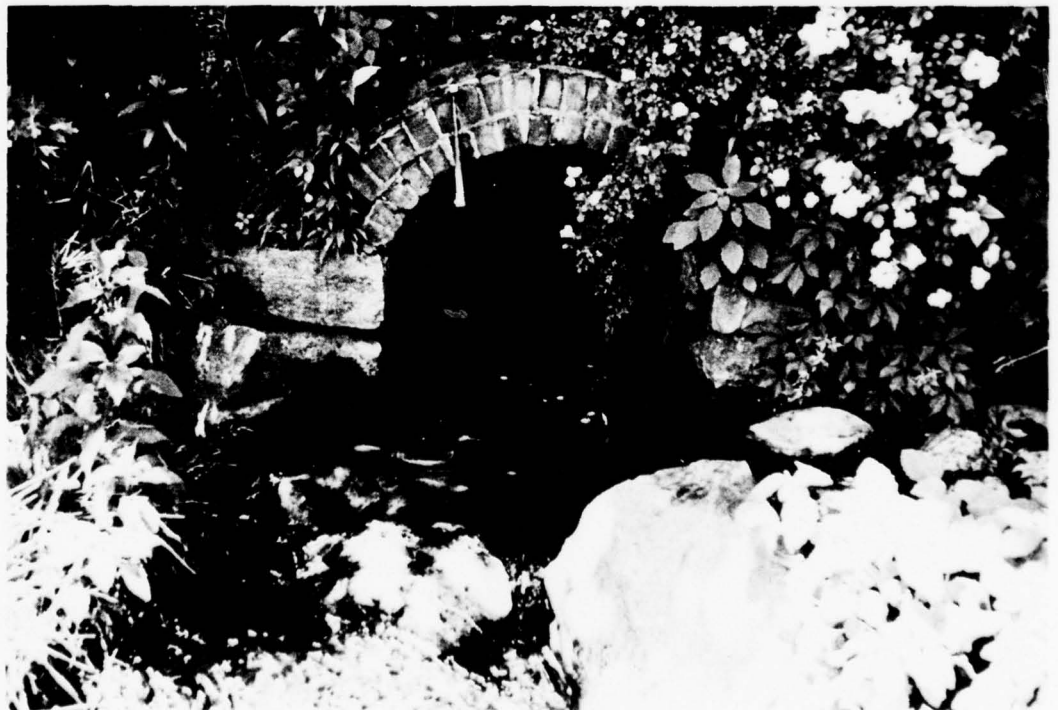
PHOTO 6

- Photo 6 - Outlet of Small Masonry Arch Culvert at Right (Southeast) End of Dam; Geologists Hammer for Scale - 10 June 1978.
- Photo 7 - View Upstream (Northwest) Along Outlet Channel From Dam; Dam is Behind Trees in Center of Photo; Suburban Savings and Loan Parking Area (Photo 1) at Left Edge of Photo - 13 June 1978.
