SYLVA LAKE DAM

PHASE I INSPECTION REPORT  
NATIONAL DAM SAFETY PROGRAM

NJ 00391

AUGUST 1978

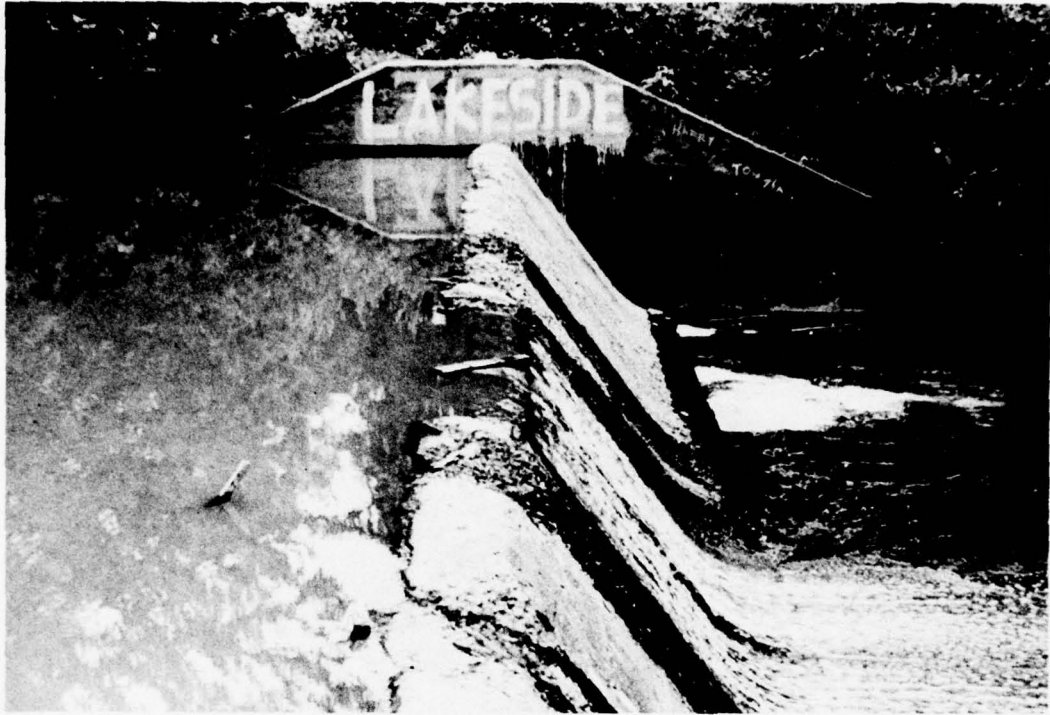
PHOTO 1

Photo 1 - View of Spillway and Left Abutment Wing Wall Looking Toward Northeast - 24 June 1978.

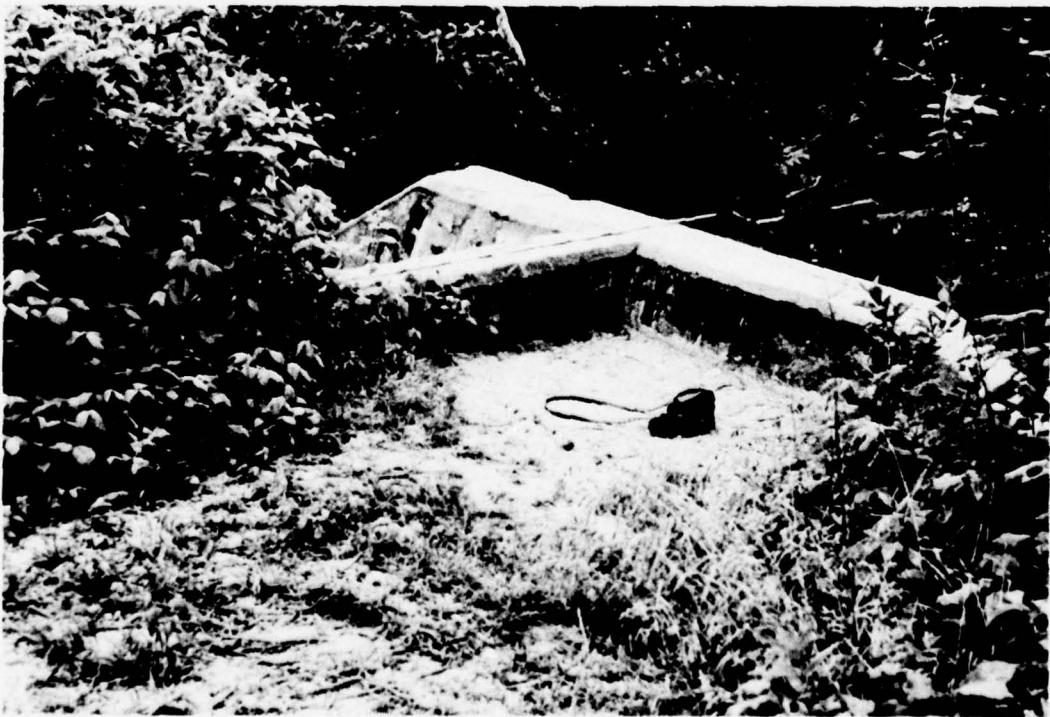
PHOTO 2

Photo 2 - Picture of Left Abutment Wing Wall and Core Wall Showing Low Ground Surface Probably Caused by Erosion and Possibly Some Settlement - 24 June 1978.

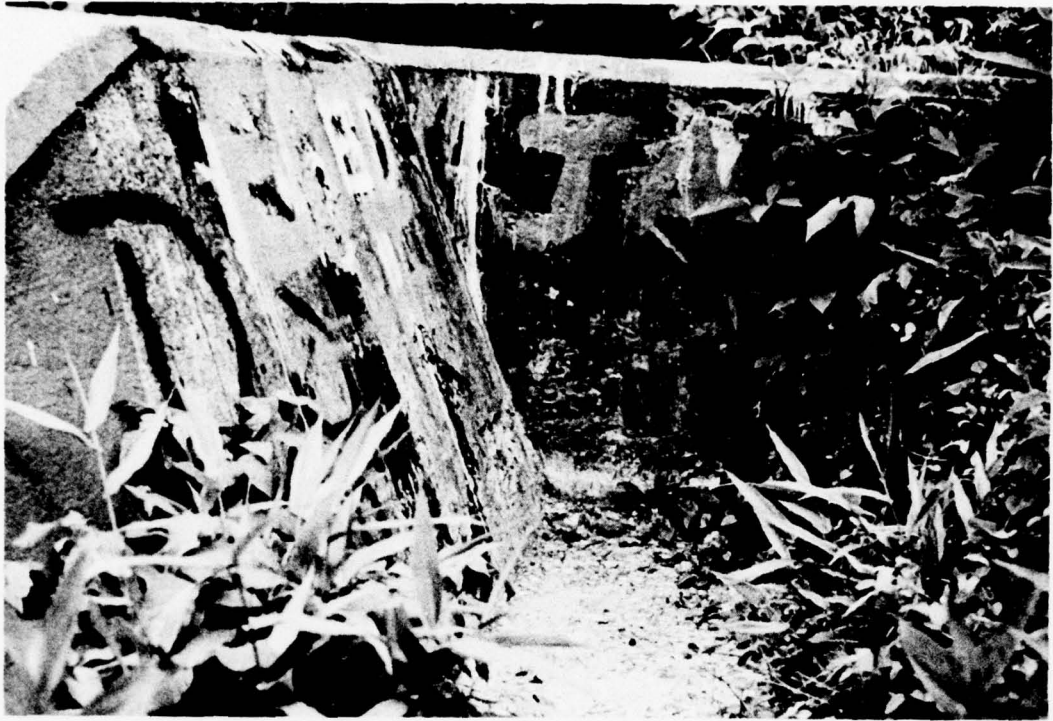
**PHOTO 3**

Photo 3 - Close-Up of Low Ground Surface at Junction of Wing Wall (Left) and Core Wall - 24 June 1978.

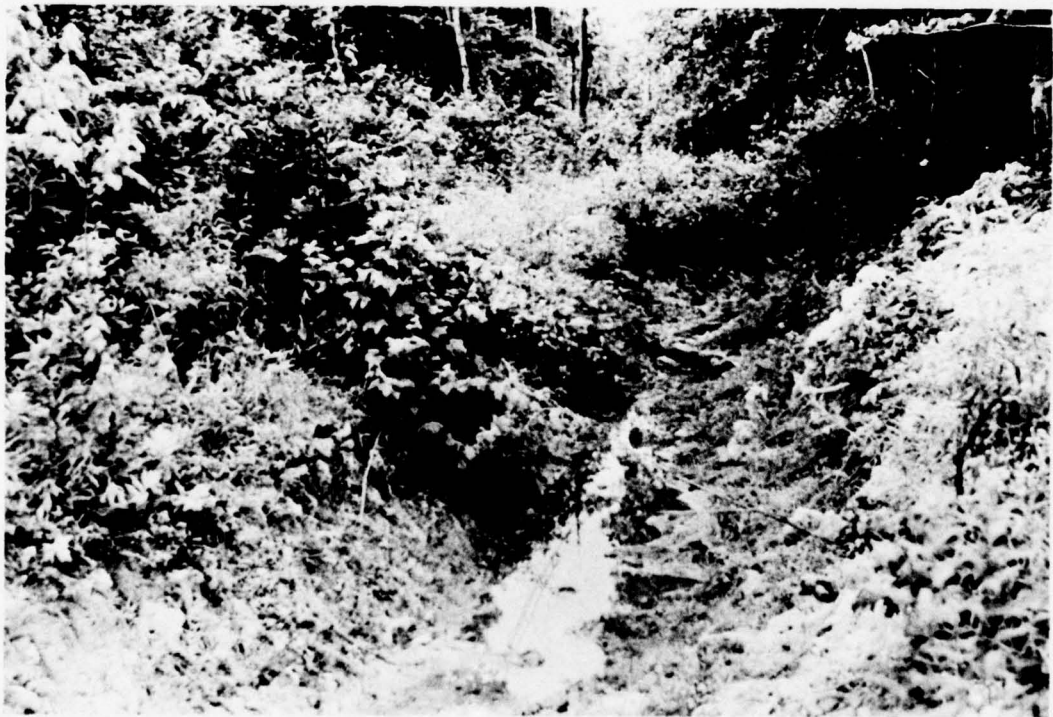
**PHOTO 4**

Photo 4 - Picture of Recently Excavated Drainage Ditch Which Connects With Downstream Channel Adjacent to Left Abutment Wing Wall (Dike Retaining Lake Sylva Is Located Toward Left of Picture) - 24 June 1978.

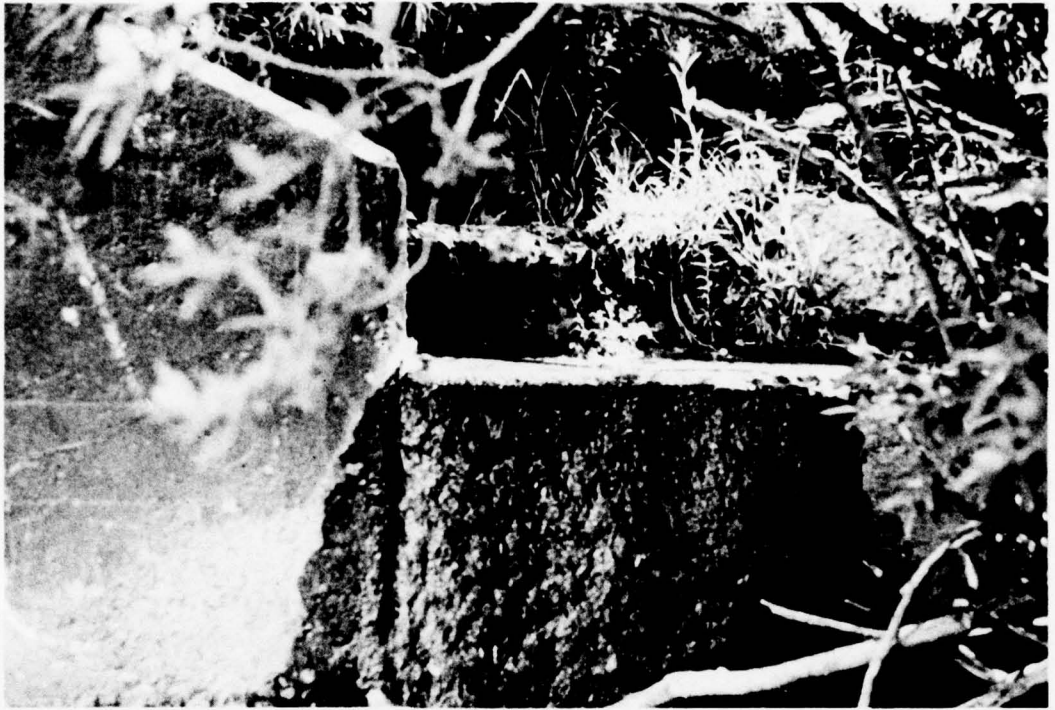
**PHOTO 5**

Photo 5 - Close-Up of Drainage Ditch Discharge Over Small Downstream Channel Wall Adjacent to End of Left Abutment Wing Wall - 24 June 1978.

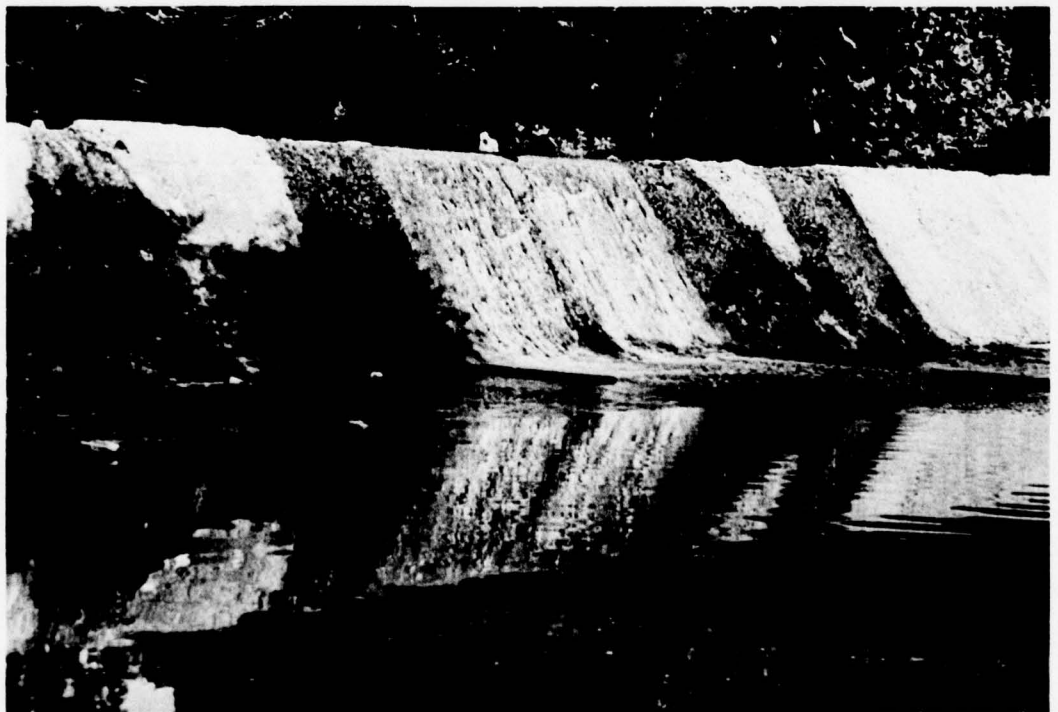
**PHOTO 6**

Photo 6 - View of Spillway Showing Badly Spalled Concrete and Pool in Foreground Formed by Scour of Channel Bottom - 24 June 1978.

(1) Extensive repairs should be made to all spalled and deteriorated concrete on the spillway weir, downstream face of the spillway, spillway wing walls, and discharge channel apron.

(3) Improve outlet channel conditions by removing deposition, trees and debris. The left stream bank should be cleared, shaped and stabilized with properly designed riprap to withstand high stream flows. The scour hole at the end of the spillway apron should be repaired to avoid further damage.

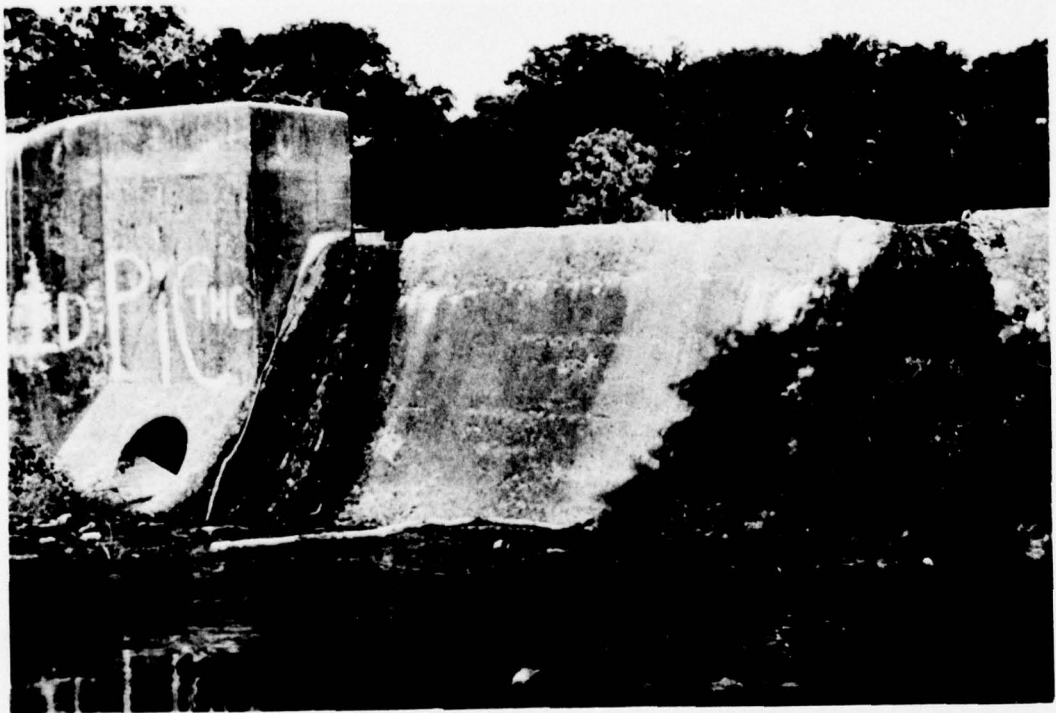
PHOTO 8

Photo 8 - Picture of Portion of Spillway and Right Abutment Showing 24 Inch Diameter Outlet Cast in Concrete - 24 June 1978.

(2) The gate and outlet works should be repaired as necessary to provide emergency drawdown facilities. Maintenance procedures should be developed and implemented for this facility in the future.

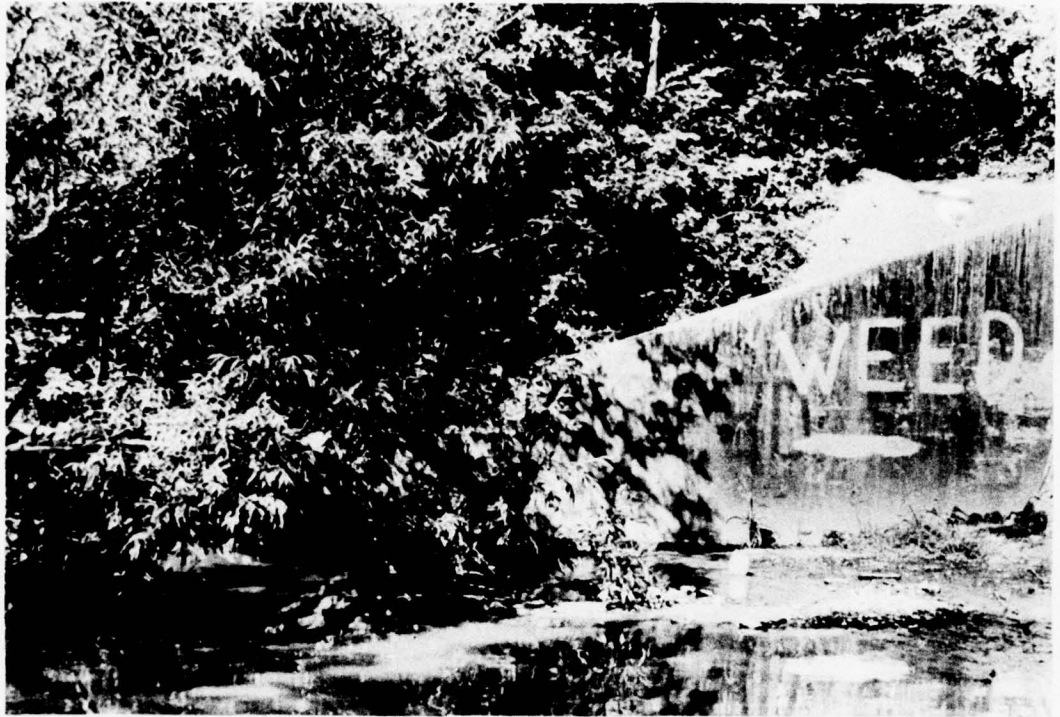
PHOTO 9

Photo 9 - View of Downstream End of Right Abutment Wing Wall (Note Eroded Gully Behind Wing Wall, and Heavy Tree and Brush Cover on Embankment) - 24 June 1978.

In the near future, the earth embankment should be cleared of trees and shrubs, properly graded, and reseeded with grass, which should be well maintained.

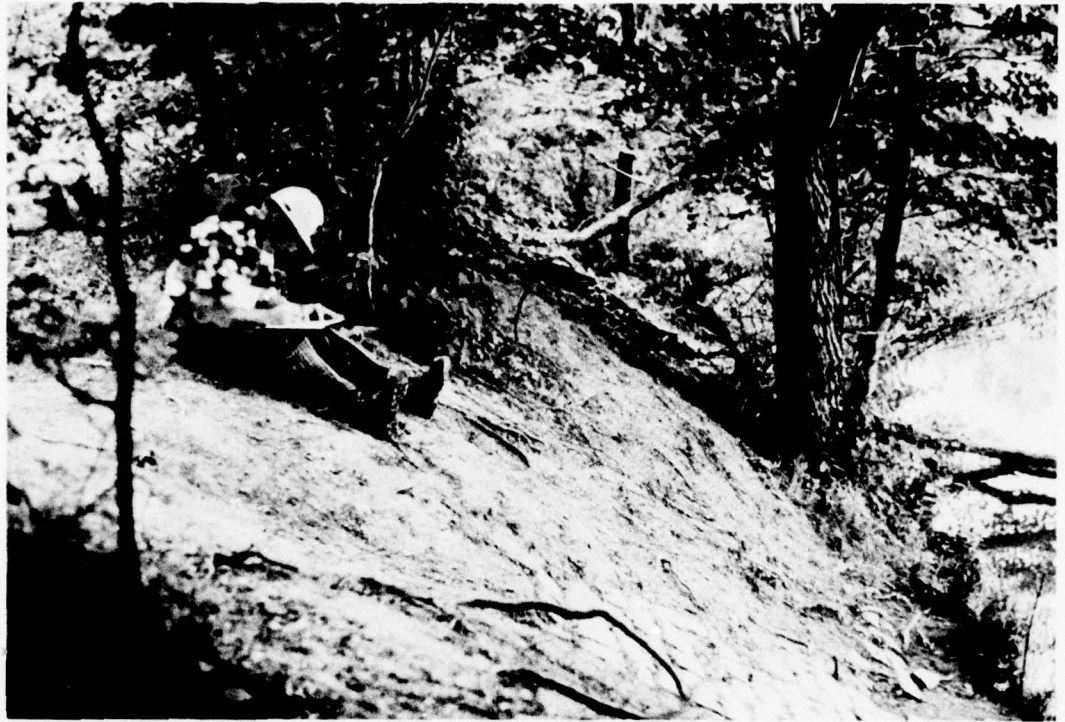
PHOTO 11

Photo 11 - View of Upstream Embankment Slope Near Right Abutment (Note Belgian Block Slope Paving, Mostly Covered With Soil, and Large and Small Trees - 24 June 1978.

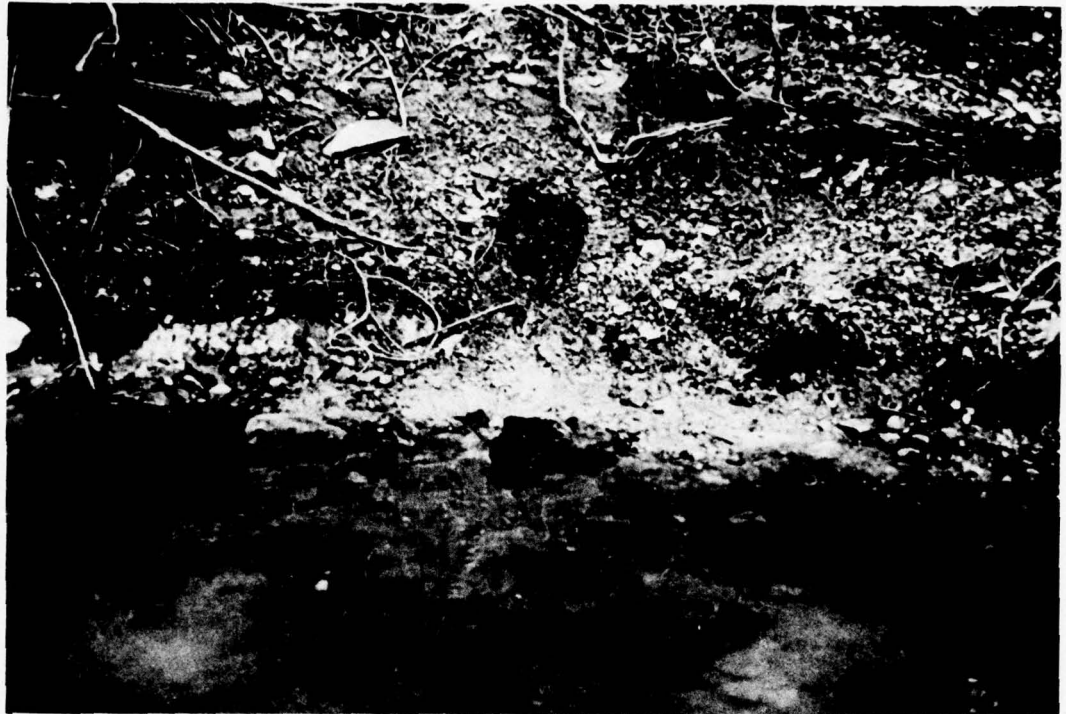
**PHOTO 13**

- Photo 12 - Picture of Downstream Channel Looking Downstream  
(Note Erosion and Undercutting of Bank Causing  
Collapse of Tree Root Systems) - 24 June 1978.
- Photo 13 - Picture of Very Slight Clear Seepage (Less Than One  
G.P.M.) From Contact of Dense Sand and Gravel With  
Little Silt (Above) With Underlying Very Stiff Gray  
Silt Exposed Just Above Stream Level on Right Bank  
About 100 Feet Downstream From Dam - 24 June 1978.
- Photo 14 - View of Upper End of Lake Sylva Showing Aquatic  
Growth Resulting From Heavy Siltation of Lake -  
24 June 1978.
