SPLIT ROCK POND DAM

PHASE I INSPECTION REPORT

NATIONAL DAM SAFETY PROGRAM

NJ 00264

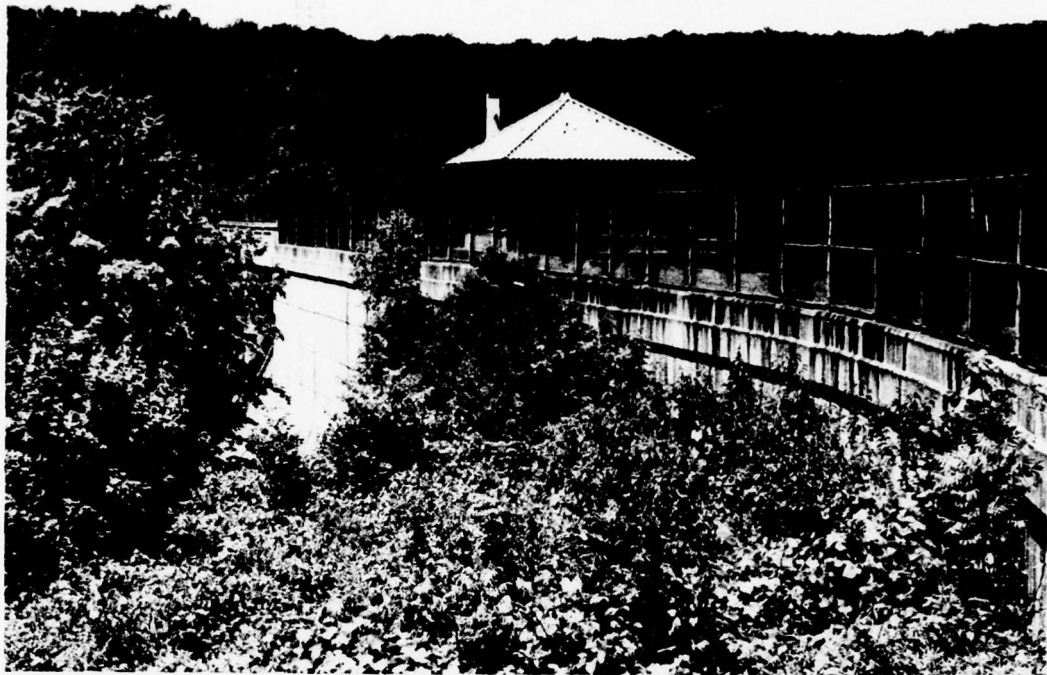
PHOTO 1

Photo 1 - View West Along Downstream Face of Dam From Left (East) Abutment - Gate Chamber in Center of Photo; Spillway Behind Trees in Left Side of Photo - 15 June 1978.

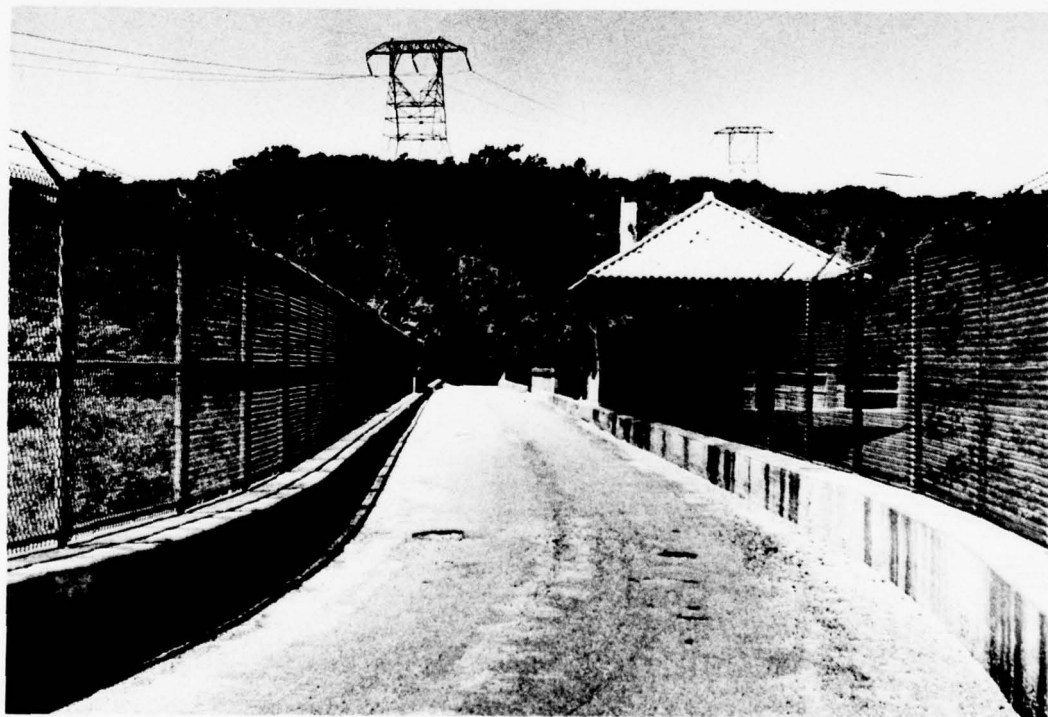
PHOTO 2

Photo 2 - View West Along Road Over Crest of Dam From Left (East) Abutment - Gate Chamber in Right Center of Photo - 15 June 1978.

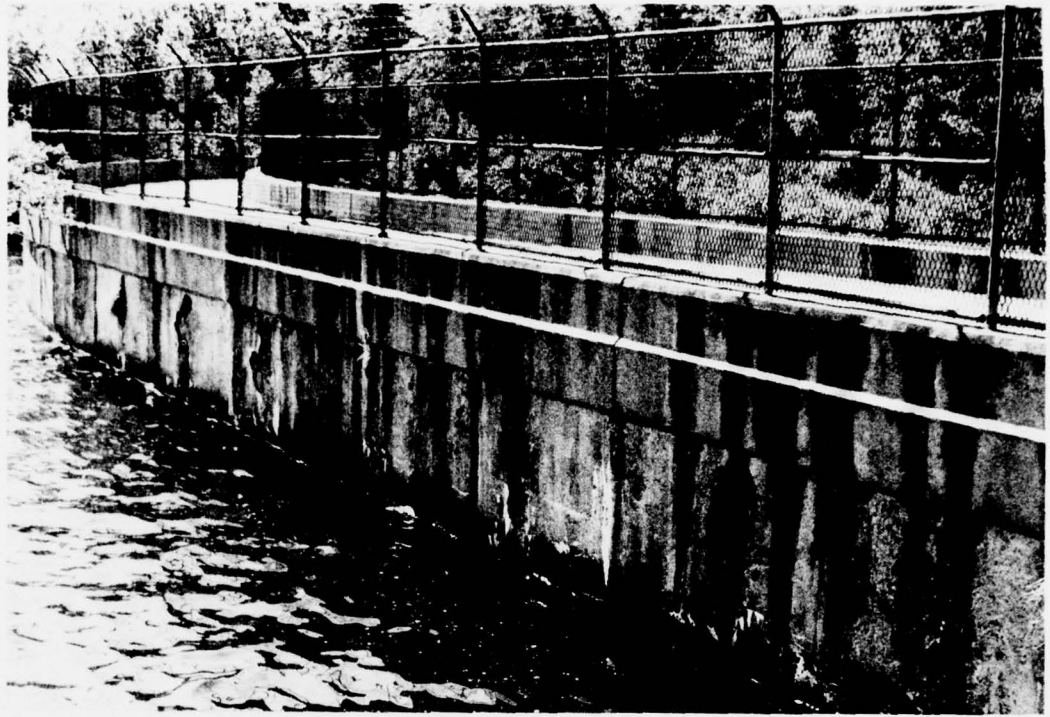
PHOTO 3

Photo 3 - View Downstream (Southeast) at Left (East) Side of Upstream Face of Dam From Gate Chamber Walkway - Small Trees in Weep Holes of Road Fill Retaining Wall in Top Left Corner of Photo - 16 June 1978.

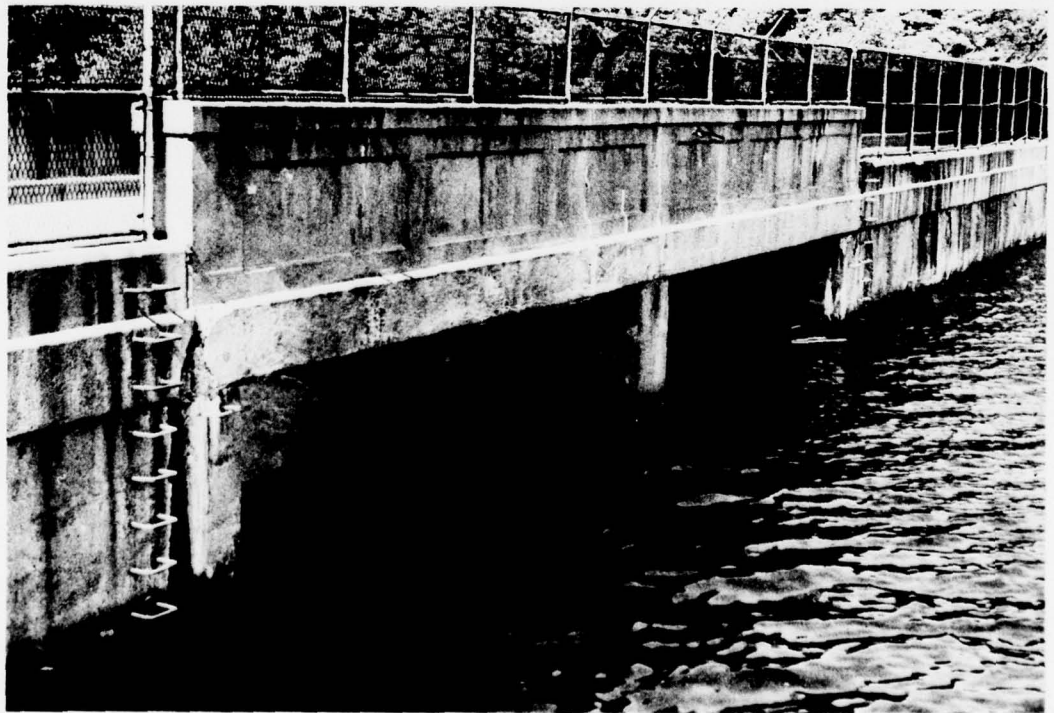
PHOTO 4

Photo 4 - View Downstream (Southwest) at Right (West) Side of Upstream Face of Dam From Gate Chamber Walkway - Spillway in Center of Photo - 16 June 1978.

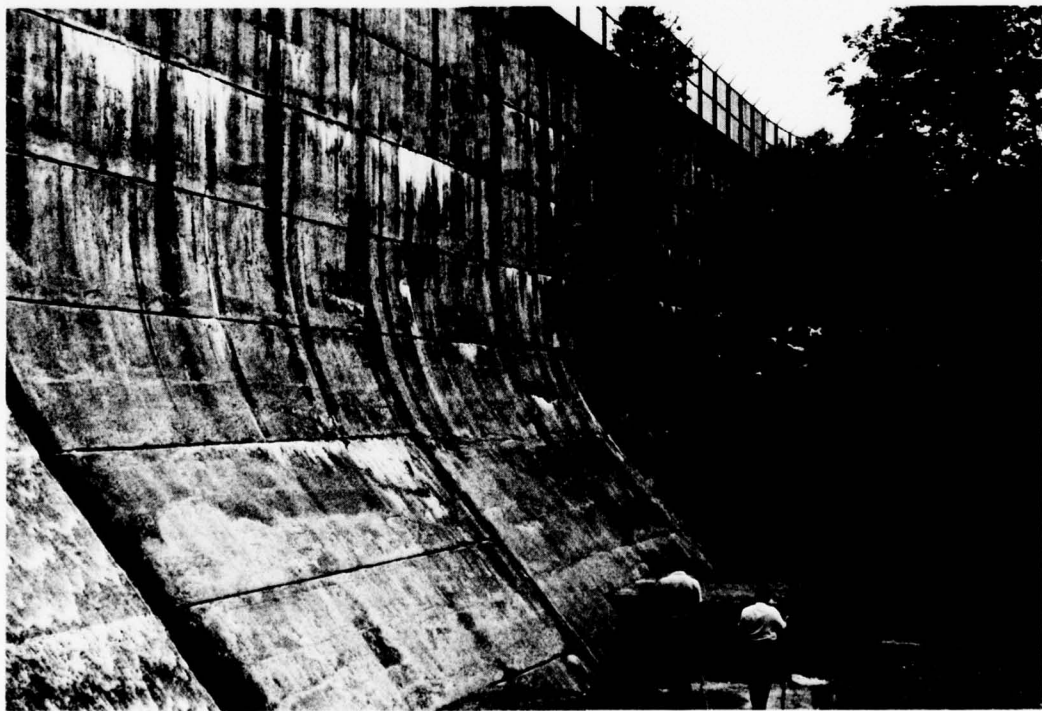
PHOTO 6

Photo 6 - View Northeast Across Downstream Face of Dam From Right (West) Abutment - Spillway in Bottom Left Corner of Photo; 36 Inch Diameter Outlet Pipe in Bottom Center of Photo Behind Two Men; Six Inch Diameter Tree Growing From Retaining Wall Weep Hole in Top Center of Photo - 16 June 1978.

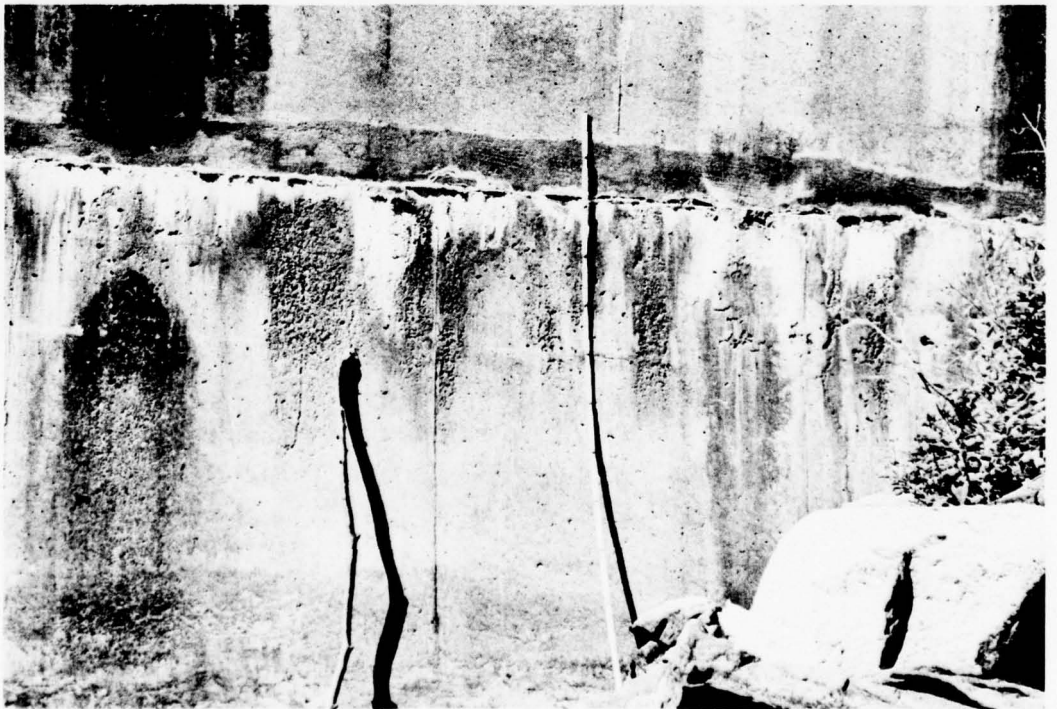
PHOTO 8

Photo 8 - Close-up of Concrete at Approximately El. 830 on Left (East) Side of Downstream Face of Dam - Seepage and Mineral Deposits Along Horizontal Joint; Six Feet Rule for Scale - 15 June 1978.

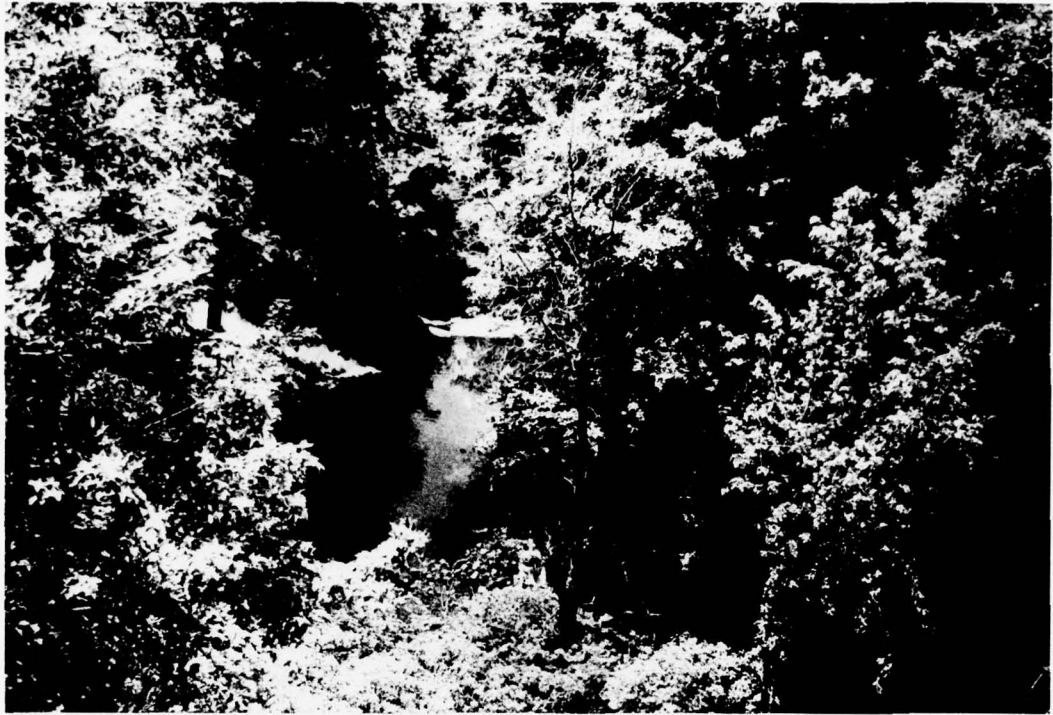
PHOTO 9

Photo 9 - View Downstream (South) Over Outlet Channel From Dam Crest Above Outlet Pipe - Concrete Weir (Close-Up in Photo 10) Is at White Water Area in Top Center of Photo - 15 June 1978.
