AFFDL-TR-78-79

REPAIR OF BONDED PRIMARY STRUCTURE

BOEING COMMERCIAL AIRPLANE COMPANY  
P.O. BOX 3707  
SEATTLE, WASHINGTON 98124

June 1978

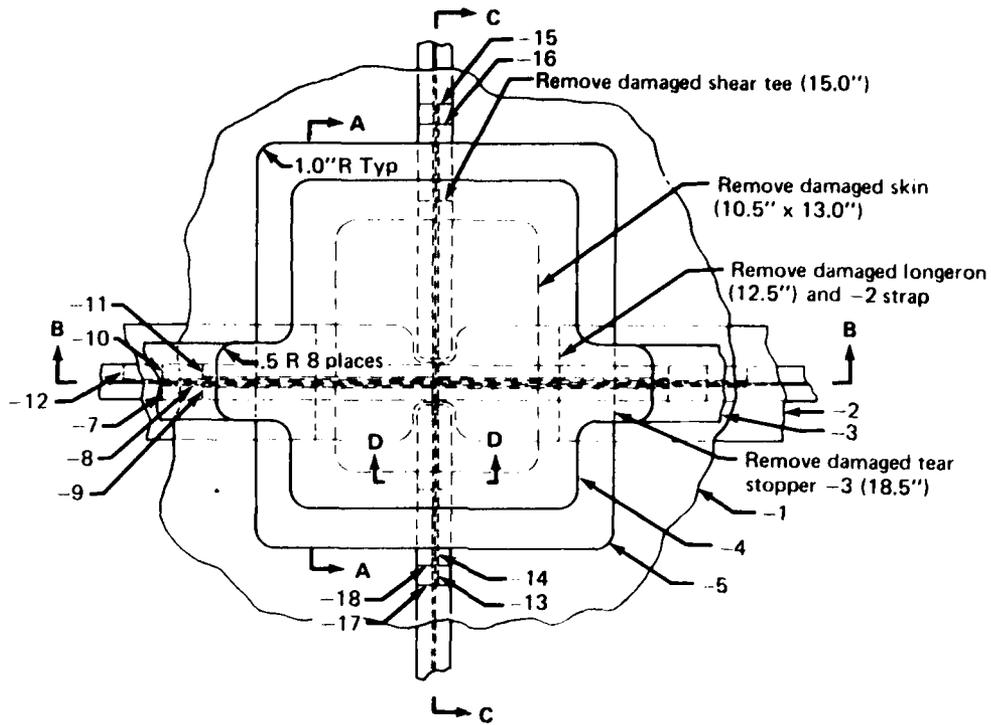
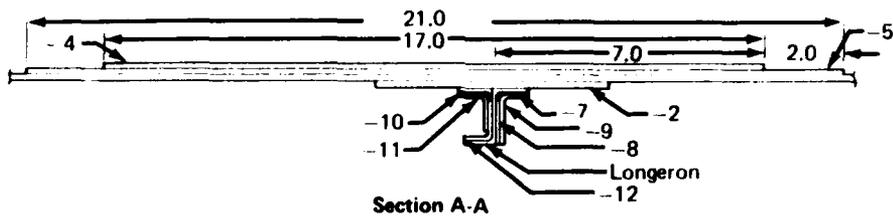
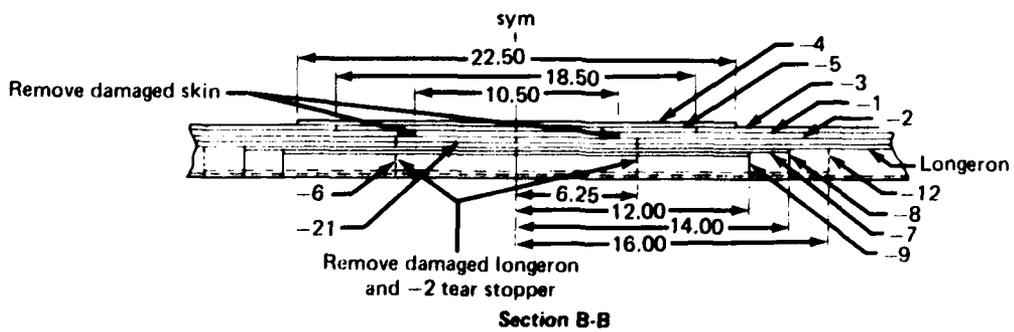
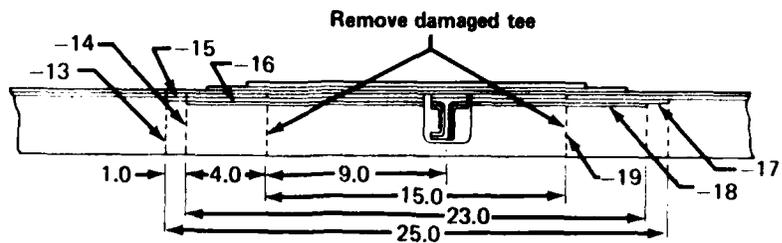
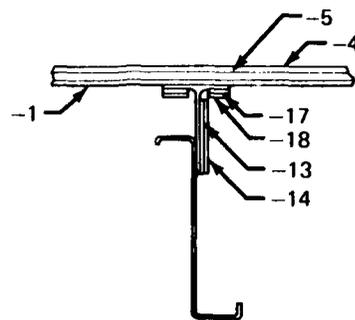
Figure 36.--Checkpoint "B" Repair Internal Longeron

Sketches of the repairs are shown in Figures 36 and 37. Splice plates were stepped to gradually transfer the load and minimize the effect of repair hard spots. Flat details were used where possible, so that they would conform easily to the contour of the curved skin or frame.

Matching stiff formed or extruded details to the frame contour may be a problem with these particular repairs. It is assumed that in actual practice consideration will be given to cutting these sections from stocked spare frame members. If these are not available, forming blocks or special roll forms may be required to fabricate the parts. This is not dissimilar to present requirements for obtaining these sections to repair current fuselage structure.

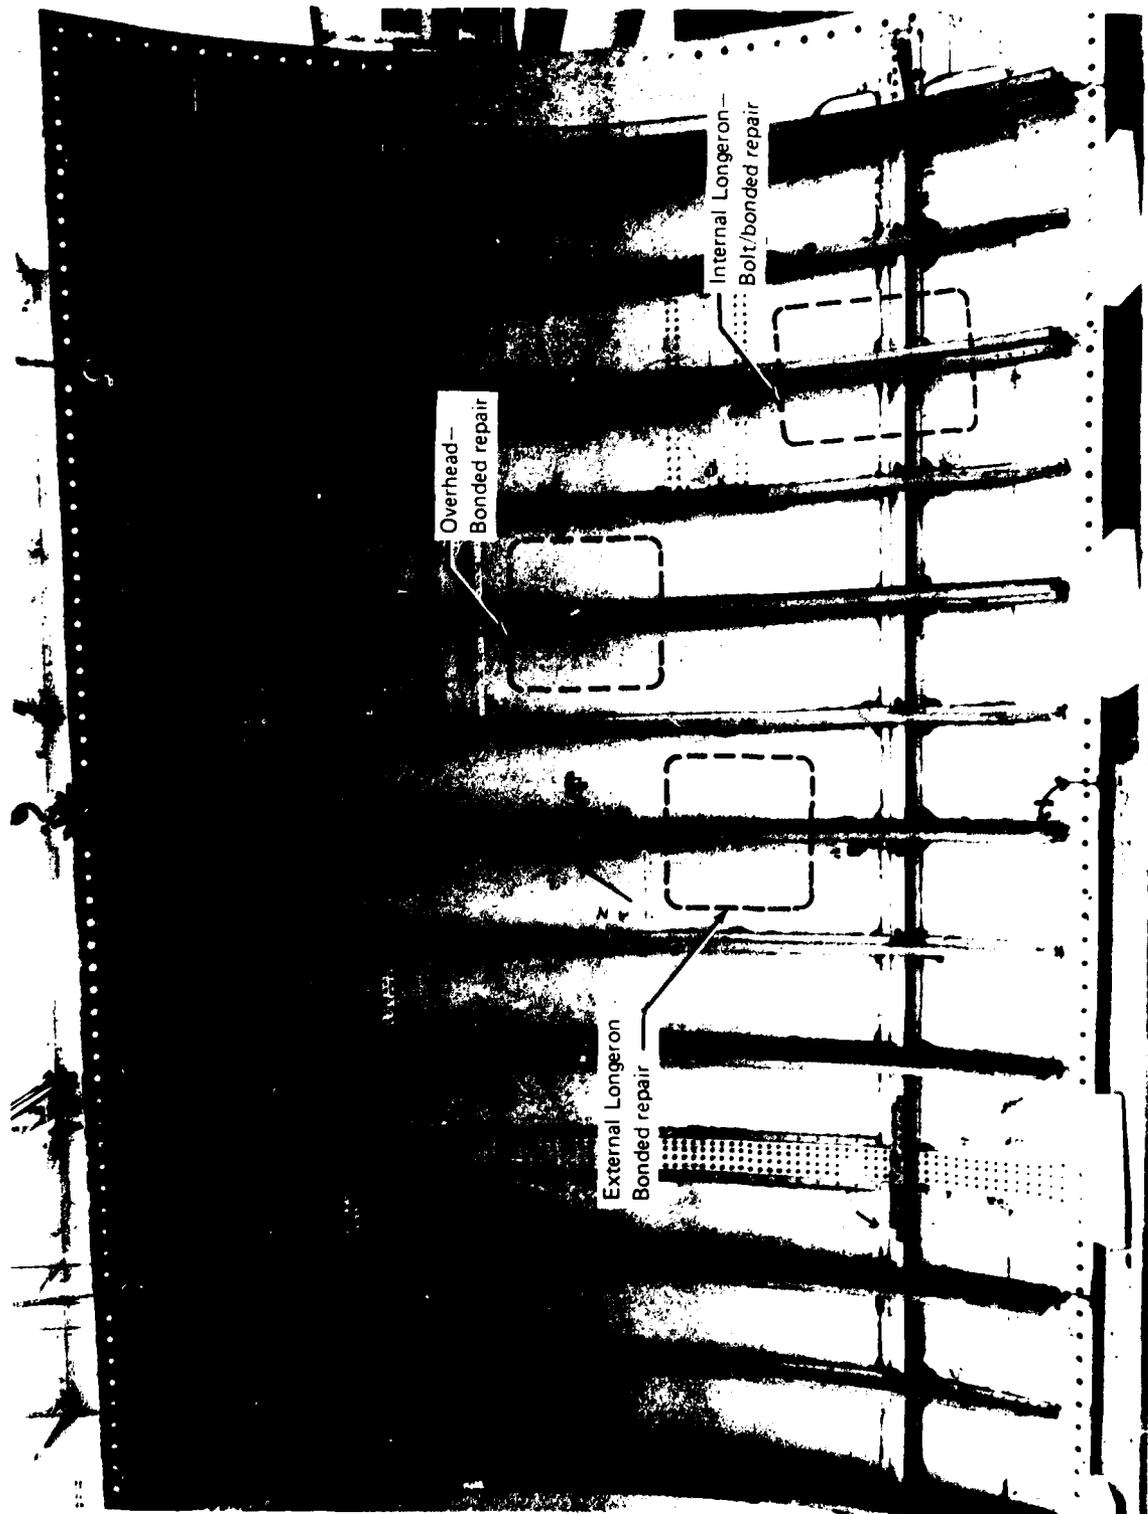
Figure 48. — Location of Repair Demonstration Areas—Pabst Panel

During coordination with Douglas, a large PABST pressure test panel (110 in. x 168 in.) was identified on which testing had been completed and which could be surplused to this program. The panel, shown in Figure 48, had been used for damage tolerance testing and had several temporary repairs that had been made to permit test continuity. Adequate areas remained, however, where permanent repairs of a structural type could be demonstrated.

Three areas where repairs could be accomplished were selected. These are shown in Figure 48. The first area was at the intersection of an internal longeron and frame. Pressure for bonding, in this case, was obtained by using mechanical fasteners.

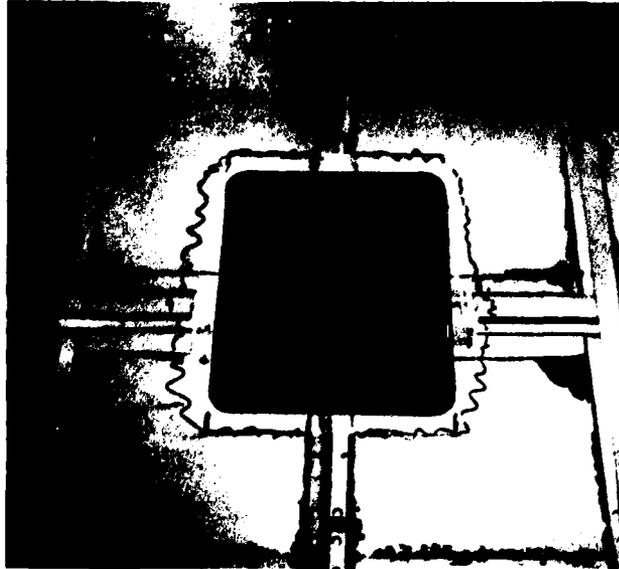
The start of the first repair on the large panel is shown in Figure 51. The riveted rib web was removed. Guide holes were drilled and then a hole saw was used to radius the corners of the cut-out area. Templates were attached to the panel as shown in Figure 52, to act as a guide for the router cuts. The frame tee and longeron were cut back beyond the skin edge to provide a splice overlap for the repair details. Removal of the "damaged" material is shown completed in Figure 53.

*Figure 53.—All "Damaged" Material Removed from Panel*

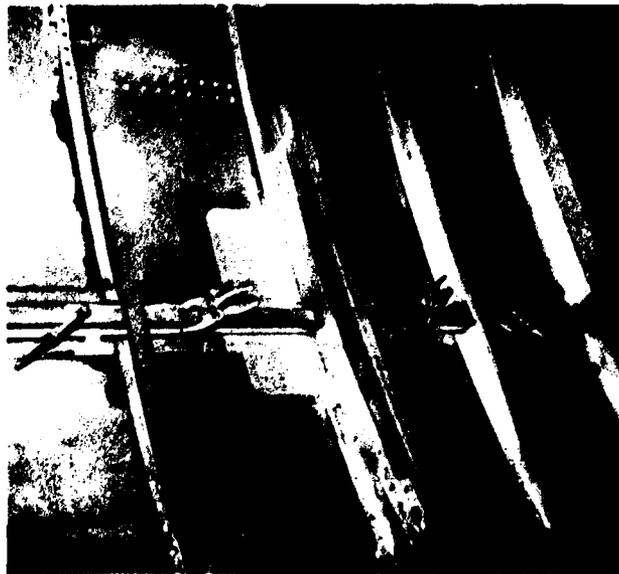
After the "damaged" material was removed, the metal repair details were fabricated. These are shown in Figure 54. They were assembled prior to bonding, i.e., prefit, to ensure proper mating of bond surfaces (see Fig. 55). The details were cleaned and primed in regular production facilities.

*Figure 55. Detail Parts Prefit Prior to Surface Preparation and Bonding*

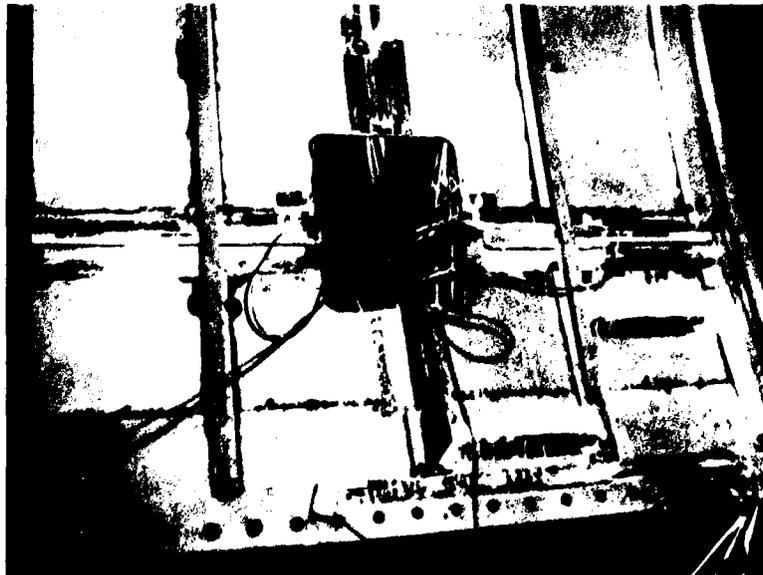
*Figure 57. Anodizing the Surfaces to be Bonded*

laying several thicknesses of gauze saturated with 12% phosphoric acid paste over the bare metal bond surfaces. A stainless steel screen was embedded in the acid over the gauze; care was taken to prevent the screen from touching, i.e., shorting, to the metal. Electrical connections were made to the screen and to the panel; the screen was connected as the cathode and the panel as the anode. Anodizing was accomplished using a potential of 6 volts dc for 10 min. The current flow was approximately one and one-half amperes.

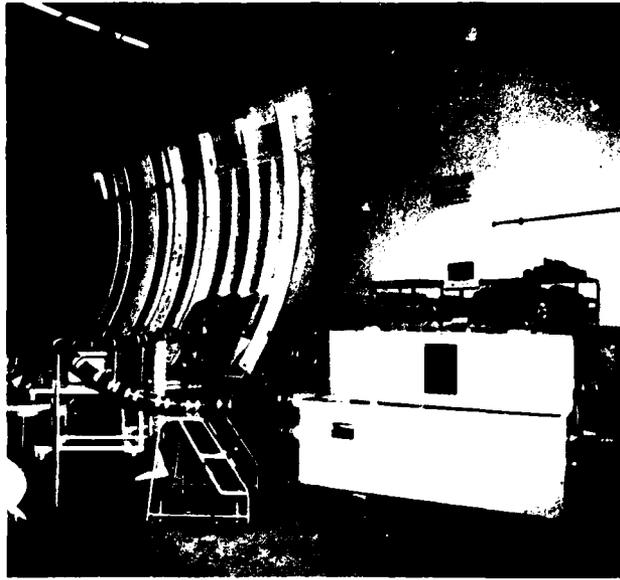
*Figure 59. --Overall View Showing Compressed Air Heater and Heating Set-up*

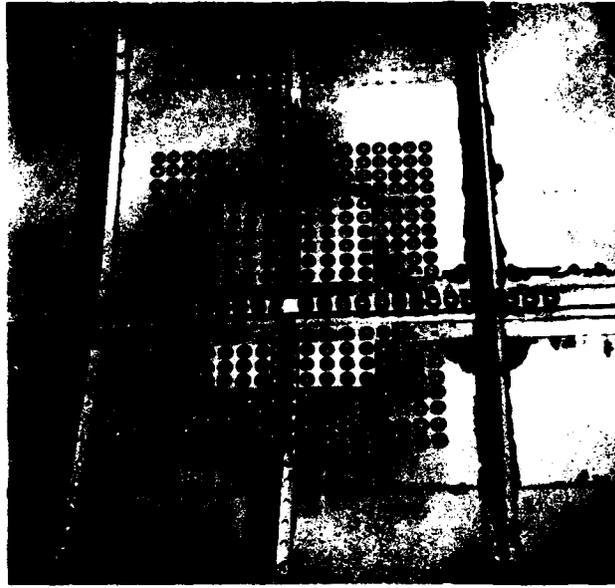
*Figure 61.—Pressurizing Bolts and Springs Installed for Cure of the Bond*

Curing of the adhesive was accomplished by heating the area at 200°F for 2 hours. This was done with a compressed air heater similar to the procedure that was used for curing of the primer. Heat was applied to both sides of the panel.
