Special Report 78-17

September 1978

EFFECTS OF WINTER MILITARY OPERATIONS ON COLD REGIONS TERRAINS

COLD REGIONS RESEARCH AND ENGINEERING LABORATORY
U.S. ARMY CORPS OF ENGINEERS
HANOVER, NEW HAMPSHIRE

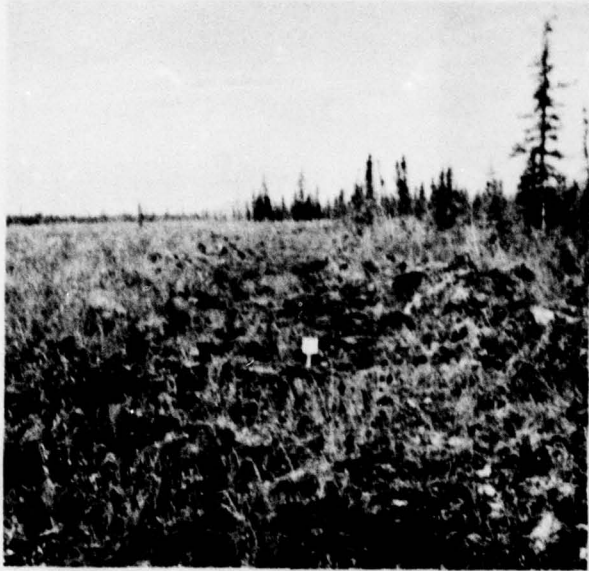
Site 20 (Figs. 32 through 35). A shrub-tussock community, adjacent to a spruce stand, similar to sites 14 and 15, but better drained, the dominant species being willows, resin birch, various berry bushes, grasses and mosses.

Figure 32. Site 20
(looking N).

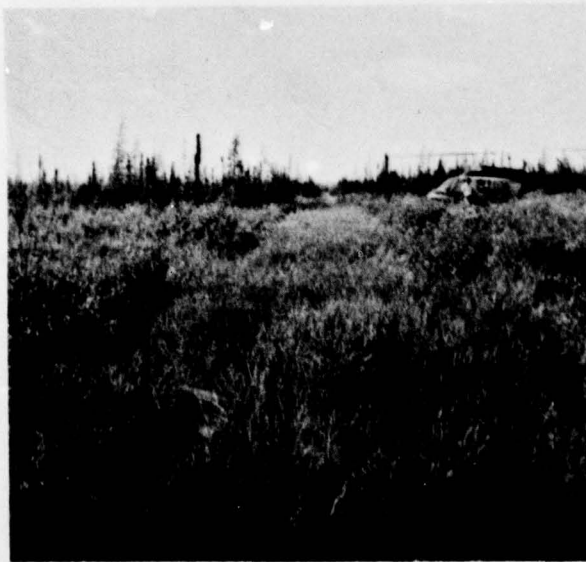
Troop concentration (artillery) (Figs. 36-39). This area has been used during previous maneuvers (for location refer to Fig. 3). The three old trails that converge toward the observation tower appear to have been cut a number of years ago. The lack of any significant berms along the trail edges implies little or no blade penetration below the terrain surface. While there is a healthy regrowth of grasses, very little regrowth of shrubs could be observed (Figure 38). For comparison, the new trail, on which Site 20 is located, is shown in Figure 39.

Figure 38. Old trail
(looking W).

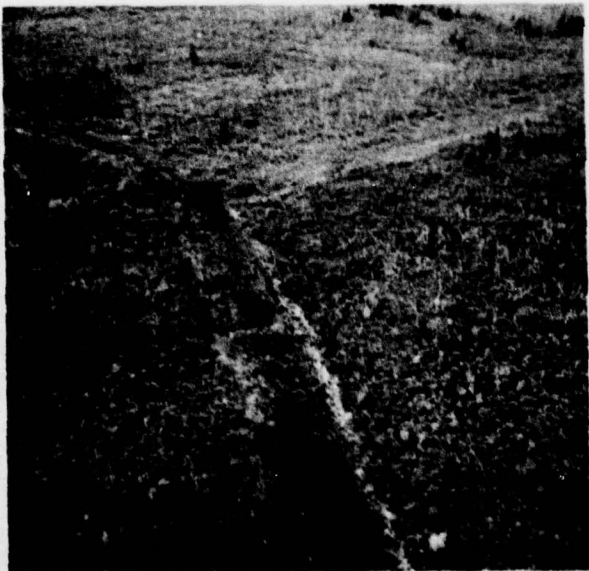
Figure 49. Communications center
area (looking S).

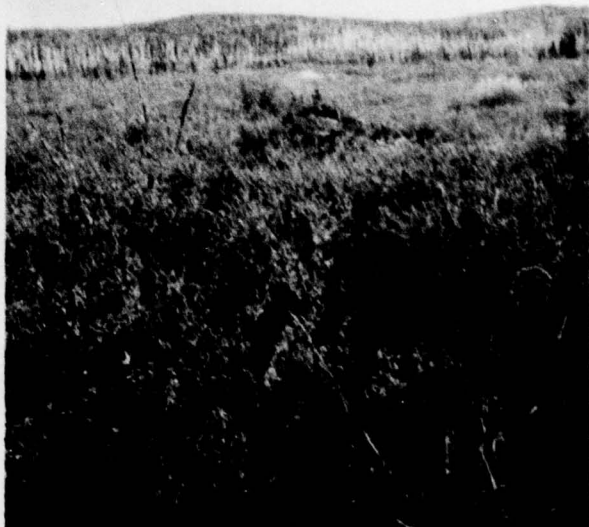
A couple of typical bivouac sites are shown in Figures 54 and 55. A dump site, with ashes still visible, is shown in Figure 56. The communications center site is shown in Figure 57. The cleanup in all of these areas has been rather thorough. Some minor debris, such as sections of communications wire, ration containers, and empty cigarette packs, were well hidden by the vegetation. From the air, the only visible signatures at this particular area were the trails. A number of fuel drums were observed at other sites in the Blair Lakes area.

Figure 57. Communications
center site.

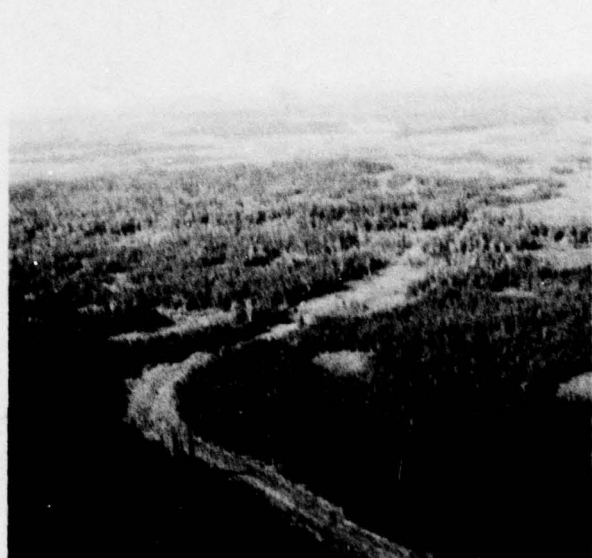
Figure 61. Trail from Tanana River
to Blair Lakes (looking W).

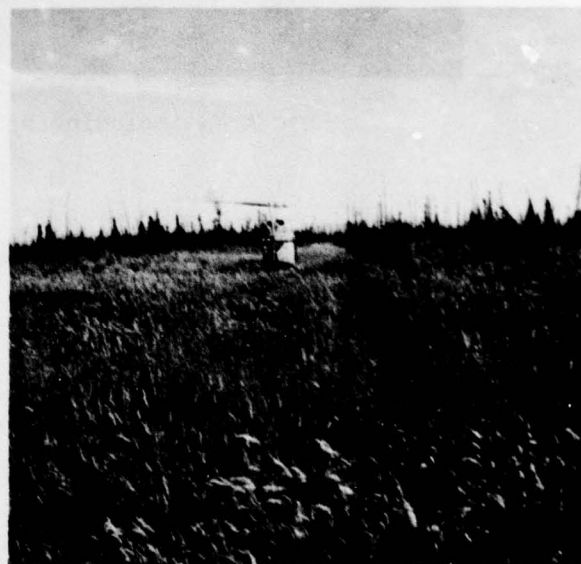
Figure 69. Ground view of trail (looking E).
