LOW FRICTION HULL COATINGS
FOR ICEBREAKERS

PHASE III TECHNICAL REPORT

S.J. Calabrese and F.F. Ling
Department of Mechanical Engineering,
Aeronautical Engineering & Mechanics
Rensselaer Polytechnic Institute

OCTOBER 1978

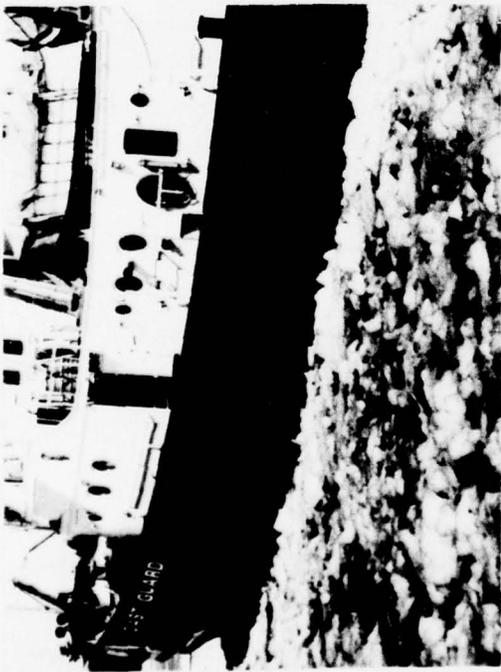
A series of tests were run in brash ice in the Saint Marie River Channel immediately after the calibration test. Figure 4 shows the ice conditions during testing.

Figure 4 Typical Conditions Existing During Full-Scale Testing in Brash Ice

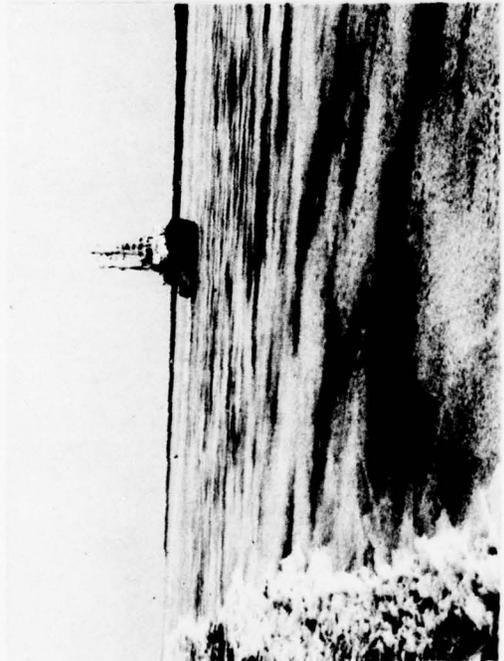
A second series of tests were run in a solid ice sheet field. The tests were inconclusive because of the condition of the ice. The tests were run in April when the ice had started to decay. The ice thickness ranged between 11 and 16" but the top 6" was soft with heavy pock marks. The results of the test were essentially the same as the brash ice except for one high point from both ships. Figure 6 shows the condition of the ice sheet during testing.

Figure 6 Condition of the Sheet Ice Field During Resistance Tests. Several inches of the top ice are heavily pock-marked and rotted.

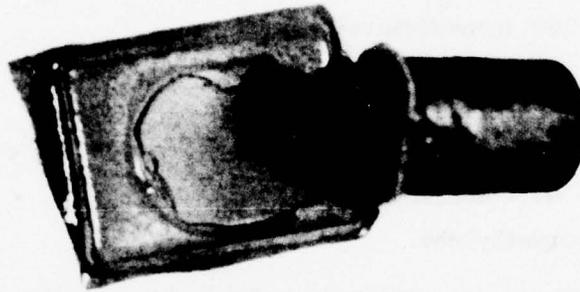
The results of the bond strength measurements on reapplied coatings indicate that the most acceptable method is to apply a second coat while the first coat is still wet. If the first coat has dried, the surface must be mechanically abraded before subsequent coatings are applied. It is also felt that further

Figure 20 Bond Strength Specimen after Testing of Reapplied Polyurethane Coating. Coating peeled between layers of coating.
