MISCELLANEOUS PAPER C-78-12

CONCRETE AND ROCK CORE TESTS MAJOR REHABILITATION OF STARVED ROCK LOCK AND DAM, ILLINOIS WATERWAY CHICAGO DISTRICT, PHASE I, REHABILITATION

September 1978 Final Report

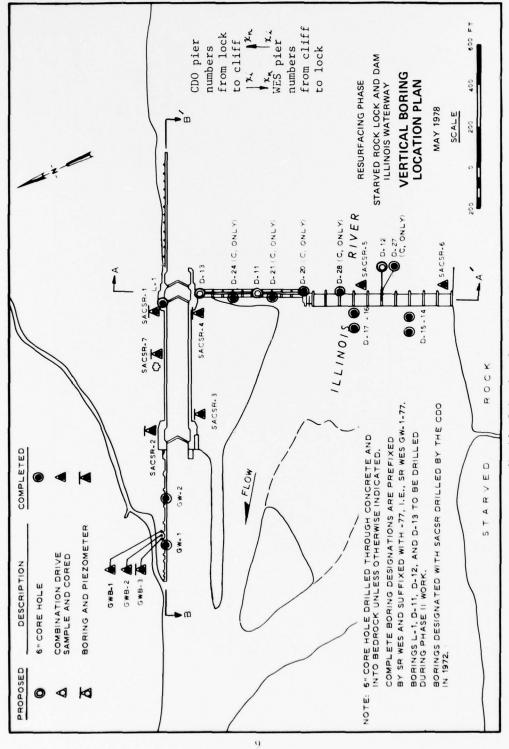
Figure 1. General boring location plans

20. Three boreholes were made into backfill material (GWB-1, GWB-2, GWB-3); see Figure 1a for boring locations. Approximately 55 ft of material was recovered. Only one borehole (GWB-1) reached bedrock and penetrated 1 ft. Bedrock overburden was probably spoil from the lock and dam excavations and consists of a mixture of clay, sand, and gravel. The backfill material varies in proportions ranging from 80 percent loose sand on top (clayey sand) to 80 percent compact clay near bottom (sandy clay) with pockets of gravel interspersed with the sand and clay layers. Up to 20 percent gravel is found within the sand and clay layers. Bedrock recovered was a green gray shale layer topping a sandstone reached at el 431. This puts the rock in the Kress Sandstone or at the contact of the Shakopee Dolomite and Kress Sandstone as inferred from comparison of this hole with surrounding lower approach wall boreholes.

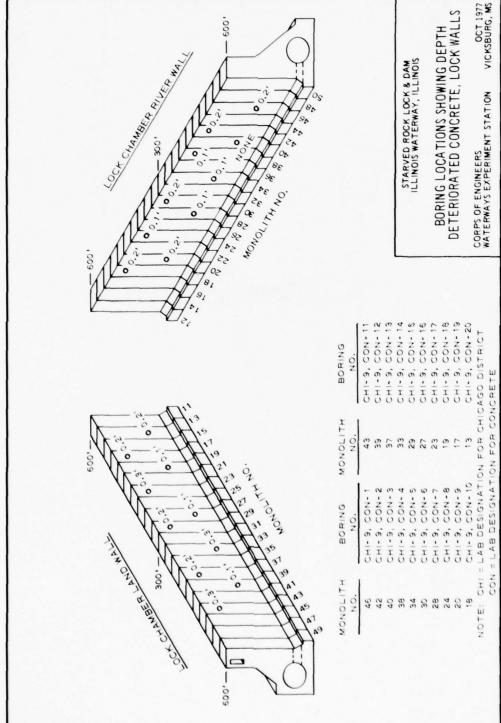
PLATE 1

- 68. Depth of Deterioration. The average depth of concrete deterioration throughout the eroded portion of the wall is 0.2 ft; maximum depth of frost-damaged concrete is 0.3 ft (see Plate 1 for individual depths of frost-damaged concrete at each boring location).
- 69. The total depth of deterioration as measured from the original face of the lock wall is the sum of the eroded depth and of the present frost-damaged concrete. The deepest damaged concrete is near the top of the wall.
- 70. Average Physical Properties. The average physical properties of the land wall concrete are tabulated below:

- 71. Depth of Deterioration. The average depth of deteriorated concrete throughout this side of the wall is 0.2 ft; the maximum depth is 0.2 ft (see Plate 1 for depth of deteriorated concrete for each boring). The deepest frost-damaged concrete is near the top of the wall. All of the core except the one taken from monolith 40 exhibited frost damage near the vertical lock wall surface.
- 72. Average Physical Properties. The average physical properties of the river wall concrete are listed below:

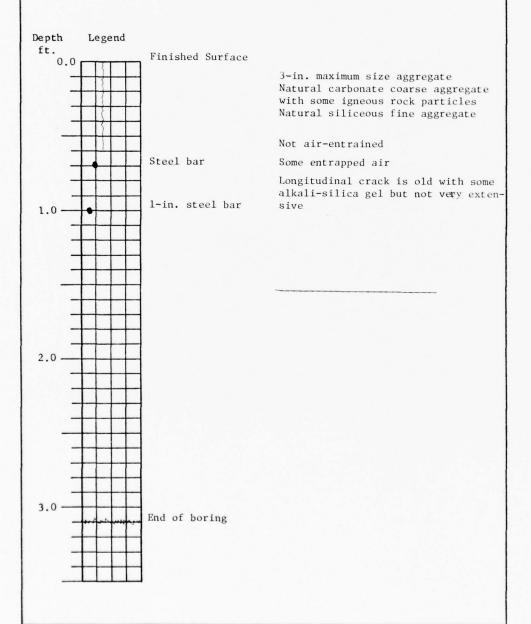
SR WES GW-4-77

Depth Legend ft. 0.0 Finished Surface 3-in. maximum size aggregate Natural carbonate coarse aggregate with some igneous rock particles Natural siliceous fine aggregate Not air-entrained Some entrapped air Longitudinal crack is old with some secondary calcite deposit in voids along crack 1.0 -Concrete is in good condition except for longitudinal crack 2.0 -3.0 -End of boring

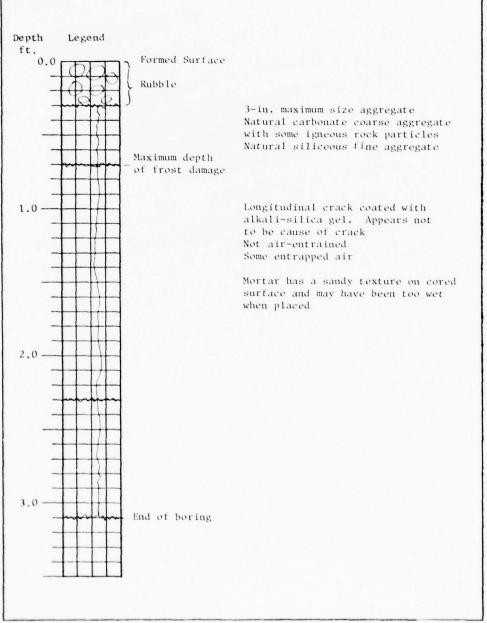
SR WES D-6-77

3-in. maximum size aggregate Natural carbonate coarse aggregate with some igneous rock particles Natural siliceous fine aggregate Longitudinal crack is old

Concrete is in good condition.

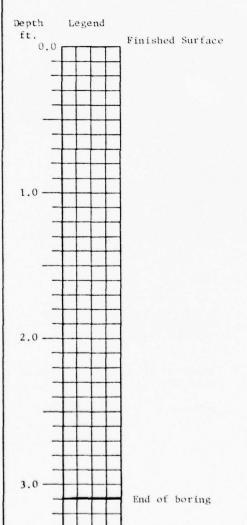
SR WES D-21-77

3-in. maximum size aggregate Natural carbonate aggregate with some igneous rock particles

Natural siliceous aggregate

Concrete is in good condition
