SUSQUEHANNA RIVER BASIN ROARING BROOK, LACKAWANNA COUNTY

NO. 7 DAM

PENNSYLVANIA GAS AND WATER COMPANY (NDS ID No. 363)

PHASE I INSPECTION REPORT

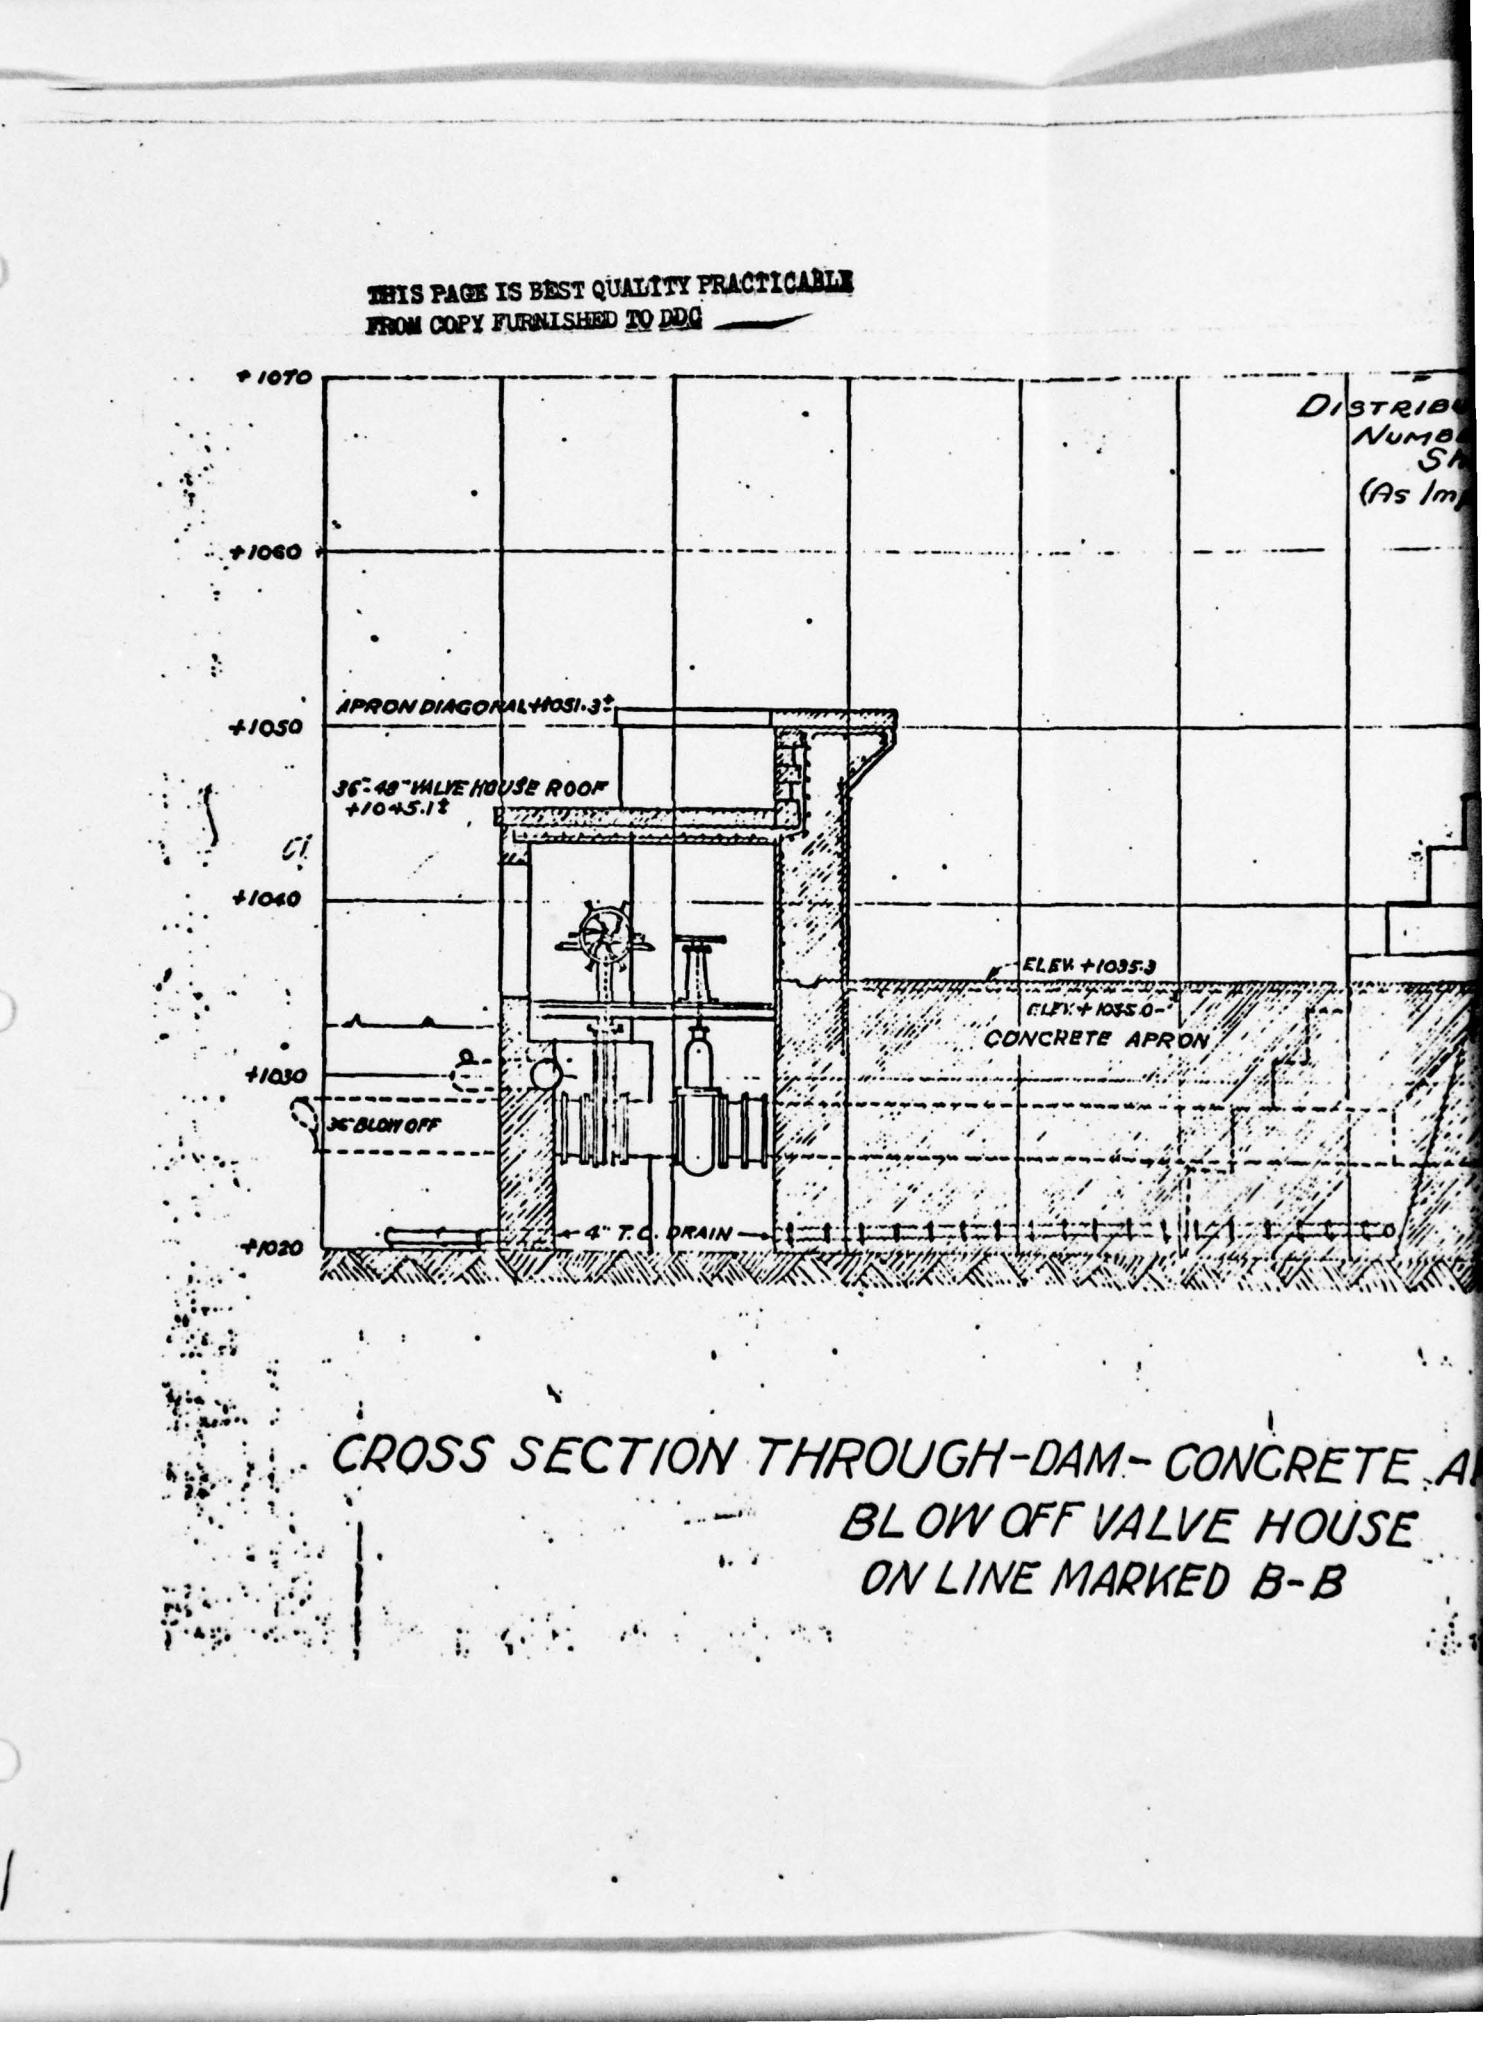
PLATE 5

IEST QUALITY PRACTICABLE FROM COPY FURNISHED TO DDC DISTRIBUTI GRESERVOIRS Number SEVEN DAM Sheet 103 H (As Improved in 1945) Flow 1051.3 ROOF 19:17 ELEV. +1035.3 SONR CONCRETE 1 4 . ECTION THROUGH-DAM- CONCRETE APRON-AND 36-46 BLOW OFF VALVE HOUSE ON LINE MARKED B-B PHASE I INSPECTION REPORT NATIONAL DAM SAFETY PROGRAM ilings 5 NO. 7 DAM PENNSYLVANIA GAS AND WATER COMPANY SPILLWAY CROSS-SECTION (B-B) MAY 1978
