**BIRCH RUN RESERVOIR DAM**

## **PHASE I INSPECTION REPORT**

**NATIONAL DAM INSPECTION PROGRAM**

Name of Dam: BIRCH RUN RESERVOIR DAM  
State & State Number: PENNSYLVANIA - 1-69  
County: ADAMS  
Stream: CONOCOCHEAGUE CREEK, POTOMAC RIVER BASIN  
Date of Inspection: APRIL 20, 1978

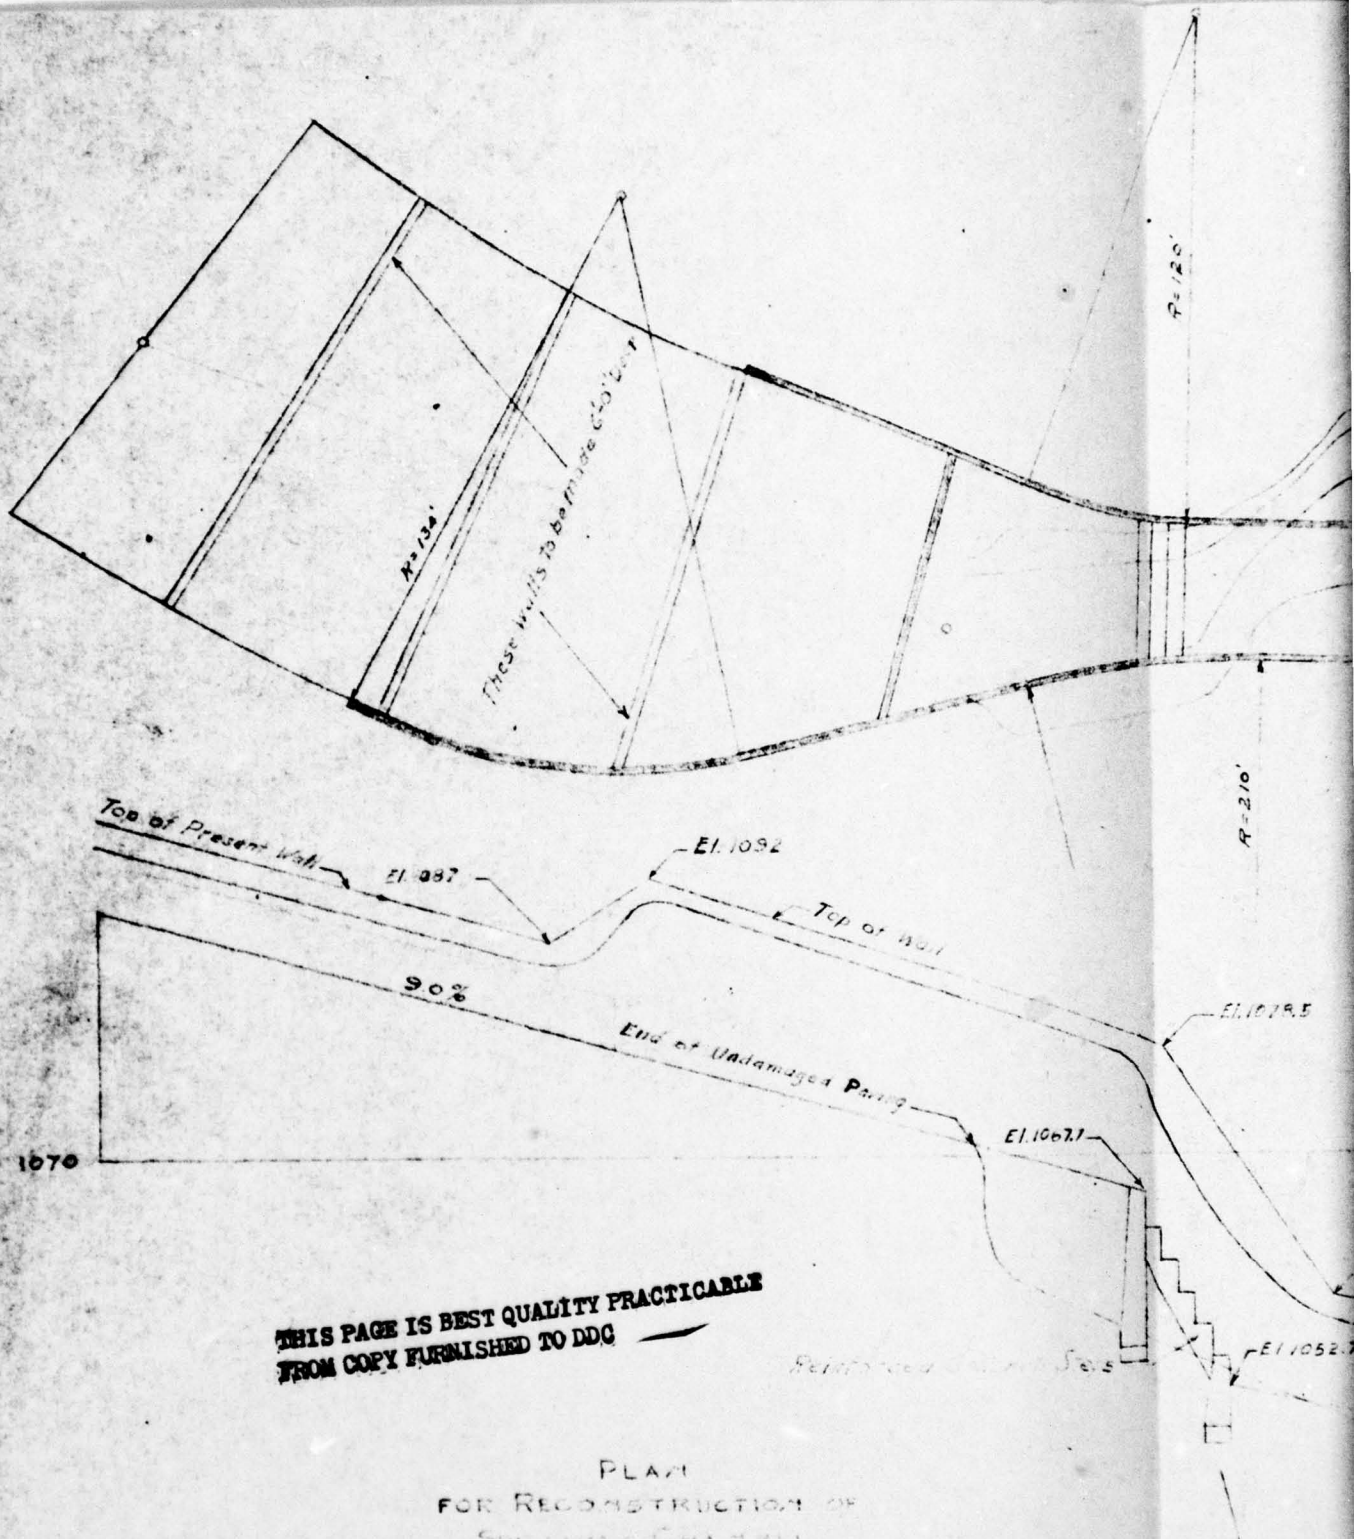
PLATE VI

The ogee section appears to be stable and well founded. The upper part of the spillway chute consists of grouted stone and does have a maintenance problem. A reinforced gunite layer was added and should be sufficient to control this condition. The reinforced concrete walls used below the steps have rather small footings. The width of footings is 5 feet for a total wall and footing height of 11'9". The need for struts indicates that the walls were not stable and future problems can be anticipated. The safety of the facility would, however, not be affected by possible erosion of the spillway (See Plan on Plate V, Appendix D).
