North Fork Dam. (NDS ID Number 234).  
Ohio River Basin, North Fork Bens Creek,  
Somerset County, Pennsylvania.

PHASE I REPORT  
NATIONAL DAM INSPECTION PROGRAM

NAME OF DAM: North Fork Dam  
STATE LOCATED: Pennsylvania  
COUNTY LOCATED: Somerset  
STREAM: North Fork of Bens Creek, tertiary tributary of Conemaugh River  
DATE OF INSPECTION: April 24 and 25 and May 4, 1978

NORTH FORK DAM  
NDS I.D. NO. 234  
APRIL 24 AND 25, 1978

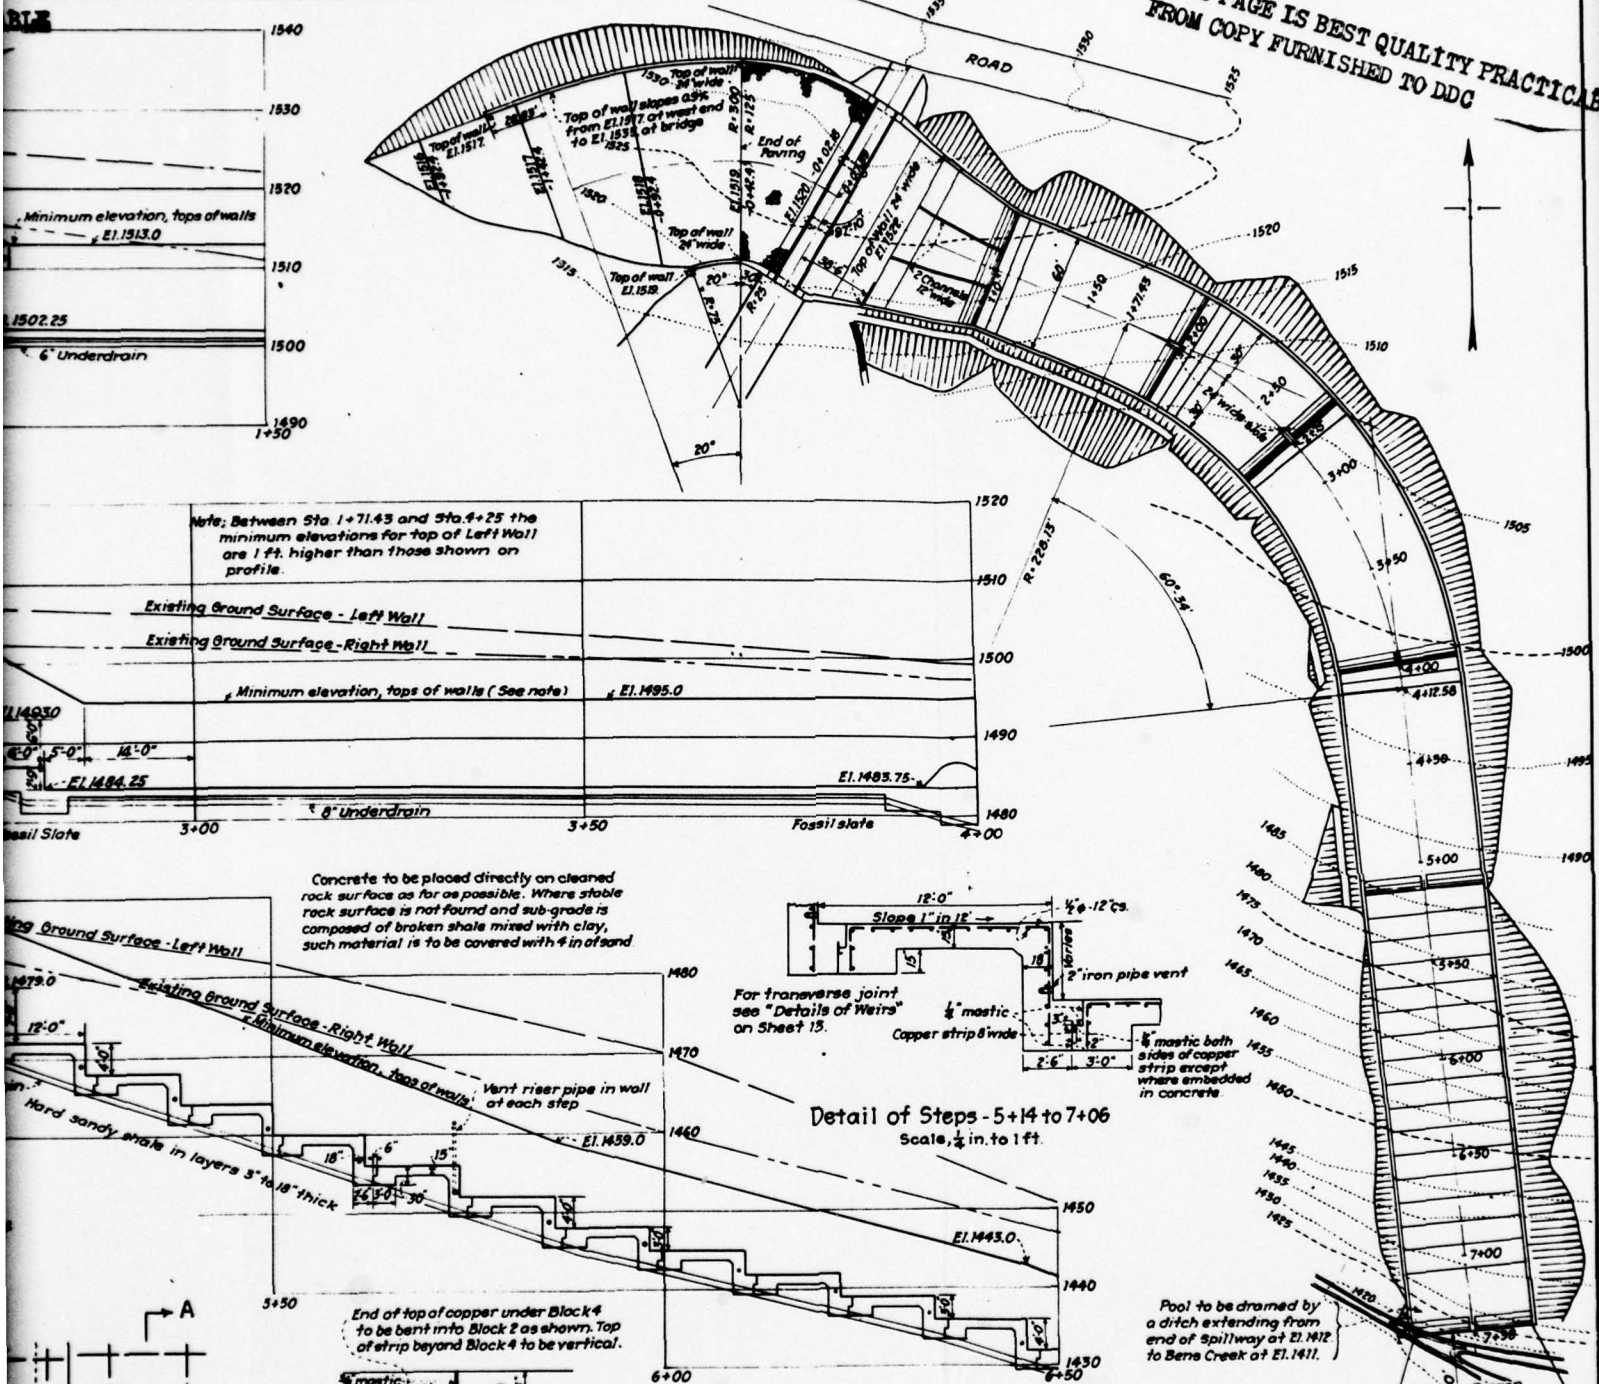
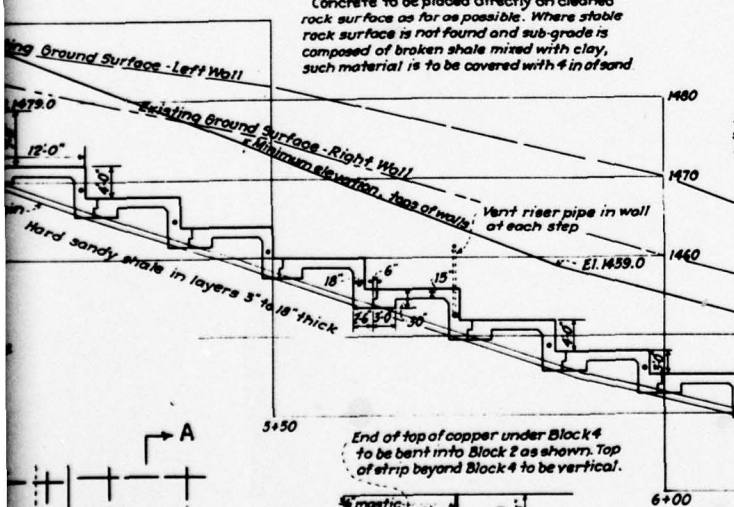
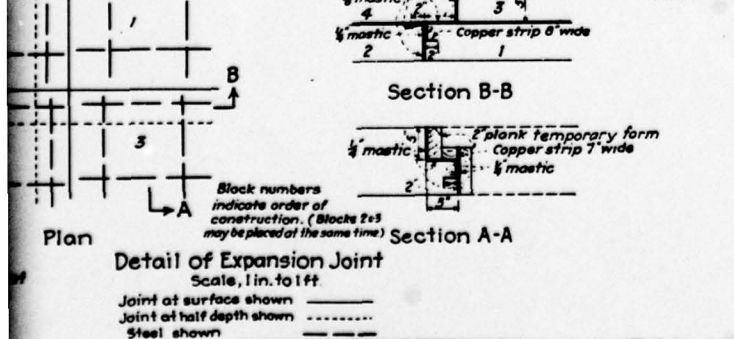
PLATE 6  
**D'APPOLONIA**

In general, the structures were found to be in good condition, except for spalling of concrete at various locations along the spillway channel. At the time of inspection, a gabion wall was under construction to prevent erosion of the sides of the pool at the end of the spillway (Photograph 6).

JOHNSTOWN WATER COMPANY  
— JOHNSTOWN, PENNA. —  
NORTH FORK RESERVOIR  
SPILLWAY CHANNEL  
PLAN AND PROFILE

ASSESSMENT: Based on the evaluation of the conditions as they existed on the dates of inspection and as revealed by visual observations, the condition of North Fork Dam is assessed to be good. However, it is recommended that appropriate repairs be made to stop concrete spalling on the spillway channel walls. The spillway capacity is classified to be "inadequate" (73 percent PMF) based on the recommended criteria. However, it is not considered to be "seriously inadequate" since it can pass flows in excess of 50 percent PMF.

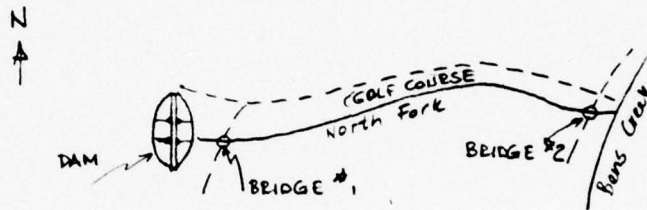
BRIDGE #1

| VISUAL EXAMINATION OF | OBSERVATIONS | REMARKS OR RECOMMENDATIONS |
|--|---|---|
| CONDITION<br>(OBSTRUCTIONS,<br>DEBRIS, ETC.) | TYPICAL STREAM CHANNEL, NO MAJOR<br>OBSTRUCTIONS. | SEE APPENDIX-A FOR<br>SKETCHES OF BRIDGES<br>OVER THE STREAM. |
