SPEERS RUN DAM
NDI Pa - 505 .

PHASE I INSPECTION REPORT,
NATIONAL DAM INSPECTION PROGRAM. ✓

Speers Run Dam

9 June 1978 (visual inspection)

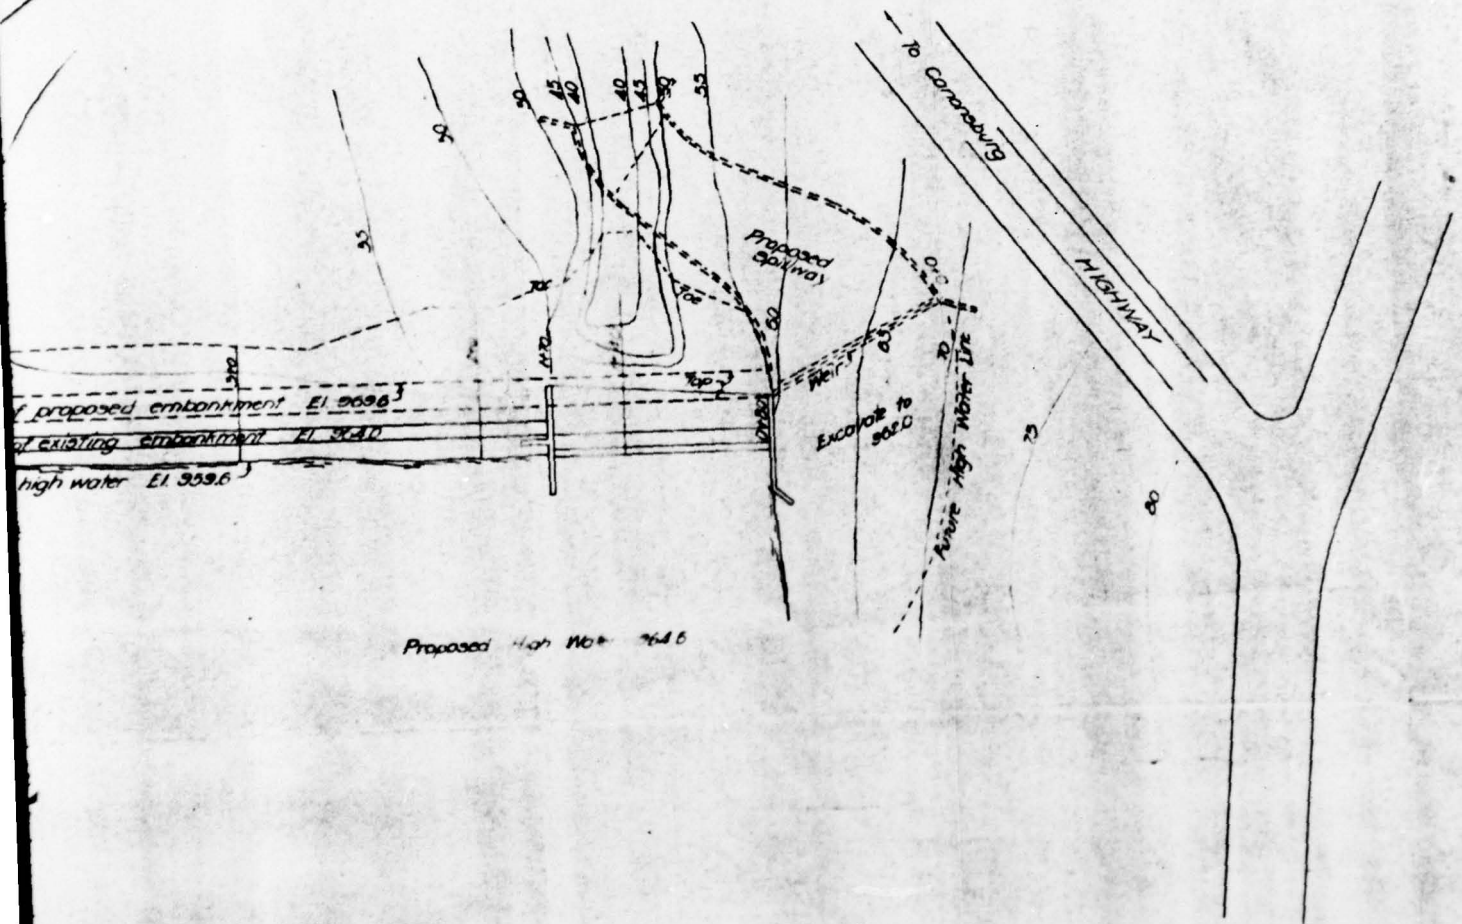
FIGURE 2

Figure 2 of Appendix F shows a plan of the 1927 renovation which included raising the original embankment by 5.6 feet, constructing a new spillway, and raising the intake tower. The top of the embankment as indicated on this drawing was at elevation 964.0 which does not agree with the proposed embankment crest shown on Figure 1 submitted in 1911. Thus, it is possible that the original embankment was not constructed as proposed in Figure 1 or was modified between 1911 and 1927. In addition, the railroad subgrade is indicated on Figure 2 at elevation 965.0+ and the ground contours between the railroad and dam embankment are rather gentle, indicating substantial fill was placed between the two embankments.

1. Embankment. Drawings indicate the embankment was constructed of rolled earthfill with a crest width of 12 feet. The original embankment which was constructed prior to 1927 (no records are available) was incorporated into the present structure and currently functions as a part of the upstream portion of the dam (see Figure 5). Presumably, near the time of construction of the original embankment, the Chartiers Southern Railroad constructed an embankment that ran tangent to the dam at the left end angling downstream as it moved from left to right relative to the dam (see Figure 2).

According to records supplied by PennDER, the Speers Run embankment is 42 feet high. The field survey, however, indicated a maximum height of 21 feet. This condition has apparently resulted from the construction of the railroad embankment which encroached over a portion of the downstream slope of the dam (see Photograph 2 and Figures 2 and 6).

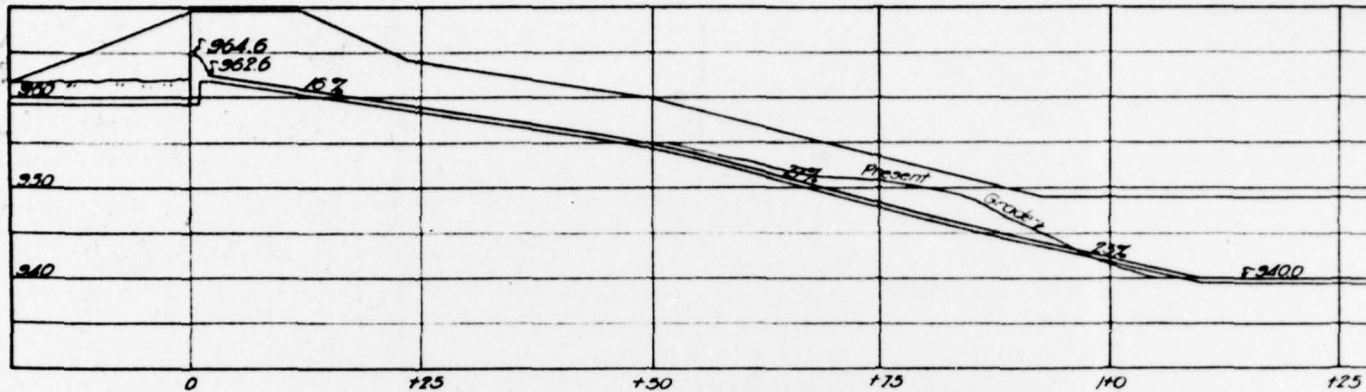
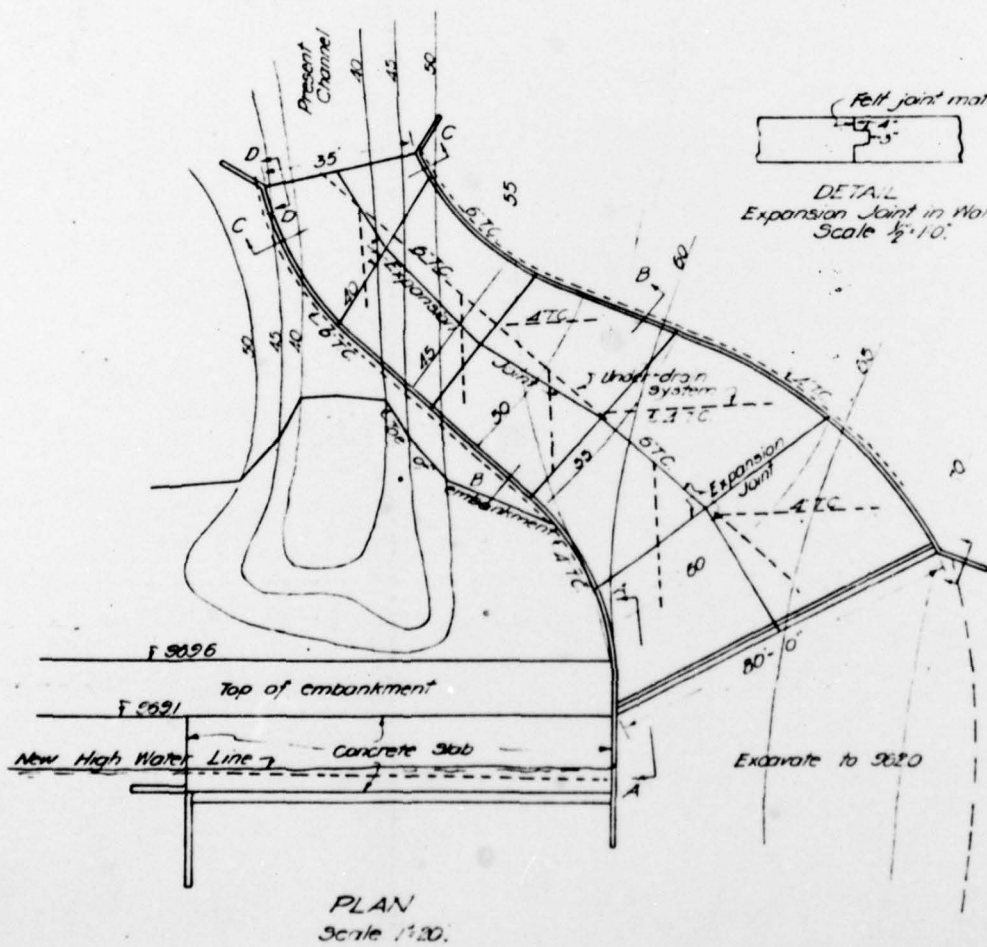
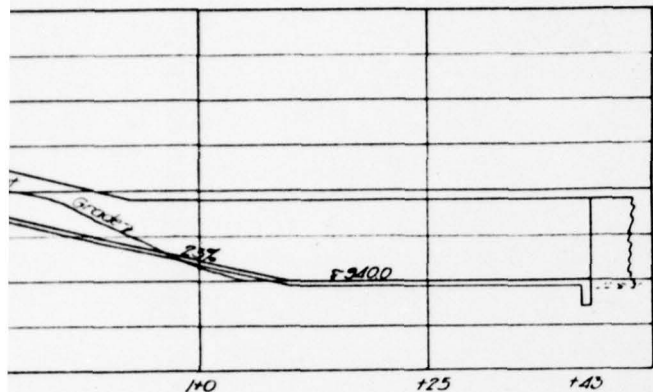
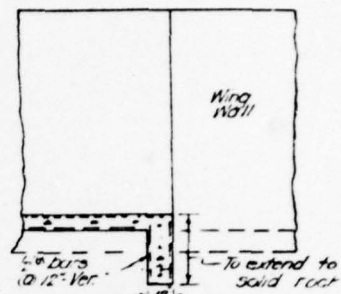
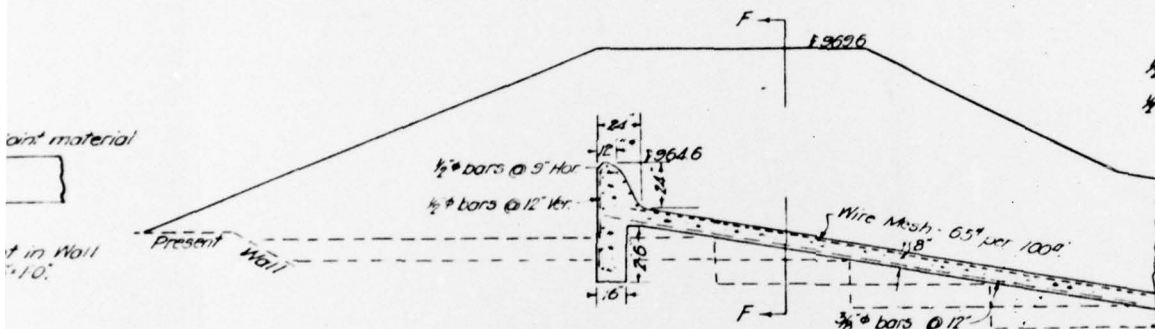
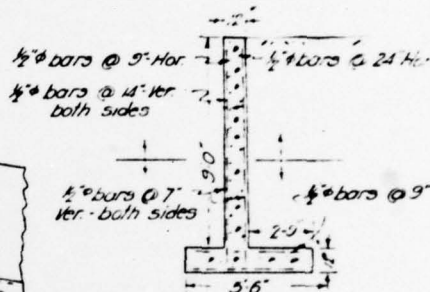
FIGURE 3

Type - One 24-inch blow-off line and one 18-inch supply pipe originate at intake (brick valve chamber) as indicated on Figure 3. Chamber submerged at time of inspection.

During the 1927 renovation, the old spillway structure was sealed with a 5-foot wide puddle trench (presumably extending to impervious material) and a concrete upstream face dowelled into the existing weir crest (see Figure 3).

The intake structure shown on Figure 3 is submerged and cannot be inspected at the present reservoir level. Outlet appurtenances could not be located and as such pose a potentially hazardous condition, since they are under full hydraulic head beneath the embankment and apparently cannot be closed.

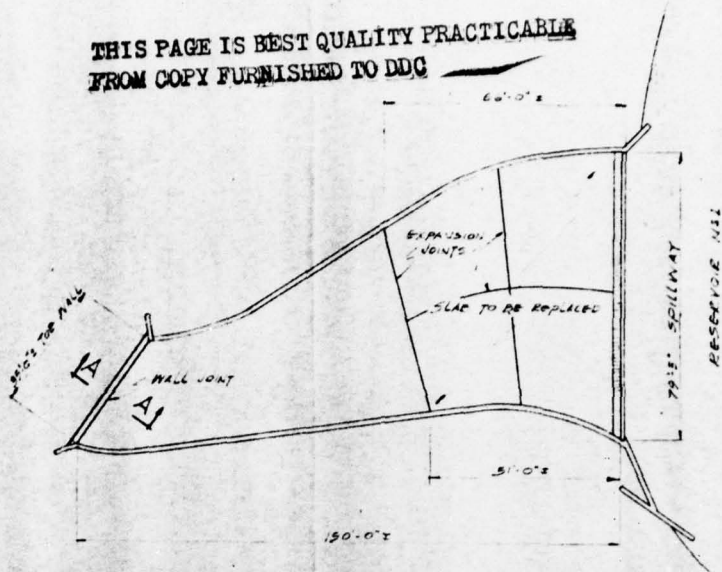
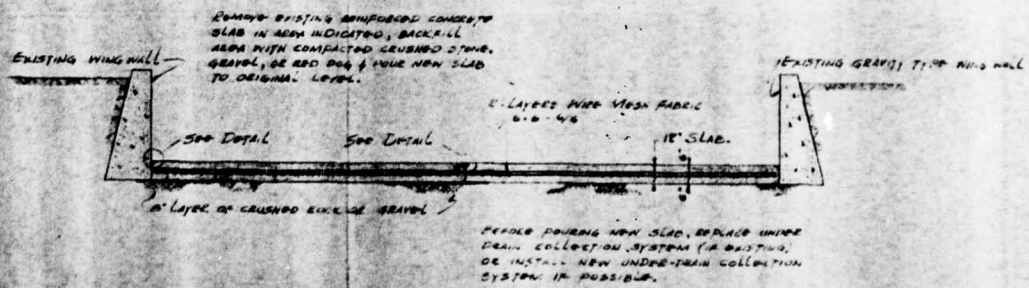
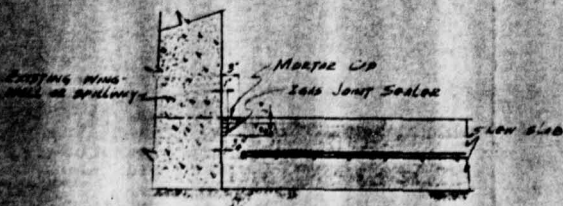
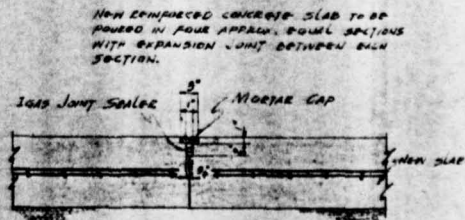
FIGURE 4

a) Spillway. The spillway is a concrete structure with an ogee-shaped crest at the entrance located along the right abutment (see Figures 2 and 4, Photographs 1, 4, and 5).

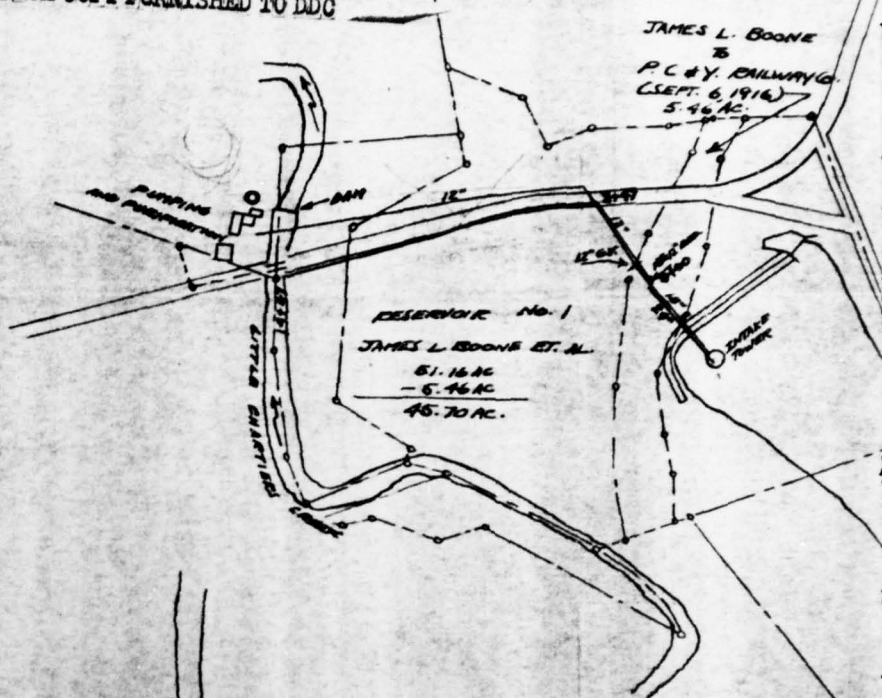
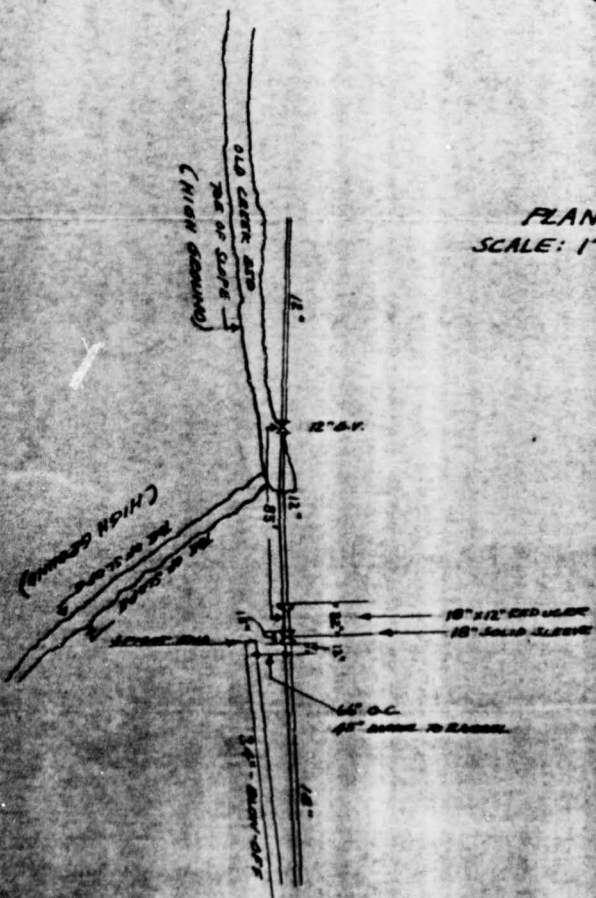
FIGURE 6

b) Outlet Conduits. An 18-inch diameter supply line and a 24-inch diameter blow-off line originate at the intake tower reportedly located along the left side of the embankment. Both lines probably pass beneath both the dam and railroad embankment and reportedly emerge at some point downstream (not located by the field team) (see Figure 6).
