National Dam Inspection Program. Still
Creek Dam (National I.D. Number PA-~~00700~~),
Schuylkill River Basin, Still Creek,
Schuylkill County, Pennsylvania. Phase I
Inspection Report,

STILL CREEK DAM
 SCHUYLKILL COUNTY, PENNSYLVANIA
 NATIONAL I.D. NO. PA 00700

PHASE I INSPECTION REPORT
 NATIONAL DAM INSPECTION PROGRAM

WOODWARD-CLYDE CONSULTANTS
 5120 Butler Pike
 Plymouth Meeting, Pennsylvania 19462

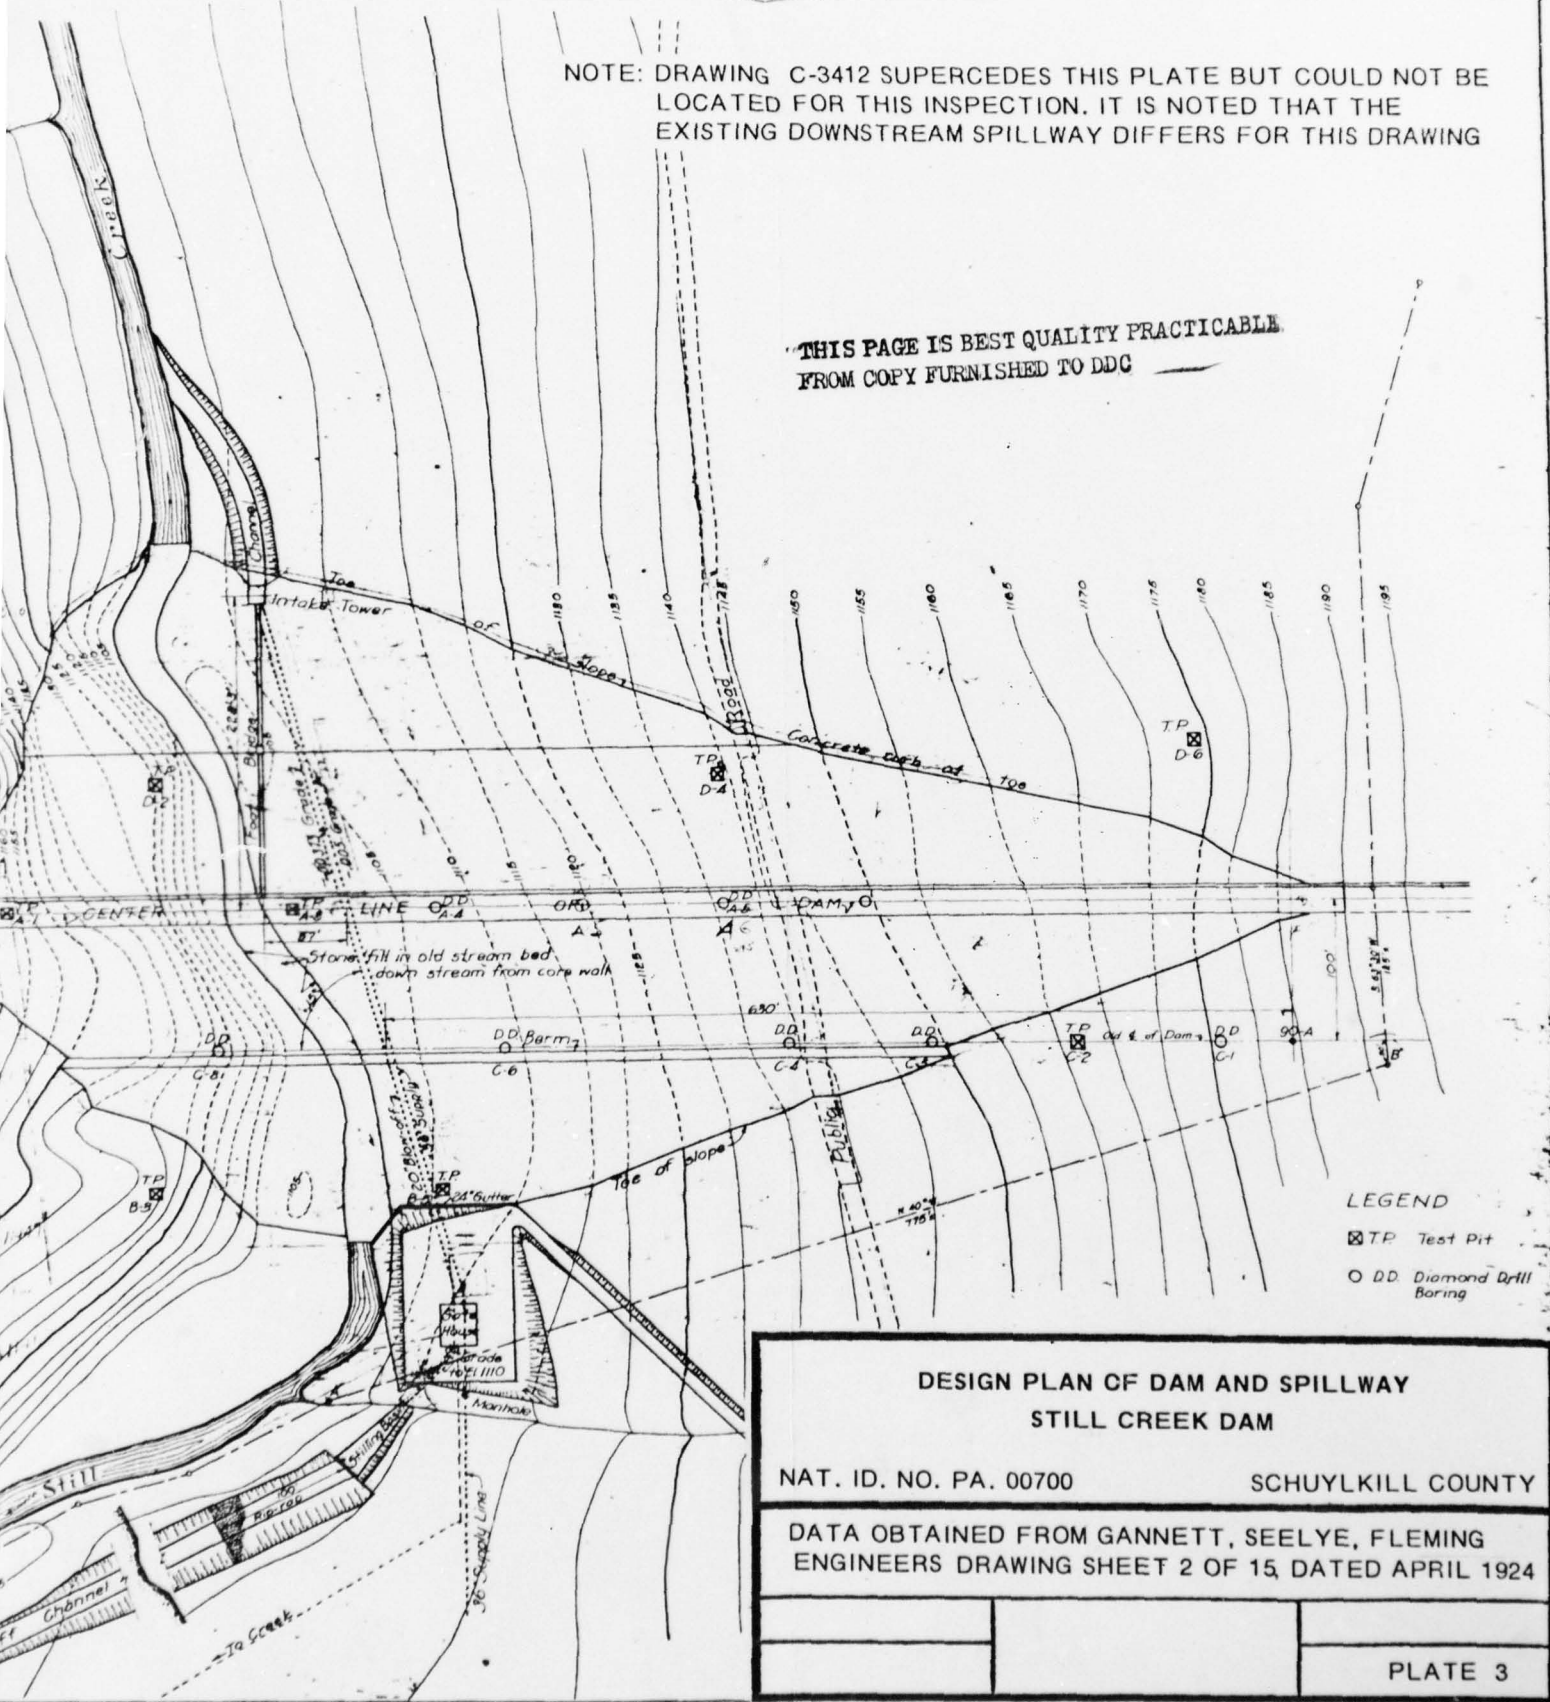
NOTE: DRAWING C-3412 SUPERCEDES THIS PLATE BUT COULD NOT BE LOCATED FOR THIS INSPECTION. IT IS NOTED THAT THE EXISTING DOWNSTREAM SPILLWAY DIFFERS FOR THIS DRAWING
