2 TUBMILL DAM

(ID NO. PA. 488)

4 PHASE I INSPECTION REPORT  
NATIONAL DAM INSPECTION PROGRAM

1268pr D'APPOLONIA CONSULTING ENGINEERS

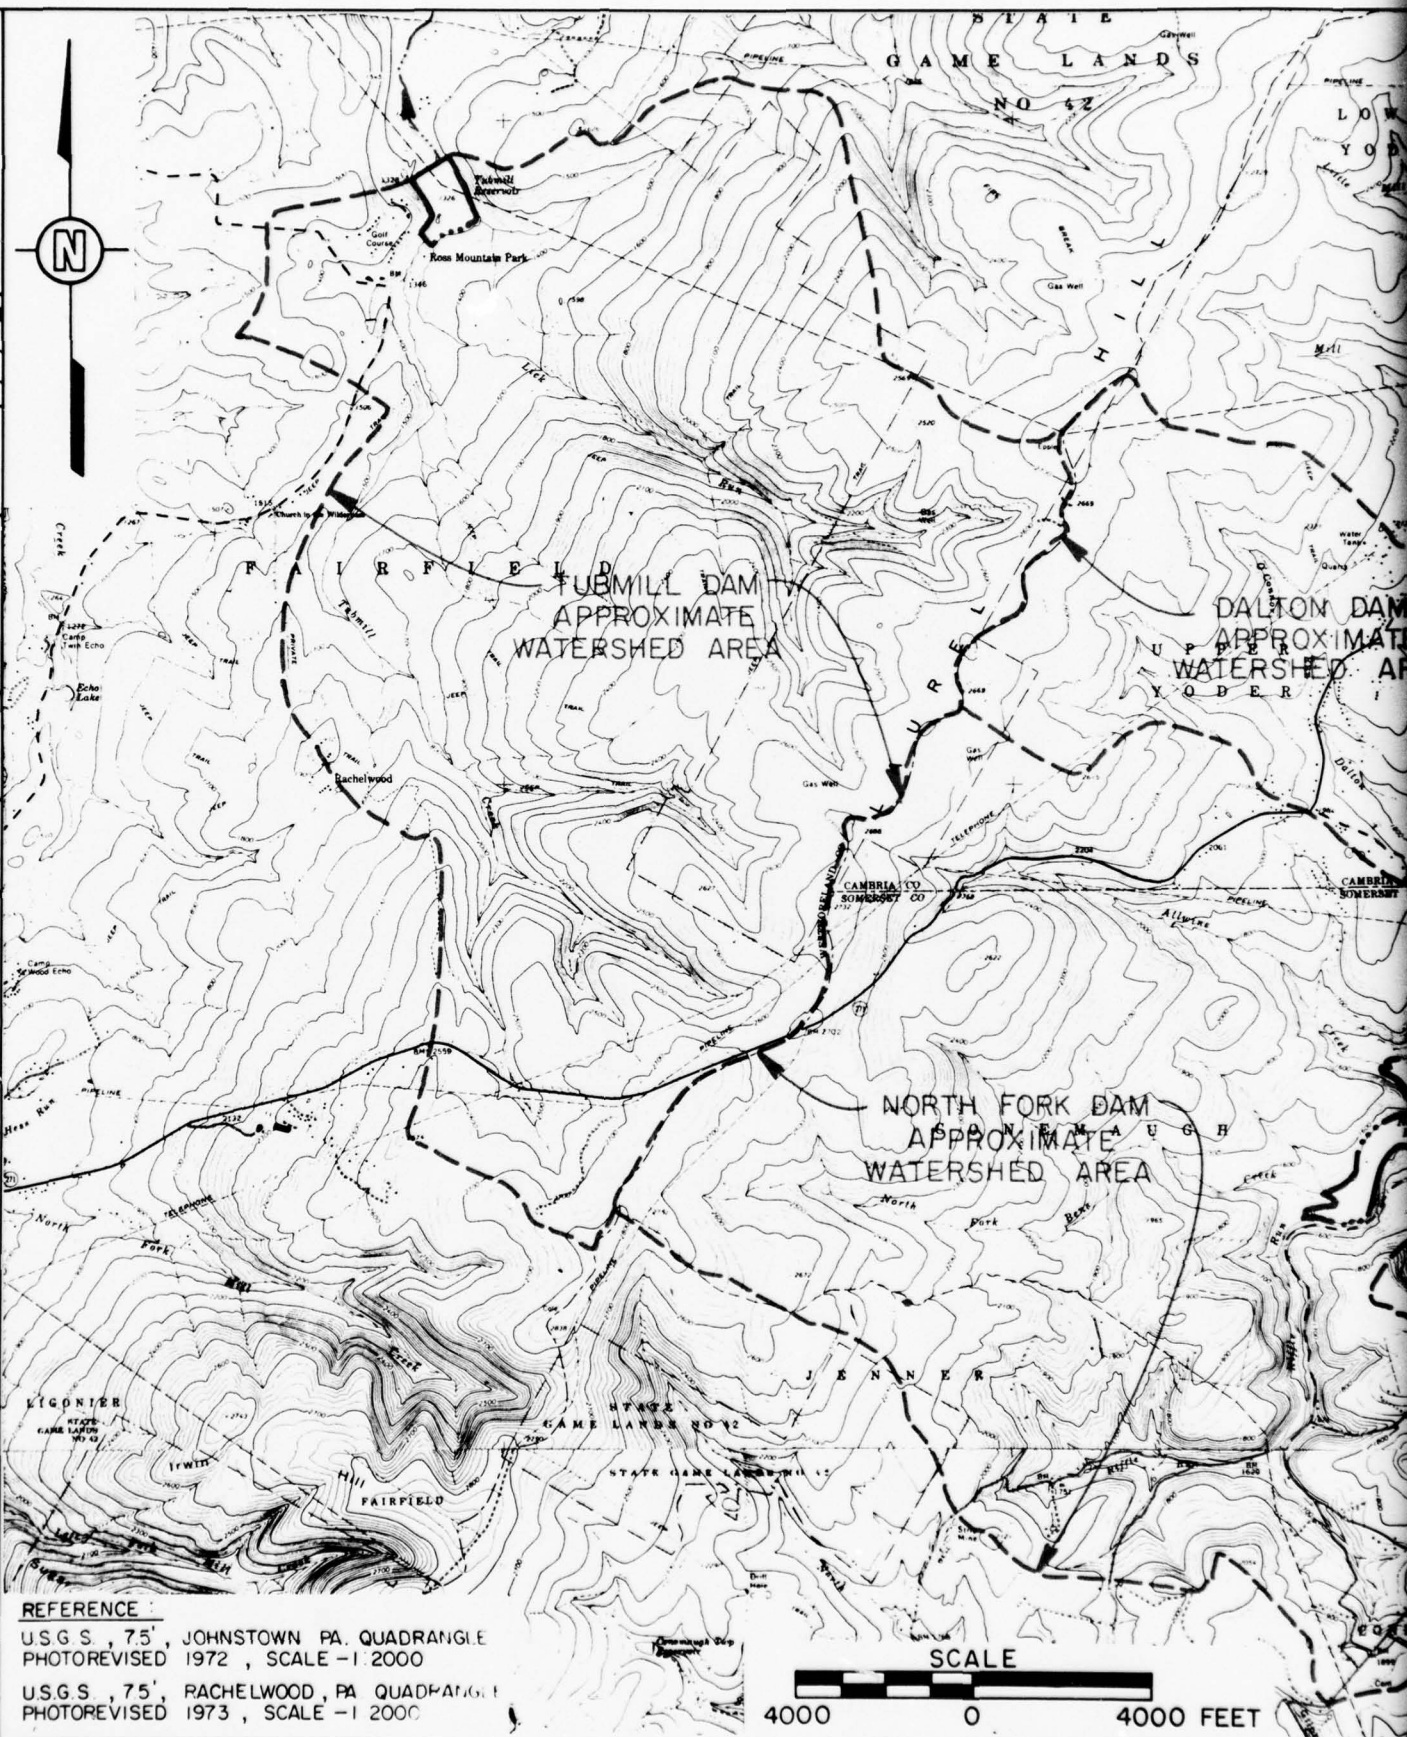
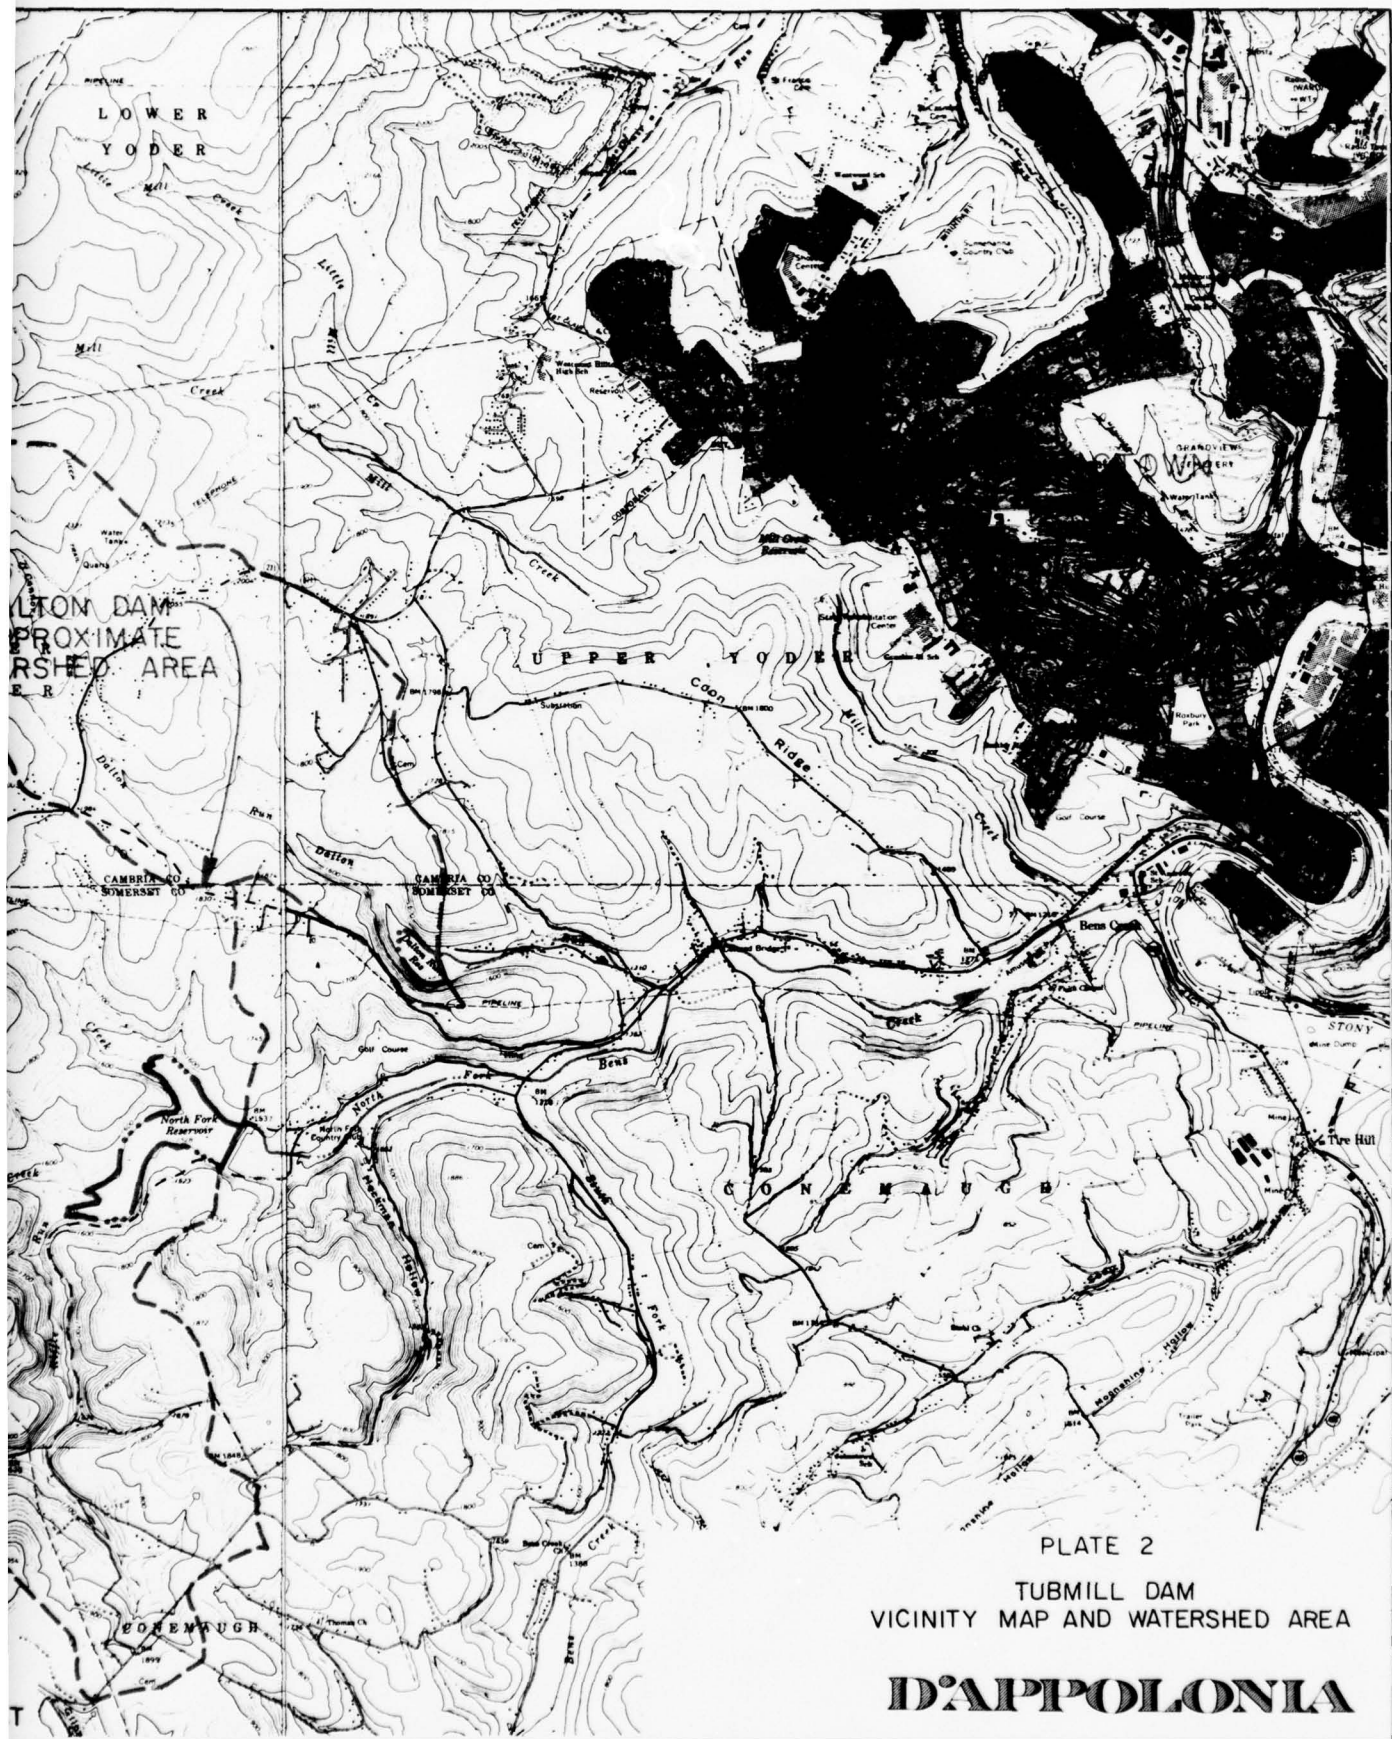
PLATE 2

a. Drainage Area - 10.66 square miles (Plate 2)
