**OHIO RIVER BASIN
SOUTH FORK LITTLE CONEMAUGH, CAMBRIA COUNTY**

LLOYDELL DAM

(ID NO. PA. 500)

**PHASE I INSPECTION REPORT
NATIONAL DAM INSPECTION PROGRAM**

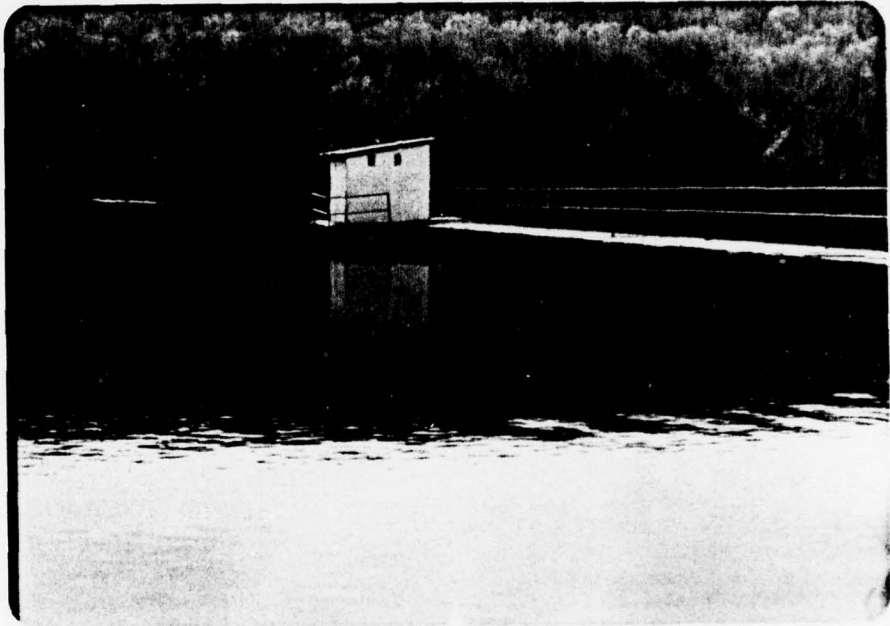
Upstream Face

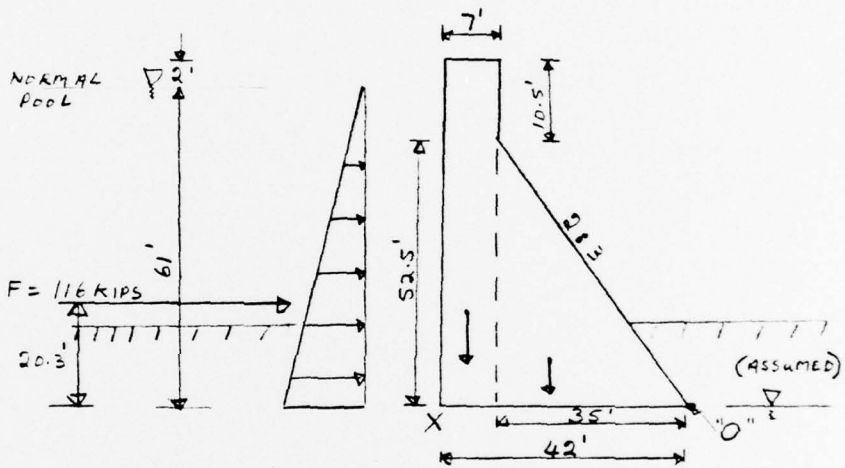
STABILITY WITH RESPECT TO OVERTURNING
— (NORMAL POOL)

ASSUME
2/3 OF HYDROSTATIC
PRESSURE

$$\begin{aligned} \text{PRESSURE AT UPSTREAM END} &= \gamma h \\ &= 62.4 \times 61 = 3806 \text{ PSF} \\ &= 38 \text{ KSF} \end{aligned}$$

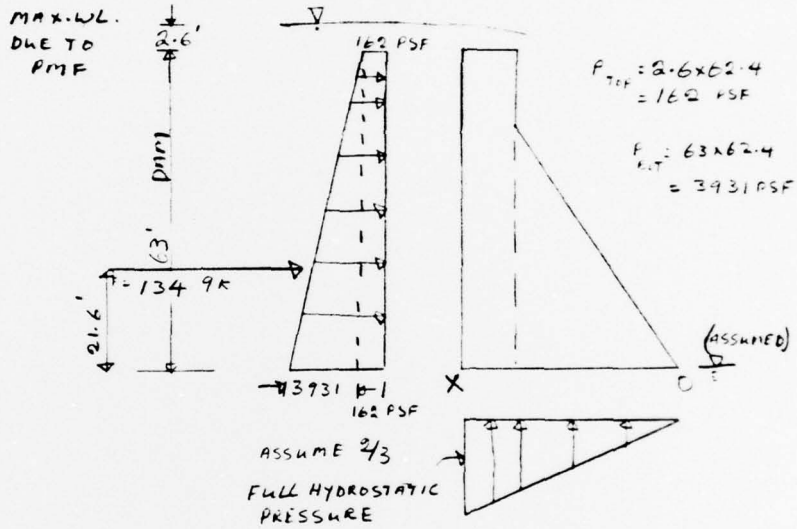
STABILITY WITH RESPECT TO OVERTOPPING

— 2.6' OVERTOPPING DUE TO PMF

TOTAL FORCE = $\frac{1}{2} (3931 \times 63) + 63 \times 162 = 134 \text{ KIPS}$
